WILLIAM STATES LEE III
NUCLEAR STATION UNITS 1 & 2
PMF Hydrograph With Upper Arm Dam
Failure, Make-Up Pond B
FIGURE 2.4.4-203 Rev 6

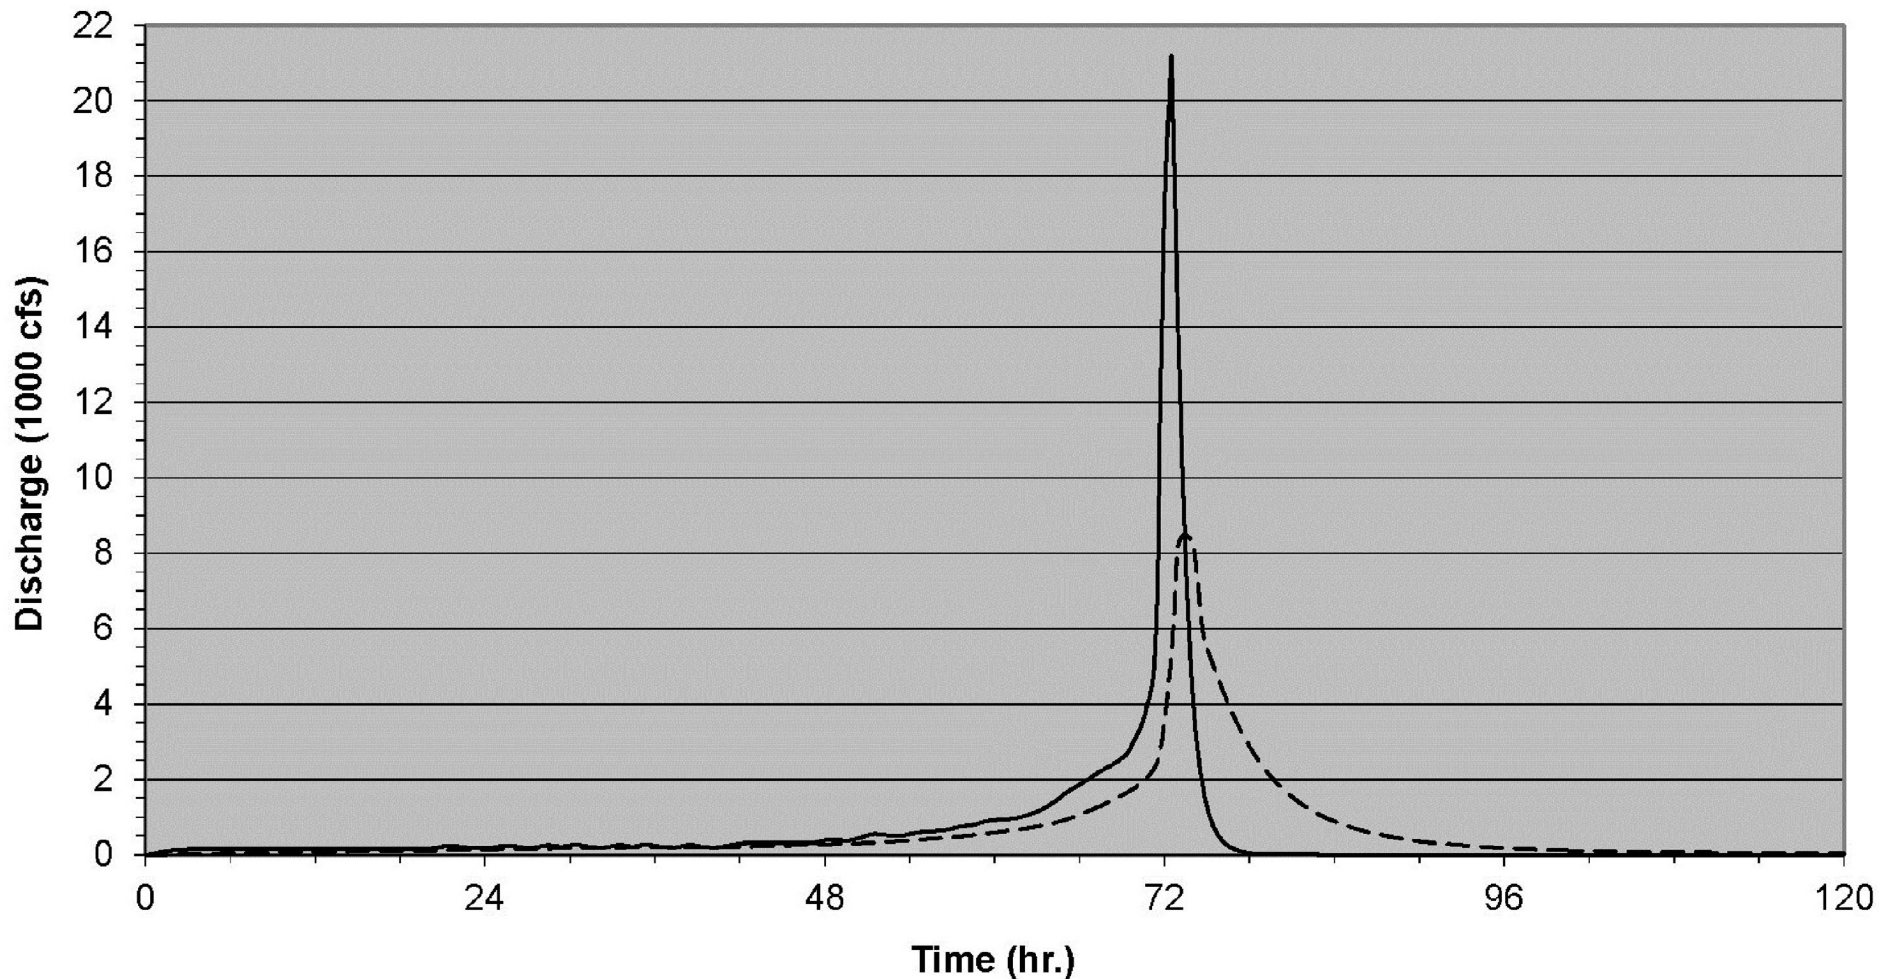
— Inflow Hydrograph - - - Outflow Hydrograph
