WILLIAM STATES LEE III
NUCLEAR STATION UNITS 1 & 2

FIGURE 2.4.4-204 Rev 6

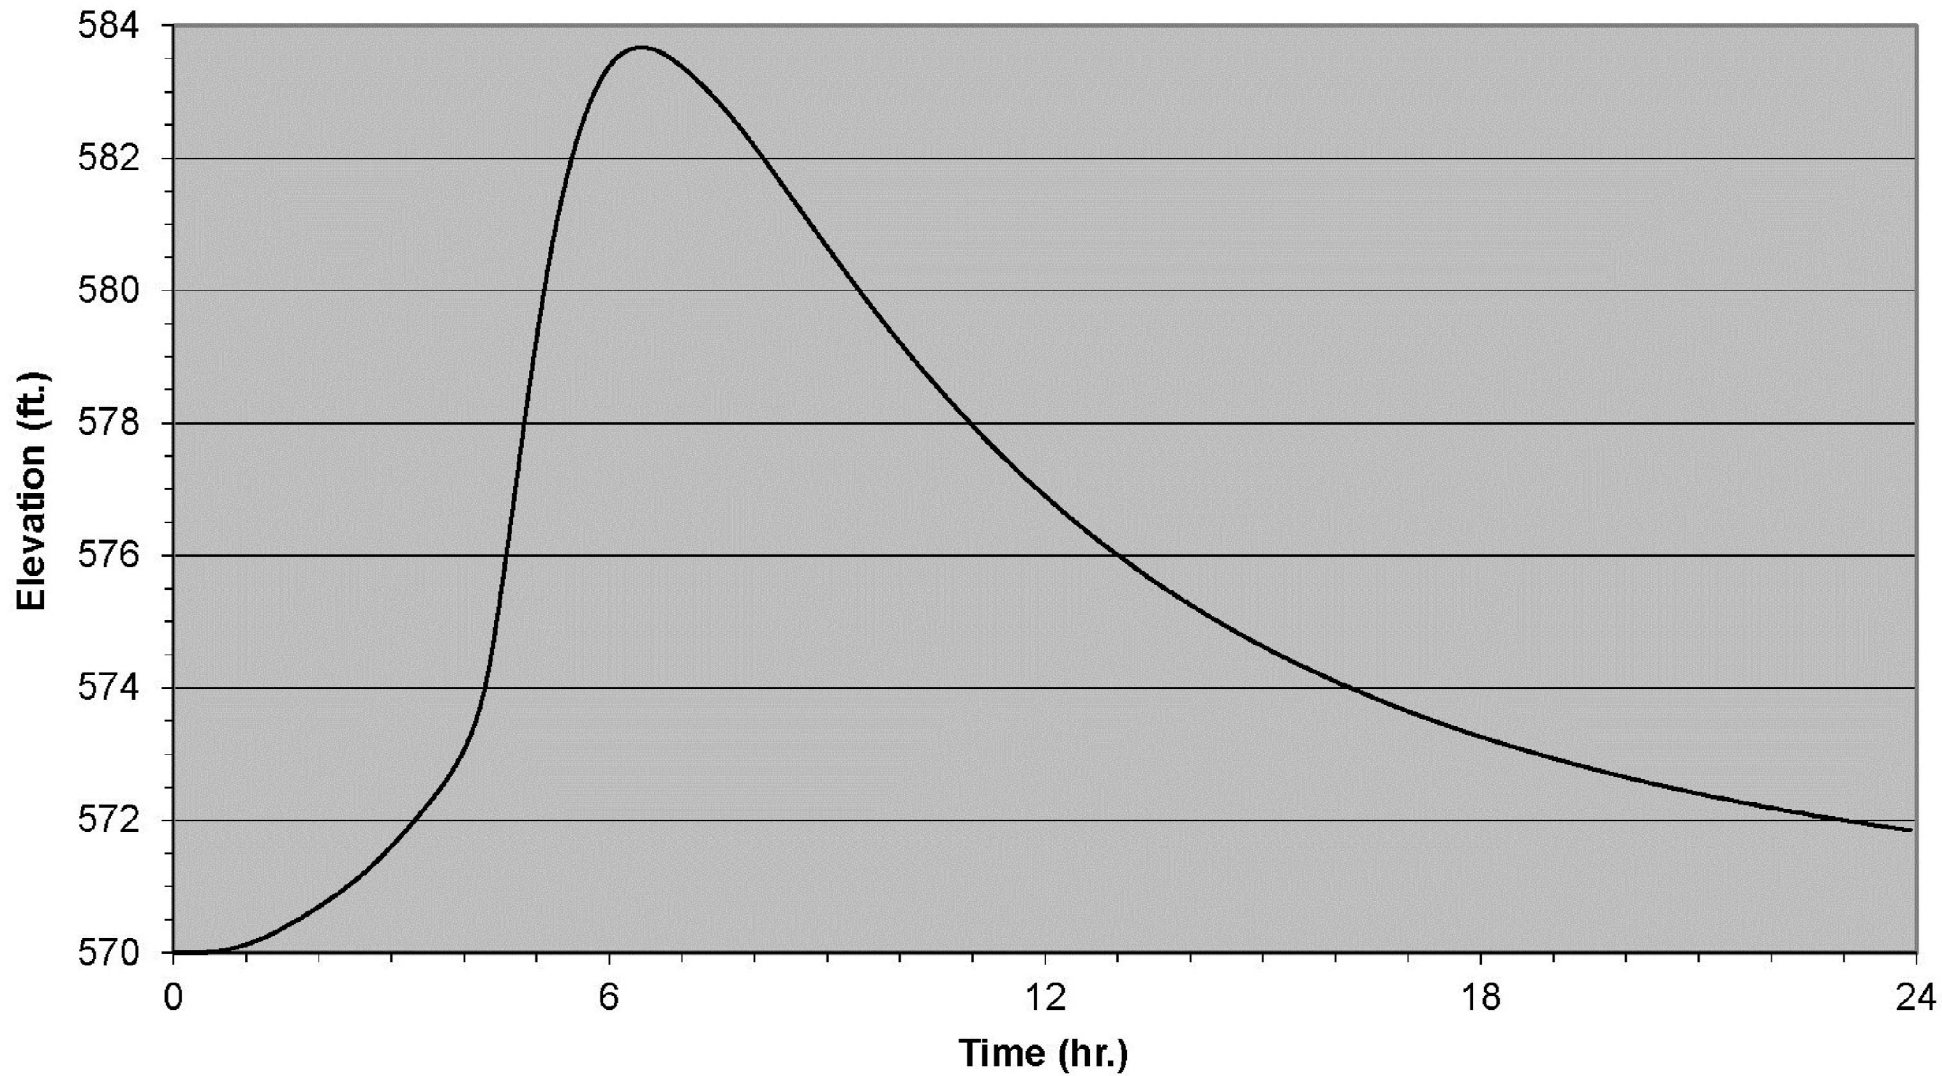
Flood El. Hydrograph Make-Up Pond B
With Upper Arm Dam Failure,
6-hr. Local Intense Precipitation
