In the Matter of: Entergy Nuclear Operations, Inc.  
(Indian Point Nuclear Generating Units 2 and 3)

EPA 600/R-11/014 | May 2011 | [www.epa.gov/ord](http://www.epa.gov/ord)

# Empire Abrasive Blast N'Vac for Radiological Decontamination

## TECHNOLOGY EVALUATION REPORT

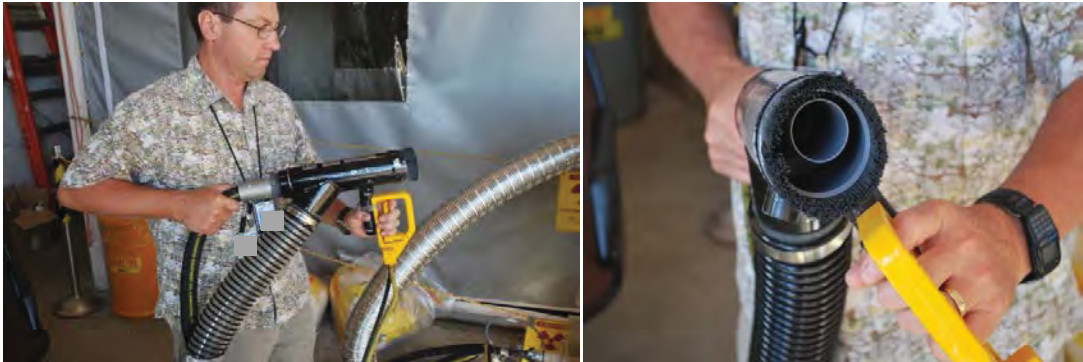
**Figure 2-1. Blast N'Vac as assembled for testing (left). Close-up of Blast N'Vac vacuum head (right).**

Figure 2-1 shows the Blast N'Vac blasting gun used during this evaluation. The photograph on the right clearly shows the inner blasting head and the vacuum shroud surrounding the blasting head. Figure 2-2 shows (from left to right) the abrasive grit reservoir, the high efficiency particle air (HEPA) filter, and the abrasive grit collection drum situated on a skid. The Blast N'Vac can also be equipped to recycle abrasive grit continuously, but that feature was not used during this evaluation in order to minimize the amount of equipment at risk of becoming contaminated with radiological material. Therefore, the abrasive grit was blasted and collected for disposal in the collection drum. All components in Figure 2-2 were successfully protected from contamination and were returned following the evaluation.

Blast N'Vac is a heavy duty abrasive grit blasting technology that also collects the spent abrasive grit by means of a blasting head surrounded with a vacuum collection shroud. During this evaluation, the Blast N'Vac was used with size 24 aluminum oxide abrasive grit. The Blast N'Vac was powered entirely by compressed air. An Ingersoll-Rand 75902 diesel-powered air compressor provided approximately 400 cubic feet per minute (cfm) of compressed air at approximately 120 pounds per square inch (psi). The Blast N'Vac is plumbed to provide not only an adequate amount of compressed air to perform the abrasive grit blasting but also adequate suction to perform the abrasive grit recovery. The air compressor was not provided by Empire Abrasive, but is considered a required utility for operation of the technology. In addition, while not tested as part of this evaluation, the Blast N'Vac came equipped with blasting heads shaped specifically for work in corners.

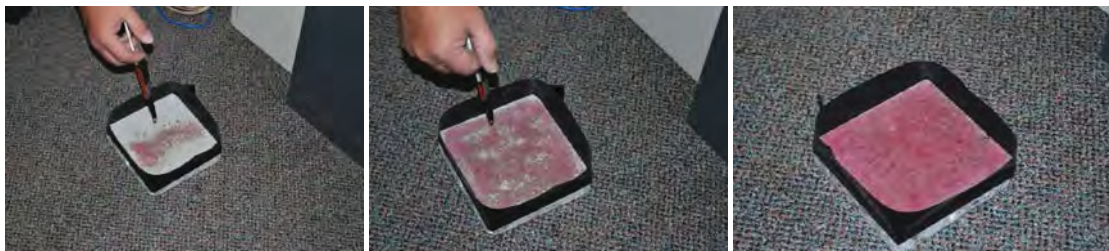
**Figure 3-1. Demonstration of contaminant application technique.**

The aerosol delivery device was constructed of two syringes. The plunger and needle were removed from the first syringe and discarded. Then, a compressed air line was attached to the rear of the syringe. The second syringe contained the contaminant solution and was equipped with a 27 gauge needle, which penetrated through the plastic housing near the tip of the first syringe. Compressed air flowing at a rate of approximately 1 - 2 L per minute created a turbulent flow through the first syringe. When the contaminant solution in the second syringe was introduced, the solution became nebulized by the turbulent air flow. A fine aerosol was ejected from the tip of the first syringe, creating a controlled and uniform spray of fine liquid droplets onto the coupon surface. The contaminant spray was applied all the way to the edges of the coupon, which were taped (after having previously been sealed with polyester resin) to ensure that the contaminant was applied only to the surfaces of the coupons. The photographs in Figure 3-1 show this procedure being performed using a nonradioactive, nonhazardous aqueous dye to demonstrate that the 2.5 mL of contaminant solution is effectively distributed across the surface of the coupon.

Eight coupons were contaminated by spiking individually with 2.5 milliliters (mL) of aqueous solution that contained 0.26 milligrams (mg)/liter (L) Cs-137 as a solution of cesium chloride, corresponding to an activity level of approximately 1 microCurie ( $\mu\text{Ci}$ ) over the 225 cm<sup>2</sup> surface. Application of the Cs in an aqueous solution was justified because even if Cs were dispersed in a particle form following a radiological dispersion device (RDD) or “dirty bomb” event, morning dew or rainfall would likely occur before the surfaces could be decontaminated. In addition, from an experimental standpoint, it is much easier to apply liquids, rather than dry particles, homogeneously across the surface of the concrete coupons. The liquid spike was delivered to each coupon using an aerosolization technique developed by INL (under a DARPA/DHS project<sup>2</sup>) and described in detail in the test/QA plan, and then allowed to age for seven days.

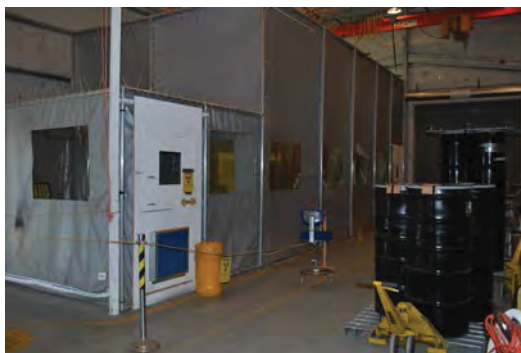
**Figure 3-2. Containment tent: outer view (left) and inner view with test stand containing contaminated coupons (right).**

To evaluate the decontamination technologies on vertical surfaces (simulating walls), a stainless steel test stand was fabricated that held three rows of three concrete coupons. A test stand, approximately 9 feet (ft) × 9 ft, was erected within a containment tent. The concrete coupons were placed into holders so their surfaces extended just beyond the surface of the stainless steel face of the test stand. Eight of the nine coupons placed in the test stand were contaminated with Cs-137, which has a half-life of 30 years. One uncontaminated coupon was placed in the bottom row of the test stand and decontaminated using the Blast N'Vac in the same way as the other coupons. This coupon was placed there to observe possible secondary contamination caused by the decontamination higher on the wall. Figure 3-2 shows the containment tent and the test stand loaded with the concrete coupons.

The containment tent consisted of two rooms. One room contained the test stand to hold the contaminated coupons and the other room (the shorter part of the tent as shown in Figure 3-2) held the collection drum. The abrasive grit hoses (both blasting and vacuum) connected to the blasting head in the room with the test stand through a small opening in the tent wall between the two rooms. The abrasive grit reservoir and air compressor were located outside the containment tent. The positive pressure blasting hose was connected directly to the blasting head through a small opening in the outer tent wall, through the smaller room, and also through a small opening in the tent wall between the two rooms. The vacuum line was connected first to the collection drum and then to the collection shroud surrounding the blasting head, through the same openings in the tent. Each of the tent openings was taped closed around the hoses. Figure 3-3 shows the smaller diameter blasting hose and the larger diameter vacuum hose connecting to the blasting head as the operator applies the Blast N'Vac to a concrete coupon.

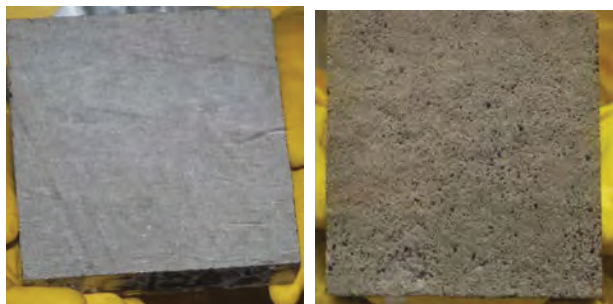
**Figure 5-1. Test coupon surfaces before (left) and after (right) treatment with the Blast N'Vac.**

A number of operational factors were documented by the Blast N'Vac operator. One of the factors was damage to the surface of the concrete coupons. Figure 5-1 shows photographs of a coupon before and after blasting with the Blast N'Vac. The surface of the coupon

at the right has been removed by the Blast N'Vac and the aggregate layer of concrete has been exposed. This is evidenced by the large pieces of gravel and sand that are visible. Because of the extensive surface removal, the effectiveness of the Blast N'Vac will have to be weighed against the amount of surface damage caused by the decontamination technology.

<b>Surface damage</b>	<p>Surface removed and aggregate exposed. See description and photograph in text.</p>
<b>Cost</b>	<p>As evaluated, the price of the Blast N'Vac would be \$11,840. This price includes the blasting equipment only and not the compressed air required for operation or the blasting grit.</p>
