Seismic Walkdown Checklist (SWC)

Equipment Description ACCW HEAT EXCHANGER

Equipment Description AFW Pump Motor Driven

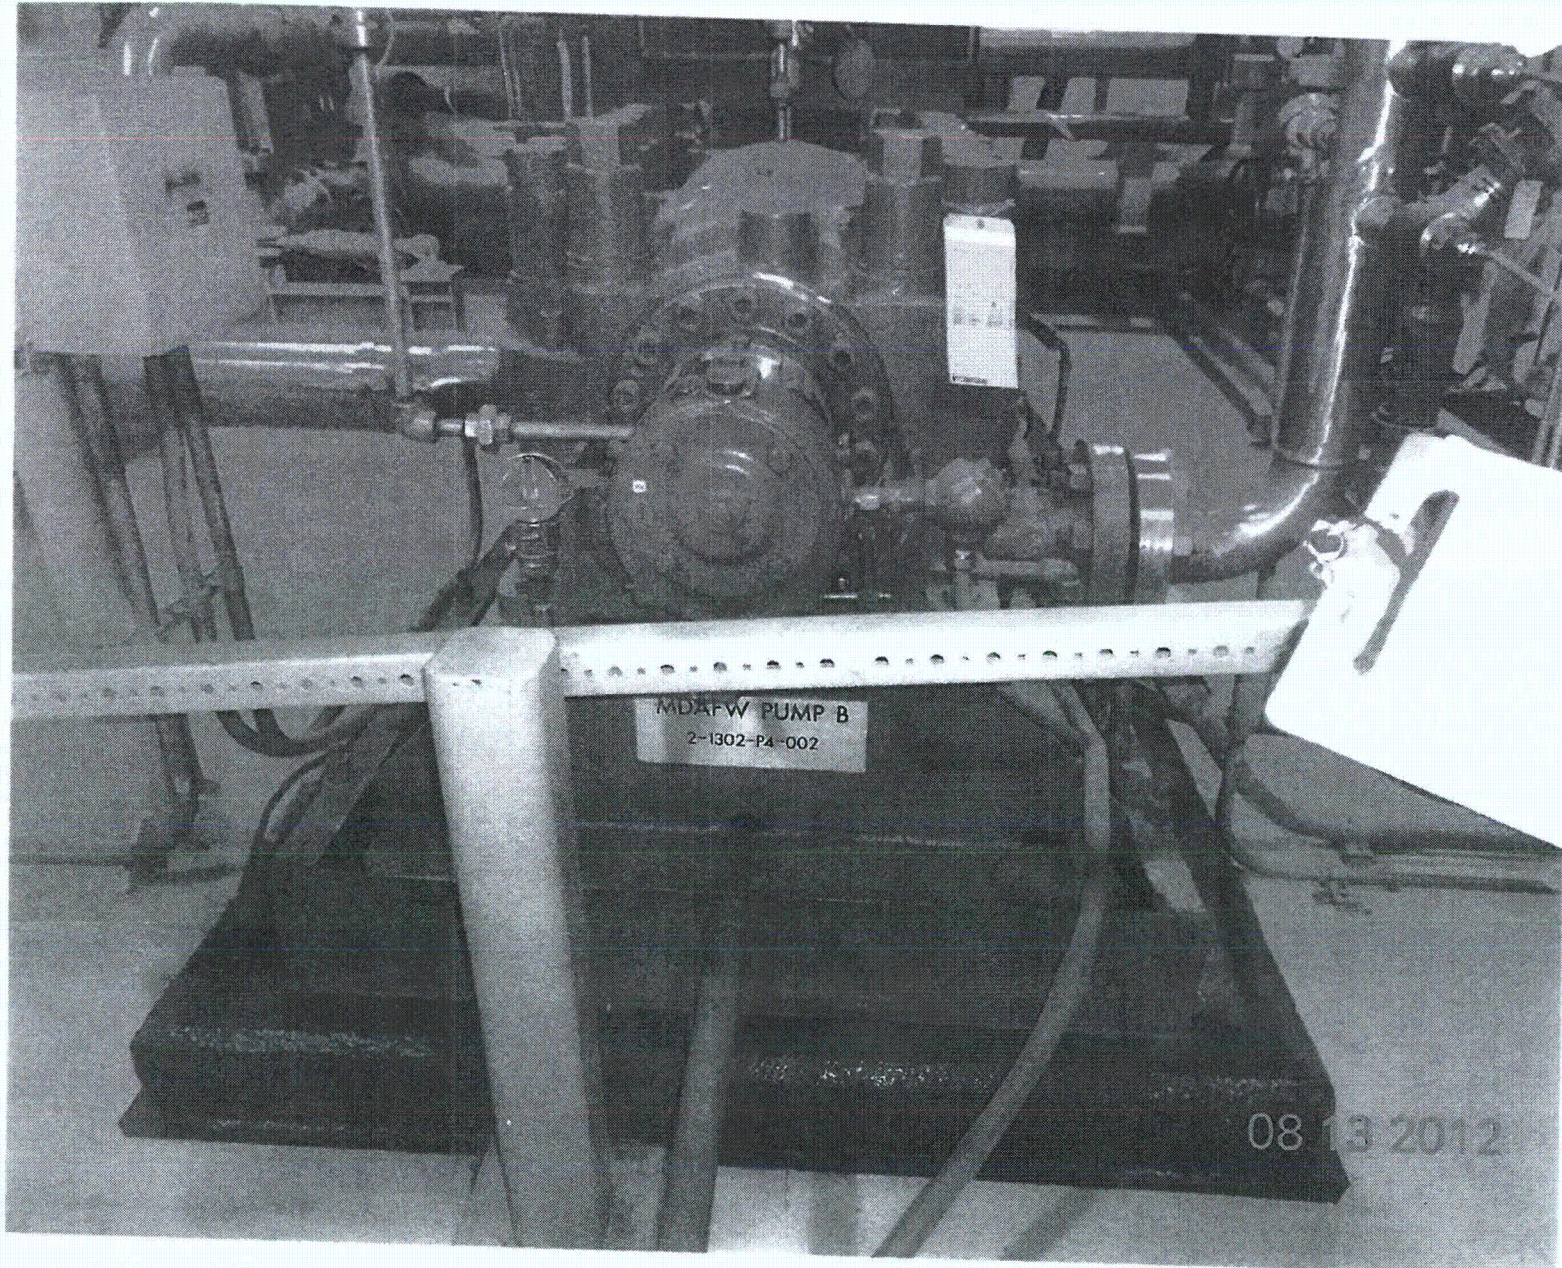
8-13-2012 DV
7. Are soft targets free from impact by nearby equipment or structures? Y N U N/A
USED FOR HOLDING
Bucket held the suspended chain for overhead
monorail is acceptable.

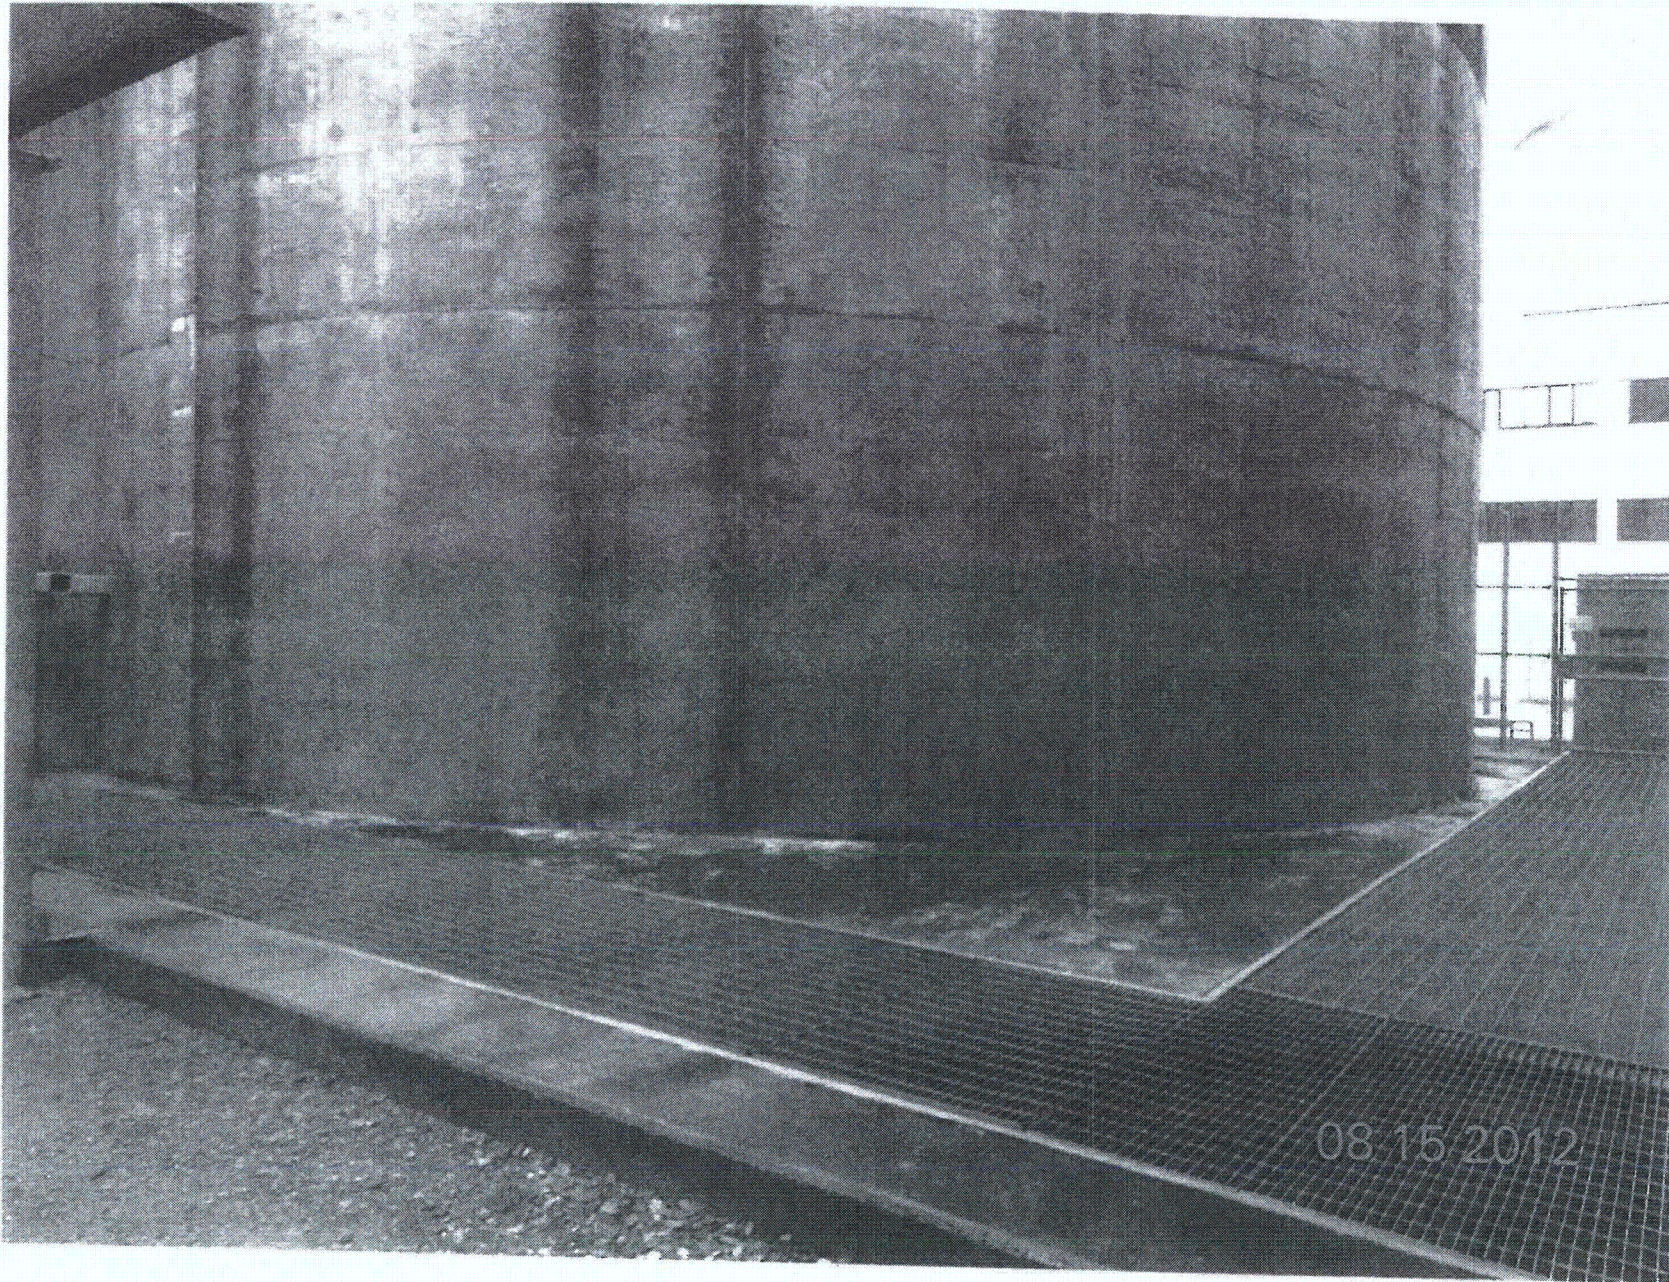
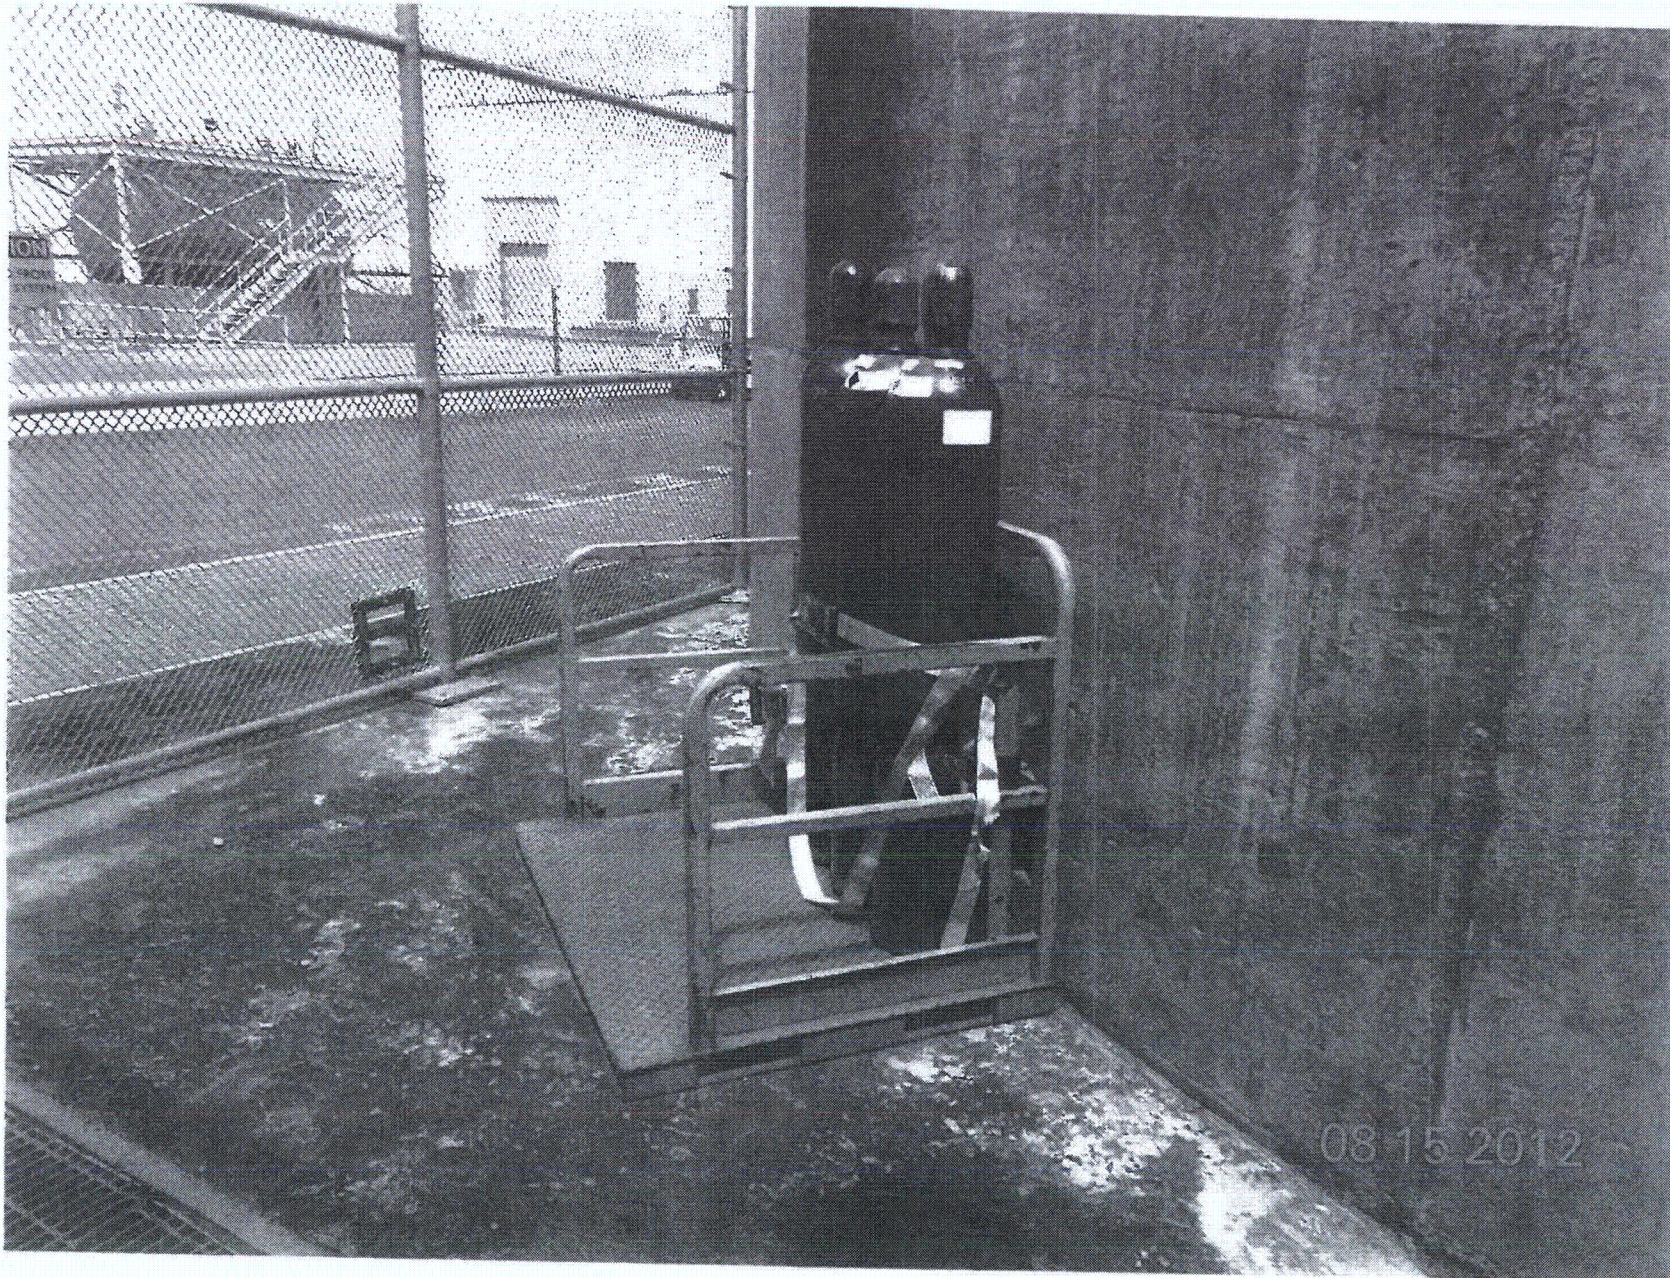
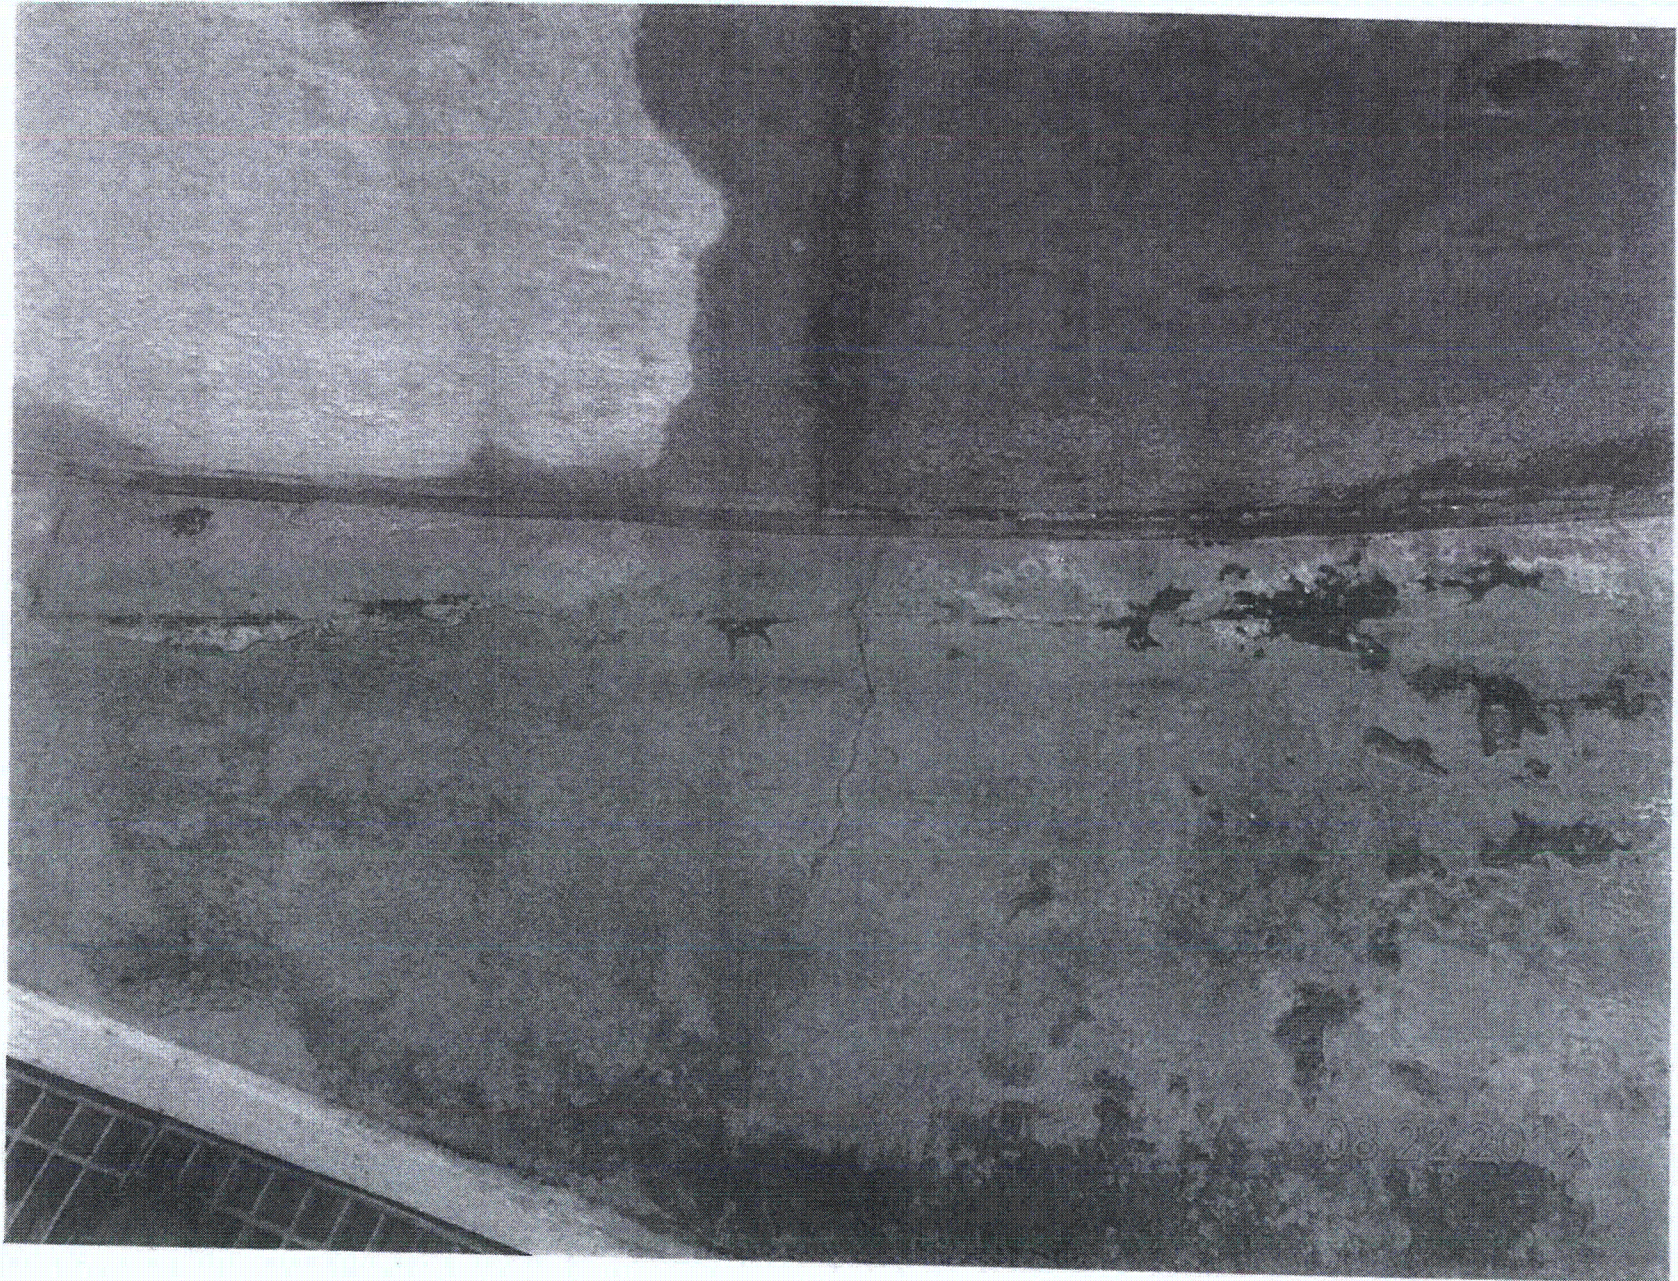
The tank is concrete shell structure. Tank shell on top of concrete foundation has no sign of degradation or structural cracks. The hairline crack is superficial and no effect to the integrity of tank and is acceptable.

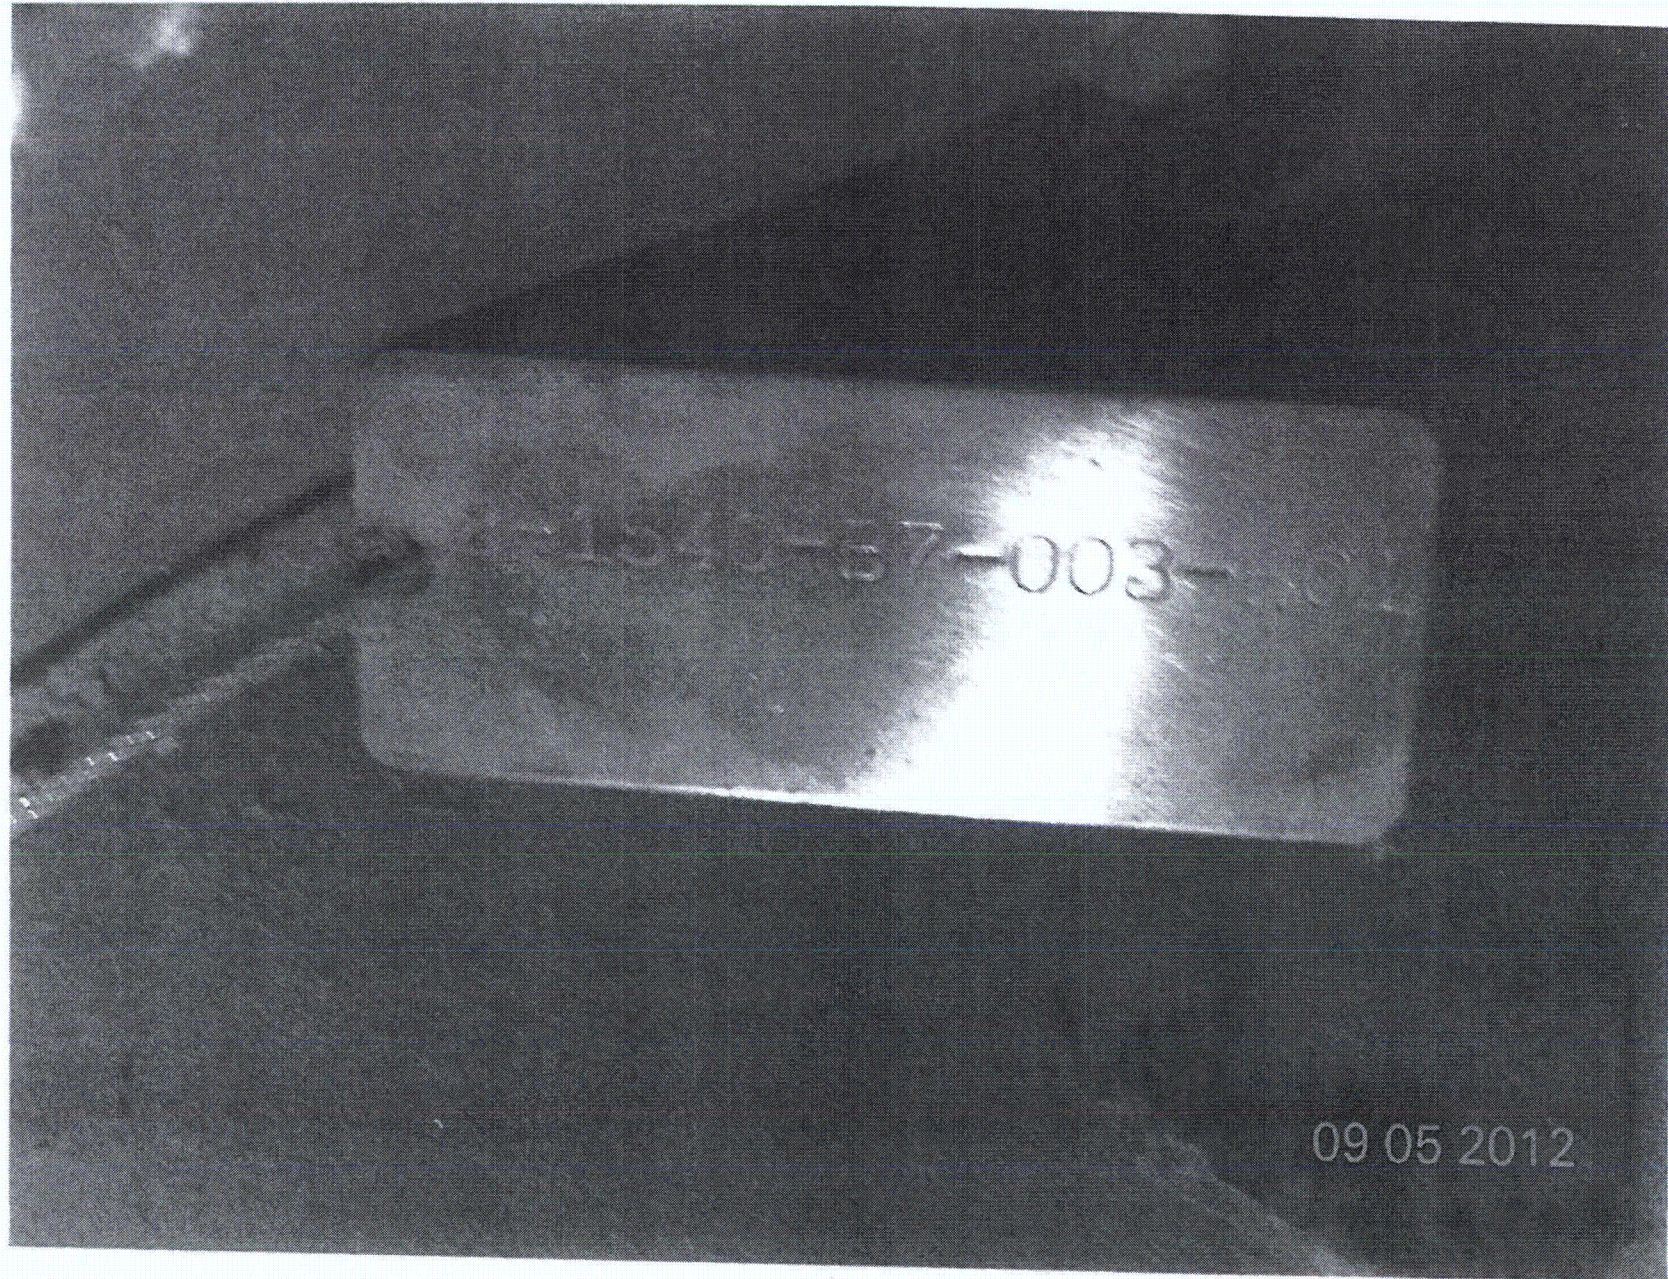
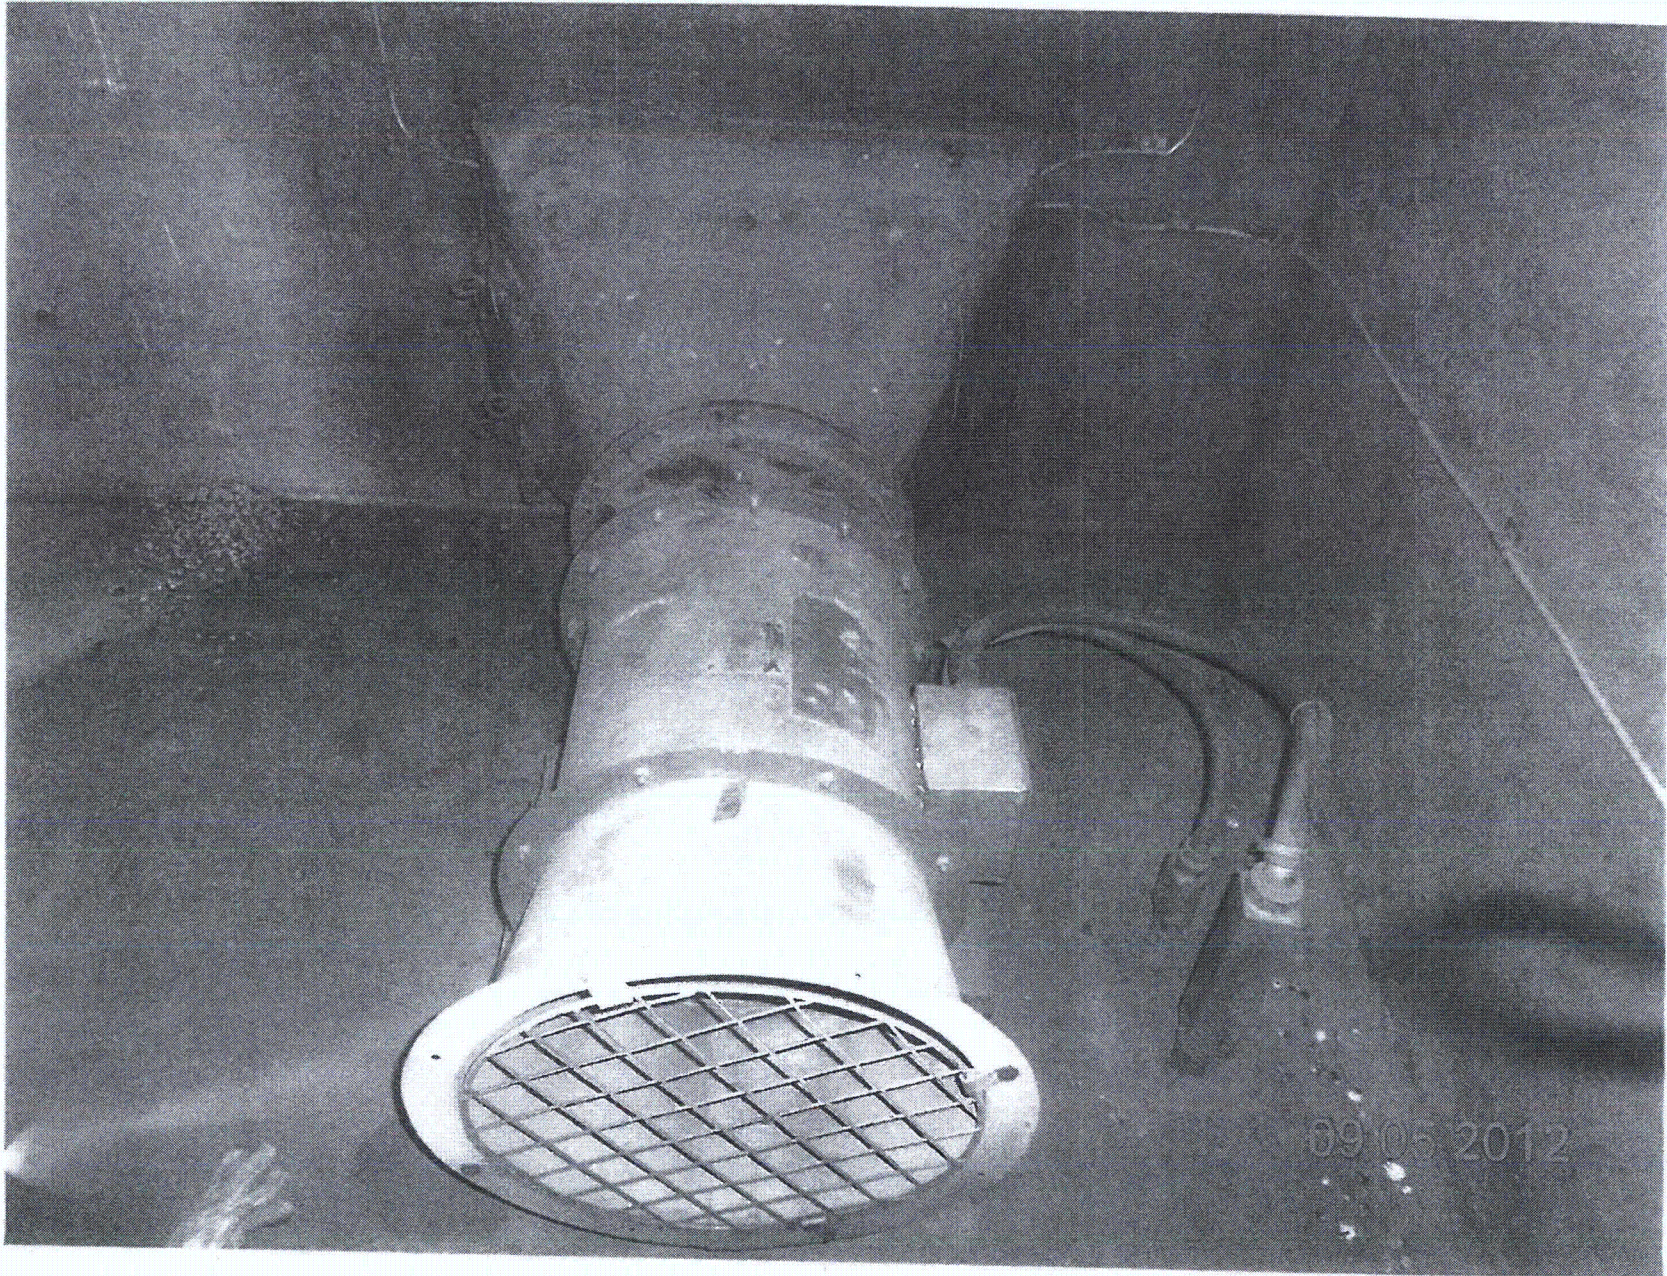
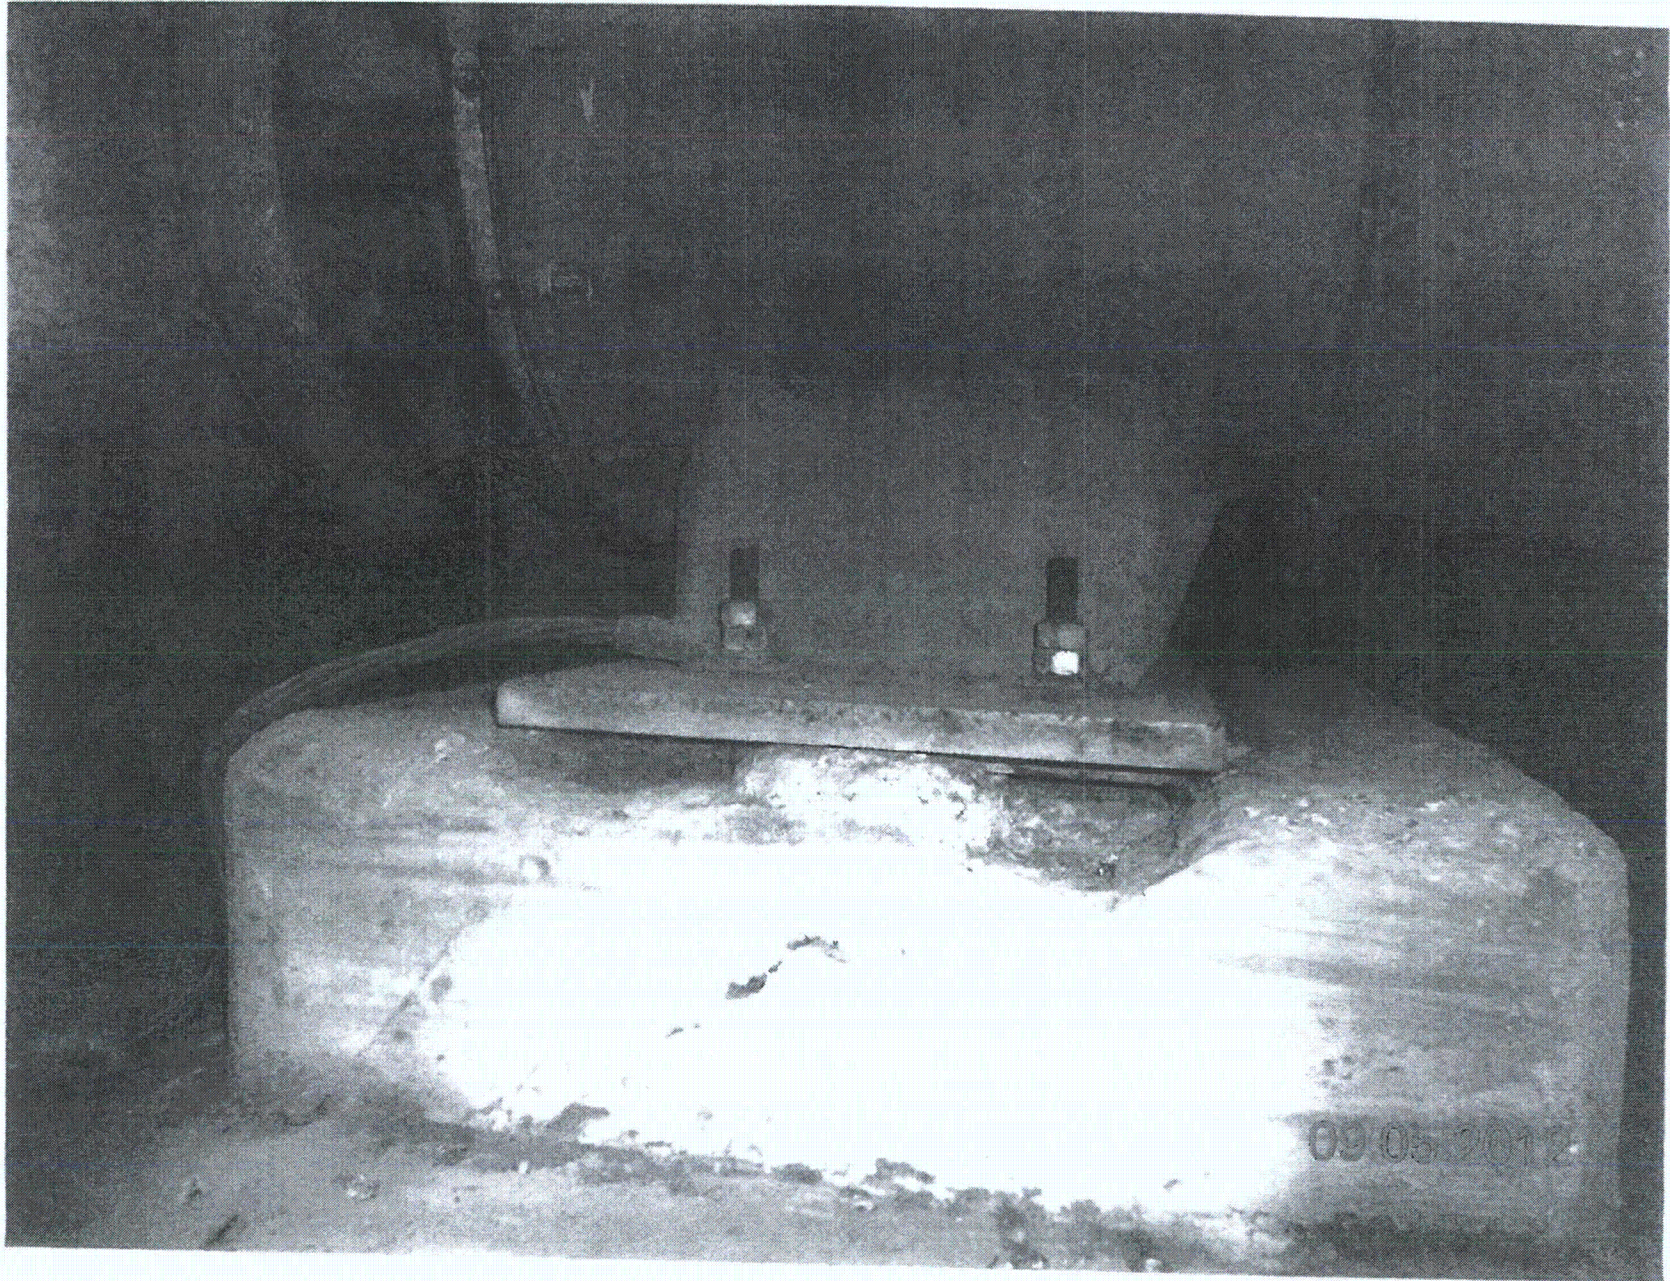
4. Is the anchorage free of visible cracks in the concrete near the anchors? Y N U N/A
*SEE CR # 51338
 Grout was missing on the anchor bolts area. The condition was documented on a CR to initiate action to correct the issue.
 JEH. 10/27/14.*

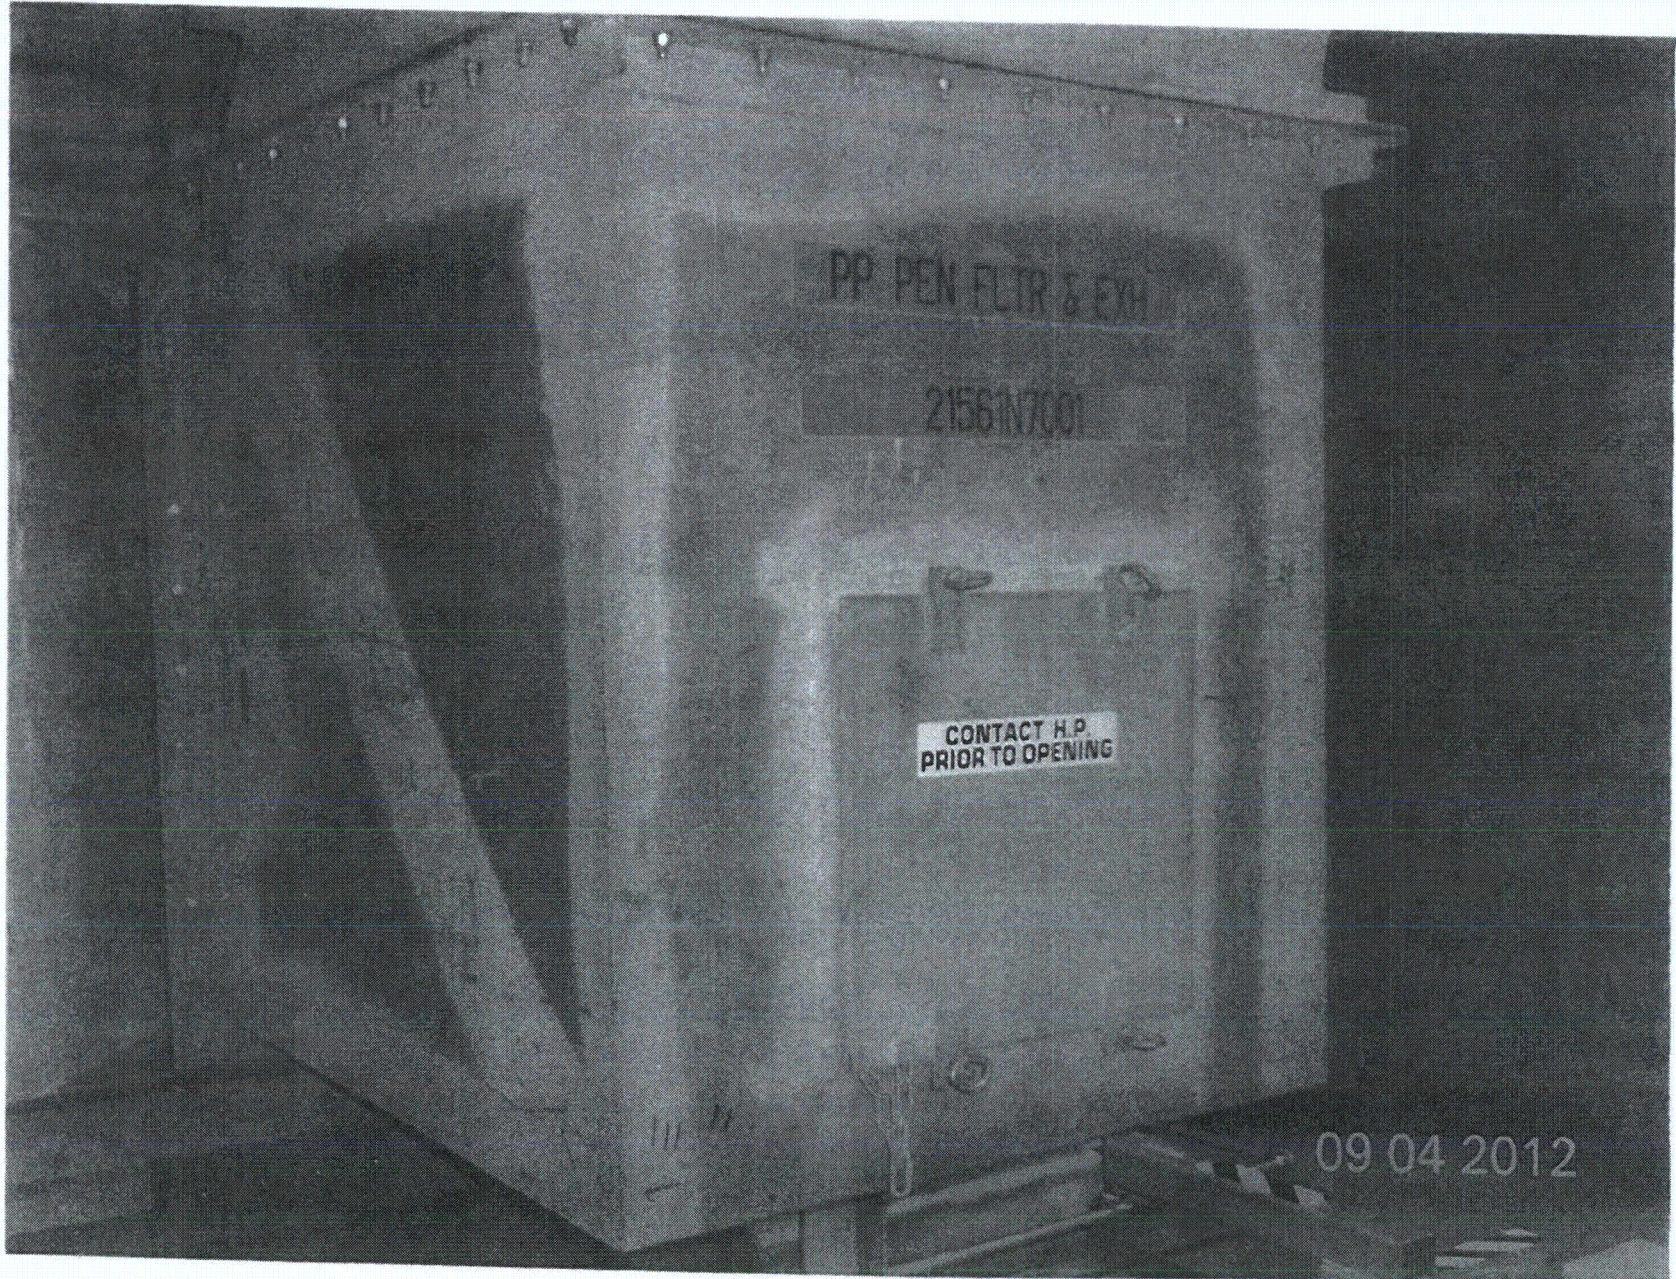
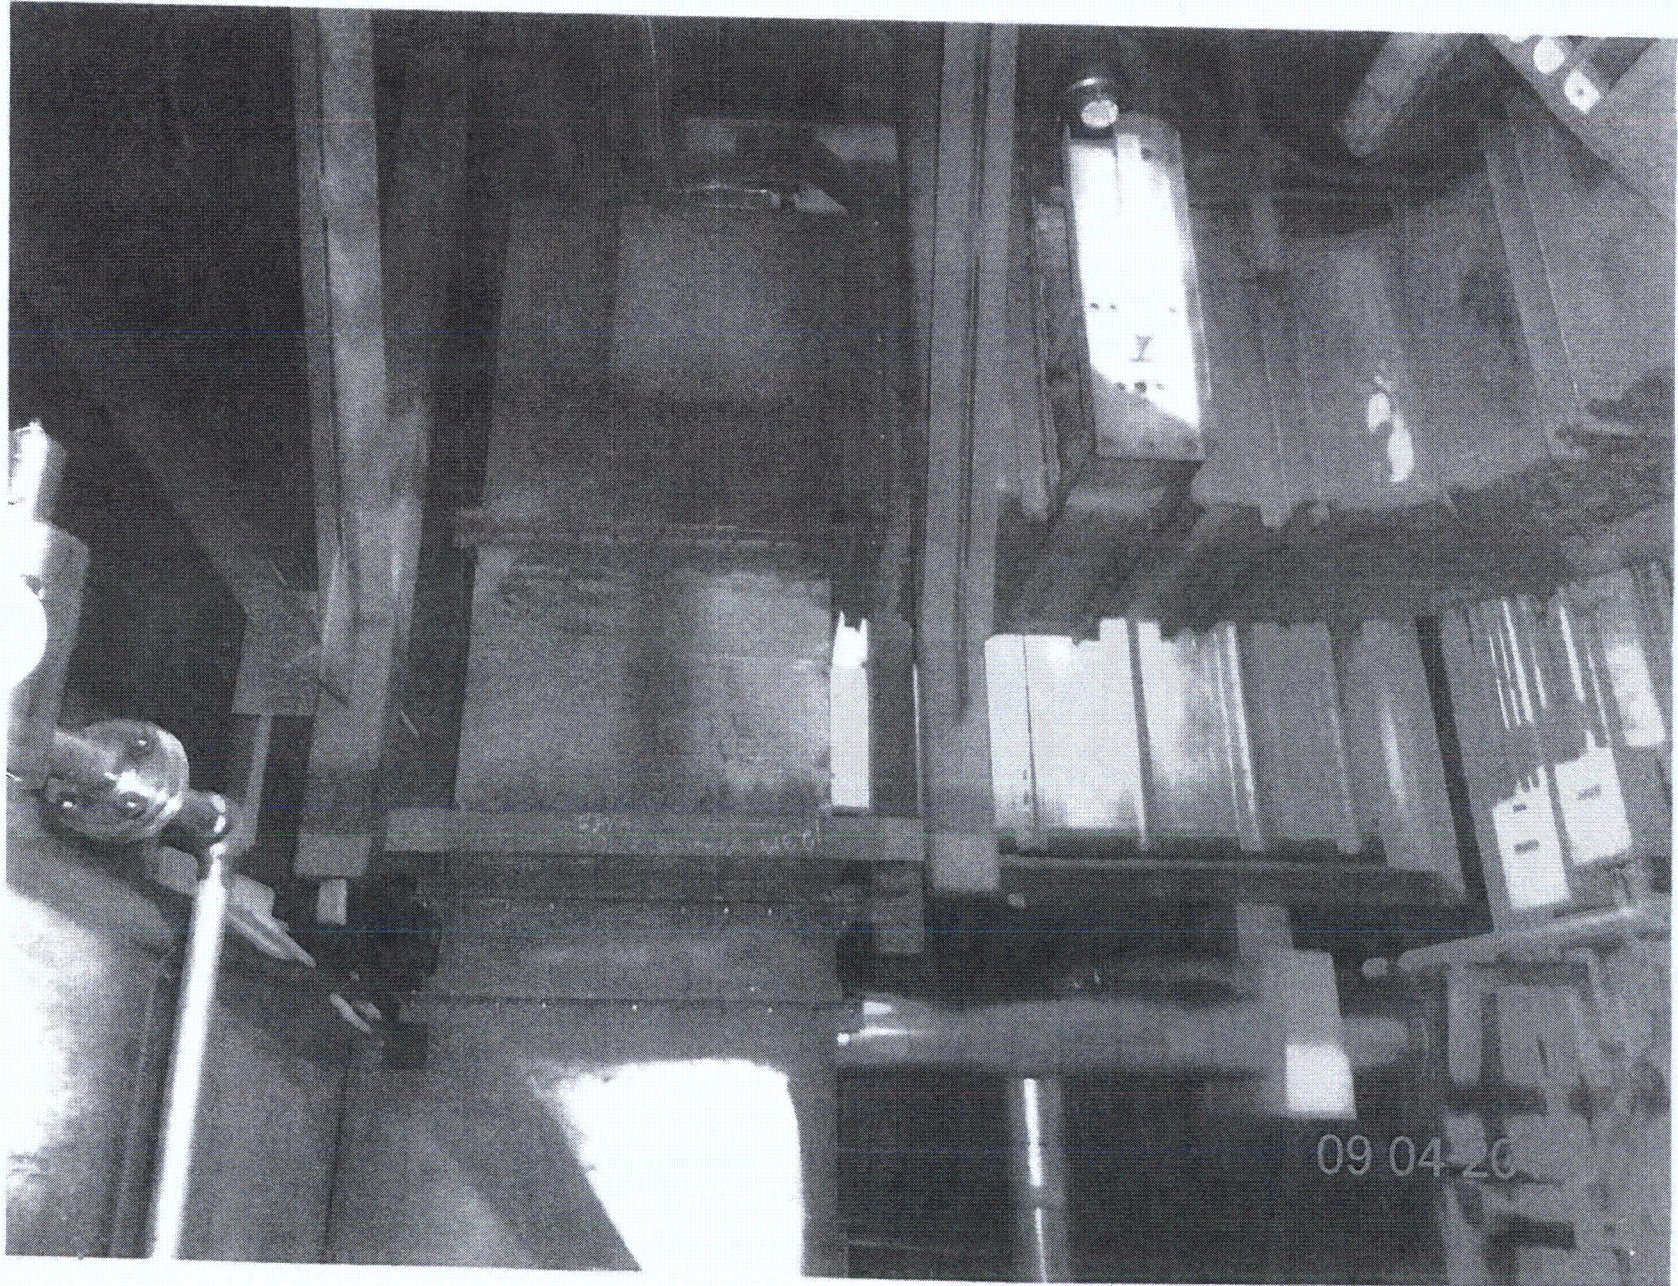
4. Is the anchorage free of visible cracks in the concrete near the anchors? Y N U N/A
 VISIBLE CRACKS NEAR ANCHORS APPEAR ONLY IN THE GROUT ON TOP OF CASTING. NO CRACKS APPEAR IN CONCRETE CASTING. NOT A SEISMIC CONCERN

9. Do attached lines have adequate flexibility to avoid damage? Y N U N/A
 ATTACHED HUNG OUT IS ANCHORED TO THE CEILING, FLOOR AS WELL AS THE UNIT ITSELF. A REVIEW OF THE RESPONSE SPECTRA FOR BOTH THE CEILING AND FLOOR SHOWS THAT THEY HAVE THE SAME PEAK ACCELERATION, (CONT'D BELOW)

SINCE BOTH THE ROOF AND FLOOR HAVE THE SAME PEAK SEISMIC ACCELERATION, NO DIFFERENTIAL MOVEMENT IS EXPECTED. THEREFORE, THE ~~REPORT~~ "AS INSTALLED" CONDITION IS ACCEPTABLE.
 J.D. 9-4-12
