**Subject: License SUA-1341, Docket No. 40-8502
Willow Creek Project
February 11, 2013
7I-30 Injection Well Release
Christensen Ranch Mine Unit 7**

Uranium One USA, Inc. - Willow Creek Project
Spill Report Summary
Mine Unit 7 ISR Injection Fluid Release

Christensen Ranch
Module 7-3, Well 7I-30 Spill
Permit to Mine #478
 Johnson & Campbell Counties, Wyoming

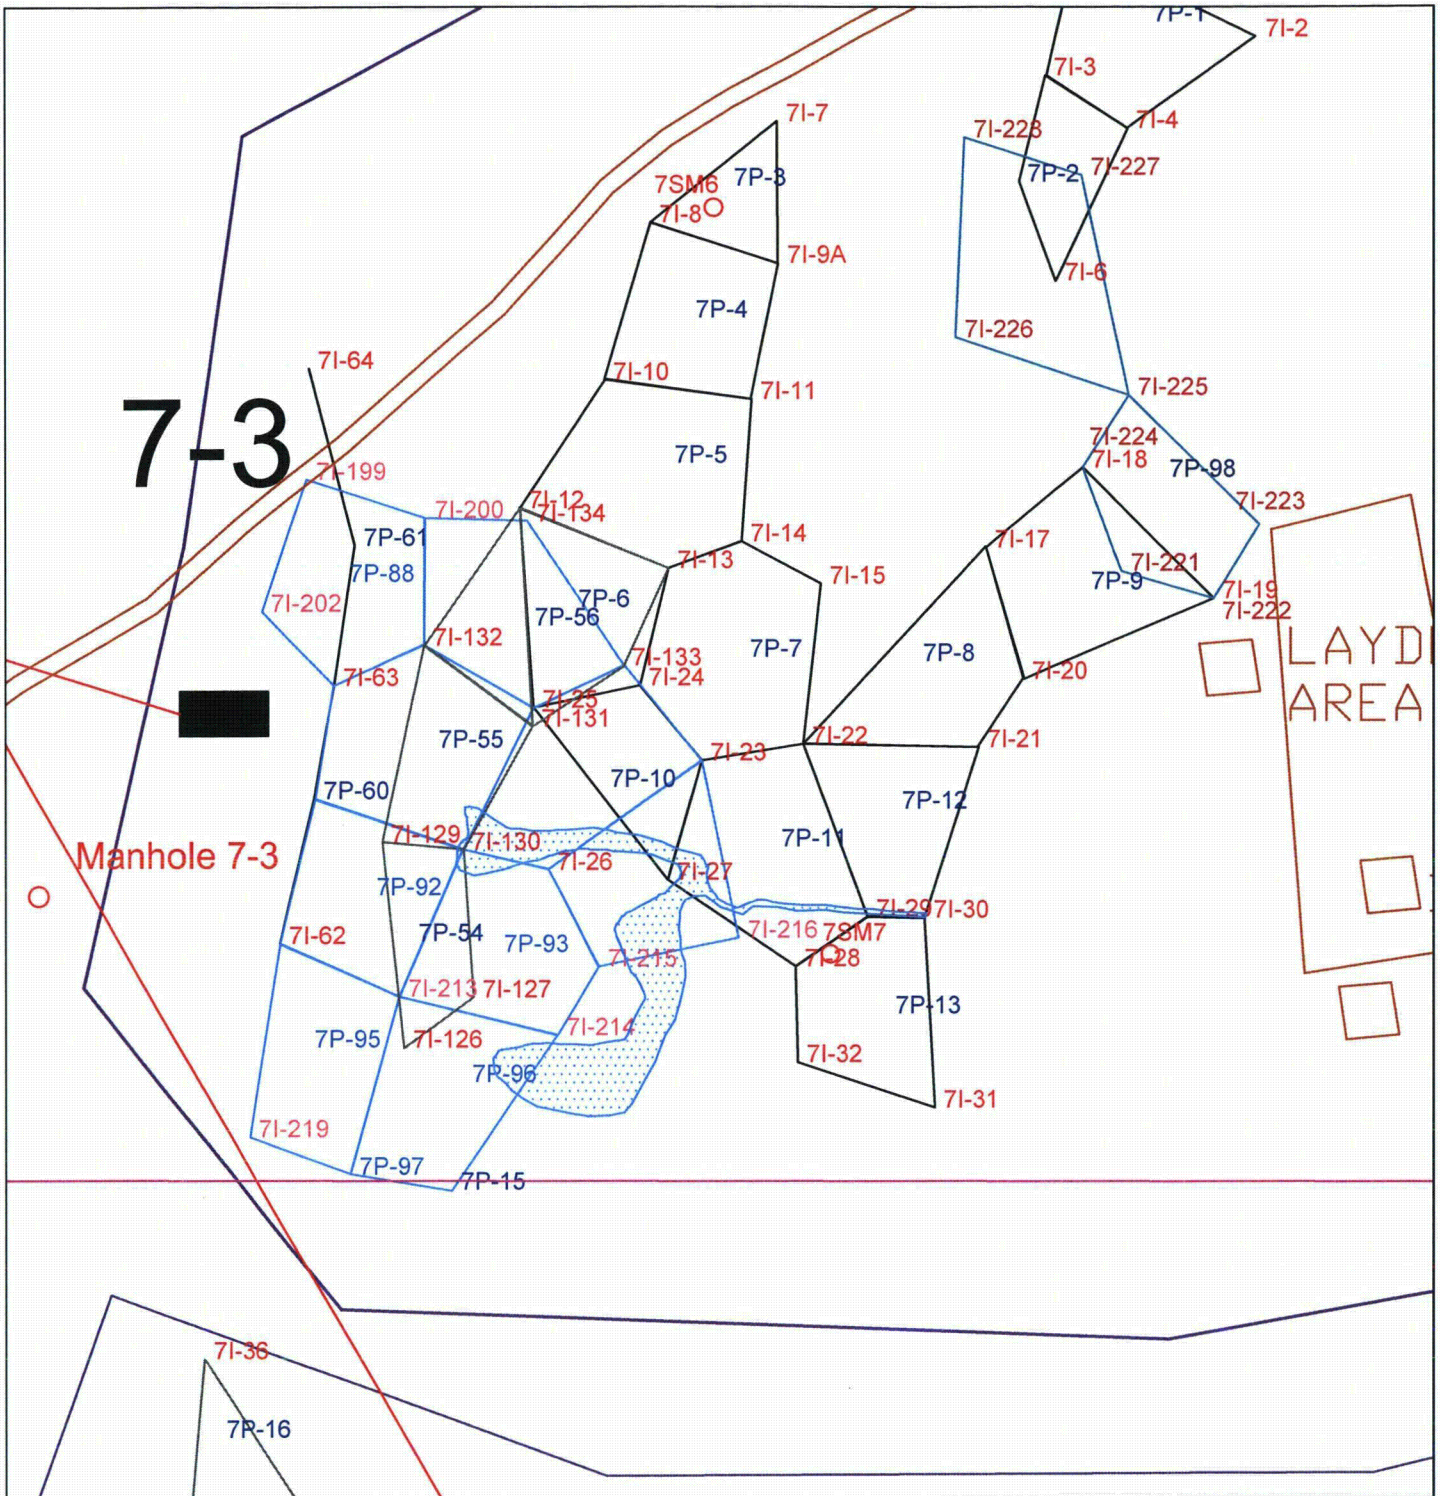
Spilled: Approximately 2,100 gallons of ISR injection fluid was released from Injection Well 7I-30 when a glue joint associated with a 5" pvc coupler and the 5" pvc well casing failed. The injection well is located in a flat area and the fluid spread approximately 400 feet in a small dry draw located in the Mine Unit 7-3 Wellfield. The failed joint was located at ground level just beneath the well box. The affected area is located entirely within the fenced Controlled Area.

The release followed site drainage and remained within the fenced MU-7 Controlled Area. It is estimated that 7,000 square feet (0.14 acre) of soil was impacted. No wildlife or livestock were affected. No significant erosion resulted from the spill, as it all soaked into the ground.

Approximate Spill Location

The well was immediately shut off and repaired.
