WILLIAM STATES LEE III  
NUCLEAR STATION UNITS 1 & 2

FIGURE 2.4.4-203 Rev 7

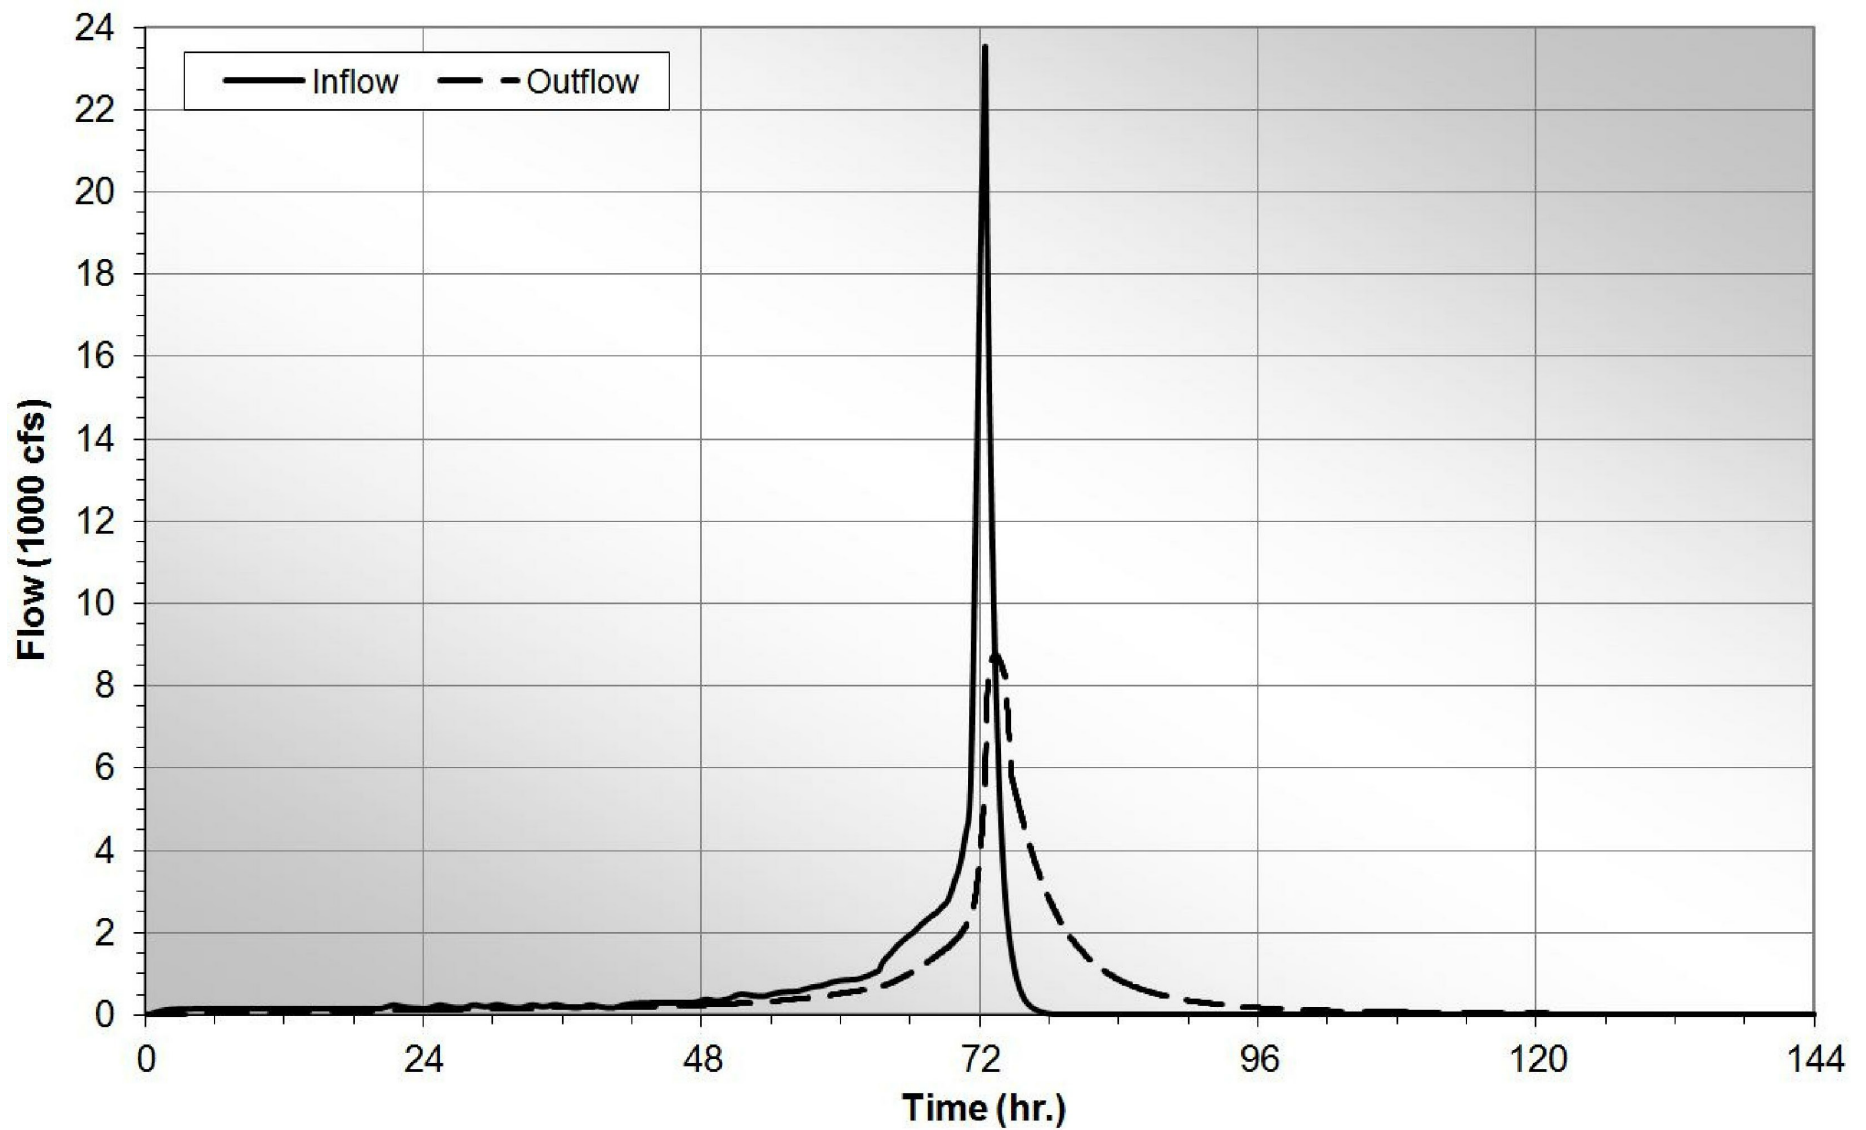
PMF Hydrograph With Upper Arm Dam  
Failure, Make-Up Pond B
