# Tank 16 Annulus Cleaning Demonstration

## 1.0 PURPOSE

The purpose of Tank 16 Annulus cleaning demonstration is to evaluate the ability to effectively clean a simulated Type II Tank annulus space which includes removing a simulate material from the inside as well as outside of the ventilation duct. The demonstration will also determine if these two cleaning methods will adversely impact the safety of personnel and/or results in the breach of the contamination boundary.

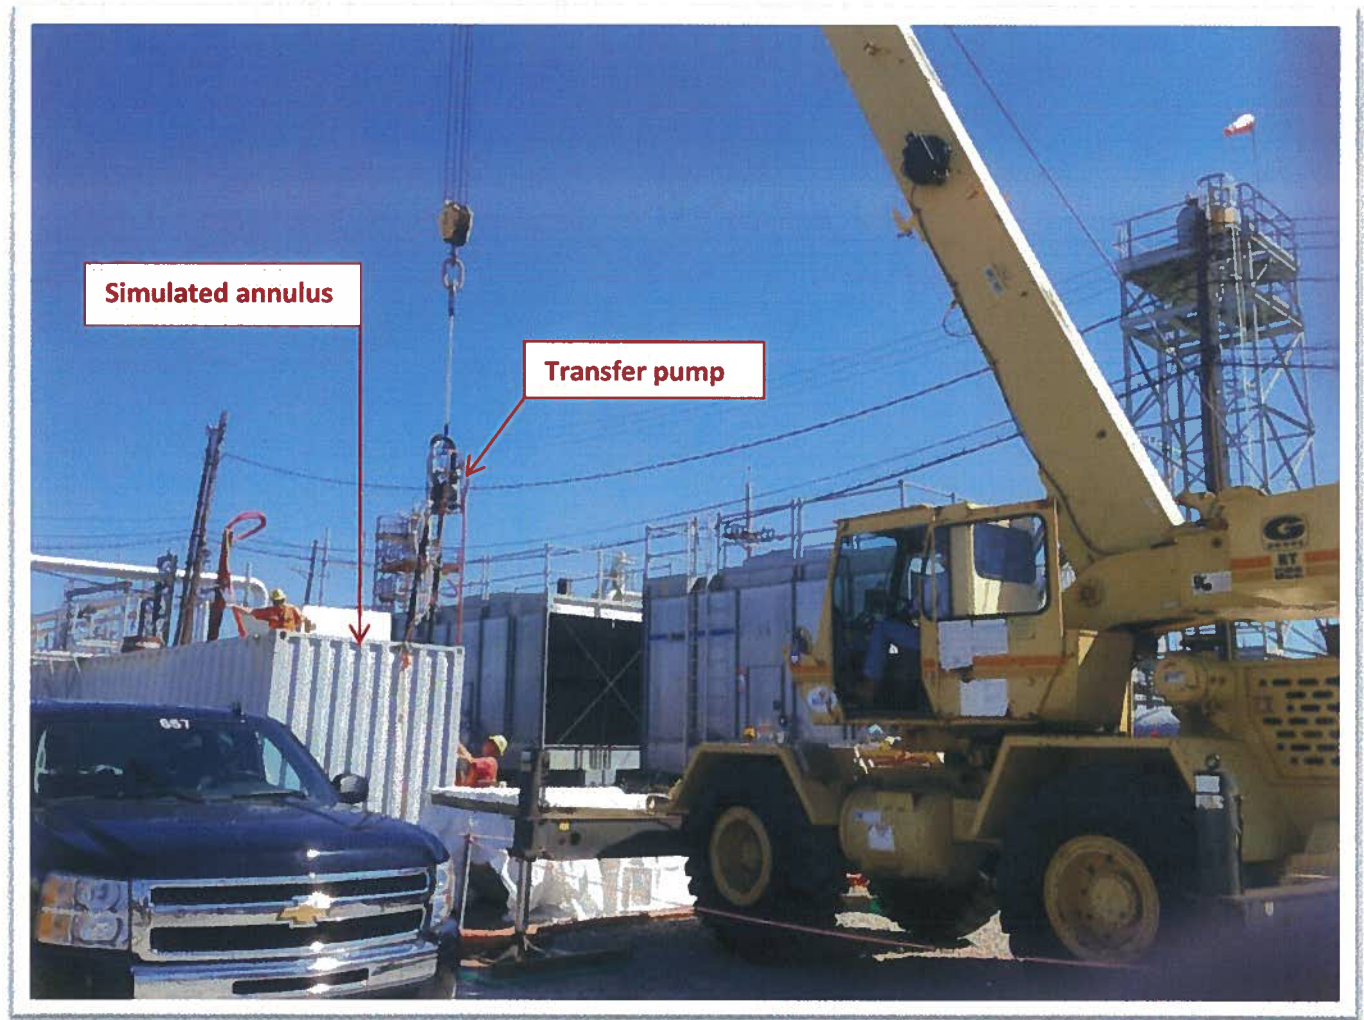
ATTACHMENT # 1

TANK 16 ANNULUS CLEANING MOCK UP

A 40 foot Sea-Land with the inside modified was used to simulate a section of a Type II Tank's annulus space. The modification included vertical and horizontal sections of ventilation duct as depicted in Attachments 1 through 5. The duct was fabricated from 16 gauge galvanized sheet metal with 20 inch diameter reducing to 12 inch diameter with a tapered reducer. This represented the full scale model of the duct as installed in Tank 16 annulus. The simulant was mobilized by the kinetic energy of the water jets produced by nozzle(s). The nozzle design varied for the inside and outside of duct cleaning. Detail discussion of nozzles and the simulant removal process is given below.

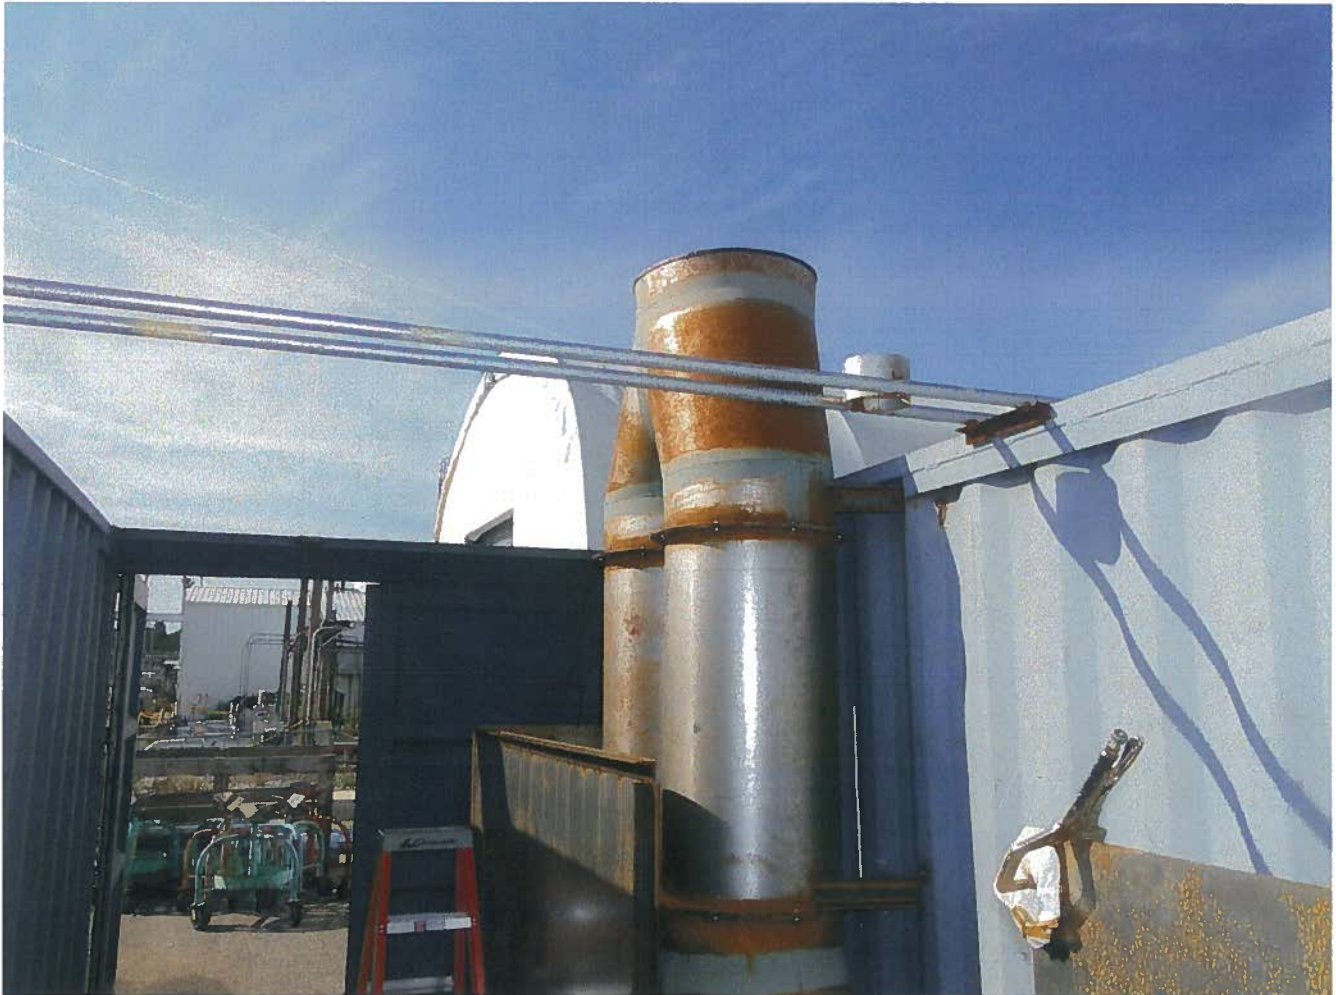
**ATTACHMENT – 3**

**Tank 16 Annulus Dehumidification Duct Simulation**

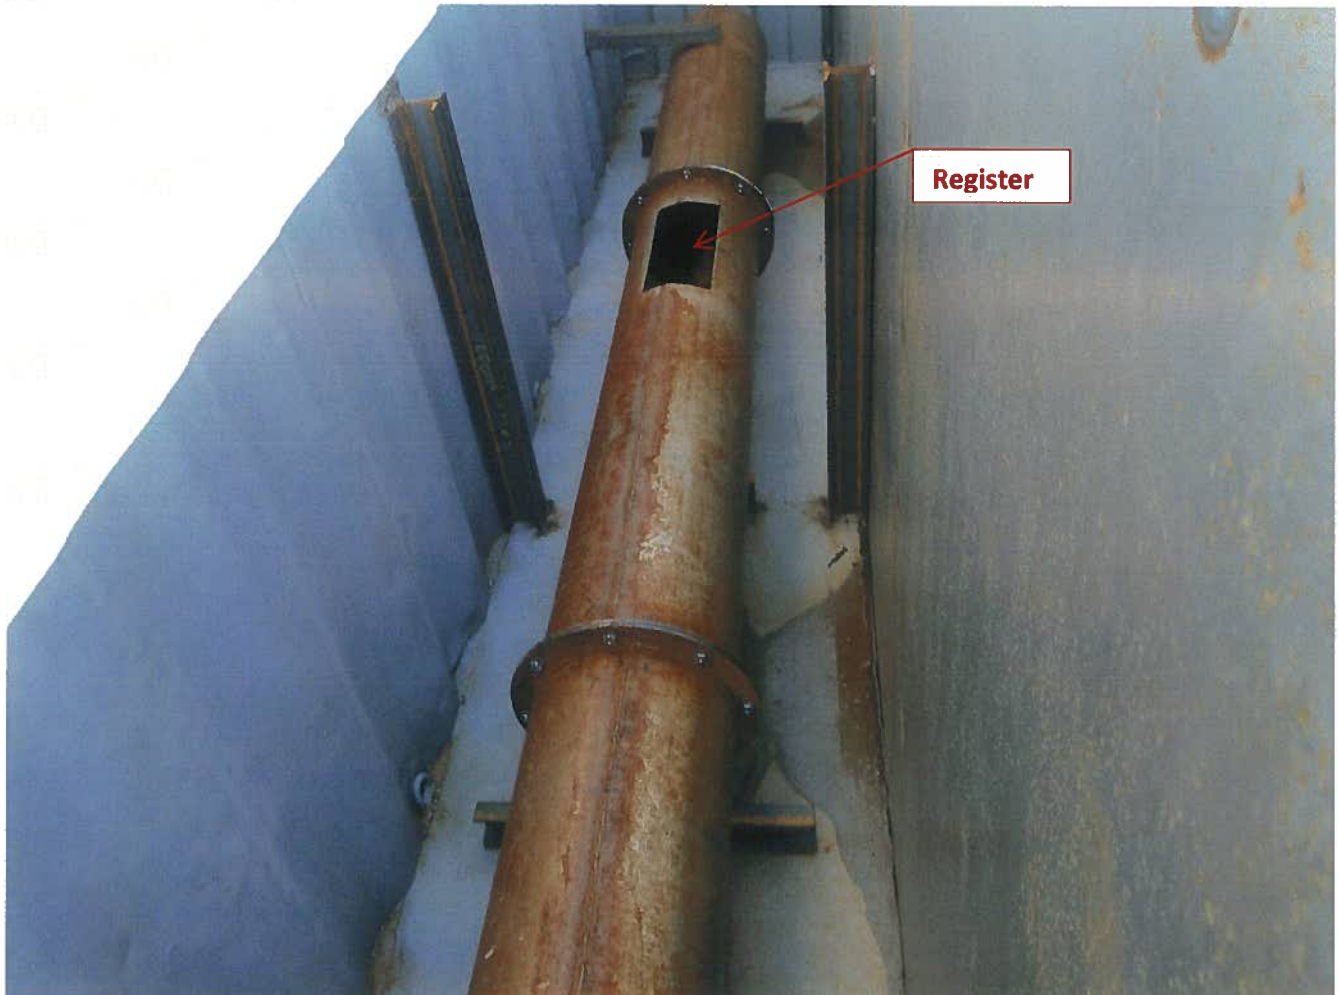
**ATTACHMENT – 4**

**Tank 16 Annulus Dehumidification Duct Simulation**

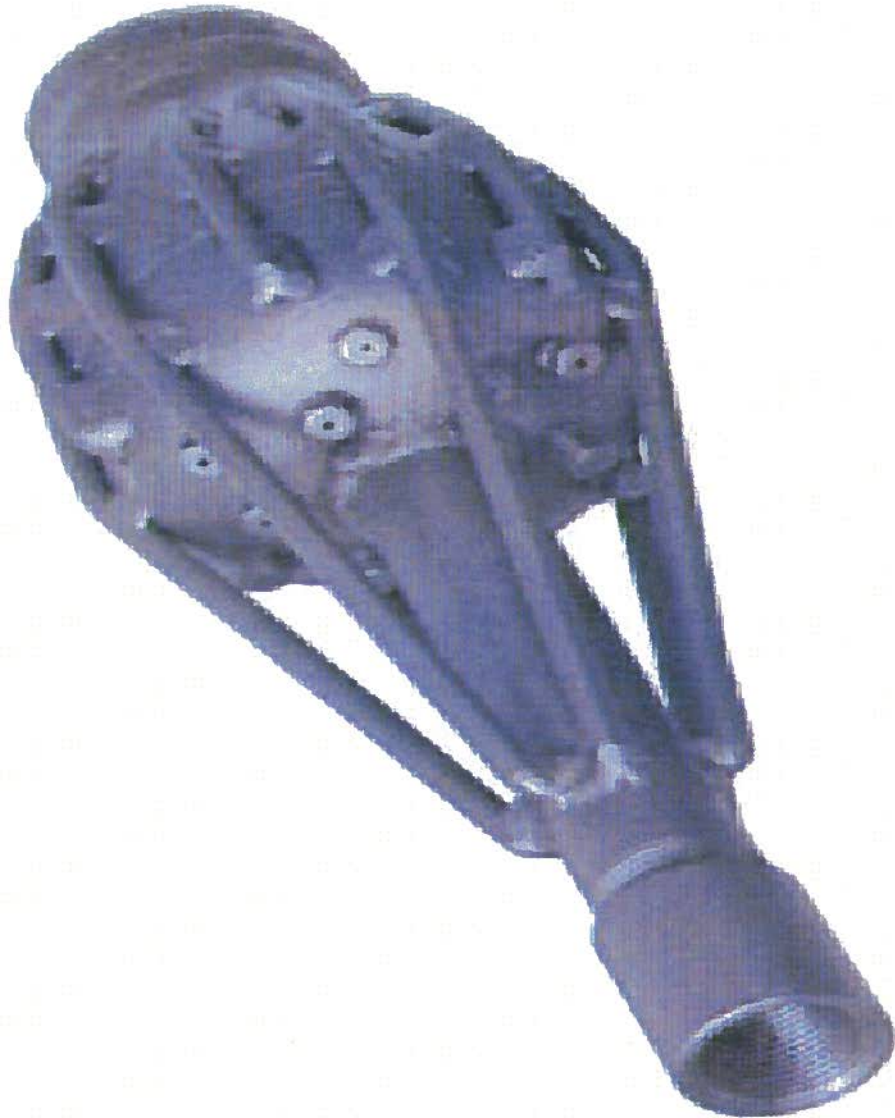
**ATTACHMENT - 6**

**Tank 16 Annulus Duct Inside cleaning nozzle – “Lil Bertha”**

The supply system for mobilizing simulant inside the duct included a self-propelled high pressure hose and a spray nozzle (Attachment # 6, called "Lil-Bertha"). The high pressure equipment, hose, and nozzle were provided by external vendor Augusta Industrial (AI). The high pressure rig had a maximum capacity of 2000 psi at 60 gpm. The nozzle design enabled the nozzle to advance in the duct by the reaction of rear jets. Front jets were used to mobilize the material. Jet velocities were proportional to the supply pressure.

The nozzle navigated through the duct as designed with little to no hesitation. The initial pressure was 500 psig when the nozzle started advancing and it continued to advance as the pressure was increased. The nozzle slid on the bottom of the duct and did not lift up when pressure was increased. The maximum pressure to the nozzle was 1300 psig at the flowrate of 60 gpm. The rated capacity of vendor's equipment is 2000 psig. There was no interference to the nozzle propagation when it was passing under the register.

The "Lil Bertha" nozzle was able to mobilize the solids as it advanced inside the duct. The jet forces did not have significant radial force to cause structural damage to the duct. The zone of jet's influence is judged to be approximately 2 in the longitudinal direction. The inside of 20 inch duct was completely covered with the jet, hence the effectiveness in the transverse (or radial) direction is judged to be at least 20 inches.
