**SRR-CWDA-2012-00170**  
**Revision 0**

**TANKS 18 AND 19 FINAL CONFIGURATION REPORT  
FOR F-TANK FARM AT THE SAVANNAH RIVER SITE**

**June 2013**

Prepared by: Savannah River Remediation LLC  
Closure and Waste Disposal Authority  
Aiken, SC 29808

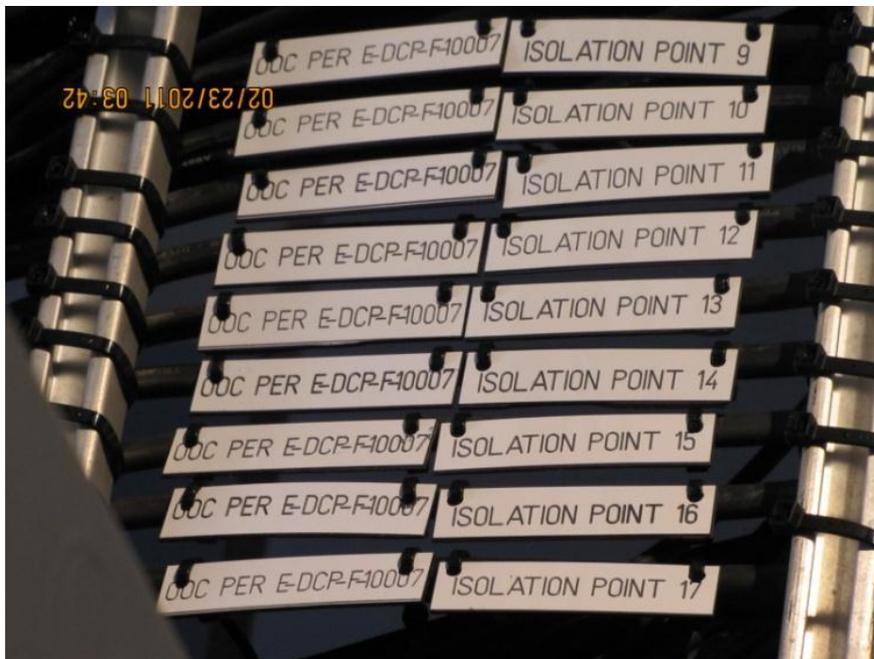
**Figure 3.1-2: Electrical Isolation at an Electrical Control Room**

Figure 3.1-2 shows electrical isolation at an electrical control room.

Waste tank isolation includes cutting or blanking mechanical system components (e.g., transfer lines, water piping, air piping, steam piping) and disconnecting electrical power to all components on the waste tank. Descriptions of mechanical isolation in Tank 18 are found in M-DCP-F-10001 and electrical isolation in E-DCP-F-10001. Descriptions of mechanical isolation

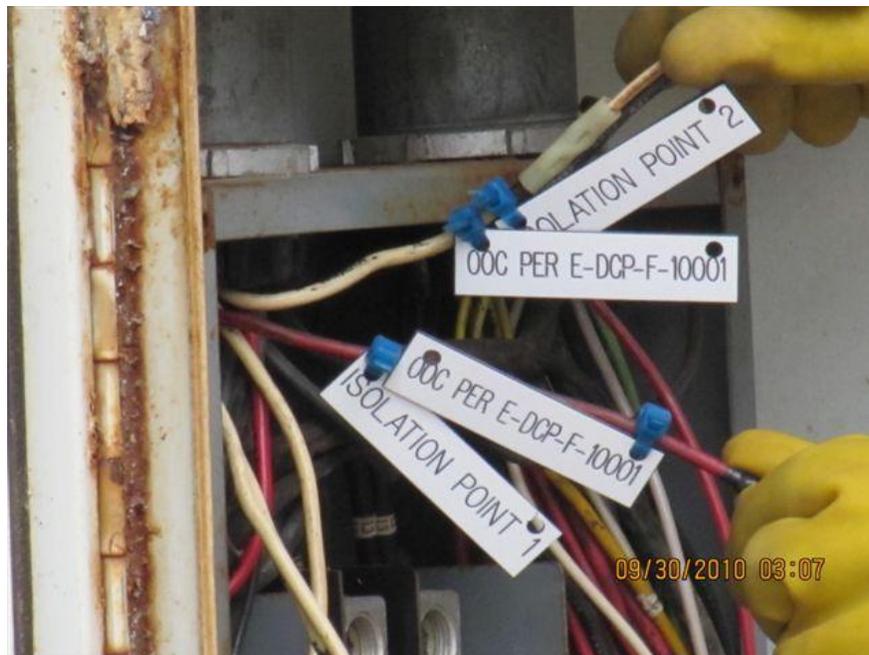
**Figure 3.1-3: Electrical Isolation at Lighting Panel**

Section 7.1 of the Tanks 18 and 19 CM specifies that isolation of electrical systems will be performed at the electrical control rooms; whereas, in fact, some electrical services were isolated in the field at a lighting panel. [SRR-LWE-2012-00217] Figure 3.1-3 shows electrical isolation at a lighting panel in the field.

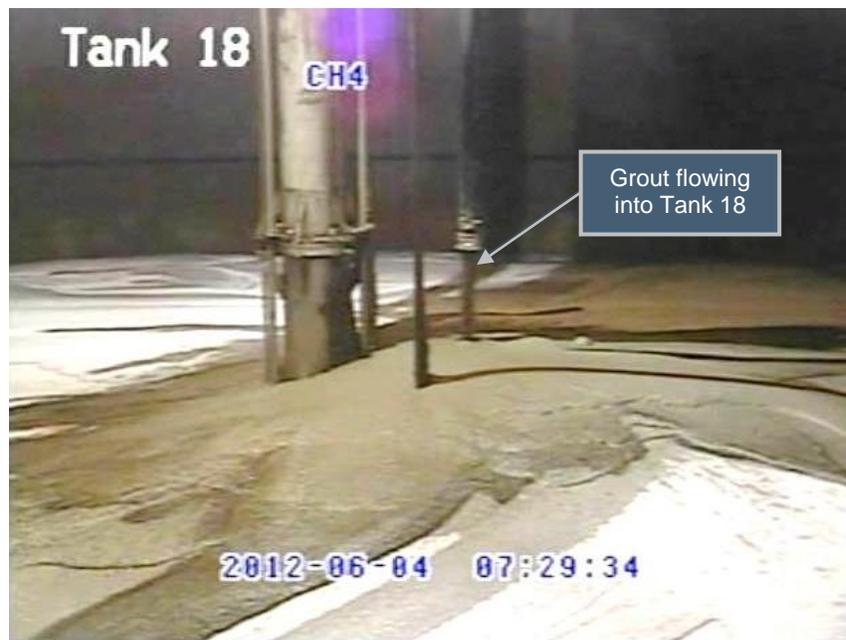
**Figure 3.2-1: Bulk Fill Grout in Tank 18 During the Filling Process**

Reducing grout was used to fill the entire volume of the interior of Tanks 18 and 19. Grout was added to the waste tanks using portable grout pumps filled from cement mixer trucks. The pumps pushed the grout through slick lines to the center riser of each waste tank. Camera inspections of the interior of the waste tanks were typically performed and recorded at the beginning, middle, and end of each day during the grouting process. These inspections indicated that the reducing grout flowed over the residual material to stabilize and immobilize it at the bottom of the waste tanks. The grout adequately flowed from the center to the perimeter of the waste tank, and there was no evidence of void spaces in the interior of Tanks 18 and 19 (Figure 3.2-1).

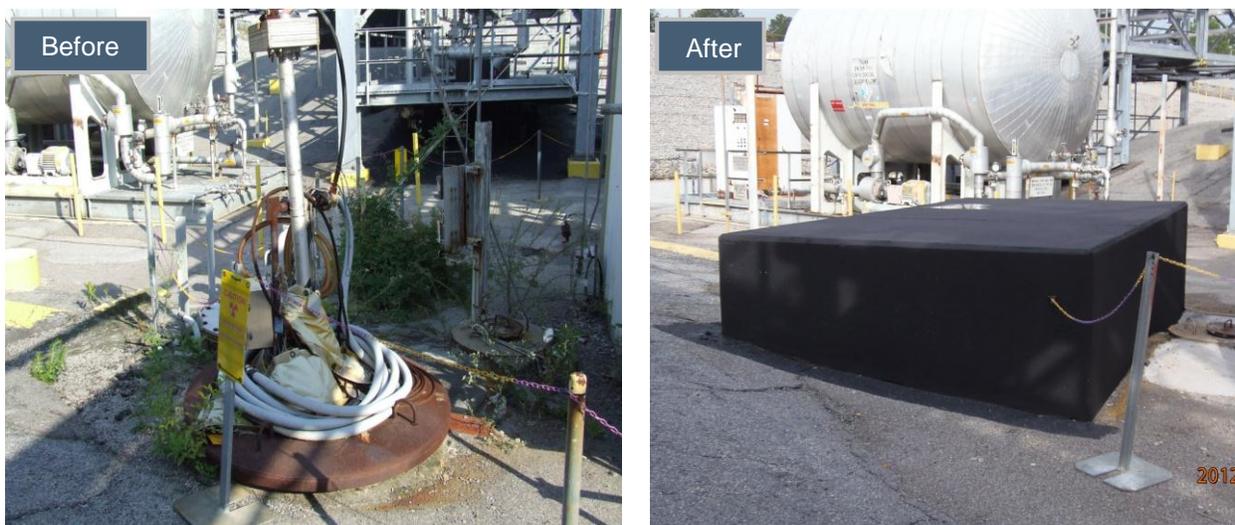
**Figure 3.2-2: Typical Riser - Before and After Filling and Capping  
(Tank 19 Northeast Riser)**

For both Tanks 18 and 19, waste tank top modifications were made to accommodate waste tank riser grouting. Examples of pre-grout modifications included removal of equipment components from risers, core drilling openings in Tank 18 pill boxes, and disconnecting and lowering miscellaneous hoses and cables into the waste tank. All waste tank risers were filled and capped with the same type of reducing grout that was used for bulk fill. Typically, a form was built around the top of the risers to facilitate capping the riser with grout to sufficiently cover the riser and any equipment entombed in the riser. Figure 3.2-2 shows a typical riser before and after riser filling and capping.
