Duke Energy Florida  
**Levy Nuclear Plant  
 Units 1 and 2**  
**Part 2, Final Safety Analysis Report**

Fracture Pattern of the Northern Part  
 of the Florida Peninsula  
 FIGURE 2.5.3-202

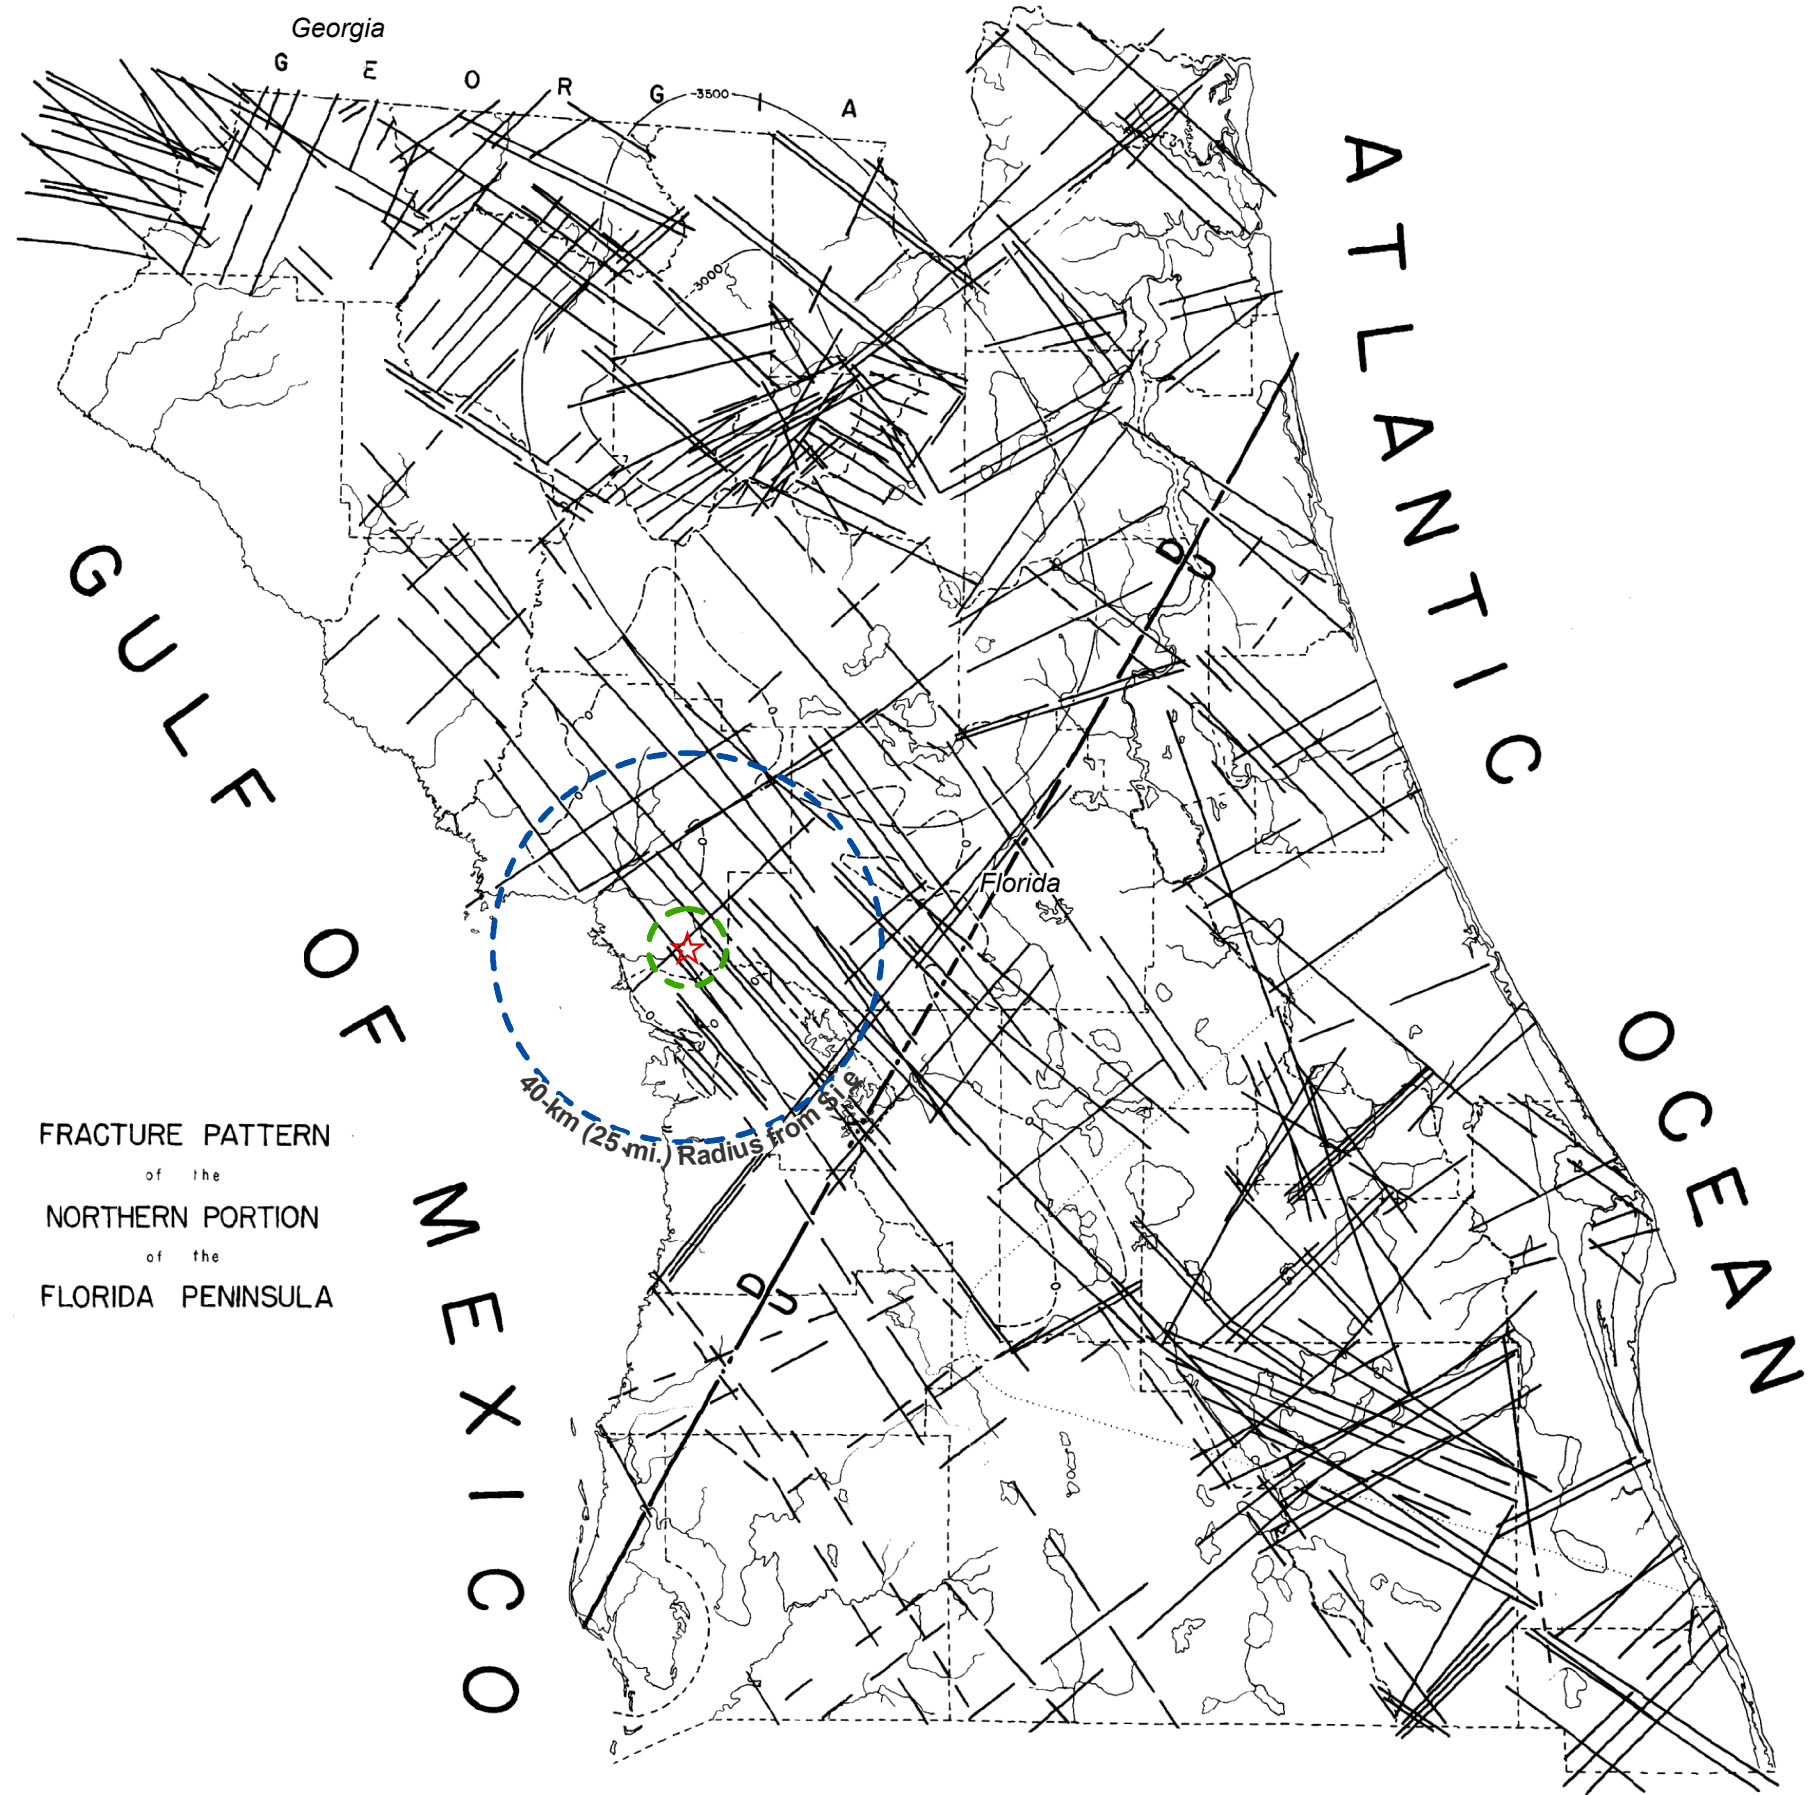
FRACTURE PATTERN  
of the  
NORTHERN PORTION  
of the  
FLORIDA PENINSULA

- ★ LNP Site
- 8-km (5-mi.) Radius from Site
- 40-km (25-mi.) Radius from Site
- Joints and Possible Faulting
- - - Contour of the Inglis Member over the Ocala Uplift
- Contours of Pre-Mesozoic Rocks (after Paul Applin)
- ..... Outline of Crystalline Rocks as Penetrated by Wells (after Paul Applin)
- $\frac{D}{U}$  Possible Post-Paleozoic Graben Fault Boundary (after Paul Applin)
