Duke Energy Florida Levy Nuclear Plant Units 1 and 2 Part 2, Final Safety Analysis Report
Diagrams Illustrating the Orientation of A)Fracture Sets in Bedrock Exposures and B)Lineaments in the LNP Site Location FIGURE 2.5.3-224 Rev 6

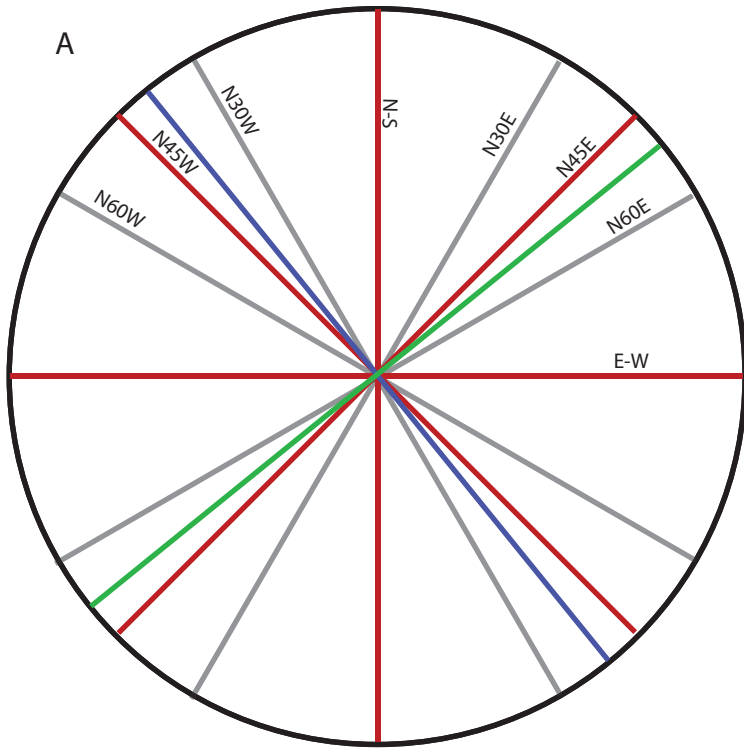
A: Joint orientations observed in Crystal River Unit No. 3 Excavation (no information on frequency or number of observations) (CR3 FSAR, 1973).

- Primary orthogonal joint systems
- Secondary orthogonal joint systems

Gulf Hammock Quarry and Wacasassa River Exposures

- Primary set
- Orthogonal set

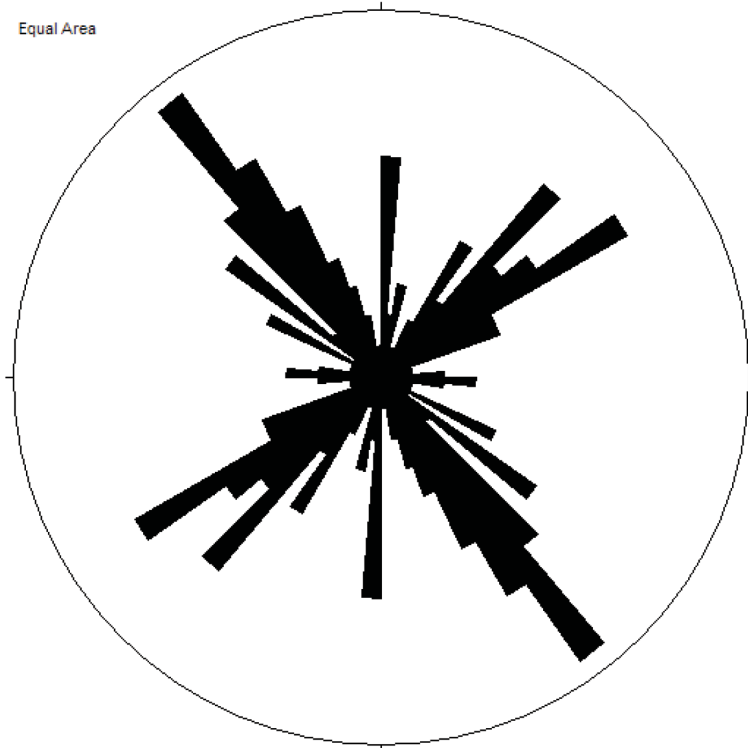
B: Rose diagram showing orientation and frequency of mapped lineaments within the site location (1-km [0.6-mi.] radius)
