Figure 6.3-4—SIS Sump Debris Entrainment Prevention Features

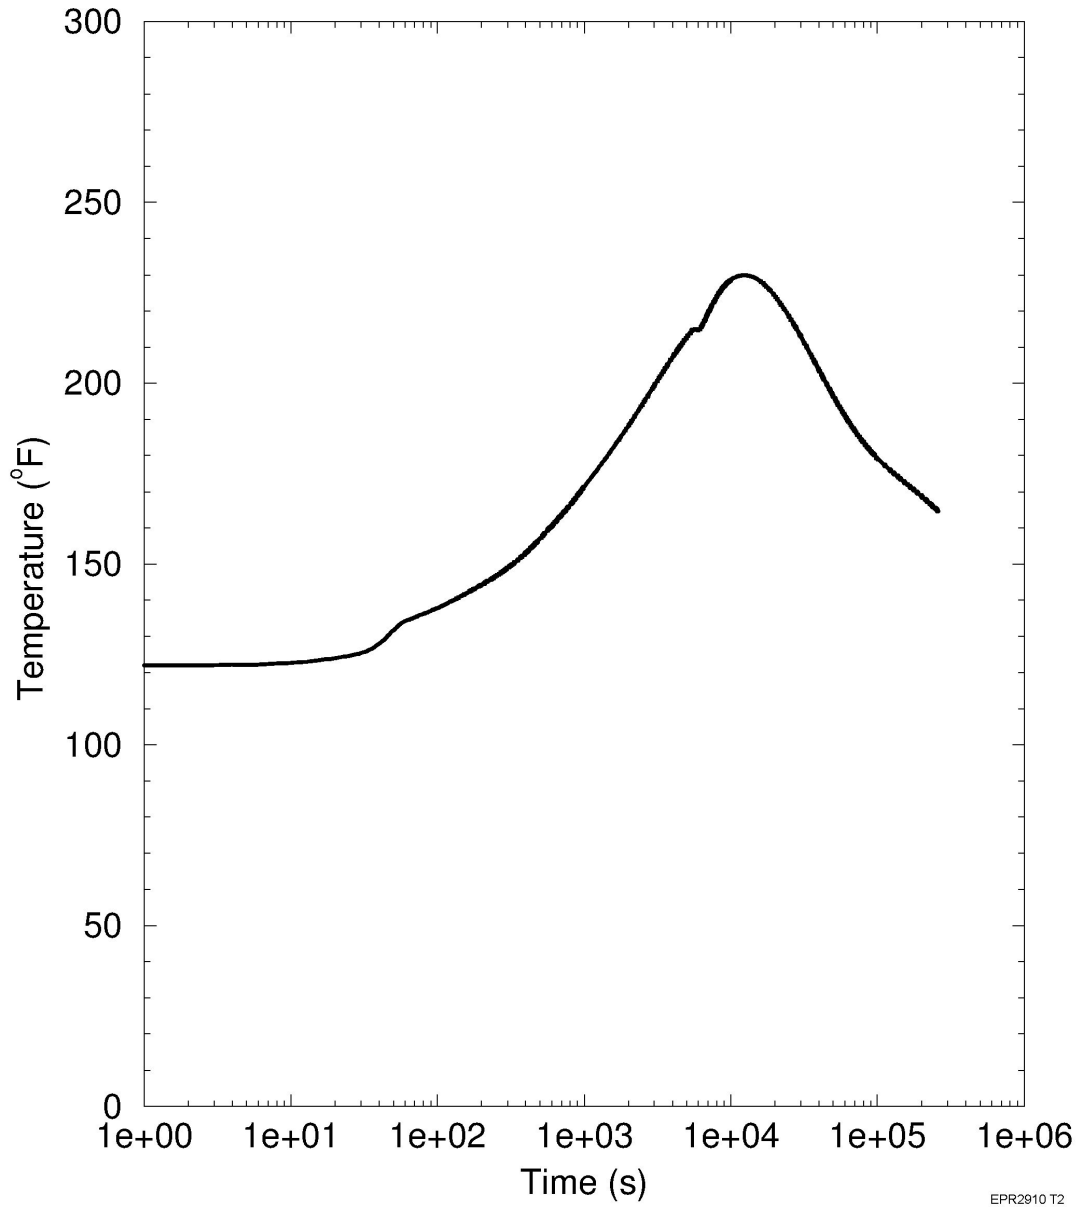
Figure 6.3-7—IRWST LOCA Temperature Response

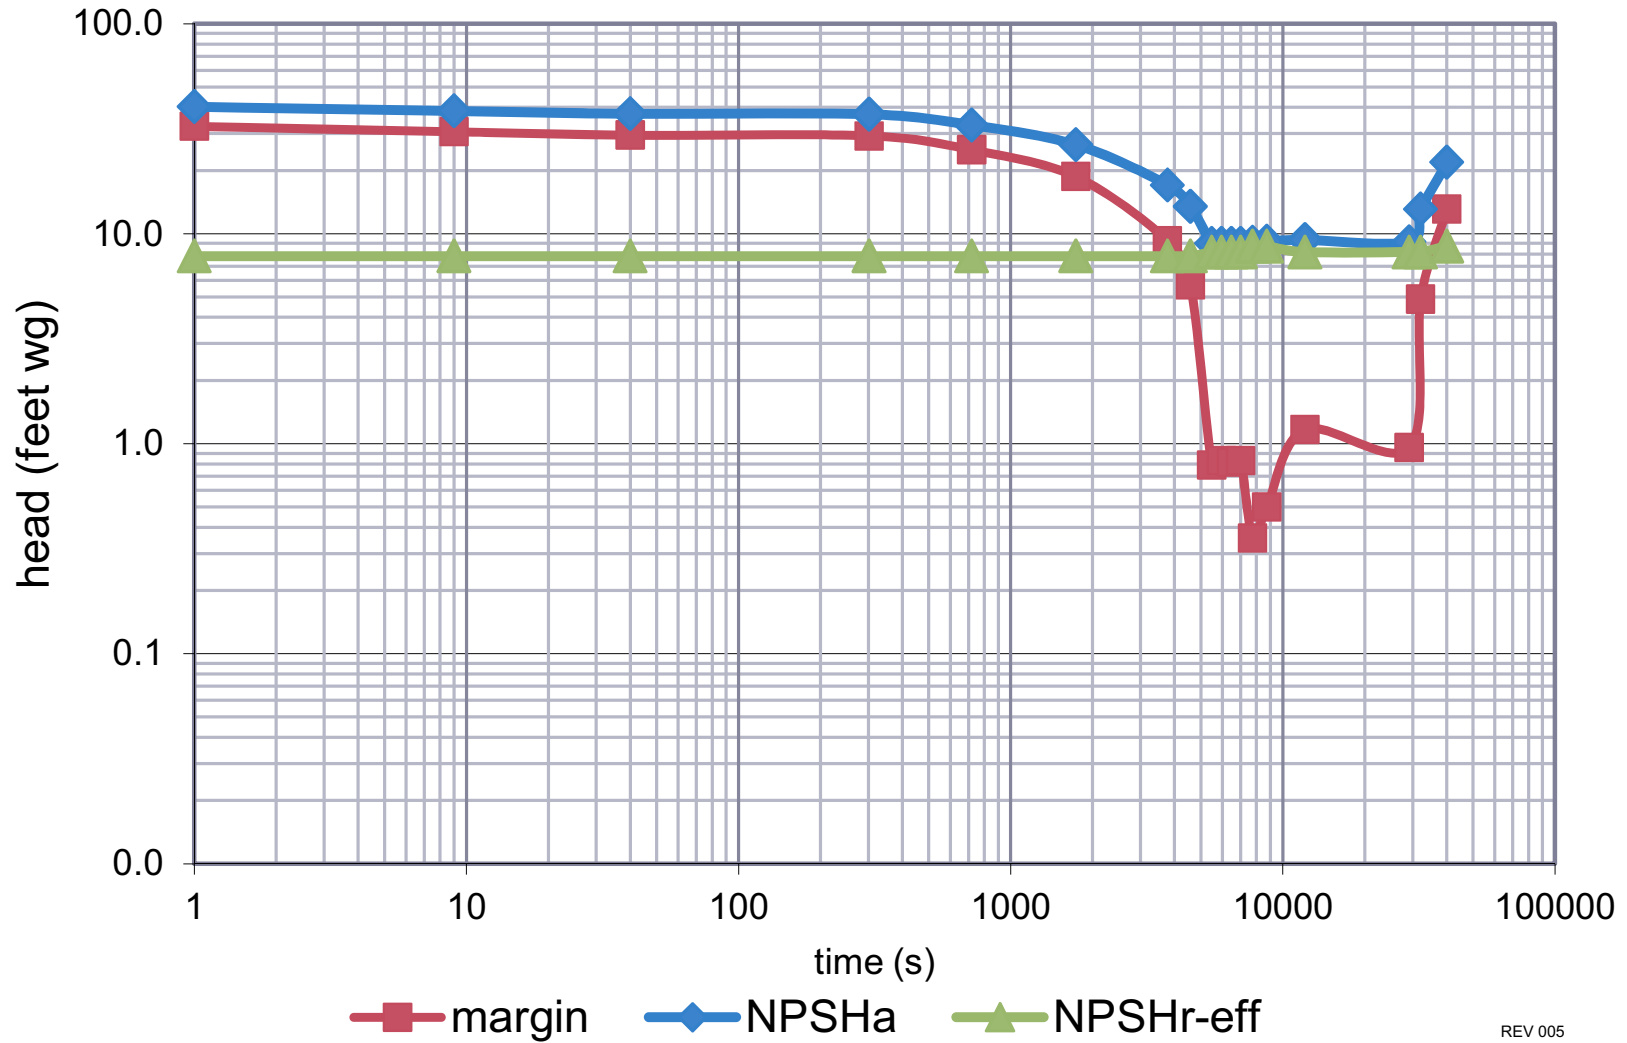
Figure 6.3-8—LHSI in LBLOCA

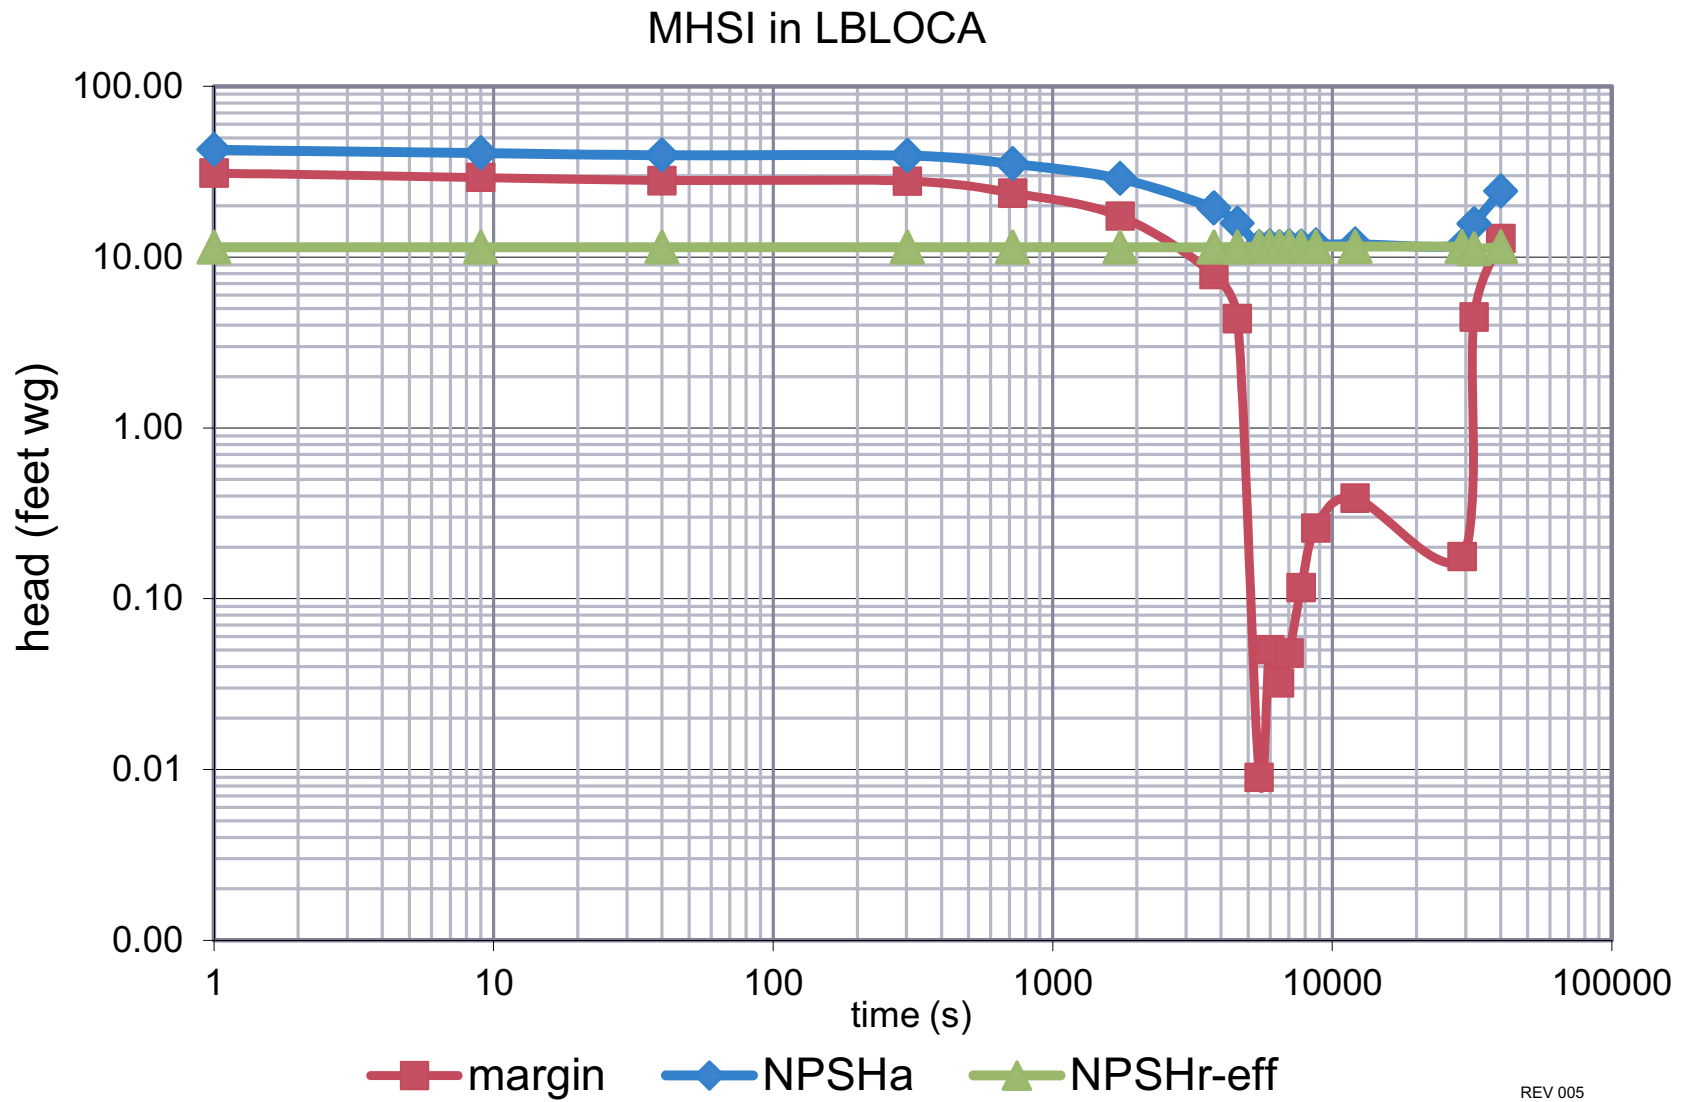
Figure 6.3-9—MHSI in LBLOCA

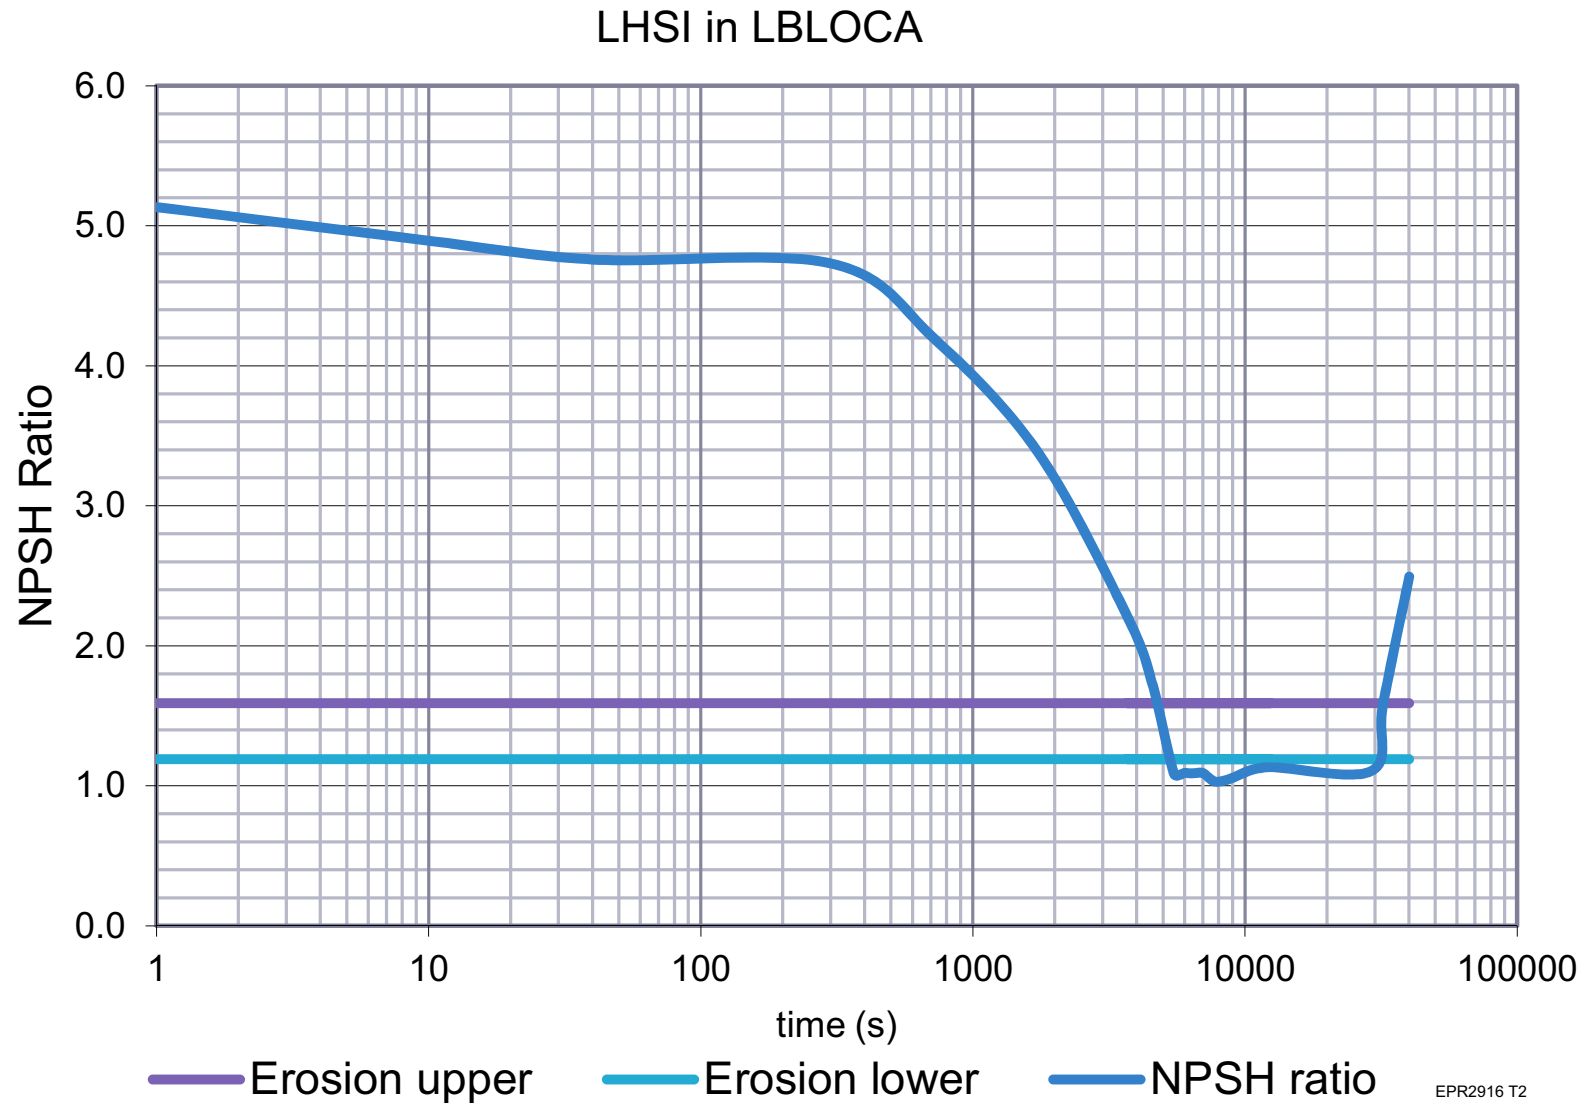
Figure 6.3-10—LHSI in LBLOCA - Cavitation Erosion

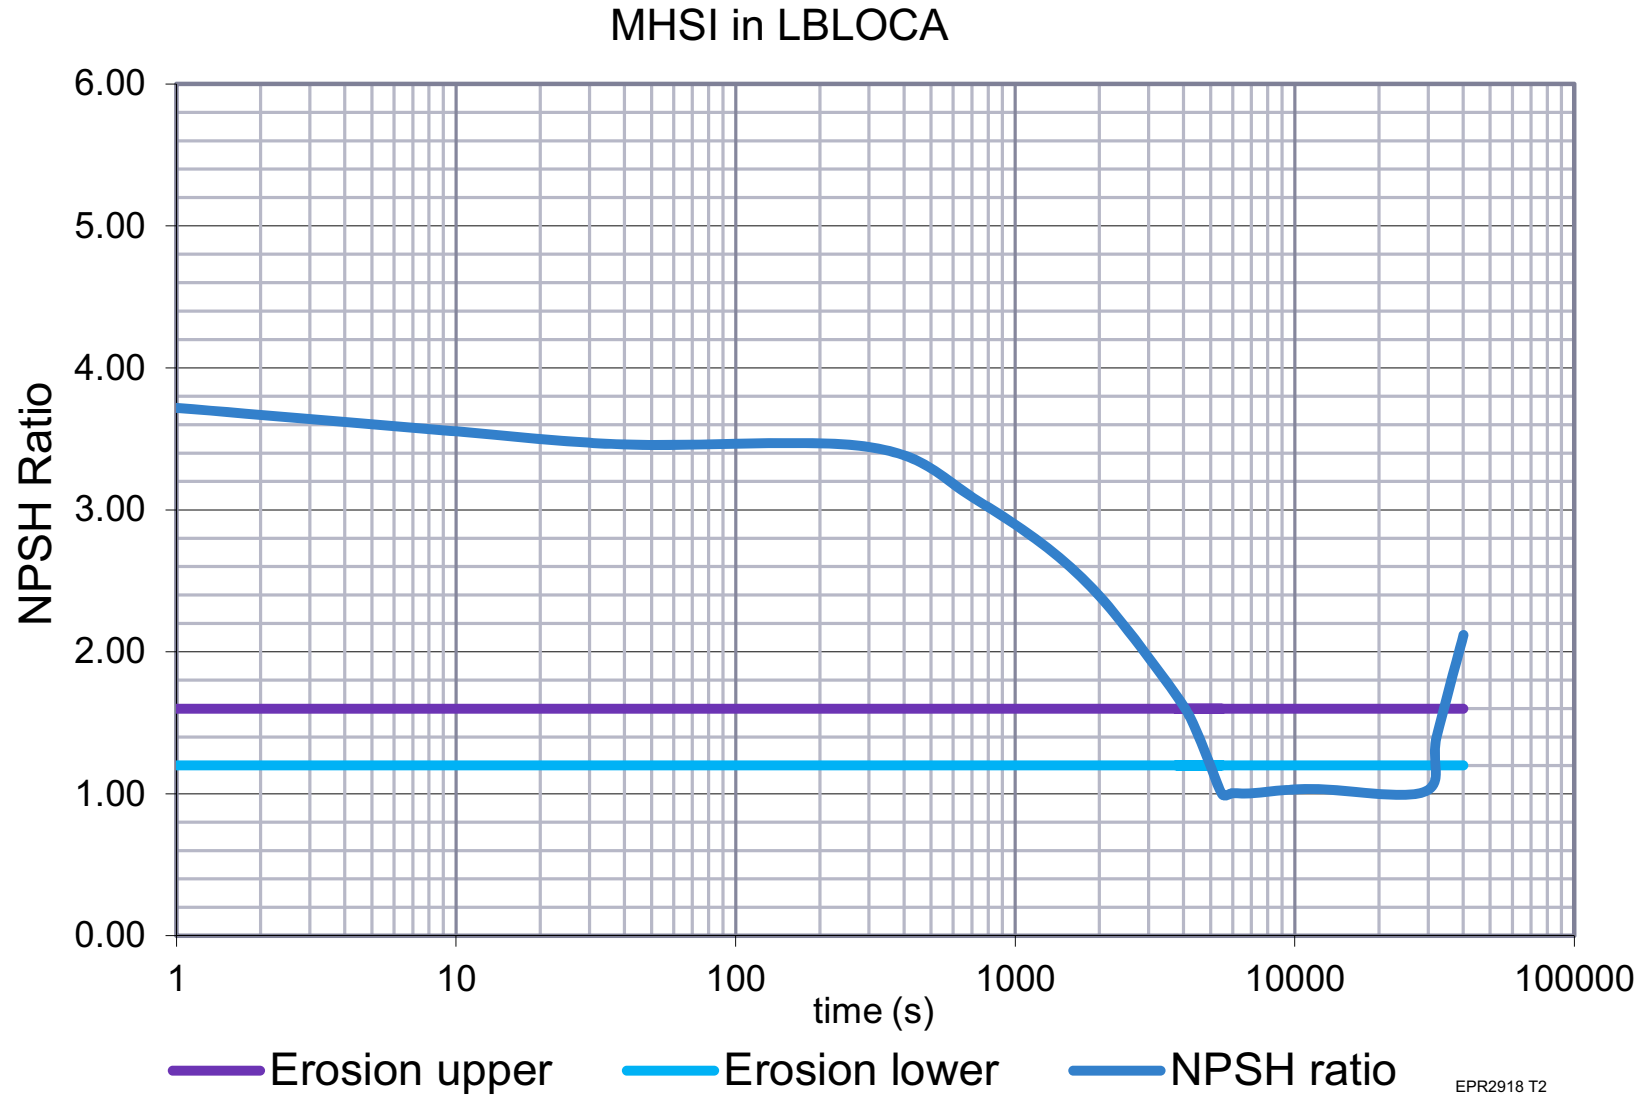
Figure 6.3-11—MHSI in LB LOCA - Cavitation Erosion
