Charlissa C. Smith  
(Denial of Senior Reactor Operator License)

ASLBP #: 13-925-01-SP-BD01  
Docket #: 05523694  
Exhibit #: CCS-100-00-BD01  
Admitted: 7/17/2013  
Rejected:  
Other:

**Exhibit CCS-100**

**C. Smith Complaint is that while the FIC 121 controller was being returned to automatic the exam team attempt to complicate and distract the crew by placing the next failure in. They administered the scenario differently than the other crews**

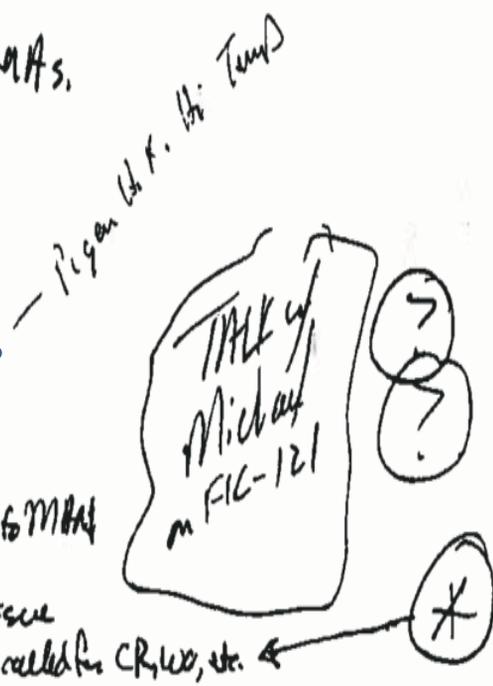
- 08:53:44 R-C: Failure of Fw Sp Control. IMAs.
- 54:10 R-C: IMAs clear
- 54:21 C-S: Place FIC 121 in Auto
- 55:52 R-C: Alms FIC-121 Failed Closed
- 57:38 C: X 18016-C Section E
- 58:40 C-R-C: Man Fw Sp Master Control was taken to MHA
- 08:32 C-UC: Notices of FIC-121 and Control Issue She called it a failure and called for CR, WX, etc.
- 09:28 Alms
- 09:40 C-R: Pull ATRP

08:55:52 Alarms come in and FIC 121 closed

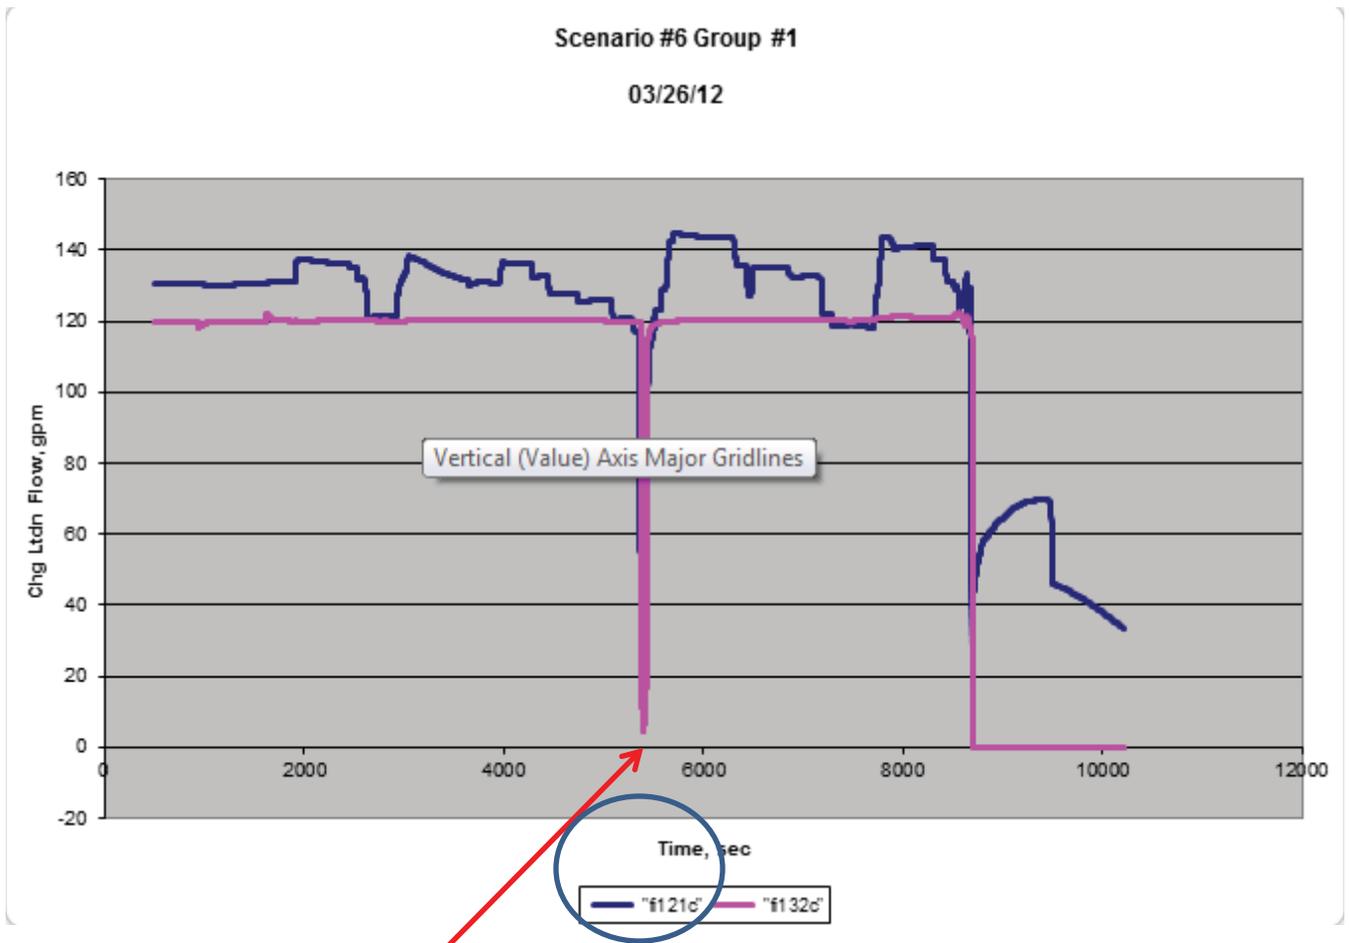
This is a chart generated by Region II and obtained through FOIA 0242

- This large drop is due to the FIC 121 closing
- FIC 121 is in blue and circled
- Look at the chart to see the approx timeframe that all the actions were occurring with FIC 121 and PT 508 (4000-6000)
- Based on the timeline the time frame from the start of the PT 508 failure to the closing of FIC 121 took approx 2 minutes, which is 120 second – so the actions should be within 120 seconds after the Main Feed Pump Speed is recovered

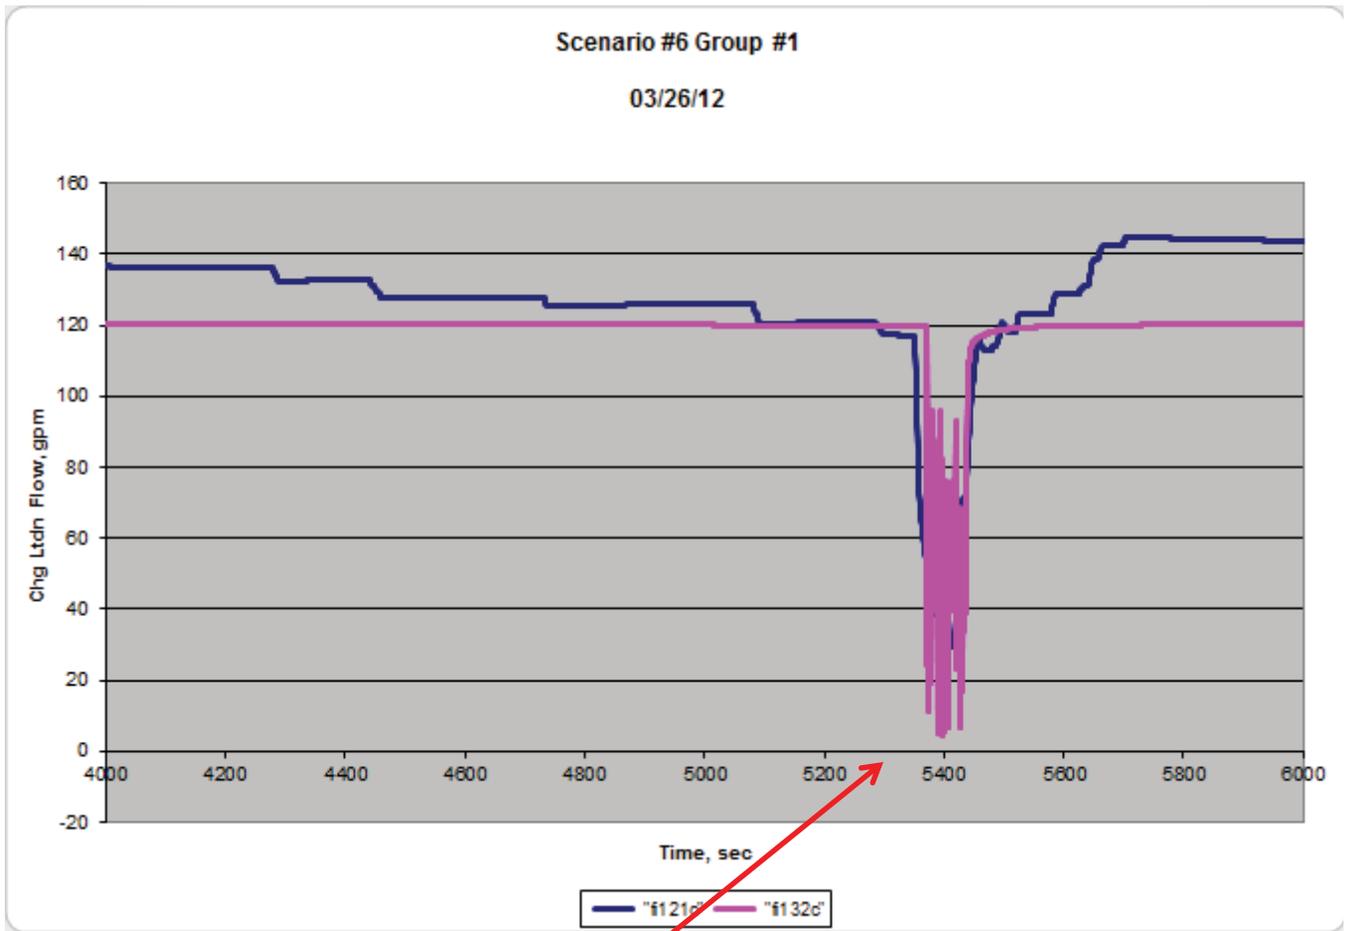
# Zoom in

C. Smith has changed the scale to zoom the image in close to make a comparison. This is zoomed in to see between 4000 and 6000 seconds into the scenario

The FIC 121 Closing occurs between 5200 seconds and 5500 seconds (this is a band of 300 seconds so our PT508 failure should have occurred in the same band)

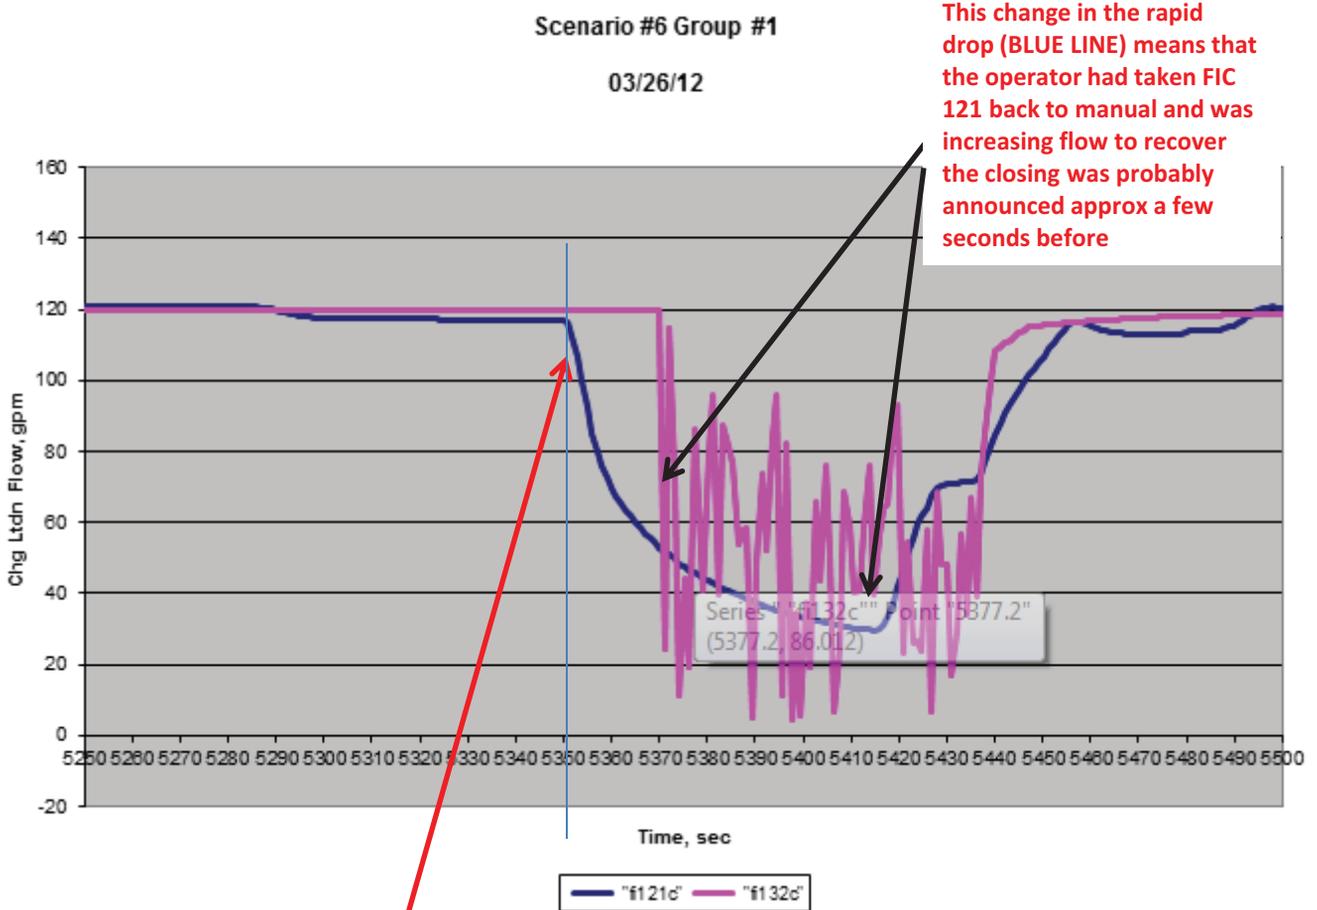
# Zoom in more

This change in the rapid drop (BLUE LINE) means that the operator had taken FIC 121 back to manual and was increasing flow to recover the closing was probably announced approx a few seconds before

- Recall that FIC 121 started closing but it took approx 91 seconds after taking it to AUTO to close, this drop off indicates the moment that FIC 121 closed (closing starts at approx 5350 seconds)
- If we go back approx 90 seconds we can see the approx time that the direction to AUTO occurred
- C. Smith has changed the scale to zoom the image in close to make a comparison. This is zoomed in to see between 5250 and 5500 seconds into the scenario

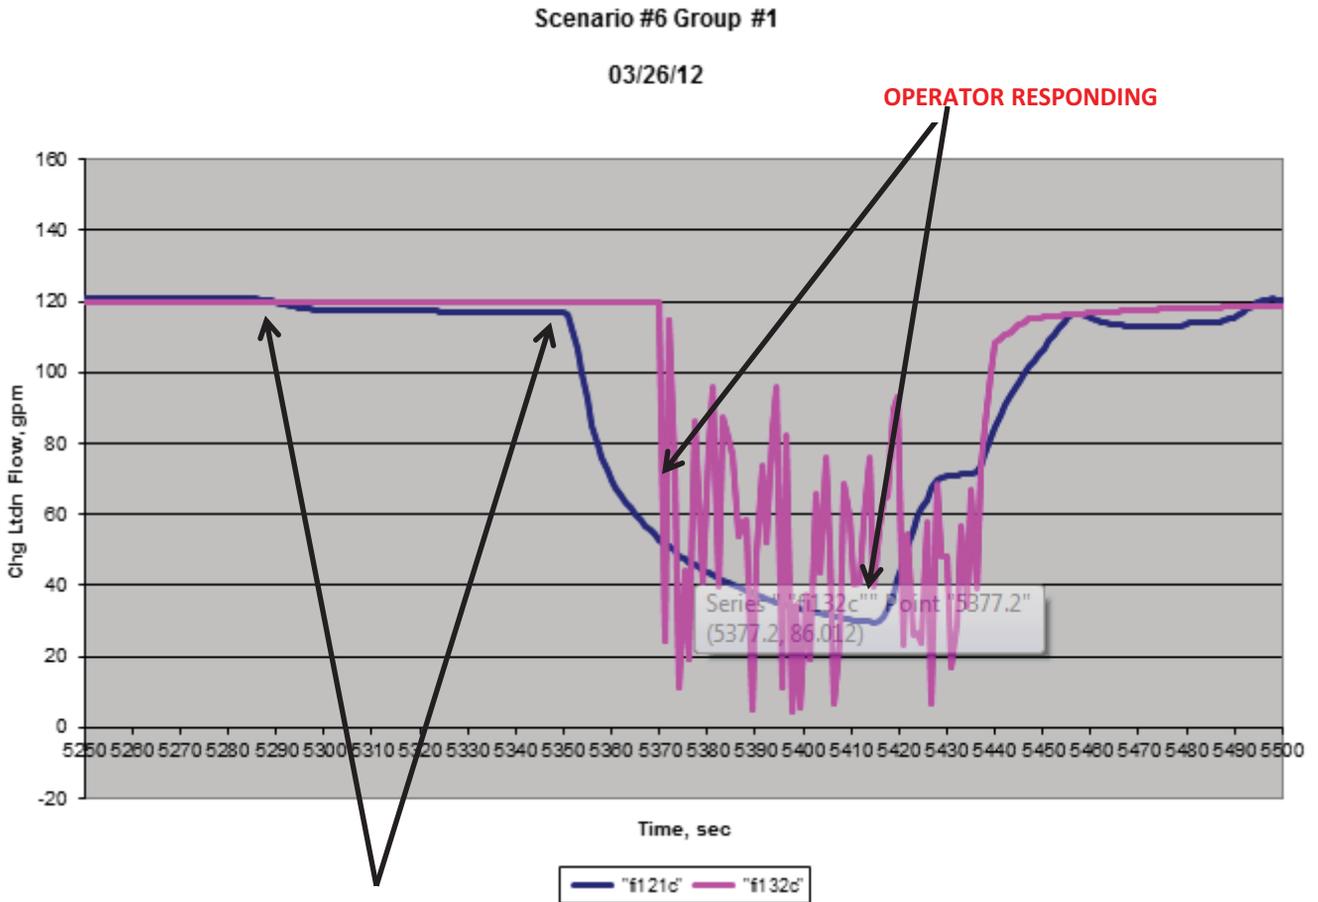
- After the crew took FIC 121 to AUTO, the component did not immediately close . So if the operator is responding at approx 5380 seconds then the direction occurred approx 90 seconds before ...the direction was between 5290 – 5330 seconds
- Either way, if you subtract 90 seconds from the middle of the drop in flow for FIC 121, it still estimates the time the direction to AUTO occurring at approx 5300 seconds

- **FIC 121 estimated the time to AUTO at approximately 5300 seconds based on simulator data**
- **FIC 121 starts closing at approximately 5350 seconds based on the simulator data**
- **The PT 508 response and recover occurs between 5300 seconds and 5340 seconds based on the simulator data**

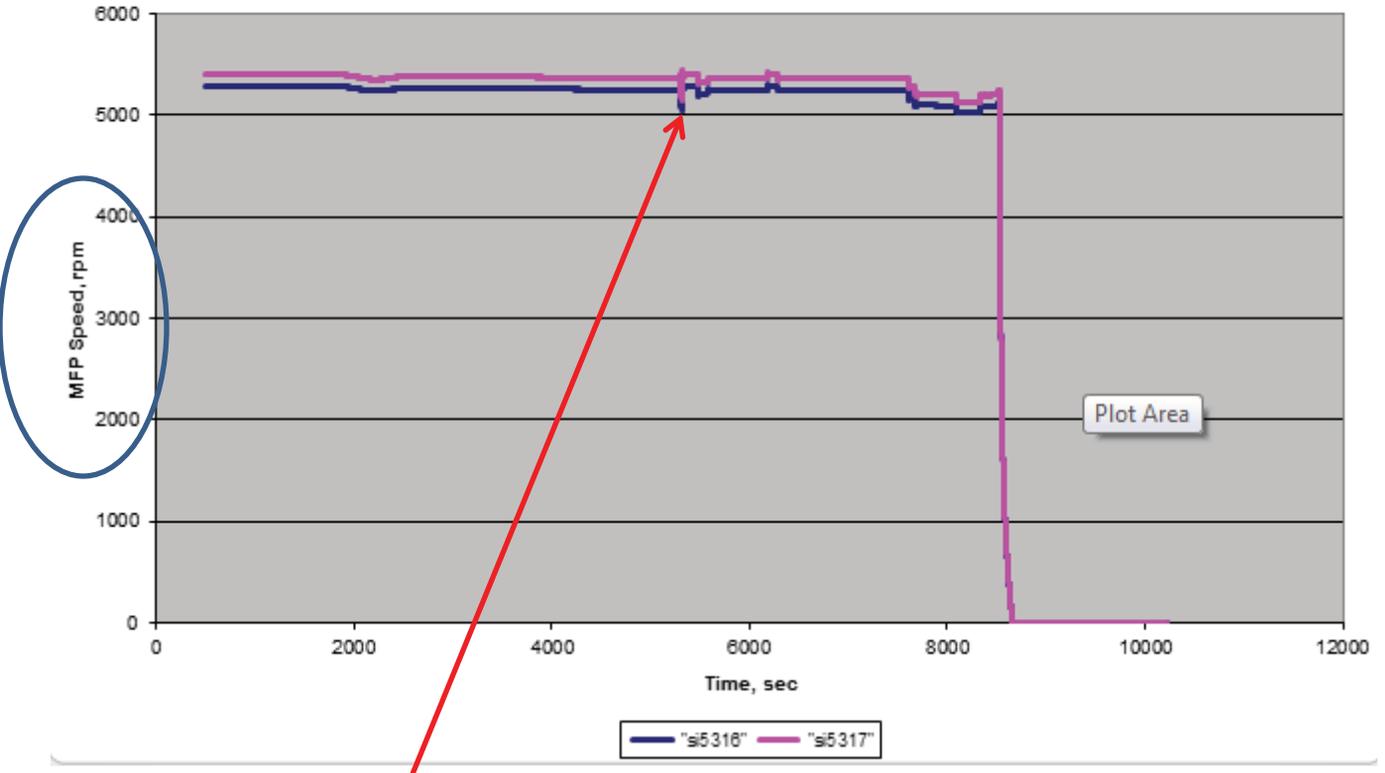
Scenario #6 Group #1

- This dip is due to the PT 508 failure**

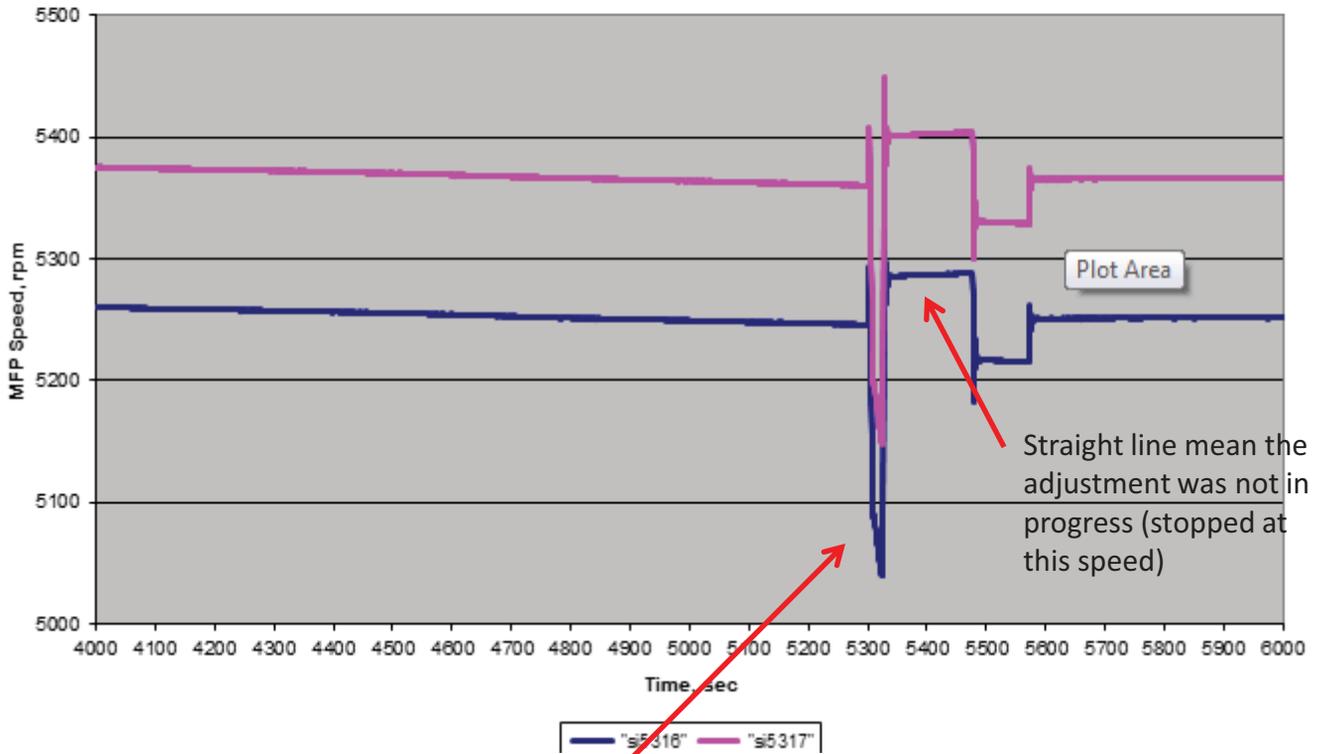
Scenario #6 Group #1

C. Smith has changed the scale to zoom the image in close to make a comparison. This is zoomed in to see between 4000 and 6000 seconds into the scenario

The PT 508 Closing occurs between 5200 seconds and 5500 seconds (this is a band of 300 seconds so our PT508 failure should have occurred in the same band)

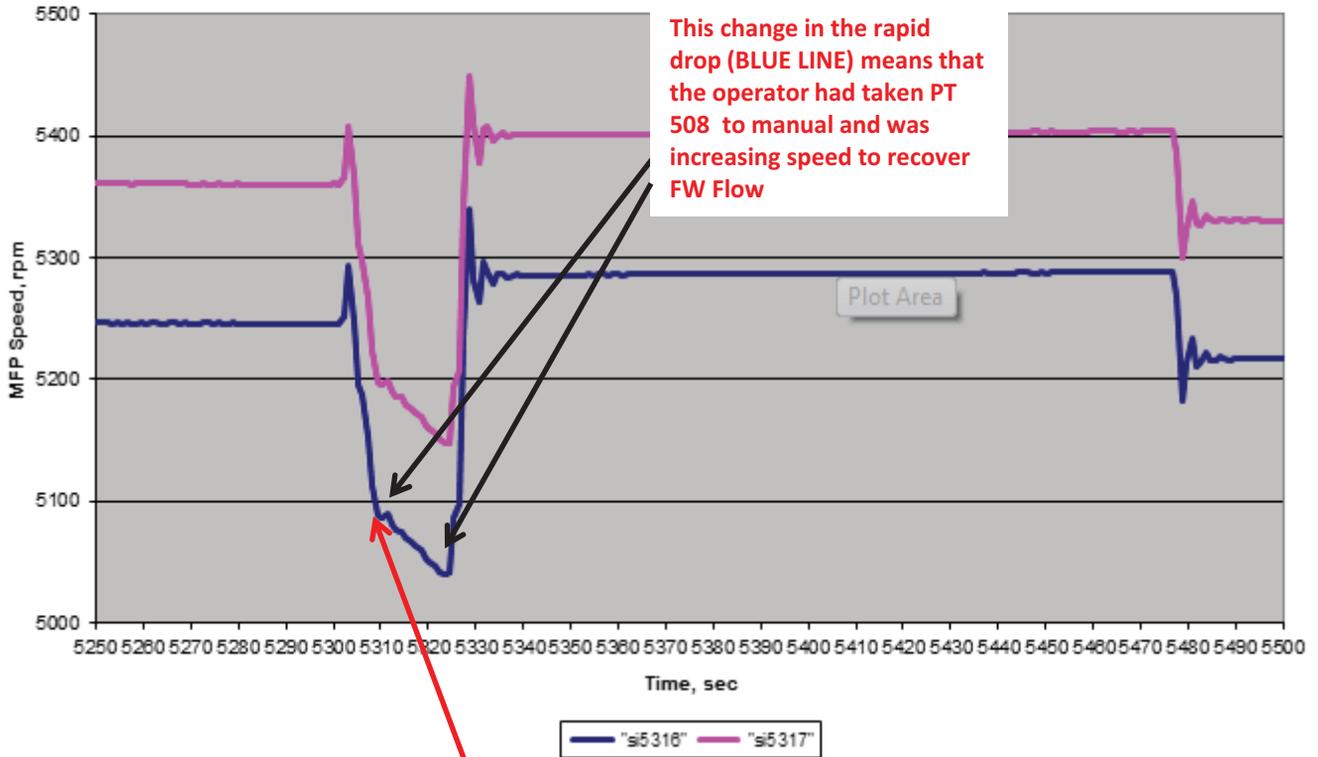
Scenario #6 Group #1

C. Smith has changed the scale to zoom the image in close to make a comparison. This is zoomed in to see between 5250seconds and 5500 seconds into the scenario

The PT 508 response and recover occurs between 5300 seconds and 5340 seconds

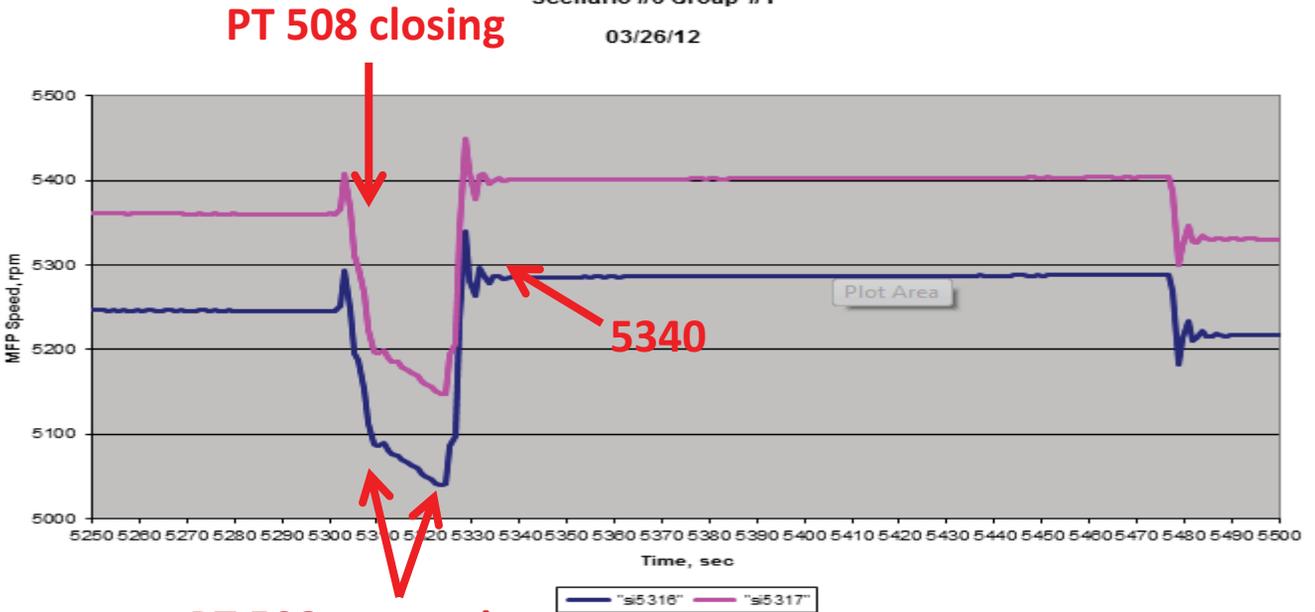
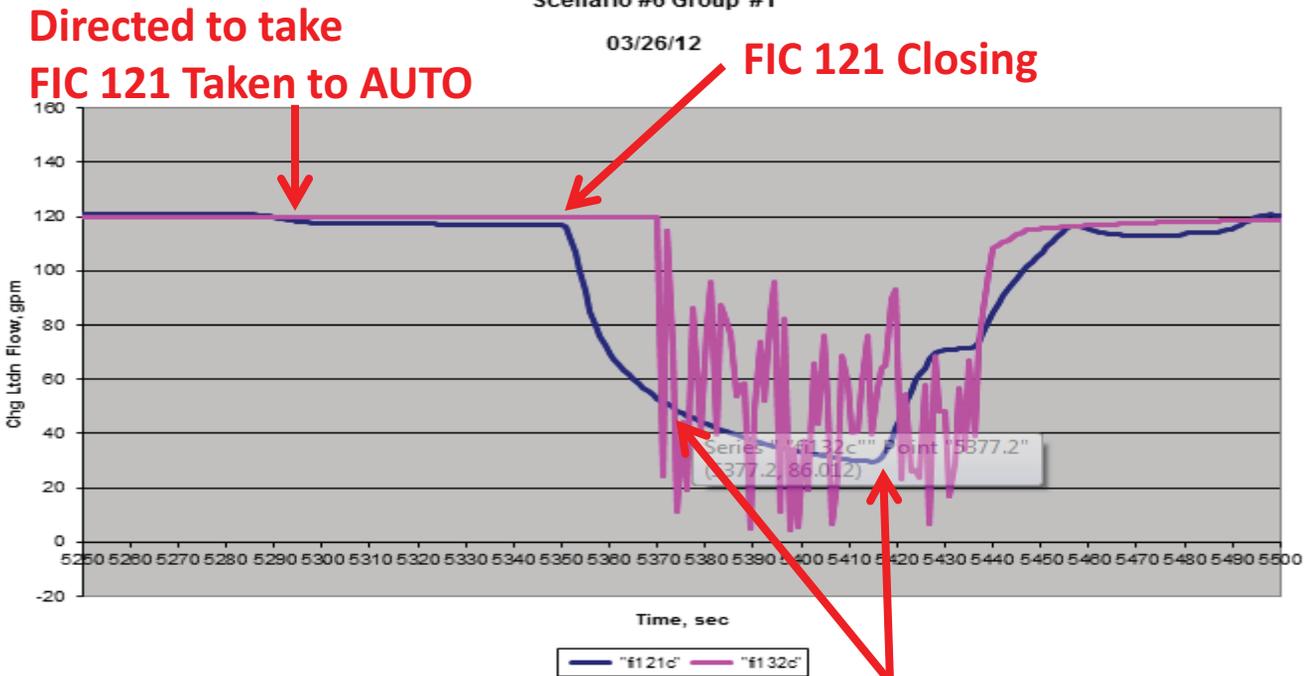
# Side by Side Comparison

PT 508 recovering  
MFP speed

According to Mark Bates, FIC was directed to auto 11 seconds after the actions for PT 508 were complete. Then 91 seconds after the direction to place in auto, FIC 121 started closing. ~1.5 minutes later the actions were complete.....This does not match the timeline here.

*Based on this information PT 508 and FIC 121 events were going on at the same time, as described in C. Smith notes. She gave direction to take FIC 121 to AUTO and received a simultaneous failure of PT 508, The crew responded to the PT 508 and upon completion the FIC 121 valve started to close.*
