Fukushima -
Flooding Hazard Reevaluation
Upstream Dam Failure Analysis

**NCR
Technical
Presentation**

March 25, 2013

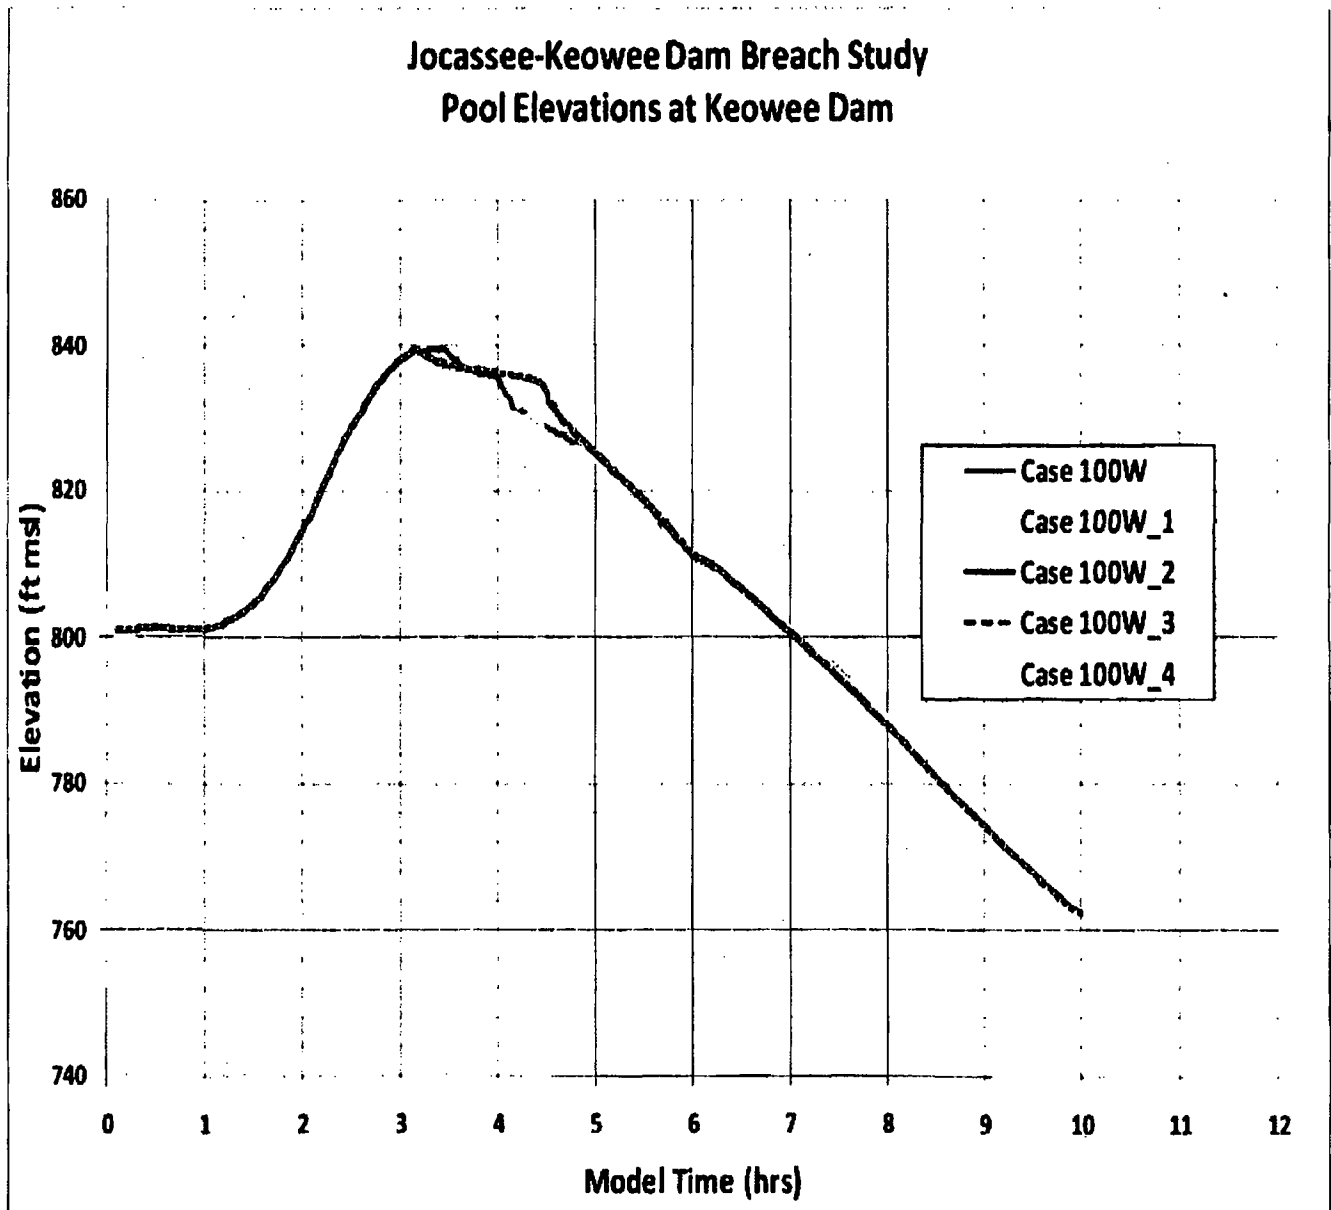
2011 Breach Analysis Summary

WATER SURFACE ELEVATIONS AT KEOWEE DAM
