Sheet 1 of 3

Status: Y ☒ N ☐ U ☐**Seismic Walkdown Checklist (SWC)**Equipment ID No. Q1N11HV3369A Equip. Class¹ 7Equipment Description MAIN STEAM ISOLATION VALVELocation: Bldg. AUXILIARY Floor El. 121 Room, Area 241

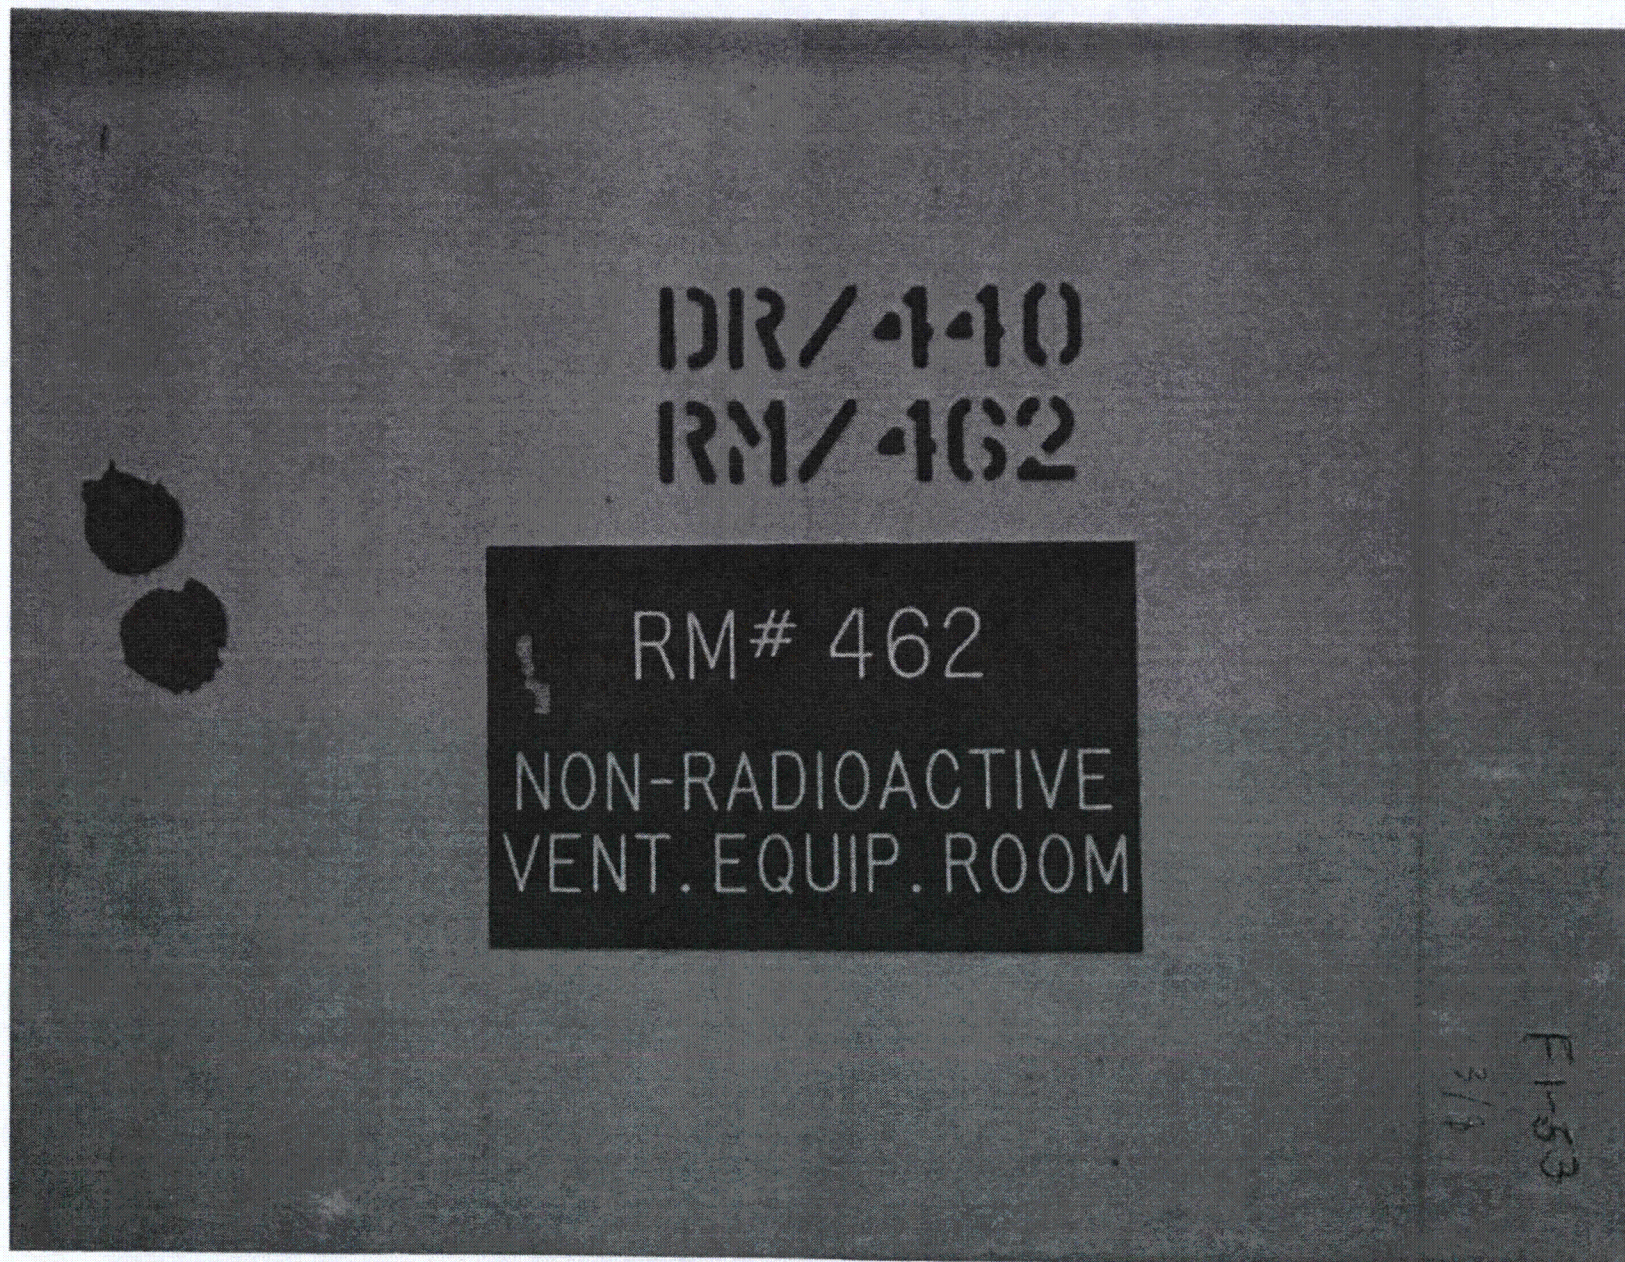
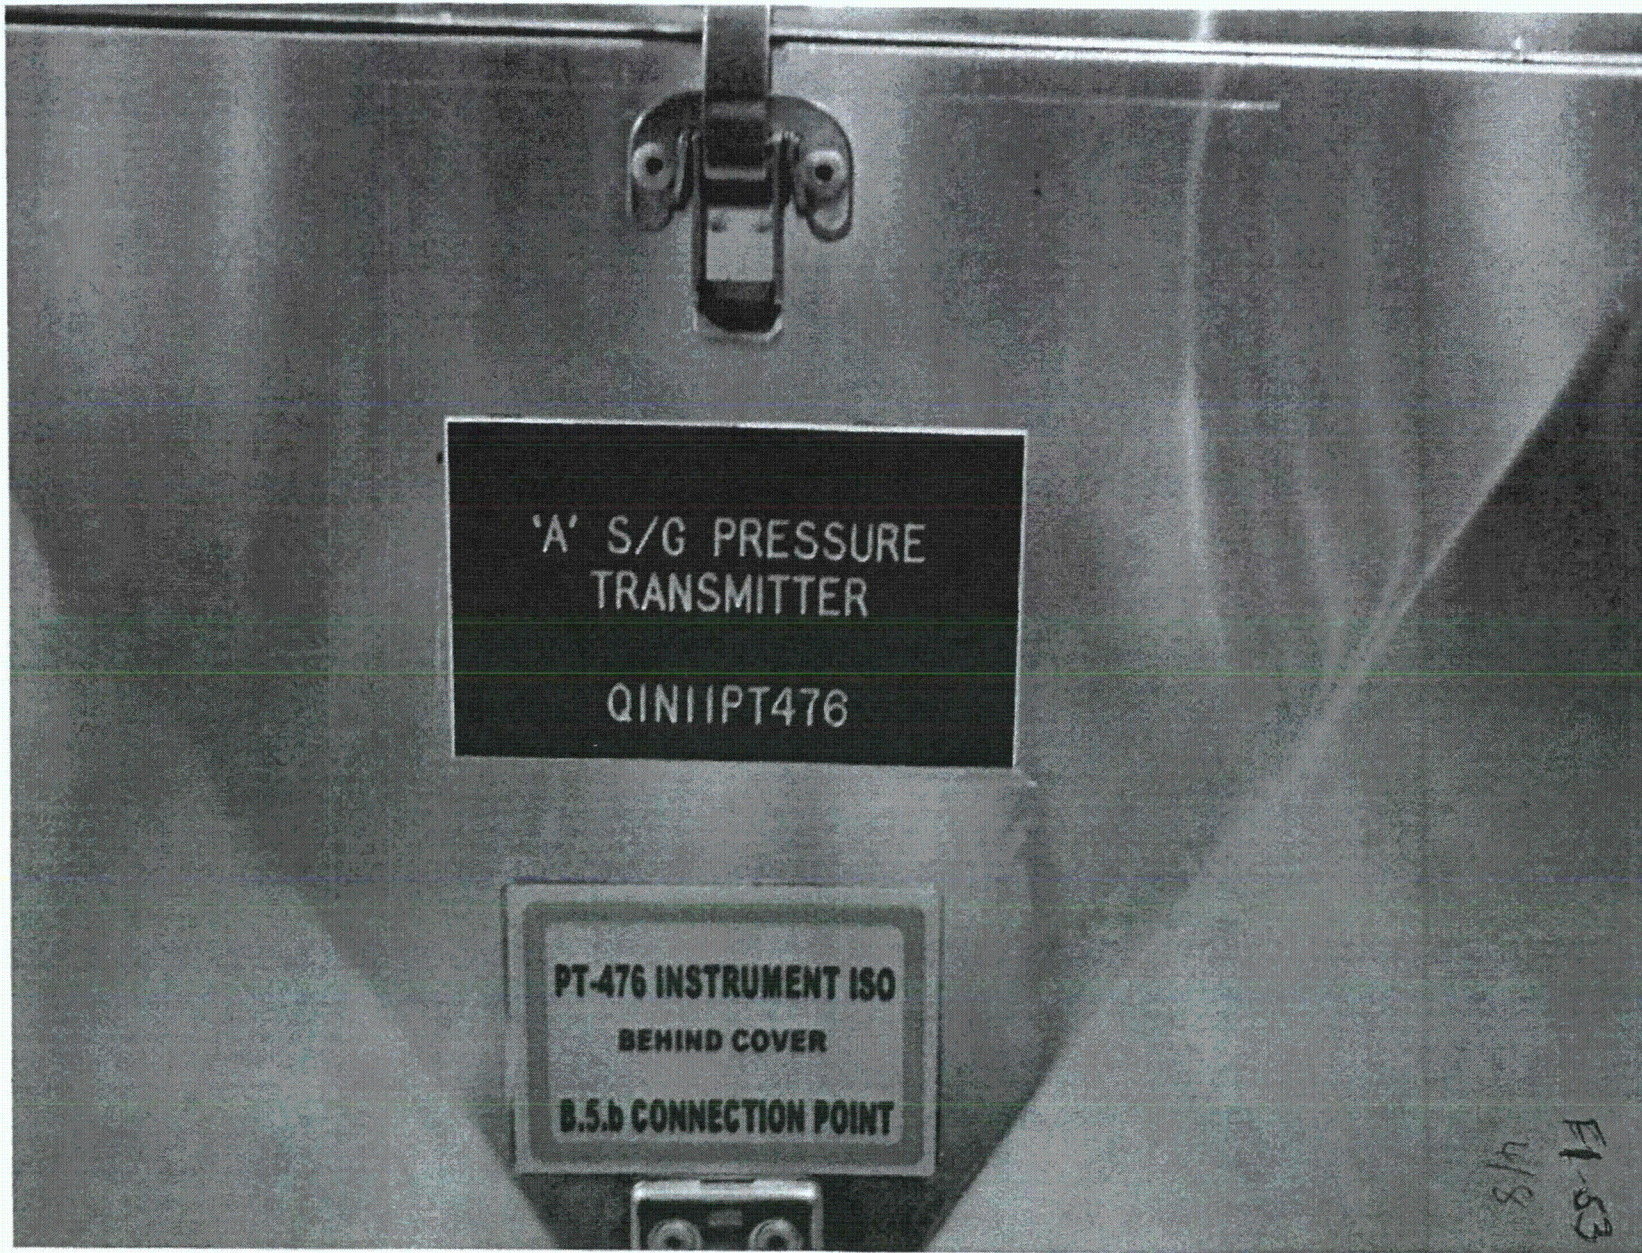
Seismic Walkdown Checklist (SWC)Equipment ID No. Q1N11PT0476 Equip. Class¹ 18Equipment Description STEAM GENERATOR 1A DISCHARGE PRESSURELocation: Bldg. AUXILIARY Floor El. 155 Room, Area 462

2. Is the anchorage free of bent, broken, missing or loose hardware? Y ☐ N ☐ U ☒ N/A ☐
 OPS
 OPENED TRANSMITTER BOX BUT THICK ^{FOAM} INSULATION ON ALL
 COMPONENTS OF THE TRANSMITTER OBSCURED THE ANCHORAGES.

3. Is the anchorage free of corrosion that is more than mild surface oxidation? Y ☐ N ☐ U ☒ N/A ☐

4. Is the anchorage free of visible cracks in the concrete near the anchors? Y ☐ N ☐ U ☒ N/A ☐

6. Based on the above anchorage evaluations, is the anchorage free of potentially adverse seismic conditions? Y ☐ N ☐ U ☒

9. Do attached lines have adequate flexibility to avoid damage? Y ☐ N ☐ U ☒ N/A ☐

REQUIRES WALKDOWN/VERIFICATION DURING A FUTURE OUTAGE

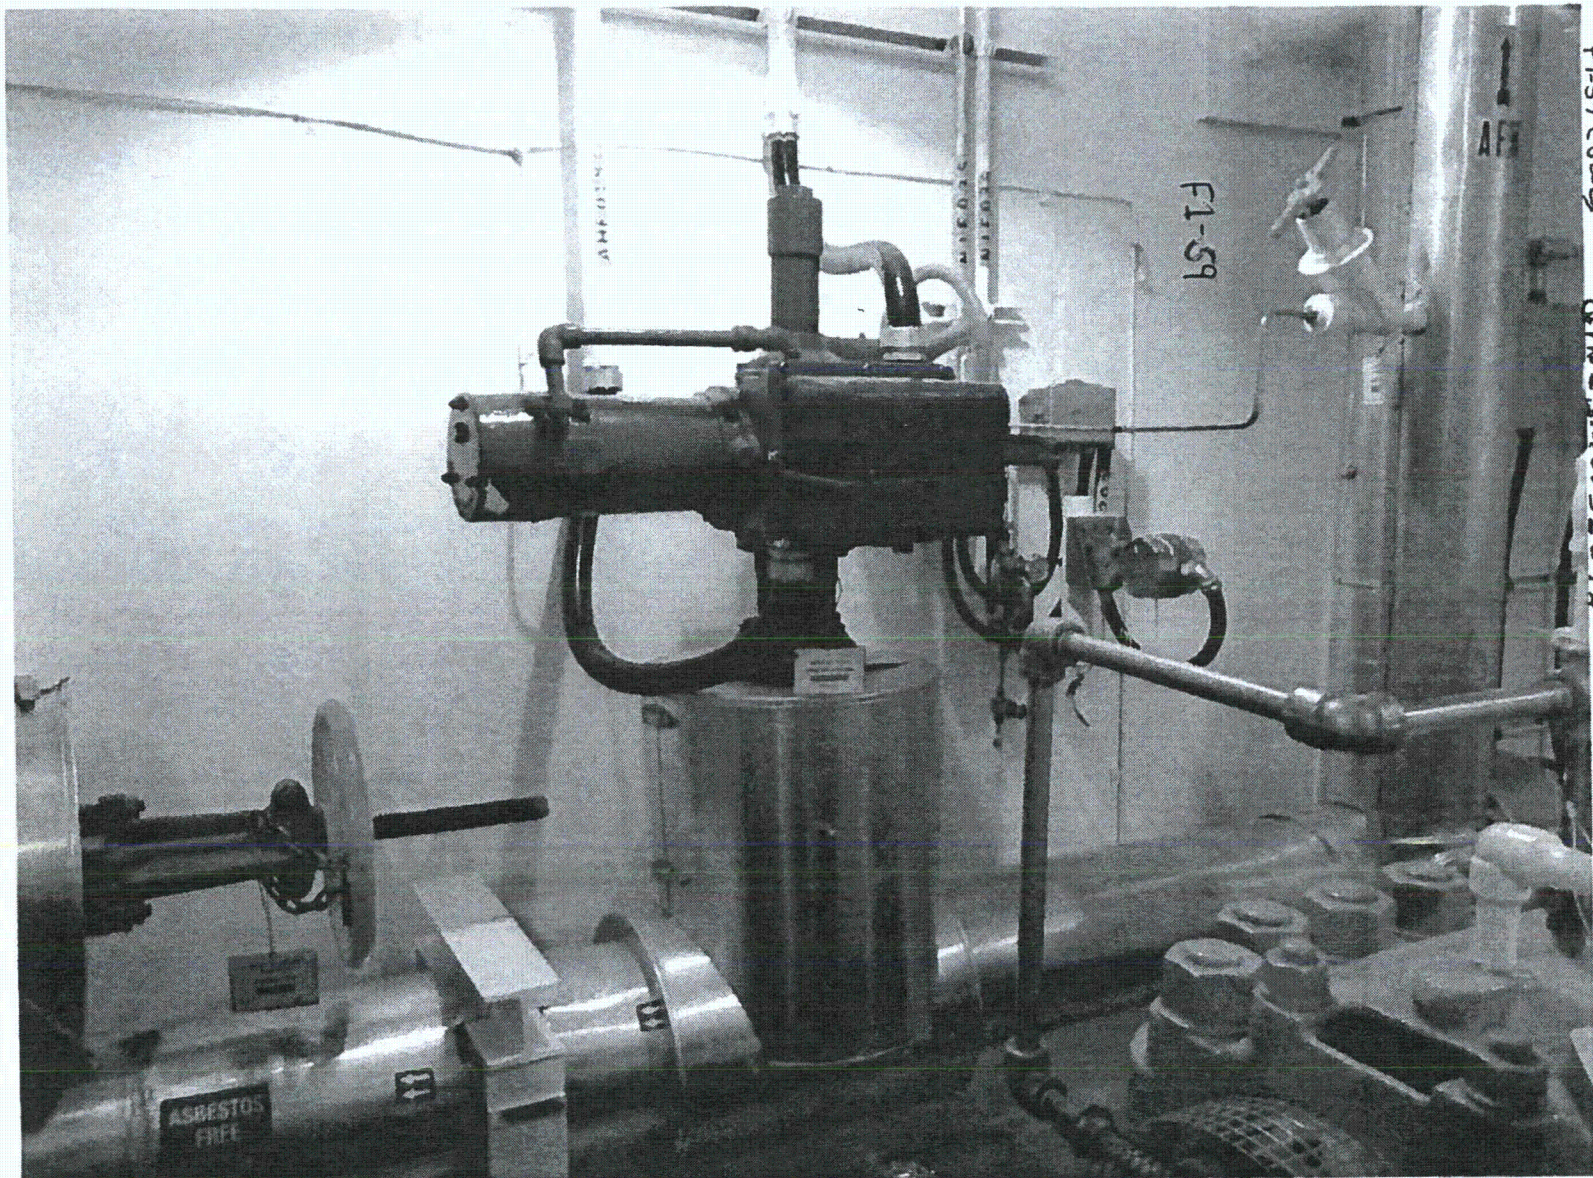
Status: Y ☒ N ☐ U ☐**Seismic Walkdown Checklist (SWC)**Equipment ID No. Q1N23MOV3209A Equip. Class¹ 8Equipment Description SERVICE WATER ISOLATION VALVE TO AUX FEEDWATERLocation: Bldg. AUXILIARY Floor El. 100 Room, Area 191

1. Is the anchorage configuration verification required (i.e., is the item one of the 50% of SWEL items requiring such verification)? Y ☐ N ☒
2. Is the anchorage free of bent, broken, missing or loose hardware? Y ☒ N ☐ U ☐ N/A ☒
IN-LINE COMPONENT
3. Is the anchorage free of corrosion that is more than mild surface oxidation? Y ☐ N ☐ U ☐ N/A ☒
4. Is the anchorage free of visible cracks in the concrete near the anchors? Y ☐ N ☐ U ☐ N/A ☒
5. Is the anchorage configuration consistent with plant documentation?
(Note: This question only applies if the item is one of the 50% for which an anchorage configuration verification is required.) Y ☐ N ☐ U ☐ N/A ☒
6. Based on the above anchorage evaluations, is the anchorage free of potentially adverse seismic conditions? Y ☒ N ☐ U ☐

NONE
