Debris Bed Preparation and Formation Test Results, Revision 4

Document No: CHLE-008	Revision: 4	Page 1 of 24
Title: Debris Bed Preparation and Formation Test Results		
Project: Corrosion/Head Loss Experiment (CHLE) Program		Date: 2/23/2014
Client: South Texas Project Nuclear Operating Company

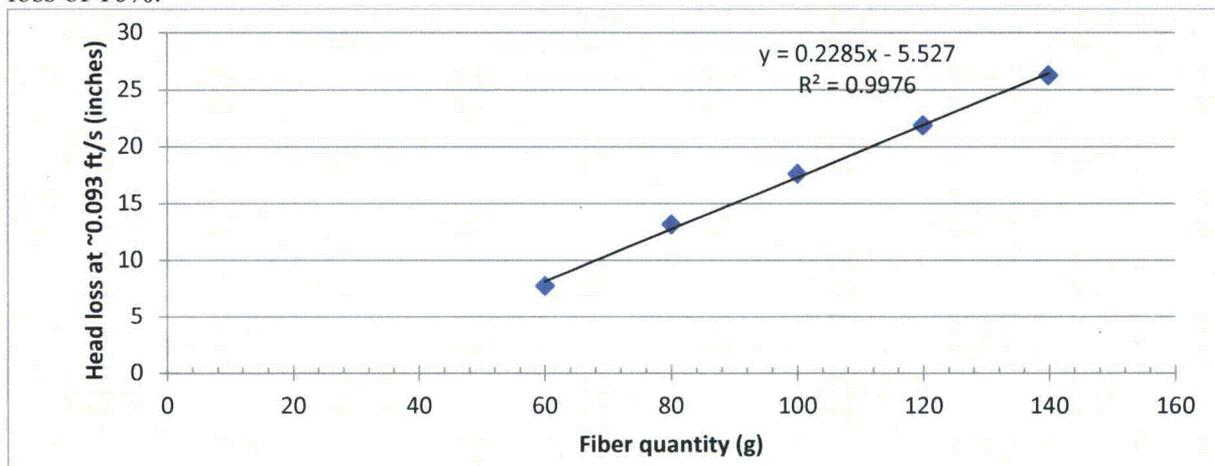
Figure 1: Head loss at approach velocity of about 0.093 ft/s with RO-treated water as the circulating fluid.

Results: Additions of fiber in 20 g increments led to uniform increases in head loss at both 0.093 and 0.01 ft/s, although the intercept did not pass through zero (see Figures 1 and 2 below). Water turbidity declined slightly with each addition of fiber (starting at 2.6 NTU and declining to 2.1 NTU after 140 g of fiber were in the column), indicating that the fiber bed was probably filtering some particles from the water. After SiC was added and the water was allowed to circulate for 10 minutes, the turbidity was measured at 162 NTU. After an additional 20 minutes, the turbidity was measured at 97 NTU, indicating that the fiber bed was removing some of the SiC carbides, but very slowly. After the SiC was added, the head loss stabilized at 30.5 inches, compared to 26.2 inches with fiber only (at a velocity of 0.093 ft/s), an increase in head loss of 16%.

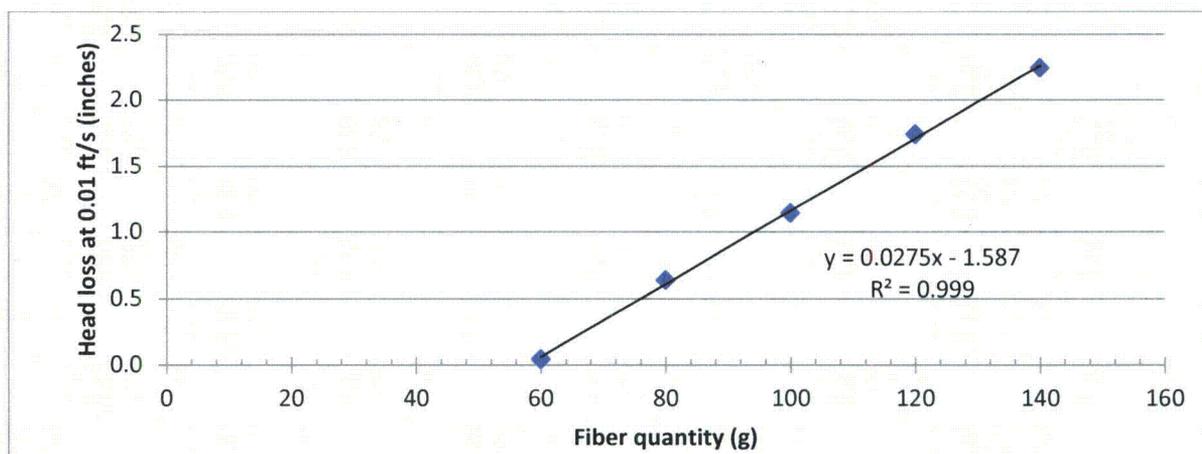
Figure 2: Head loss at approach velocity of 0.010 ft/s with RO-treated water as the circulating fluid.

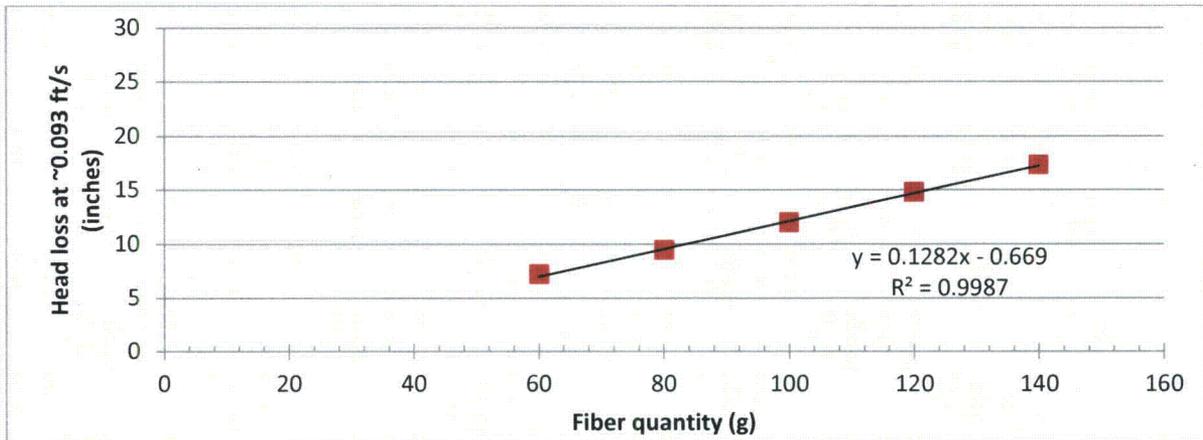
Figure 3: Head loss at approach velocity of about 0.093 ft/s with water containing boric acid and TSP as the circulating fluid.

Results: Additions of fiber in 20 g increments led to uniform increases in head loss at approach velocities of both 0.093 and 0.01 ft/s, similar to Test 1. Two differences between this test and Test 1, however, were that the overall head loss was lower in this test (with 140 g of fiber, Test 2 had 17.3 inches of head loss compared to 26.2 inches in Test 1), and the intercept of the increasing head loss trend was close to zero (see Figures 3 and 4).

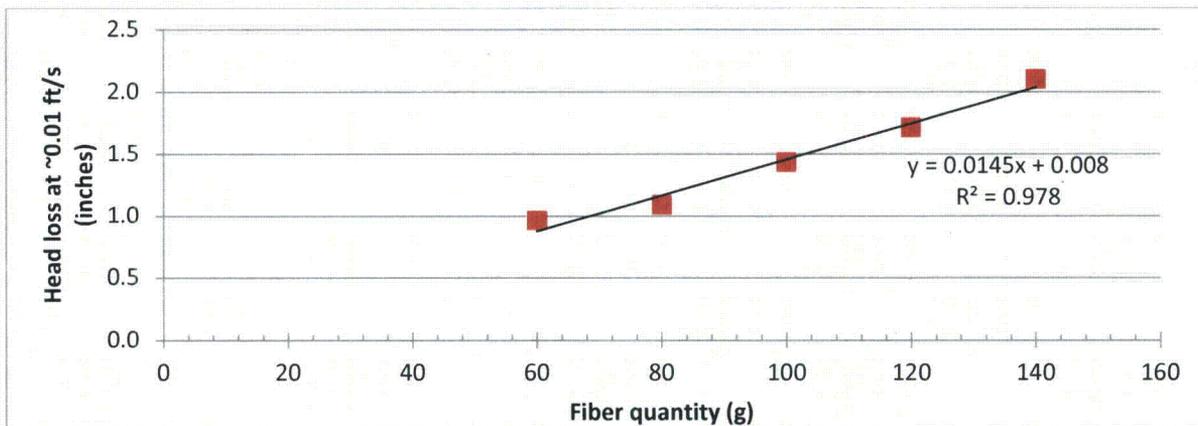
Figure 4: Head loss at approach velocity of 0.010 ft/s with water containing boric acid and TSP as the circulating fluid.

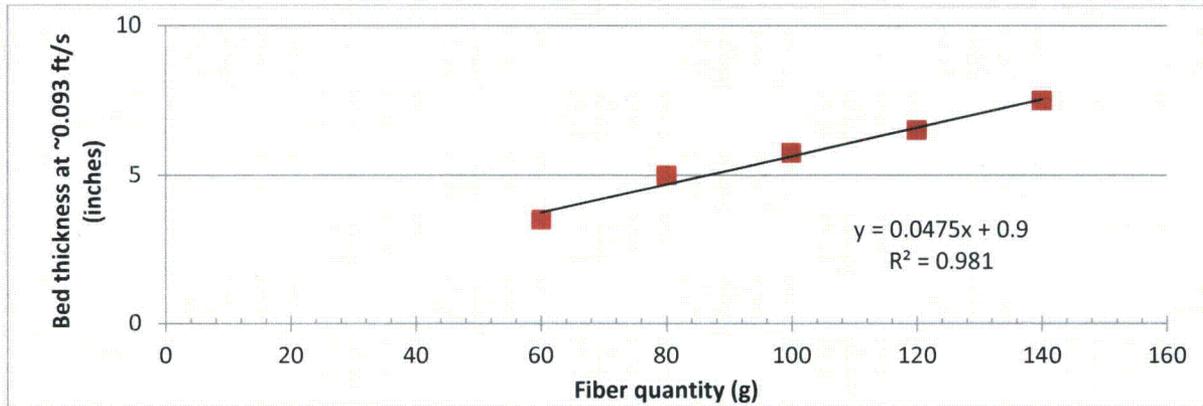
Figure 5: Bed thickness at approach velocity of 0.010 ft/s with water containing boric acid and TSP as the circulating fluid.

The increase in bed thickness was also relatively linear with additions of fiber, as shown in Figure 5.

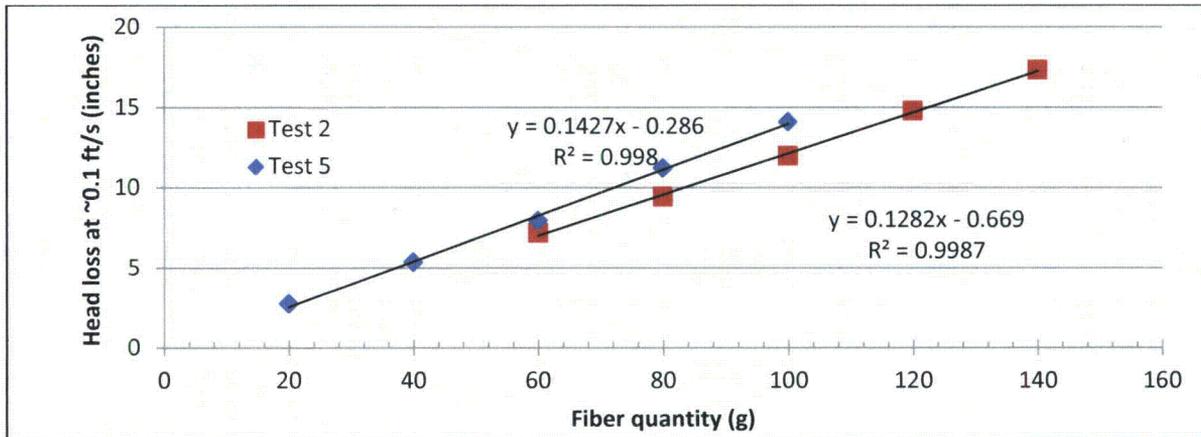
Figure 6: Head loss at approach velocity of 0.093 ft/s in Test 2 and 0.1 ft/s in Test 5.

Results: The incremental addition of fiber in Test 5 produced head loss and bed thickness results very similar to Test 2. At an approach velocity of 0.1 ft/s, the corresponding head loss in Test 2 was about 85 to 90 percent of the corresponding head loss in Test 5, as shown in Figure 6. However, Test 2 was conducted at an approach velocity of about 0.093 ft/s, whereas Test 5 was conducted at 0.1 ft/s. Considering the difference in approach velocity in the two tests, the results are very similar. Nearly identical head loss results were obtained at an approach velocity of 0.01 ft/s, as shown in Figure 7. The slope of the linear trend of head loss with fiber addition is virtually identical in Tests 2 and 5 at 0.01 ft/s, and the intercept varies by only 0.15 inches. Similarly, nearly identical bed thickness results were obtained in the two tests, as shown in Figure 8.

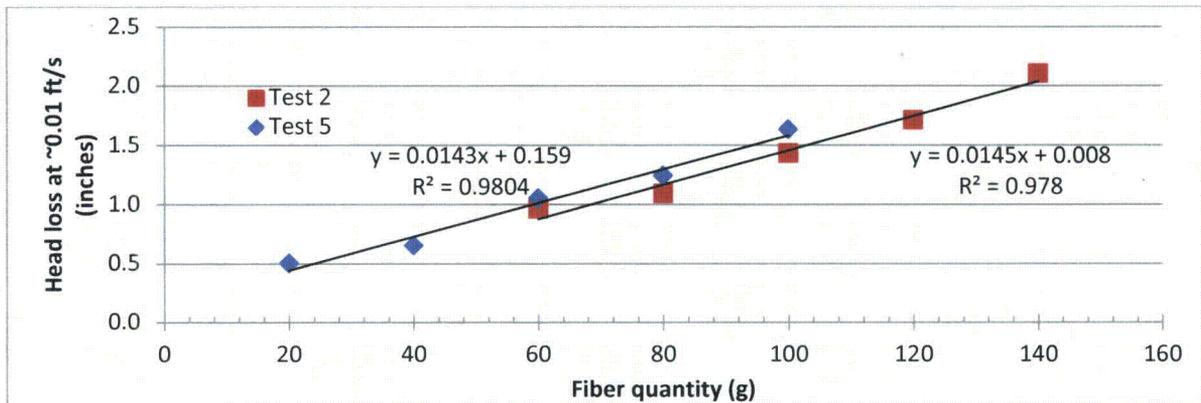
Figure 7: Head loss at approach velocity of 0.01 ft/s in Tests 2 and 5.

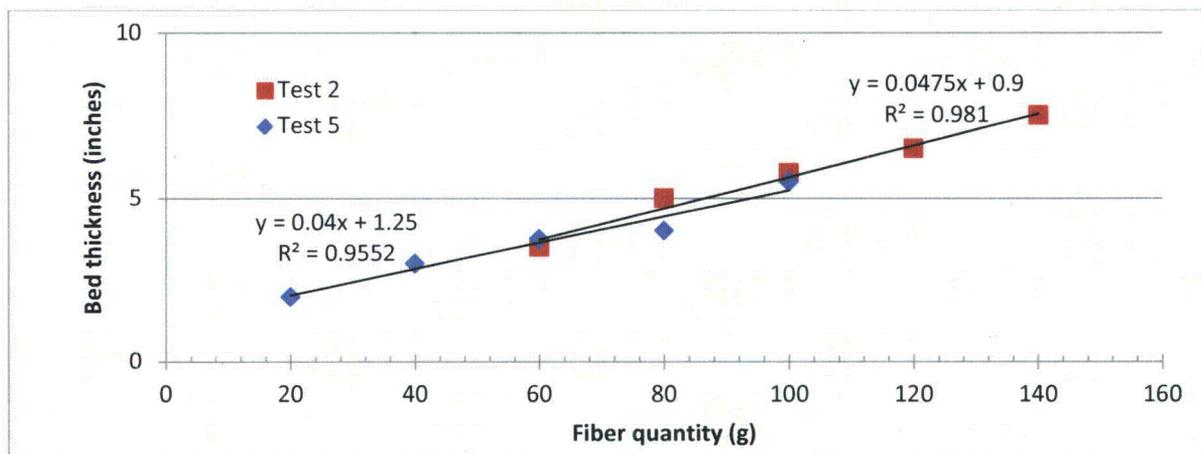
Figure 8: Fiber bed thickness at approach velocity of 0.1 ft/s in Tests 2 and 5

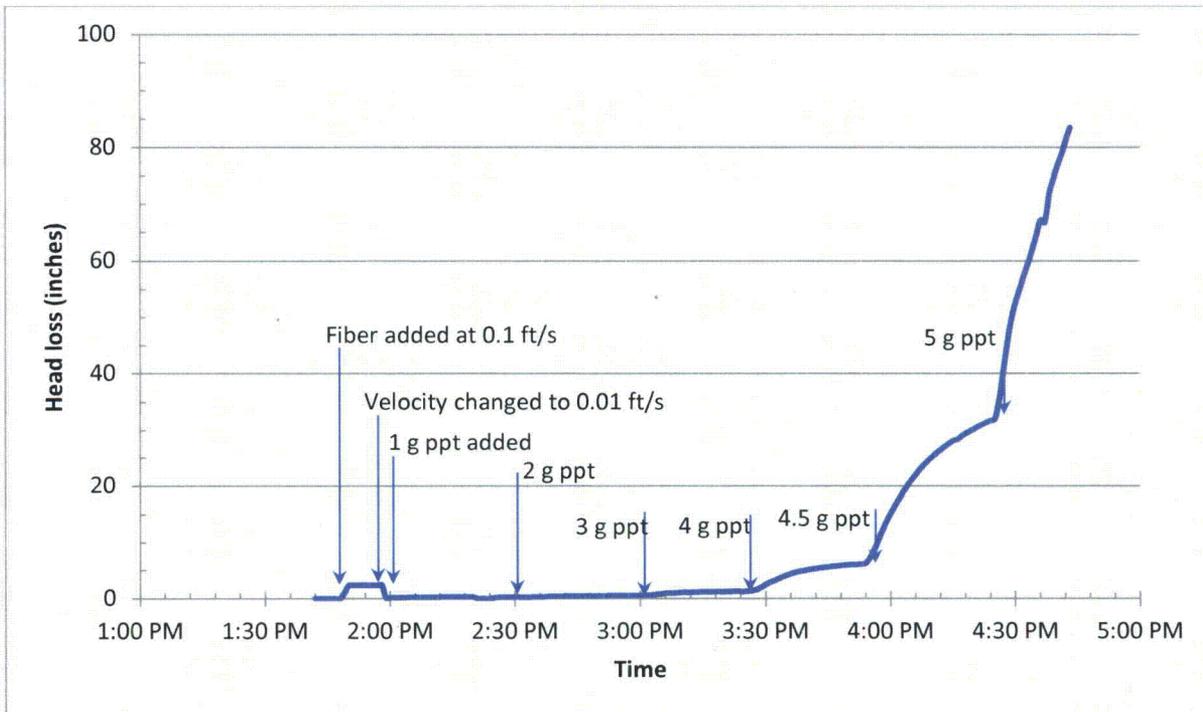
Figure 9: Head loss after addition of 1g increments of WCAP precipitate (Test 6)

Results: Measured head loss increased only slightly after the first 3 additions of WCAP precipitate. Head loss was more significant after the 4th addition, and the next two additions consisted of only 0.5 g of WCAP precipitate each, but head loss increased rapidly after each. The head loss trend during the test is shown in Figure 9.

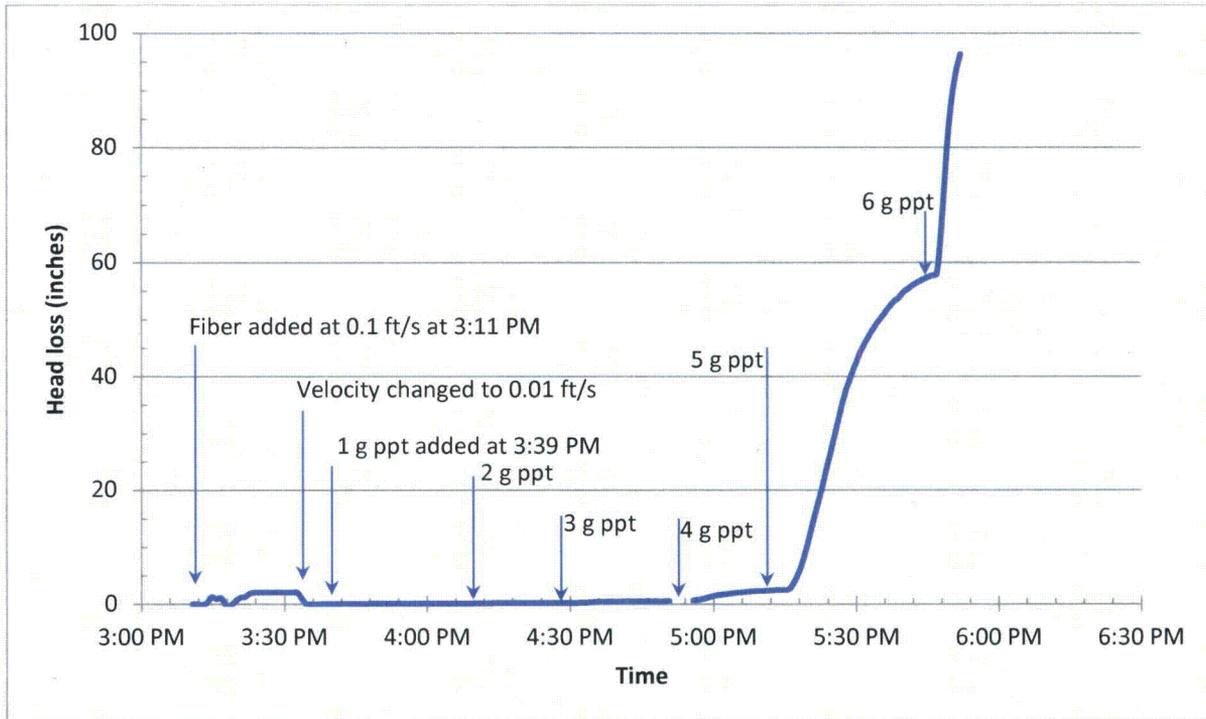
Figure 10: Head loss after addition of 1g increments of WCAP precipitate (Test 8)

Results: The results were similar to Test 6. Measured head loss increased only slightly after the first 3 additions of WCAP precipitate. Head loss started to creep up after the 4th addition, and increased rapidly after the 5th and 6th additions. The head loss trend during the test is shown in Figure 10 and a comparison of the head loss resulting from each addition in Tests 6 and 8 is shown in Figure 11. The results from Tests 6 and 8 demonstrate reproducibility.

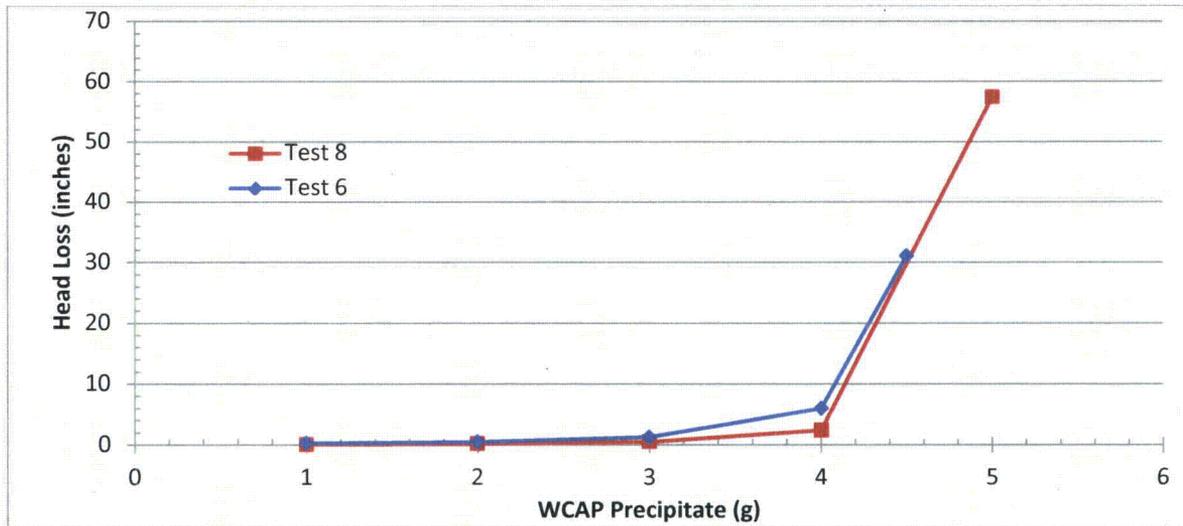
Figure 11: Comparison of head loss after additional of WCAP precipitate in Tests 6 and 8.

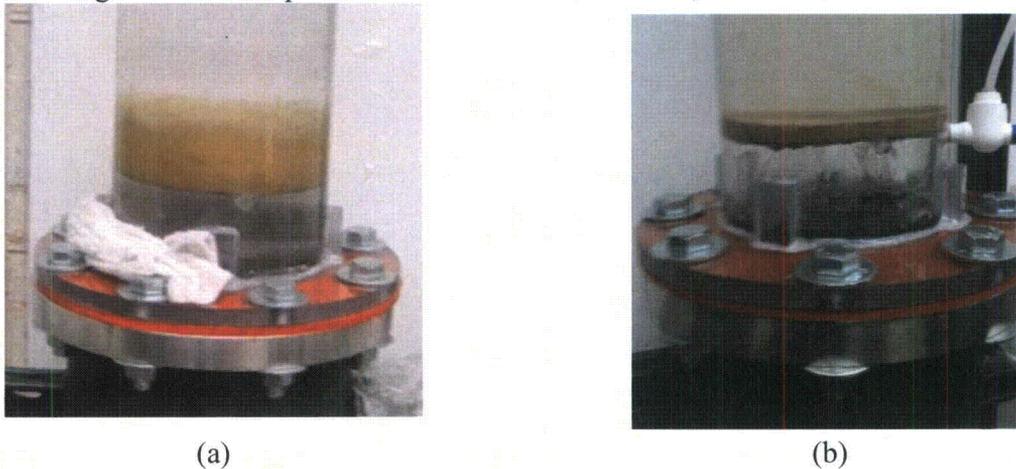
Figure 12: Photographs of fiber beds with 18g of fiber at 0.1 ft/s approach velocity (a) prepared with NEI pressure-washer method and (b) prepared in a blender.

Results: The fiber prepared in a blender resulted in debris beds with substantially more head loss than fiber prepared by pressure washing. The pressure-washed fiber beds were much thicker than the blandered fiber beds, as shown in Figures 12 and 13. The blandered fiber beds were less reproducible and did not result in a linear relationship between fiber amount and head loss (see Figures 14 and 15). The head loss increased rapidly as the fiber amount increased, reaching over 50 inches of head loss with a 60 g fiber bed at 0.1 ft/s approach velocity, and over 50 inches of head loss with a 100 g fiber bed at 0.01 ft/s approach velocity.

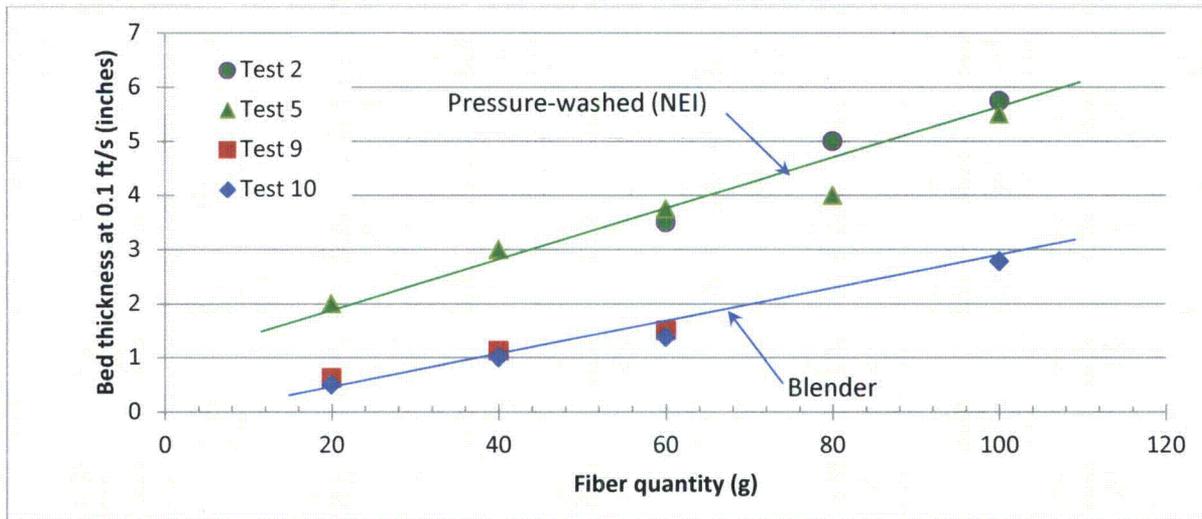
Figure 13: Fiber bed thickness at approach velocity of 0.1 ft/s in NEI pressure-washed fiber beds (Tests 2 and 5) and fiber blended beds (Tests 9 and 10)

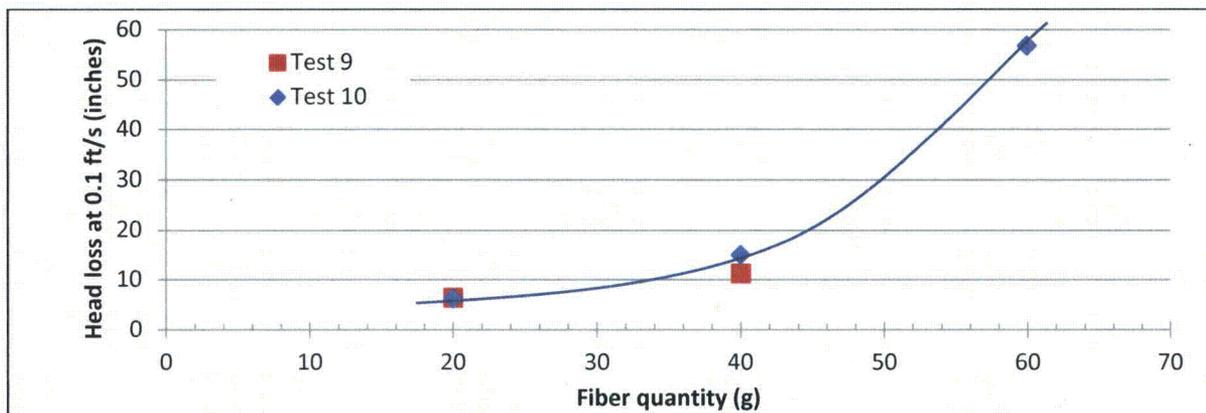
Figure 14: Head loss at approach velocity of 0.1 ft/s in fiber beds prepared with a blender (Test 9 and 10).

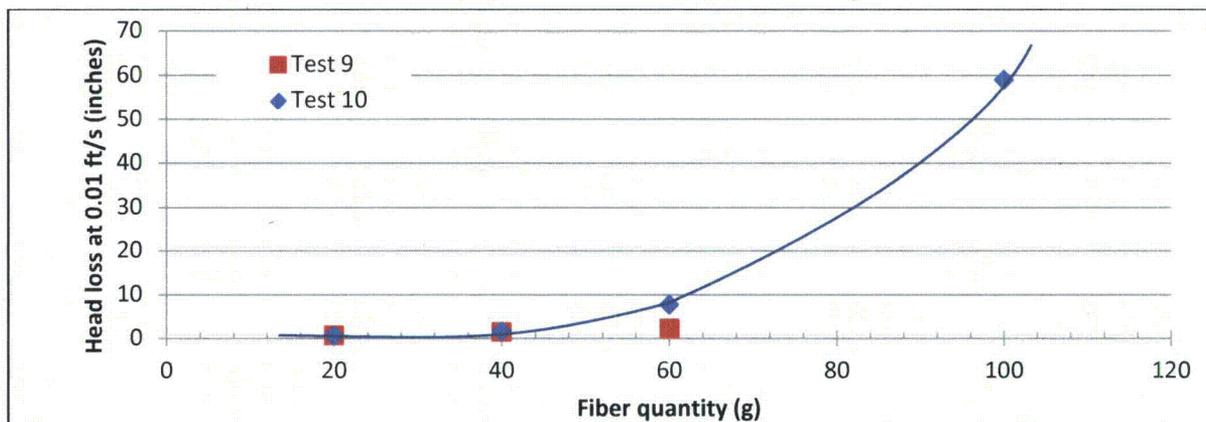
Figure 15: Head loss at approach velocity of 0.01 ft/s in fiber beds prepared with a blender (Tests 9 and 10).

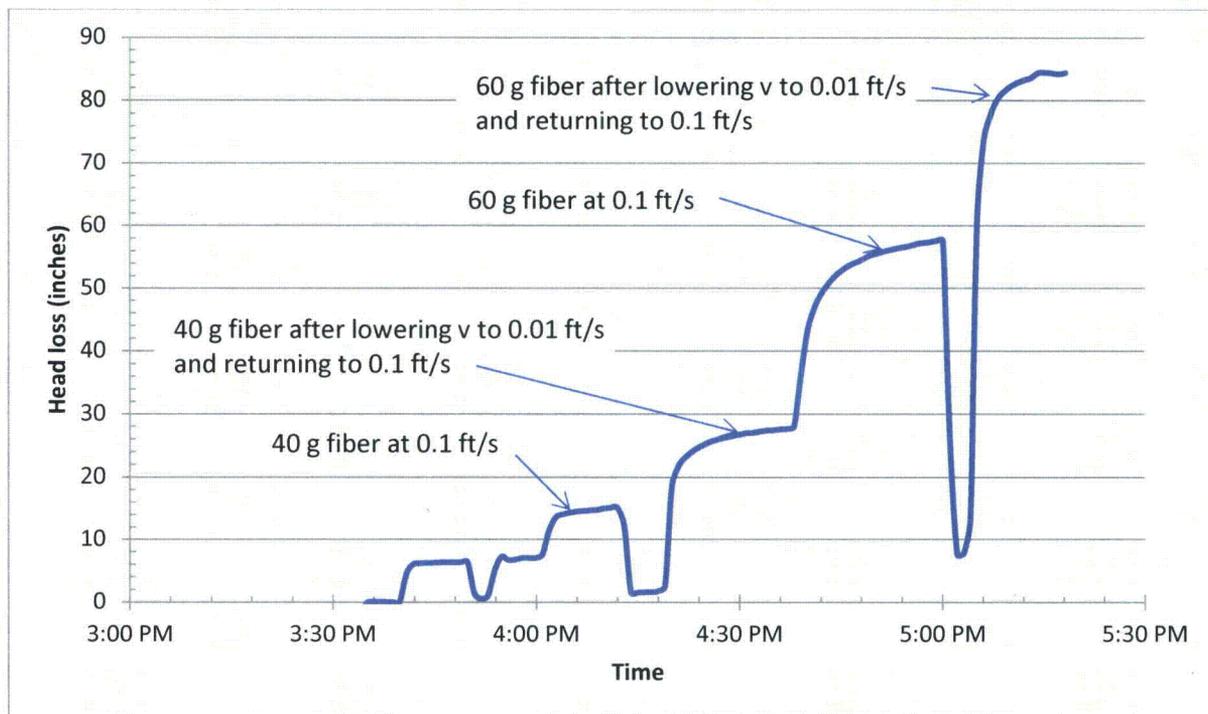
Figure 16: Head loss in Test 10 with fiber bed prepared with a blender.

4	<p>The NEI fiber preparation method results in very consistent debris beds. Incremental additions of fiber result in a linear increase in bed thickness and head loss. Repeated tests resulted in similar increases in bed thickness and head loss.</p>	<p>Fiber was added in increments in Tests 2 and 5. Not only did the tests individually display linear results, but the data matched well between tests. See Figures 6, 7, and 8. Addition of WCAP precipitates in Tests 6 and 8 also matched well. See Figure 11.</p>
5	<p>The blender method results in less consistent debris beds. The increase in head loss with additions of debris was non-linear. In addition, changing the approach velocity and returning it to the original velocity resulted in significant increases in head loss.</p>	<p>After a threshold quantity of fiber was introduced into the column, the head loss through the fiber-only bed increased rapidly to over 50 inches at both 0.1 and 0.01 ft/s, see Figures 14 and 15. The increase in head loss caused by cycling the velocity low and high was as much as 80 percent, see Figure 16.</p>

The head loss through the beds changed significantly in response to changes in flow. Decreasing the flow from 0.1 ft/s to 0.01 ft/s, and increasing again to 0.1 ft/s caused substantially more head loss, as reflected in Figure 16. This increasing head loss is probably due to a rearrangement of the fibers that decreased bed thickness (a decrease in bed thickness by about 1/8-inch was also noted). While an increase in head after changing flow was observed with NEI pressure-washed beds, the effect was slight compared to blandered beds. The increase in head loss after changing the flow averaged less than 5 percent in both Test 2 and Test 5, but was dramatic in Test 10.

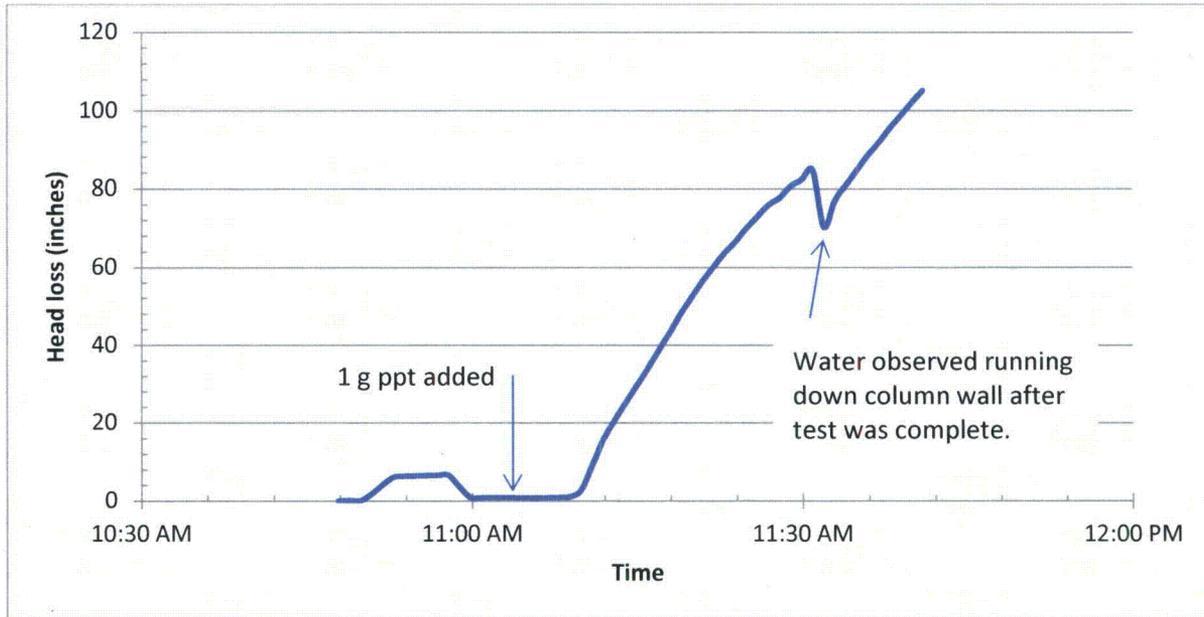
Figure 17: Head loss in Test 11 with fiber bed prepared with a blender and addition of WCAP precipitate.

Results: After the first batch (1 g) of WCAP precipitate was added, the head loss rapidly climbed above 100 inches and the test was terminated. As the head loss exceeded 80 inches, a sudden drop in head loss occurred, indicating bypass of water through the bed (often described as a borehole). The head loss is shown in Figure 17. After the test was terminated and the column draining was in progress, water was not observed pouring through any perforations in the bed but was observed running at the wall of the column. Thus, the bypass through the column appears to have occurred at the interface between the bed and the column wall.

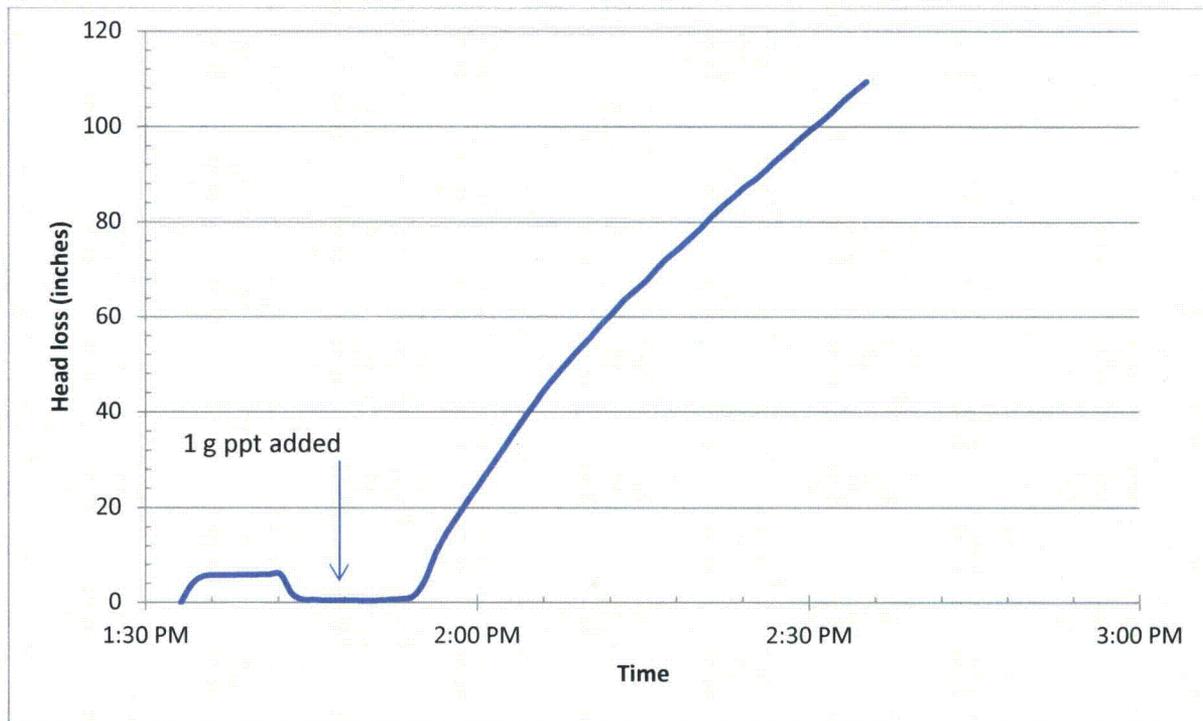
Figure 18: Head loss in Test 12 with fiber bed prepared with a blender and addition of WCAP precipitate.

Results: The results were essentially a repetition of Test 11, except that the fiber bed bypass did not occur. The head loss is shown in Figure 18. The results of Tests 11 and 12 demonstrate that the blendered bed is more sensitive to the presence of WCAP precipitates than the NEI preparation under these conditions.

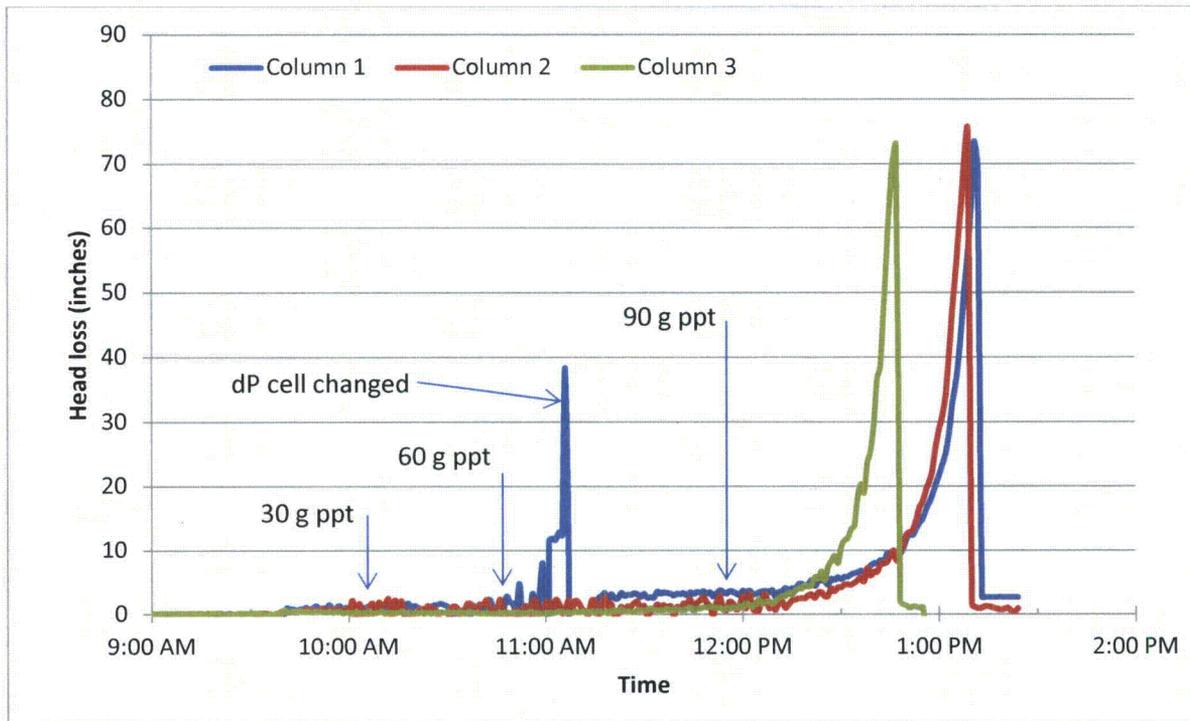
Figure 19: Head loss in Test 13 and 3 fiber beds prepared with the NEI procedure and WCAP precipitates added to the CHLE corrosion tank at 174 °F.

WCAP precipitates were introduced in 3 batches, at 10:05 AM, 10:44 AM, and 11:52 AM. No increase in head loss was evident after the first two batches. The head loss started increasing in all three columns shortly after the third batch was introduced, as shown in Figure 19. Three batches of WCAP precipitate corresponds to a concentration of 57 mg/L of AlOOH in the CHLE corrosion tank, which would form from 25 mg/L of aluminum ions in solution. For comparison, the WCAP calculations for the STP plant predict the formation of 337 mg/L of precipitates (AlOOH and $\text{NaAlSi}_3\text{O}_8$ combined). Thus, the NEI bed formation procedure is able to detect WCAP precipitates in the CHLE corrosion tank at concentrations considerably lower than the levels predicted to occur in the STP plant by the WCAP calculation procedure.

The head loss in the 3 columns followed the same trend in terms of increasing head loss, but column 3 increased earlier than the other two (by about 20 minutes). This difference in response time could be because of natural variability in bed formation and capture of precipitates, or it could be because of minor hydraulic differences in the supply piping. A piping modification is going to be implemented to ensure that all three columns receive the same flow. Regardless of the slight difference in response time, the similarity in the response by all 3 columns demonstrates that the debris beds are reproducible and reliable for detecting WCAP precipitates.

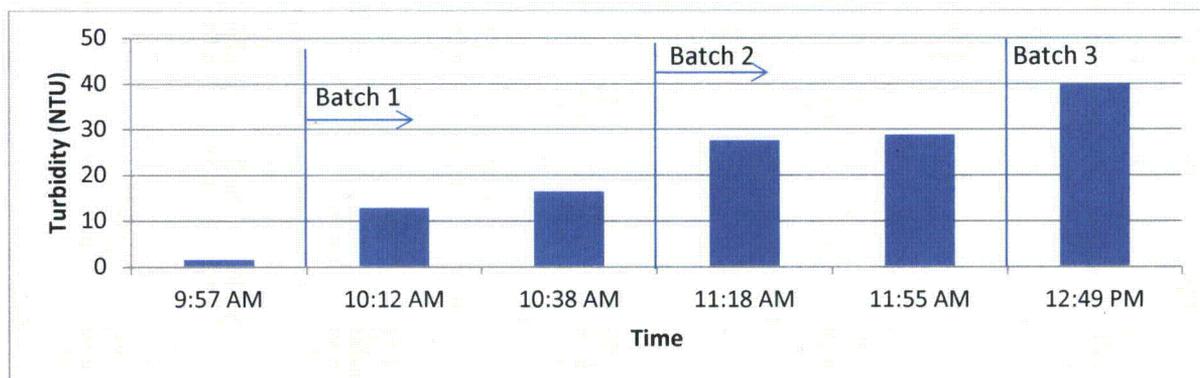
Figure 20: Turbidity in Test 13 and 3 fiber beds prepared with the NEI procedure and WCAP precipitates added to the CHLE corrosion tank at 174 °F.

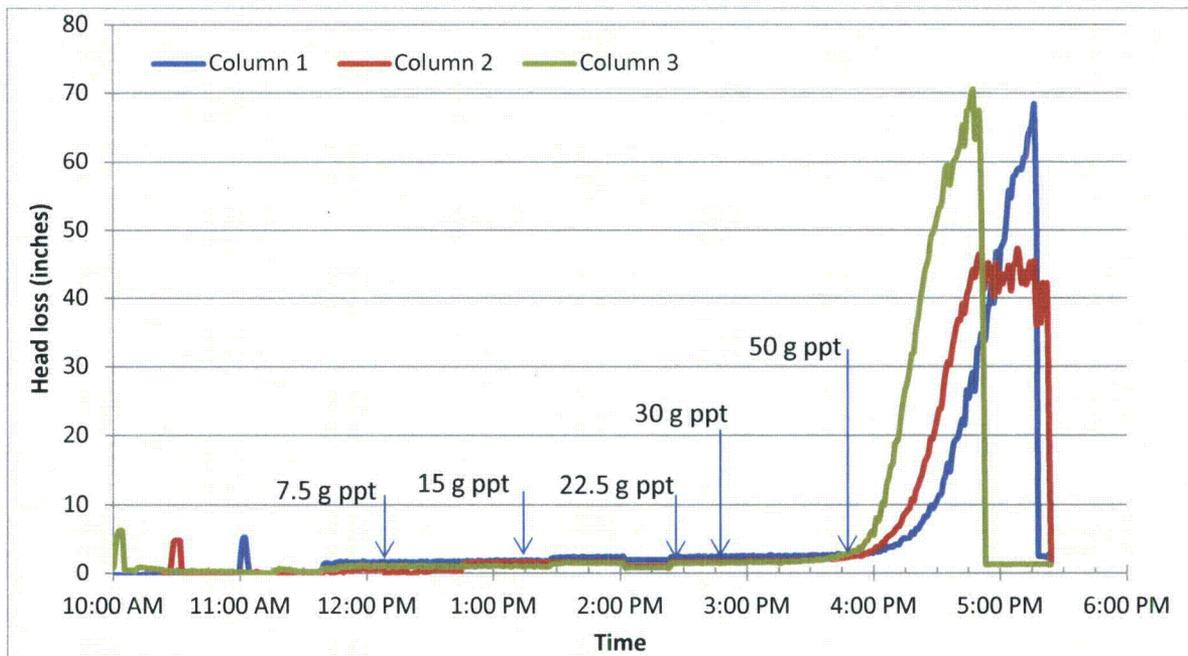
Figure 21: Head loss in Test 14 with 3 fiber beds prepared in blender and WCAP precipitates added to the CHLE corrosion tank at 174 °F.

Results: Based on the expectation that the WCAP precipitate would cause a more rapid increase in head loss with the blended fiber bed than the NEI fiber bed (see Tests 11 and 12 compared to Tests 6 and 8), the WCAP precipitate was added in smaller batches than in Test 13. The first 4 batches were added in 7.5 g quantities and no significant increase in head loss was observed. The next batch added 20 g to the CHLE corrosion tank and a rapid increase in head loss was observed, as shown in Figure 21. The increase in head loss occurred when 50 g of WCAP precipitate had been added to the CHLE corrosion tank, which was less than when the NEI fiber preparation procedure was used, but not as significant as when the WCAP precipitates were added directly to the head loss columns at room temperature. In addition, the performance of the 3 columns was not as consistent as it was for the NEI fiber beds. In the NEI fiber bed test, the head loss increased in a very similar fashion in all 3 columns, whereas in this test, one of the columns (Column 2) appeared to develop a “bore hole” that cause the head loss to level off at about 45 inches of head, whereas the head continued to increase in the other two columns.
