LA SALLE COUNTY STATION
UPDATED FINAL SAFETY ANALYSIS REPORT

FIGURE 9.1-1
NEW FUEL STORAGE

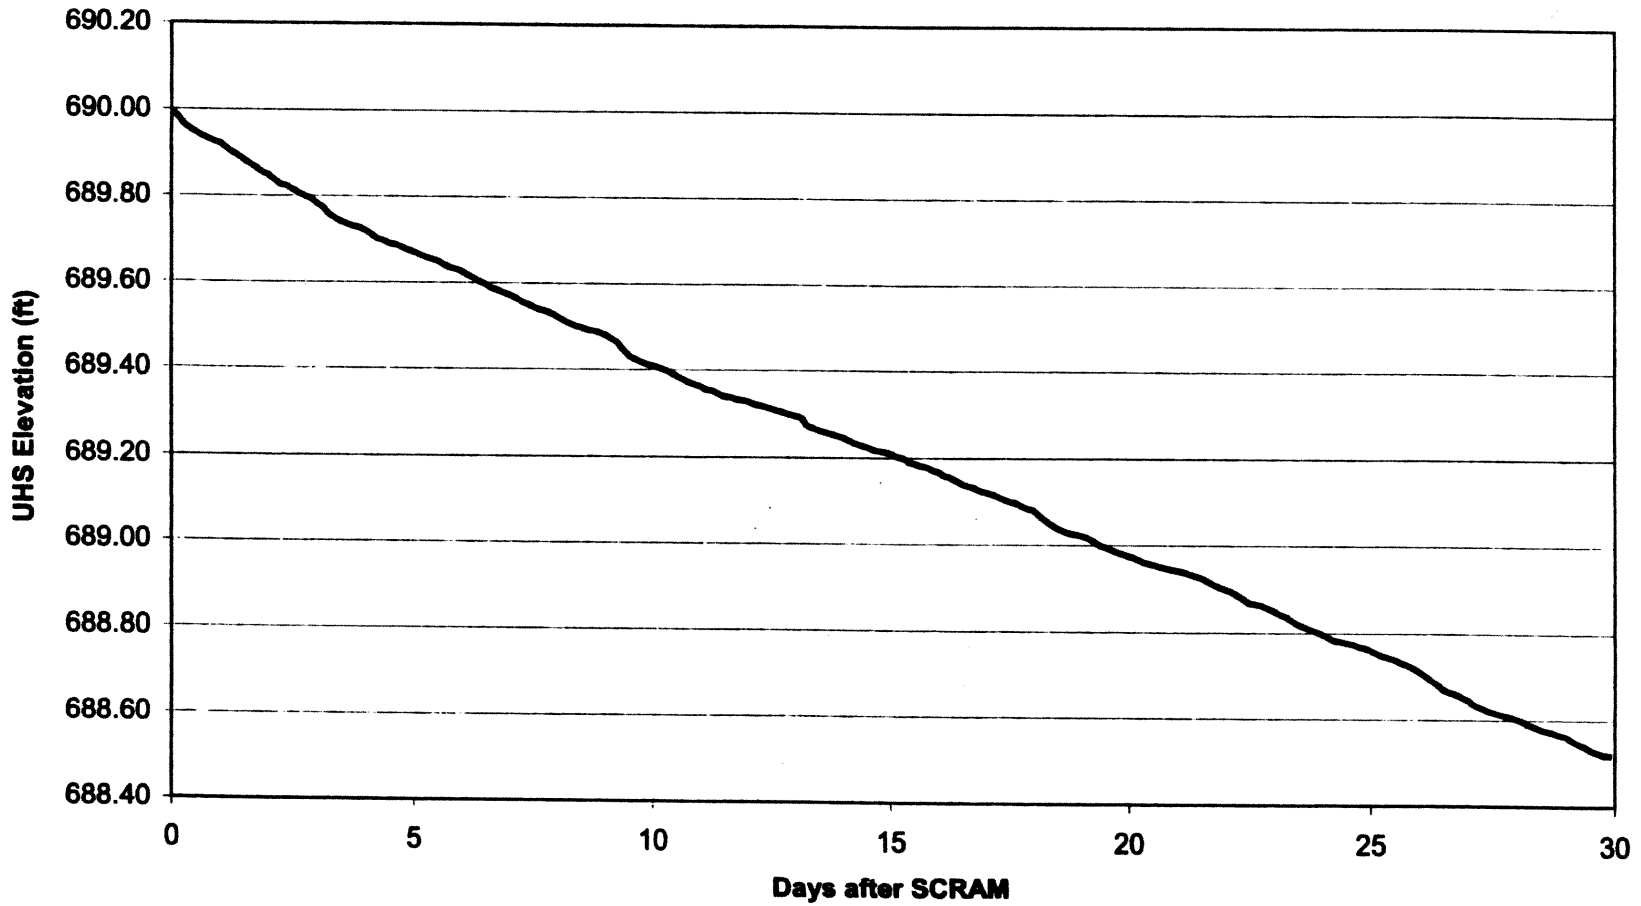
**Figure H7.7, Case 3c: UHS LOCA Drawdown
Worst 30 Day Evaporation Weather Period
(d = 18", t=1200 hrs, Ti = 102.3F)**

LASALLE COUNTY STATION UPDATED FINAL SAFETY ANALYSIS REPORT FIGURE 9.2-3
UHS TEMPERATURE RESPONSE TO LOCA WORST 30-DAY EVAPORATION CONDITIONS
