License SUA-1341, Docket No. 40-8502

10209 Injection Well Release **Christensen Ranch Mine Unit 10A**

Uranium One USA, Inc. - Willow Creek Project Spill Report Summary Mine Unit 10A ISR Injection Fluid Release

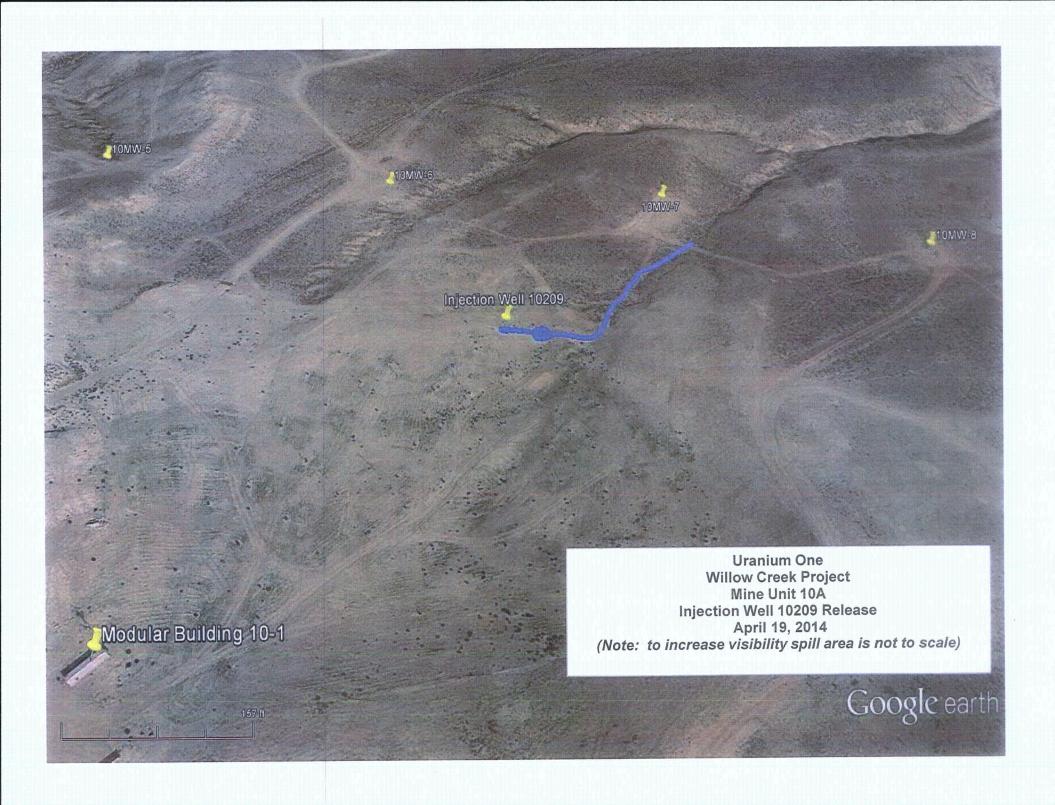
Map of Spill Location and Impacted Area

Christensen Ranch Mine Unit 10A
Injection Well 10209
Module 10-1
Section 1, Township 44N, Range 77W
Johnson County, Wyoming
(See attached map for detailed location)

The release followed site drainage for approximately 450 feet down a small ephemeral draw before dissipating (see map). It is estimated that approximately 1,962 square feet (0.05 acre) of soil was impacted. No wildlife or livestock were affected. No significant erosion resulted from the release.
