Re: Florida Power & Light Company
Proposed Turkey Point Units 6 and 7
Docket Nos. 52-040 and 52-041
Voluntary Revised Response to NRC Request for Additional Information Letter No. 043 (eRAI 5875) SRP Section - 02.05.03 Surface Faulting

Attachment 1: FPL Revised Response to NRC RAI No. 02.05.03-1 (eRAI 5875)
Attachment 2: FPL Revised Response to NRC RAI No. 02.05.03-2 (eRAI 5875)
Attachment 3: FPL Revised Response to NRC RAI No. 02.05.03-3 (eRAI 5875)
Attachment 4: FPL Revised Response to NRC RAI No. 02.05.03-4 (eRAI 5875)

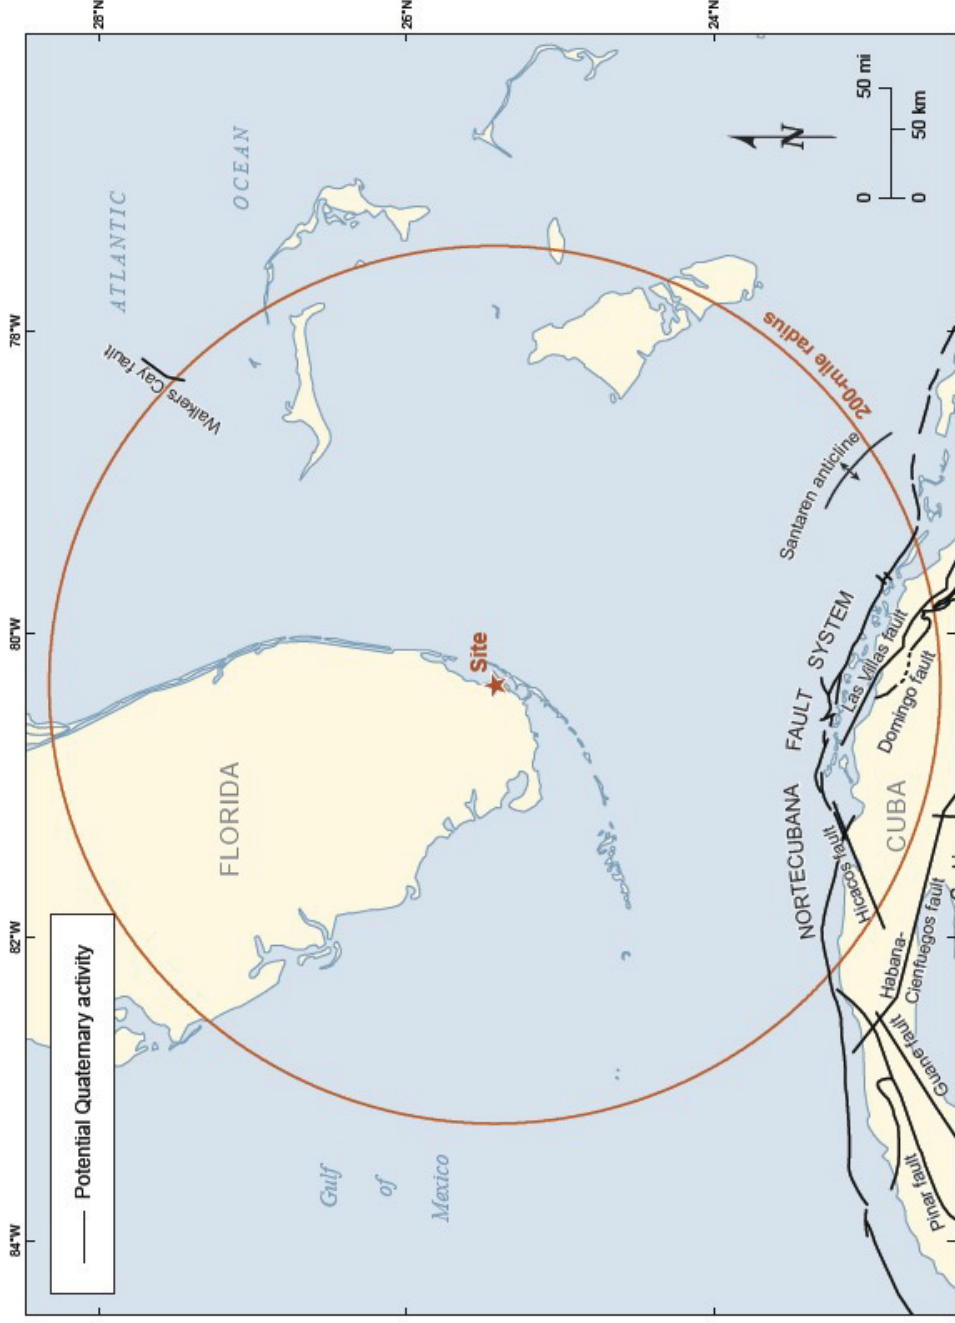
Figure 2.5.3-205 Potential Quaternary Tectonic Structures in the Site Region

FSAR Figure 2.5.3-205 "Potential Quaternary Tectonic Structures in the Site Region" will be added to Subsection 2.5.3 in a future COLA revision as indicated below:

New FSAR Figure 2.5.3-205 will depict tectonic structures within the site region with potential Quaternary deformation, including the Walkers Cay fault, the Santaren anticline, and faults on Cuba within the site region. So as not to minimize hazard, the Walkers Cay fault has been assigned a Quaternary age, and some faults associated with Cuba may also be active in the Quaternary, although timing of specific structures is not established in published research. Although FPL questions Masaferrero et al.'s (2002) (FSAR 2.5.1 Reference 479) assertion that the stratigraphic relationships indicate intermittent fold growth into the early Quaternary, the Santaren anticline will be shown as a potential Quaternary structure on FSAR Figure 2.5.3-205. Deformation on the Straits of Florida normal faults occurred in the late Tertiary, and thus, these faults are not included on FSAR Figure 2.5.3-205.

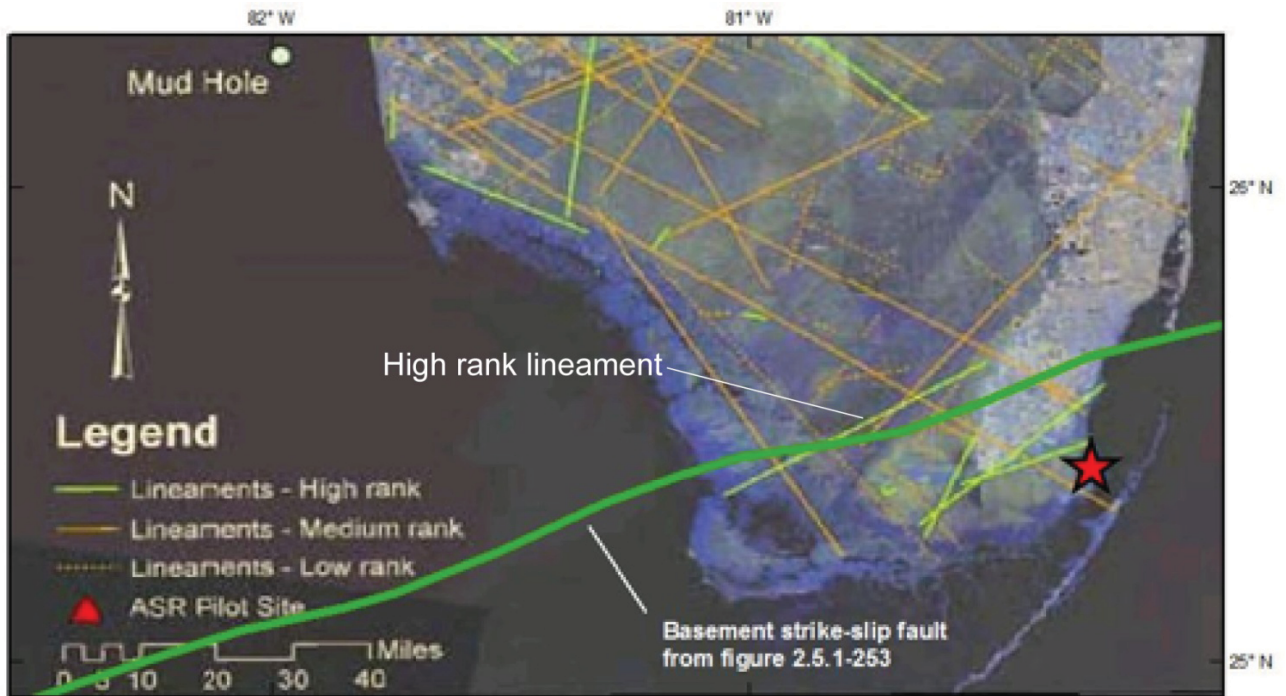
Figure 1 Illustration from USACE Lineament Study and Barnett (1975) Strike-slip Fault

Source: FSAR 2.5.3 Reference 232 and FSAR 2.5.1 Reference 458

There is no clear relationship between the postulated buried strike-slip basement fault depicted in FSAR Figure 2.5.1-253 and the high-rank lineament on FSAR Figure 2.5.3-204. As shown in Figure 1, the two features are both northeast-striking, but have different geometries, extents, and locations. The high-rank lineament is more north-striking,

completely straight and mapped onshore, terminating at the Atlantic coastal ridge, while the postulated basement fault strikes more easterly, has a variable strike, and extends tens of kilometers offshore both to the east and west. Where the high-rank lineament is most well defined (at its southwest end, near the mouth of the Shark river), the basement fault is located more than 5 km to the north (Figure 1). No geologic evidence of faulting is reported to support a tectonic origin for the lineaments identified in the USACE study, and no evidence links the postulated basement faults at depth to any lineament at the surface (FSAR 2.5.3 Reference 232). The original study by Barnett (1975) (FSAR 2.5.1 Reference 458) did not interpret geomorphic expression of any of the postulated basement faults depicted in FSAR Figure 2.5.1-253. FPL interprets the similarity in general location (southern Florida) and strike (northeast) of the high-rank lineament and postulated basement fault to be coincidental. Because the high-rank lineament in FSAR Figure 2.5.3-204 is not associated with faulting, this figure provides no conflict with FSAR statements regarding faulting within the site vicinity.

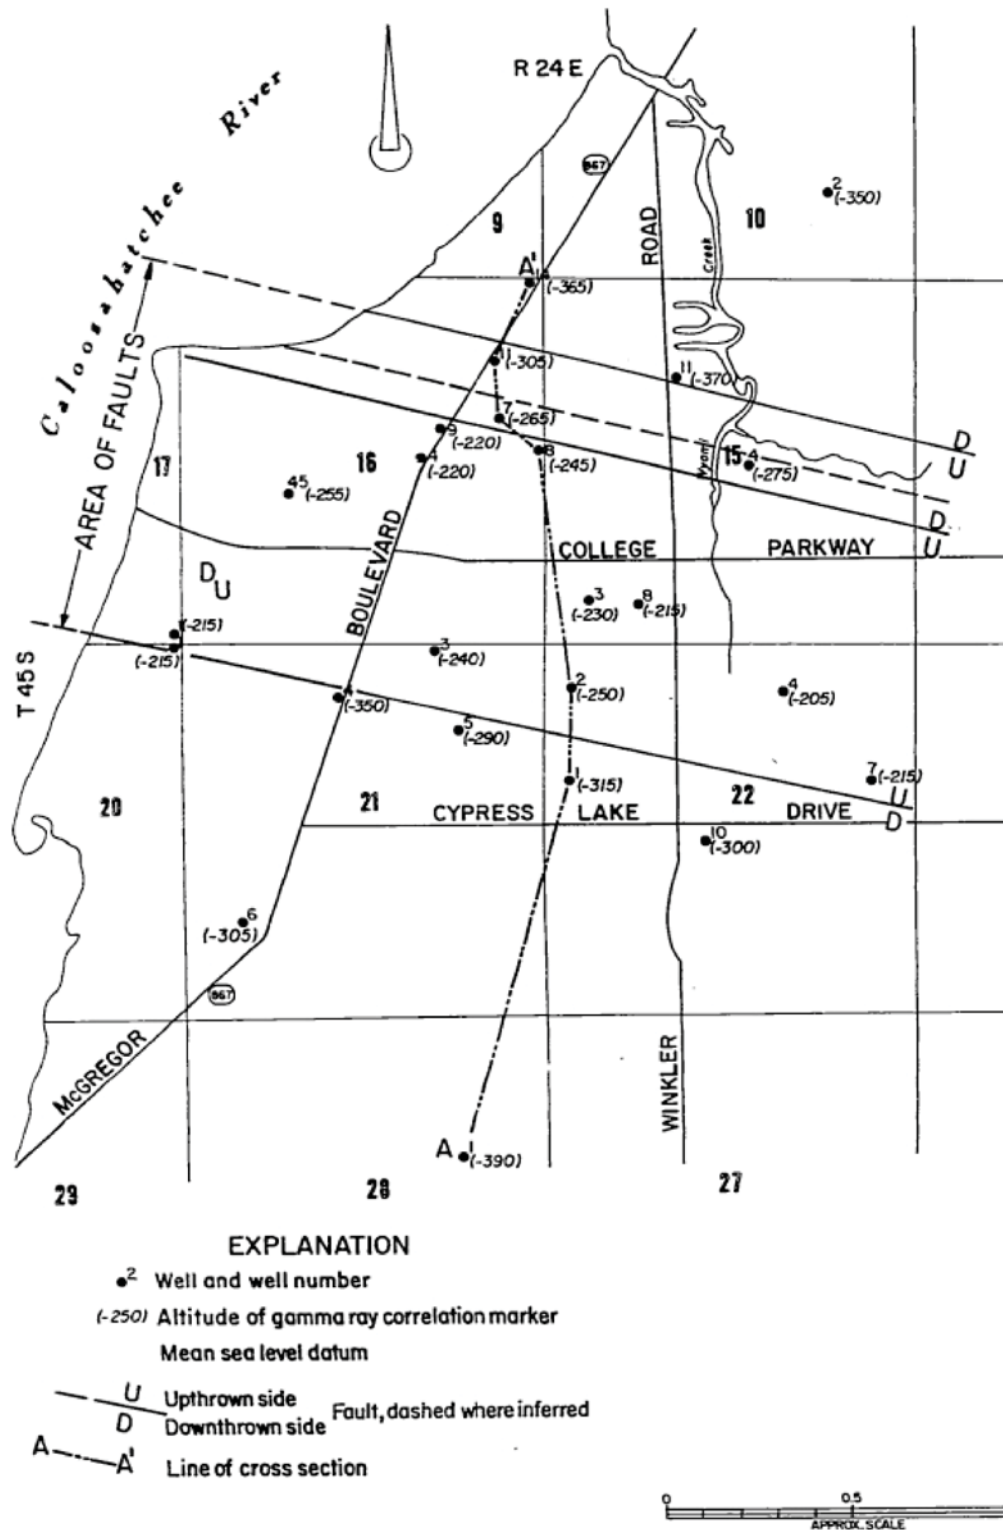
Figure 1 Map of McGregor Isles Area

A brief field reconnaissance consisted of driving along roads in the area and walking along available sidewalks that crossed the proposed faults. A map of this work is shown as Figure 3. Heavy modification of the landscape through suburban development left few natural exposures useful to assessing the pre-development geomorphology. No fault scarps or topographic features suggested a fault-controlled influence on the geomorphology.
