August 28, 2007

ST Environmental Professionals, Inc.
114 Lutz Road
Boyertown, PA 19512
Phone: 610-845-3070
Fax: 610-845-3137
E-Mail: STEP_CORP@att.net

Subject: Rock Selection Procedures, Revision 3
Reading Slag Pile Site
STEP Project Number 90C057

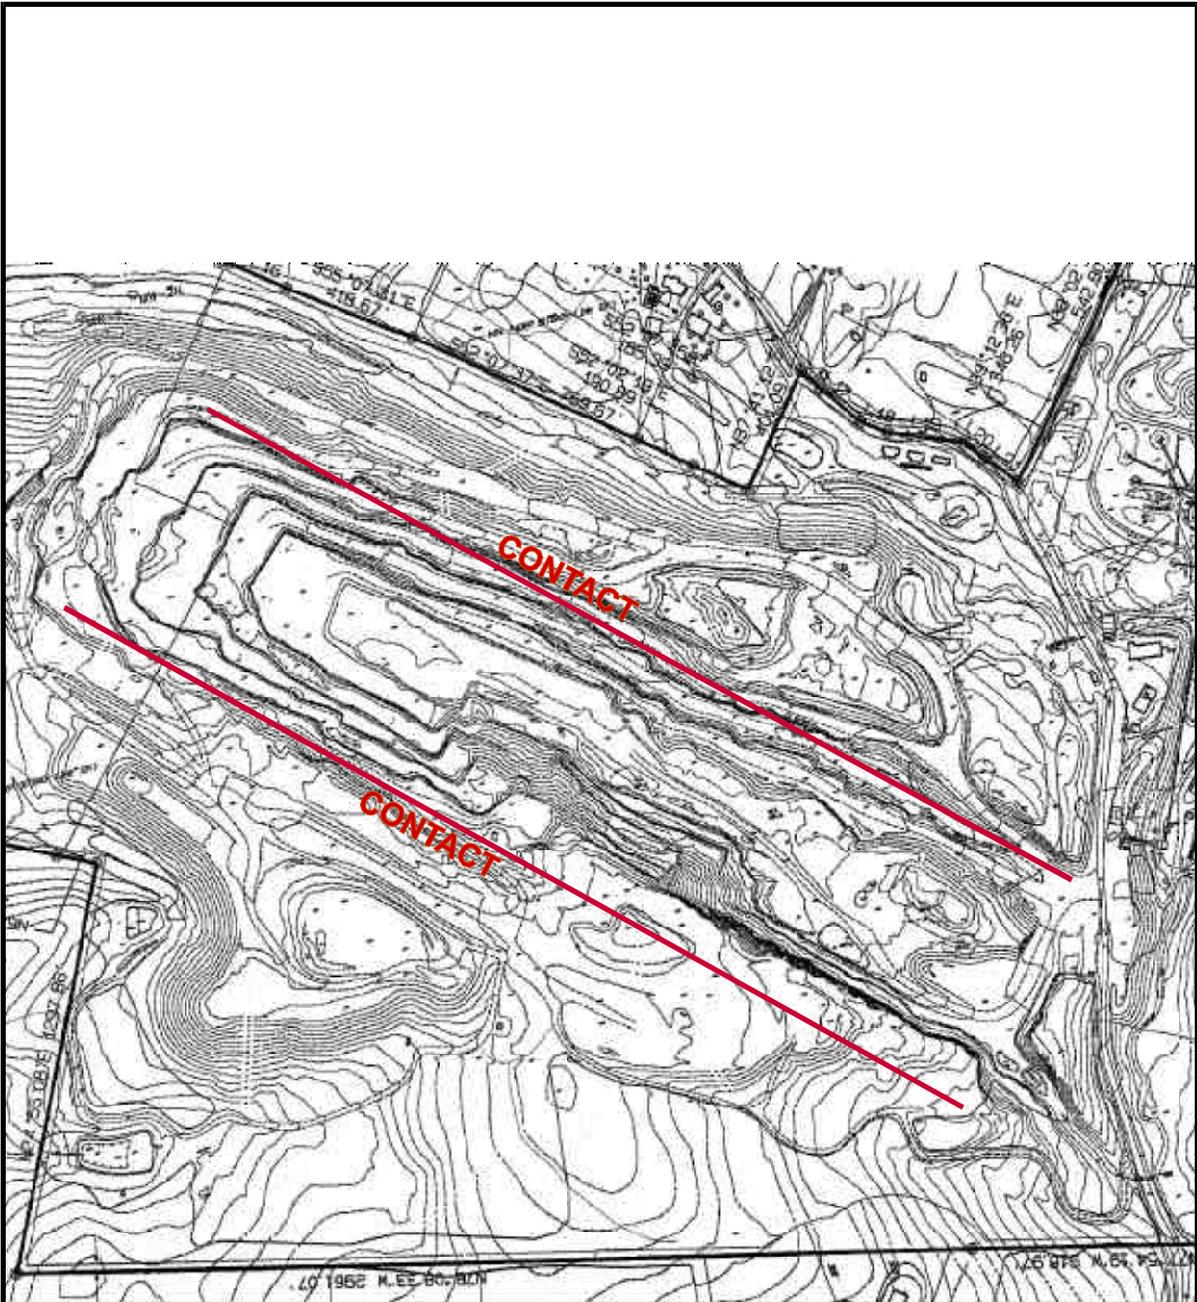
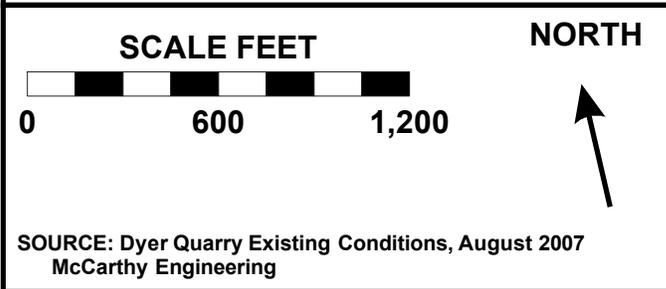
FIGURE 1
DYER QUARRY
TOPOGRAPHIC MAP

The quarry operators and managers report that the “country rock” around the diabase (which consists of baked sandstone and shale) is not quarried (except for removal) and that the quarry takes great care to preclude country rock from becoming mixed with the diabase. Inclusions of country rock in the diabase being quarried and stockpiled were not observed or noted during subsequent and current quarry inspections (Addendum 1; pg 3-3). A recent topographic map of the quarry is attached as Figure 1. The approximate location of the contact with country rock is shown on that figure.

The quantity of rock required for this project does not allow Cabot to be directly involved in the quarrying operations, such as selecting a blast face for the project material. At initiation of the project, the geologist will meet with representatives of the quarry to understand the locations of recent blasts and schedule for future blasts. If the schedule allows, rock selection will follow blast areas which are as far away from the country rock as possible. However the selected blast areas will be no closer than 100 feet from the contact. If accessible, the geologist will inspect the recent blasts and the next 3-4 scheduled blast faces and review Figure 1 to ensure the country rock will remain at least 100 feet from the expected blast face.
