**NEA/CSNI/R(2013)12/ADD1**

**Updated Knowledge Base for Long Term Core Cooling Reliability**

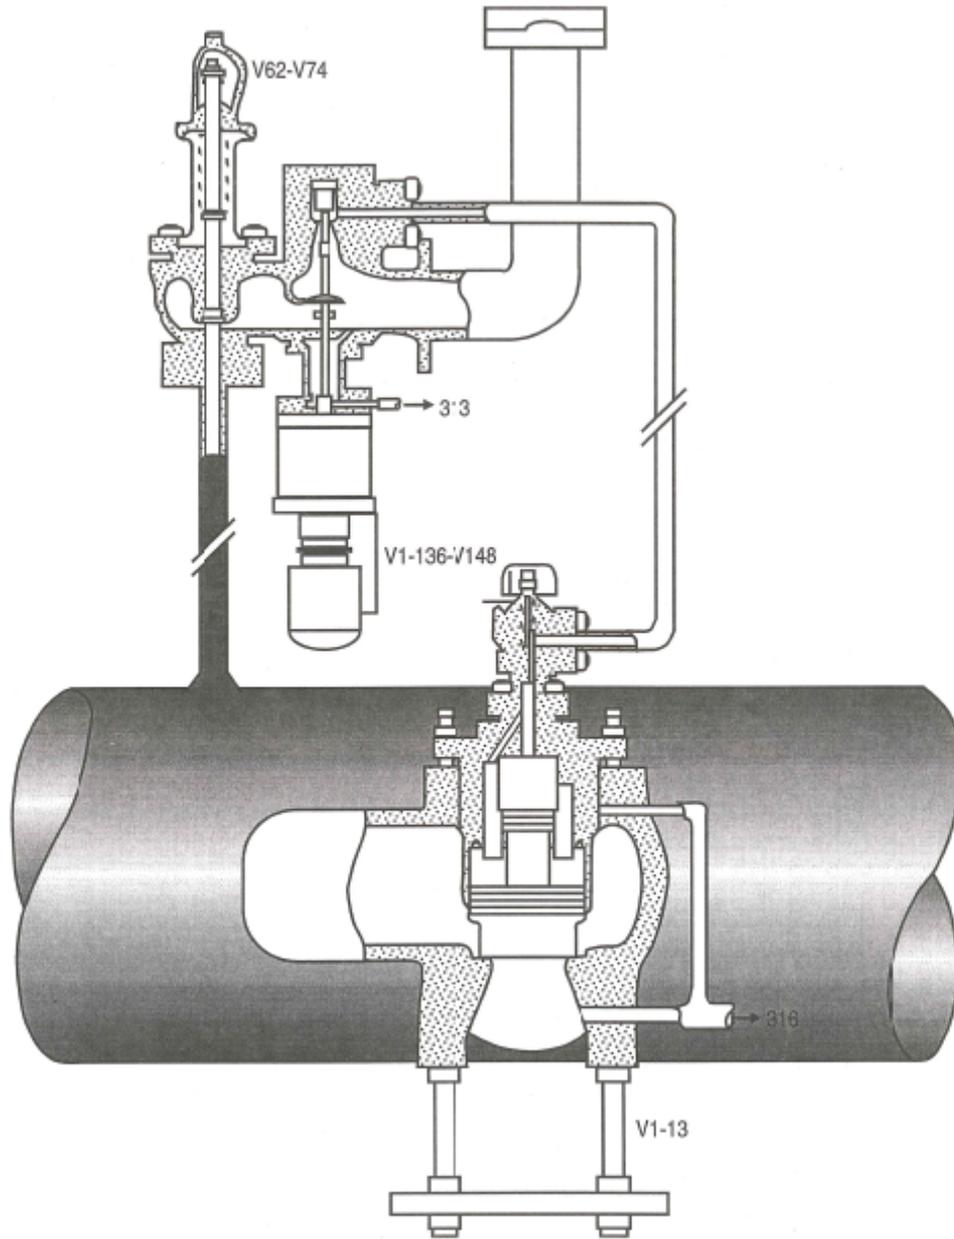
**Figure B1: System 314 Pressure Relief Valve**

Function of the V1-V13 main valves is tested at a reactor pressure of 11-15 bar. The test involves checking the opening and closing of the valve. In order to open the main valve, the V136-V148 test unit is activated, causing the guide in this unit to raise the stems (7) and (8) of the control valve. The process is now the same as at high reactor pressure.

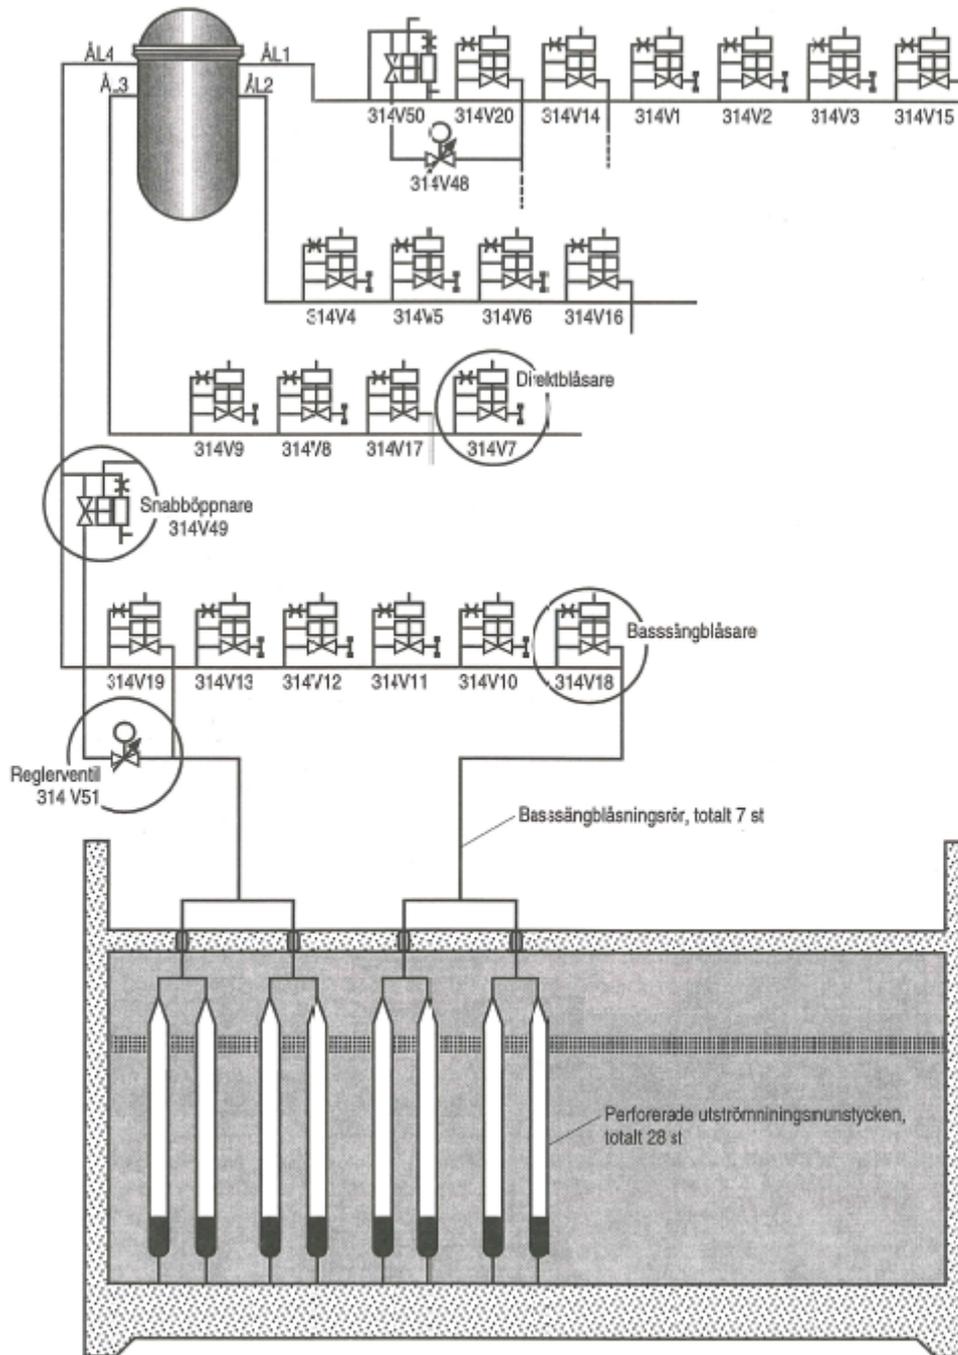
**Figure B2: System 314 Pressure Relief System**

VI2, which is the valve that failed, is placed (level 117.67 m) approximately 6 m (26 feet) over the drywell floor (level 111.5 m) and there is one grating between the valve and the drywell floor.

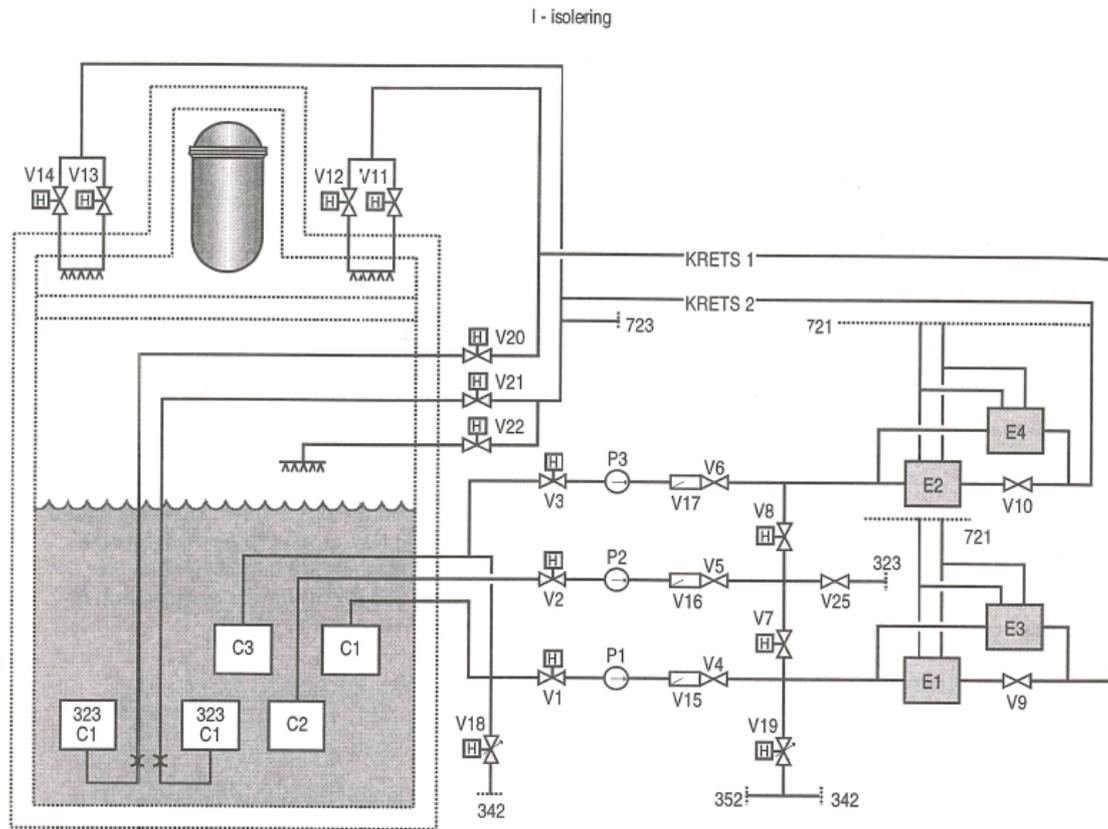
**Figure B3: System 322, Containment Vessel Spraying System (CVSS).**

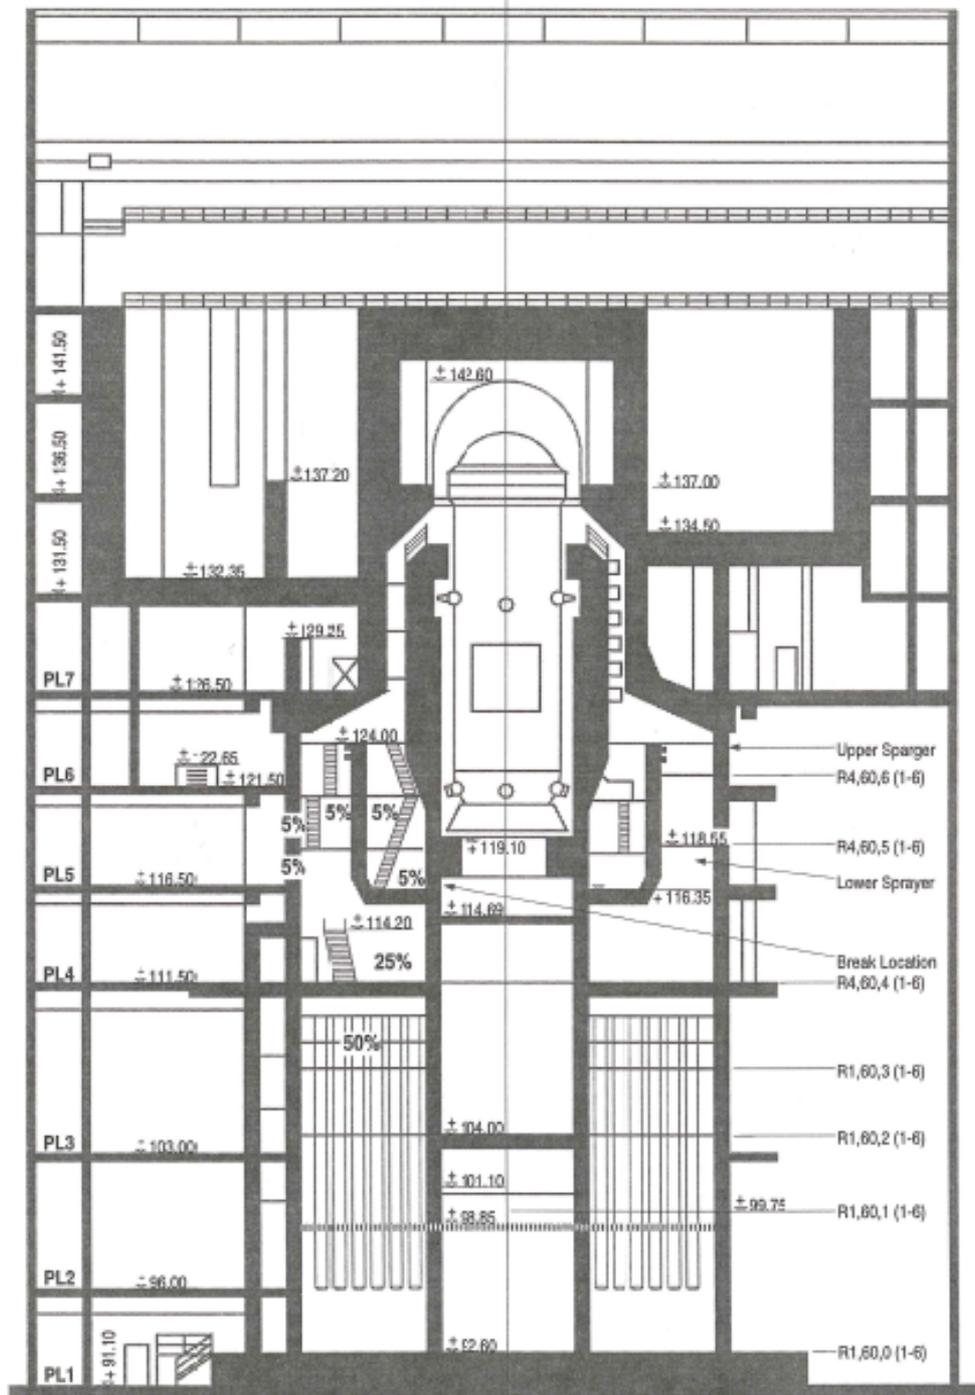
Figure B4: The Containment with Break Location.

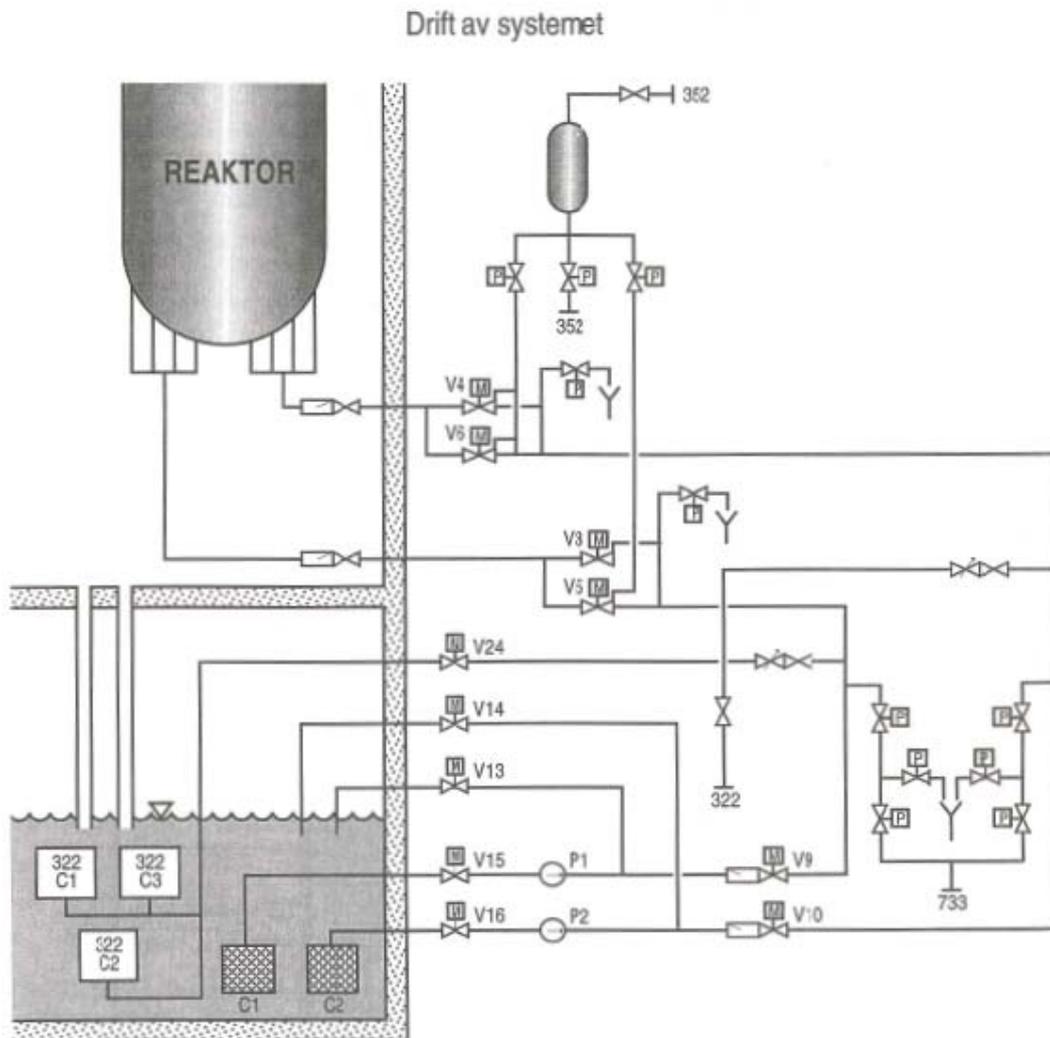
**Figure B5: System 323, Emergency Core Cooling System.**

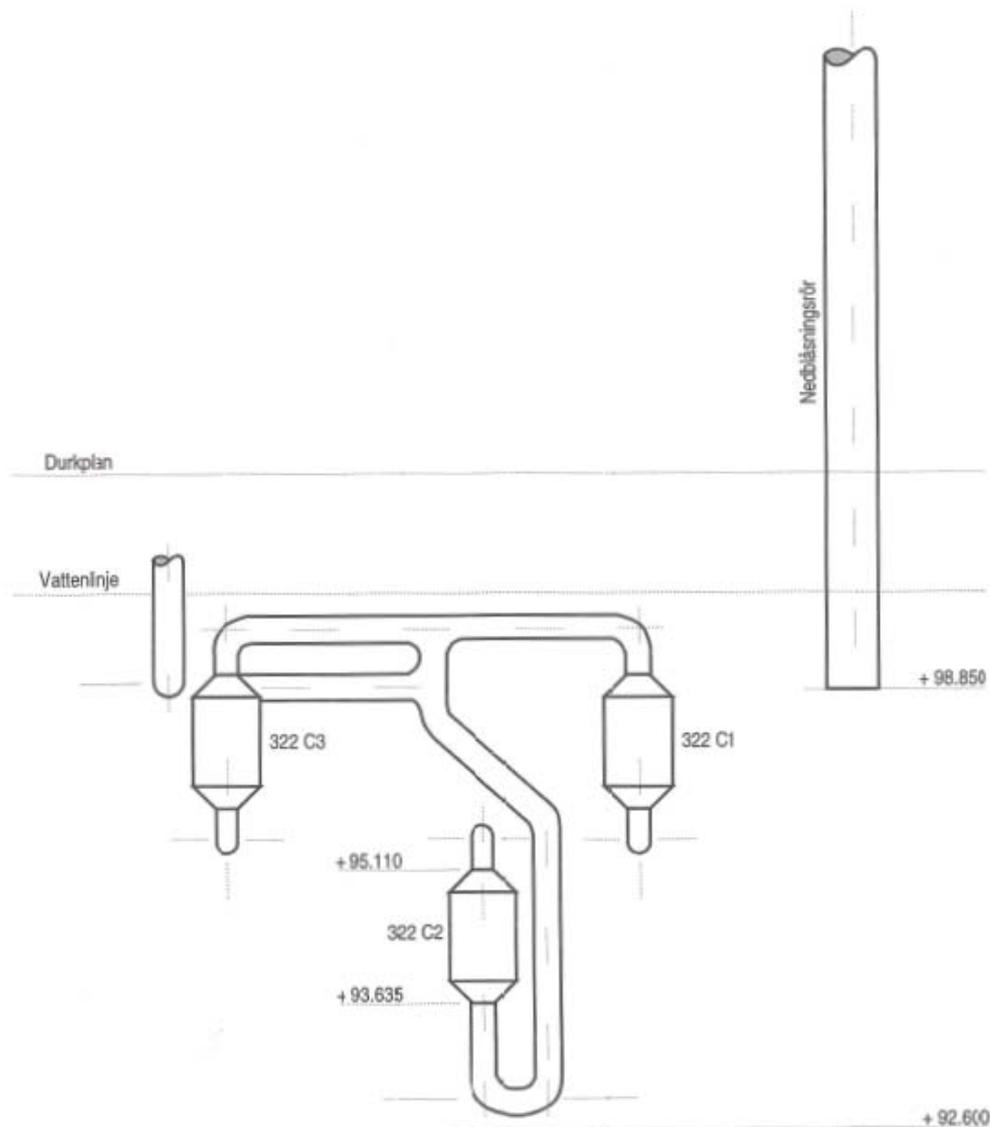
**Figure B6: System 322, the CVSS Strainers in the Barsebäck Plant.**

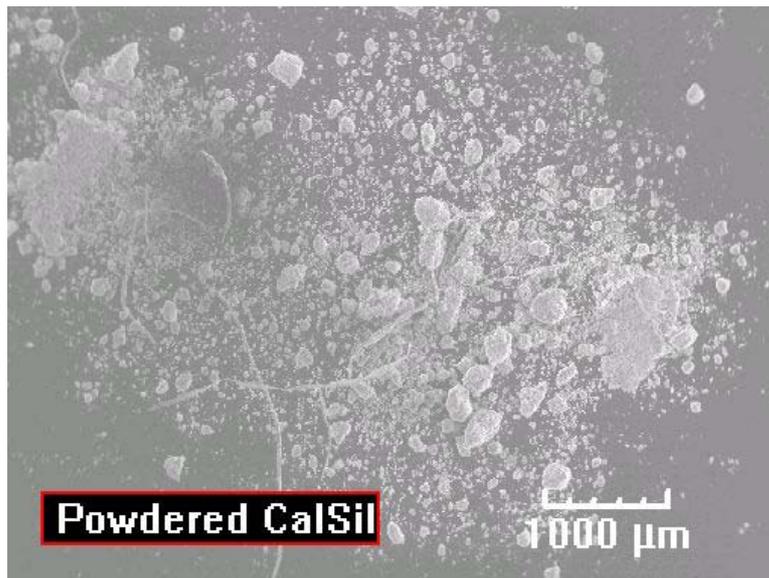
**Figure C-1: SEM Micrograph of Powdered Calcium Silicate [C.8].** The calcium silicate insulation was obtained from Performance Contracting Inc. (PCI), Lenexa, Kansas in the form of molded blocks, which were broken up by hand-crushing with a mortar and pestle.

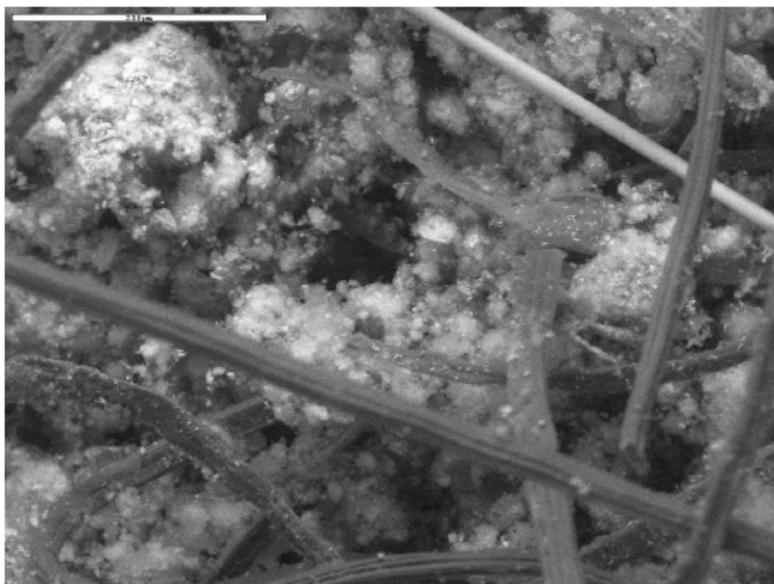
**Figure C-2: SEM Micrograph of Calcium Silicate [C.7].** The scale white bar in the upper left corner represents 200 μm. The calcium silicate particles are mixed with fibers added to the insulation to provide strength.

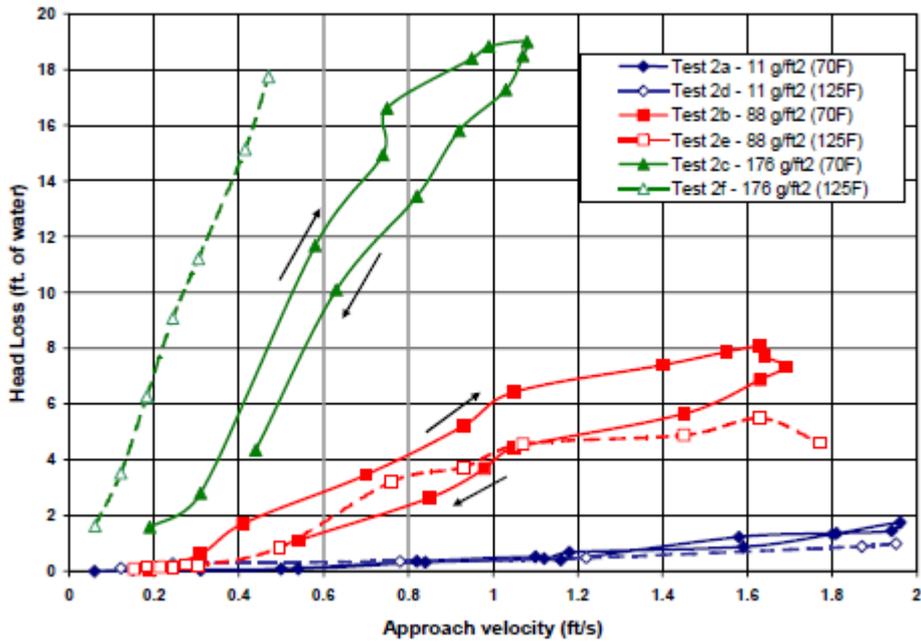
**Figure C-3: Head-loss Measurements for Three Different Quantities of Calcium Silicate at Two Different Water Temperatures [C.7].**

Head-loss tests were conducted at LANL with debris beds of calcium silicate only at three debris loadings and at two temperatures (Figure C-3). Significant head loss was measured for all the calcium silicate debris beds formed on the 1/8-in.-mesh screen, even the thinnest bed with a theoretical bed thickness of only ~0.02 in. As a significant fraction of the screen area was effectively uncovered, it was concluded that even higher head losses would have occurred if the bed had been truly uniform. If the calcium silicate had been totally pulverized before insertion into the test, its accumulation would likely have been less than shown in these tests where the debris was not completely turned into fine particulate.

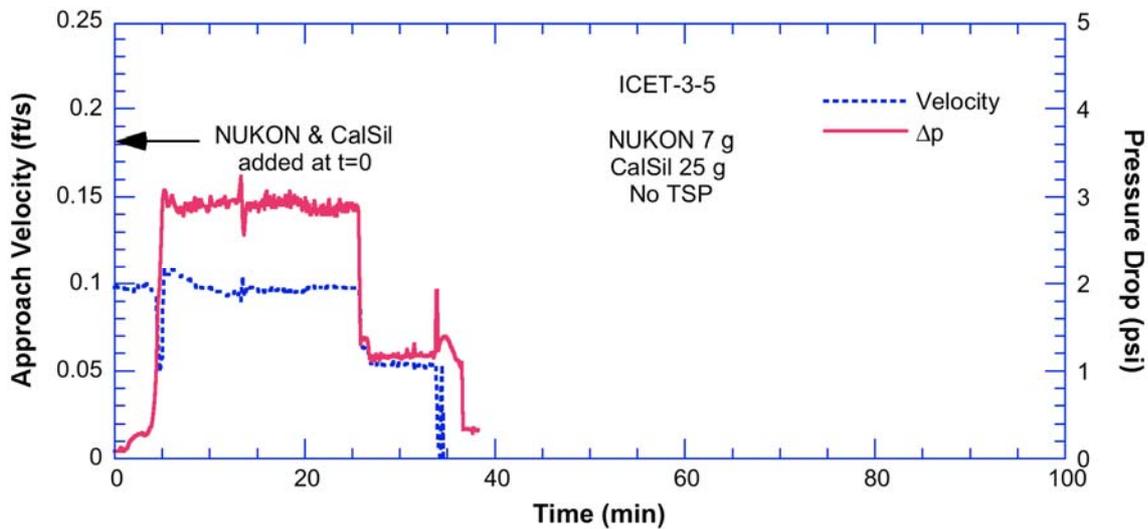
**Figure C-4: Bed Approach Velocity and Differential Pressure across the Screen as a Function of Time for Test ICET-3-5 [C.8].**

Figure C-4 shows the results of head loss testing at ANL. Calcium silicate and NUKON were heated outside the test loop for 30 minutes at 60 °C (140 °F) in borated water (2800 ppm B and 0.7 ppm Li). After the debris was added to the loop, the head loss increased very rapidly, within the first six minutes (or after approximately one test loop recirculation) after introducing the debris.

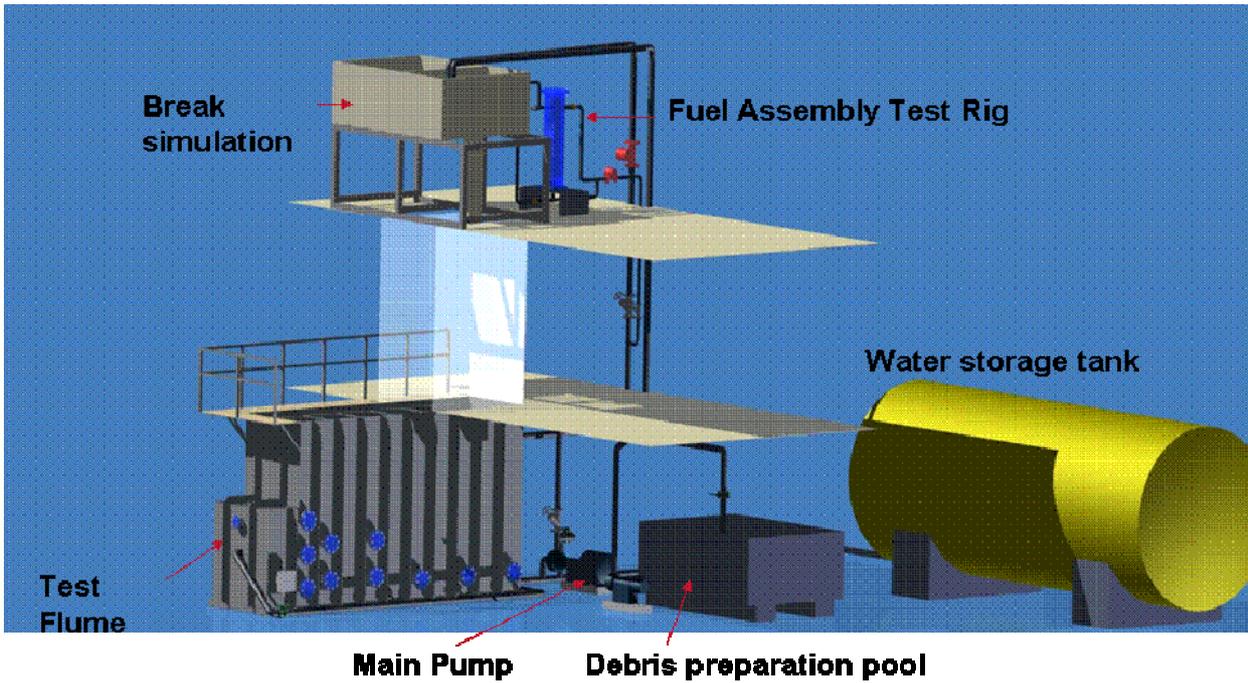
Erlanger Wanne Test facility 3-D view

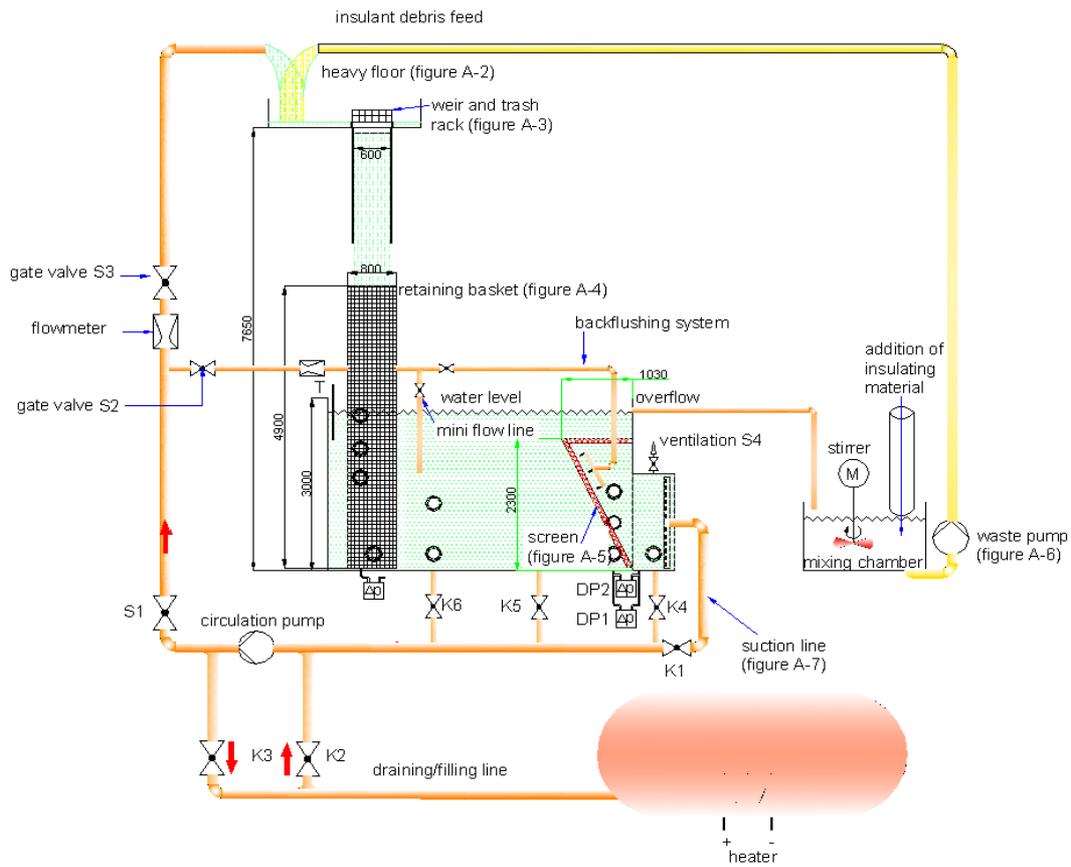
Erlanger Wanne Test facility set up EPR configuration

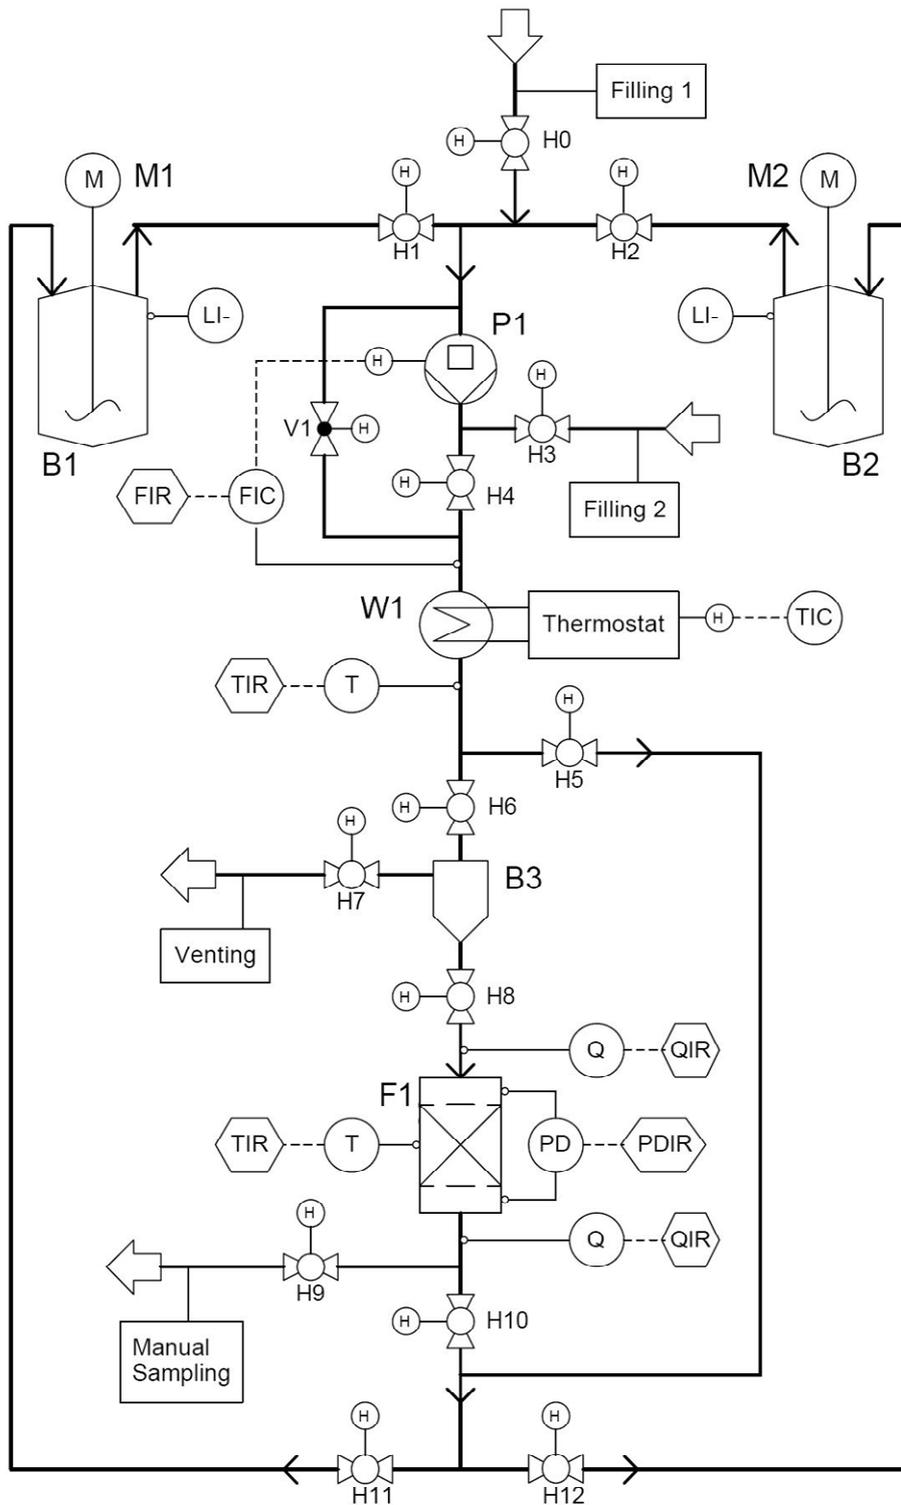
Lab-scale deep-bed filtration test facility “TiFi” schematic

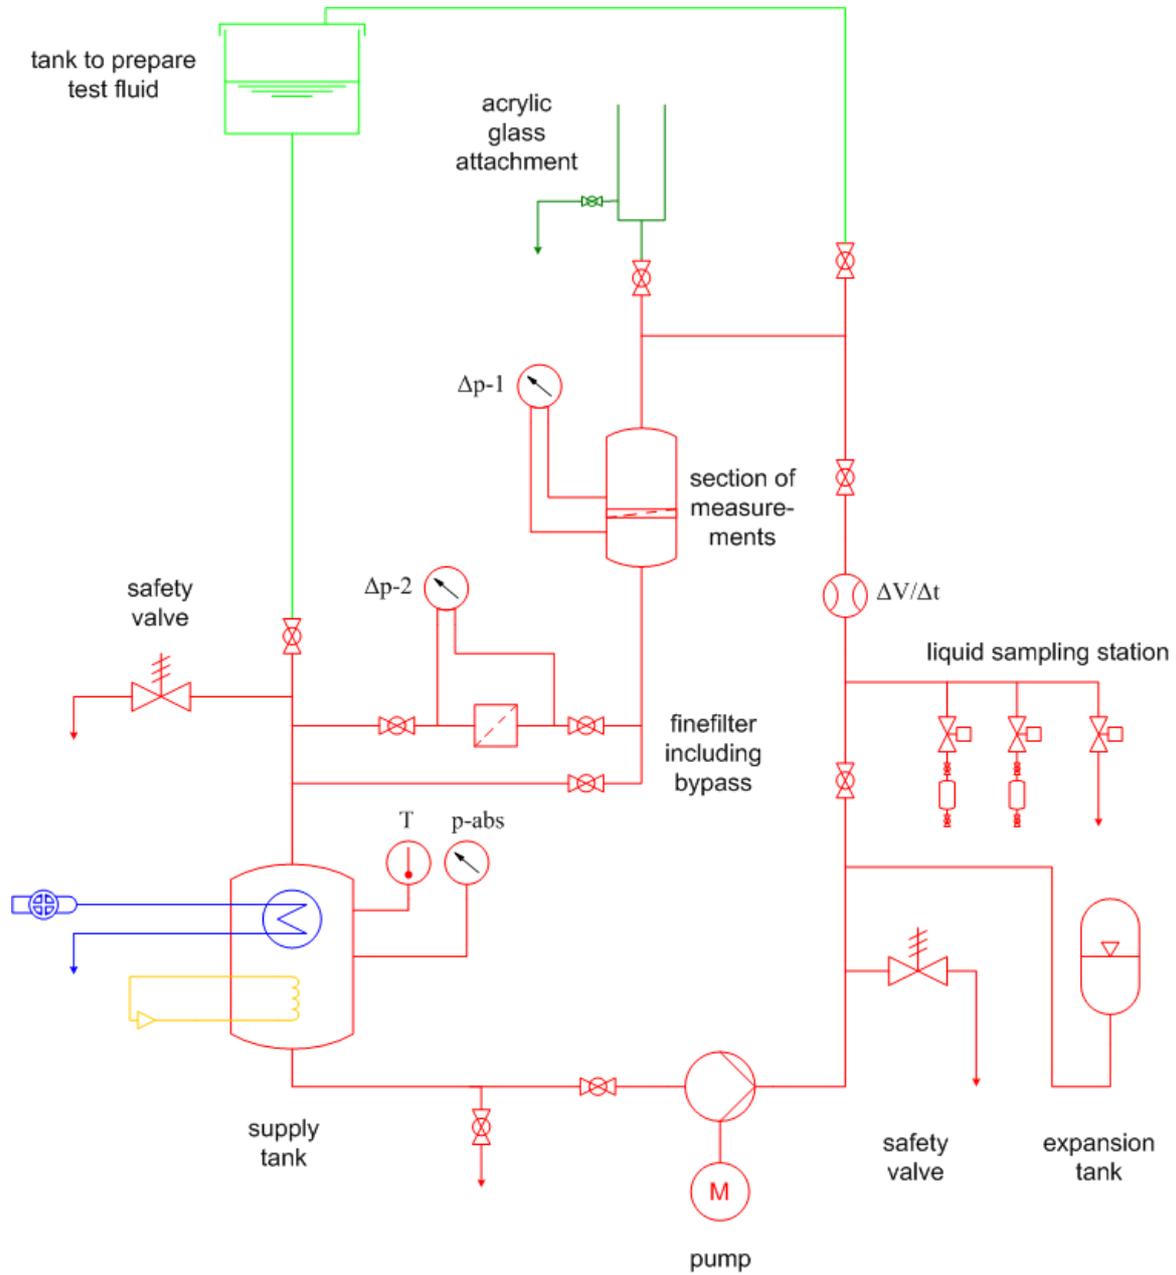
**Test Facility Schematic**

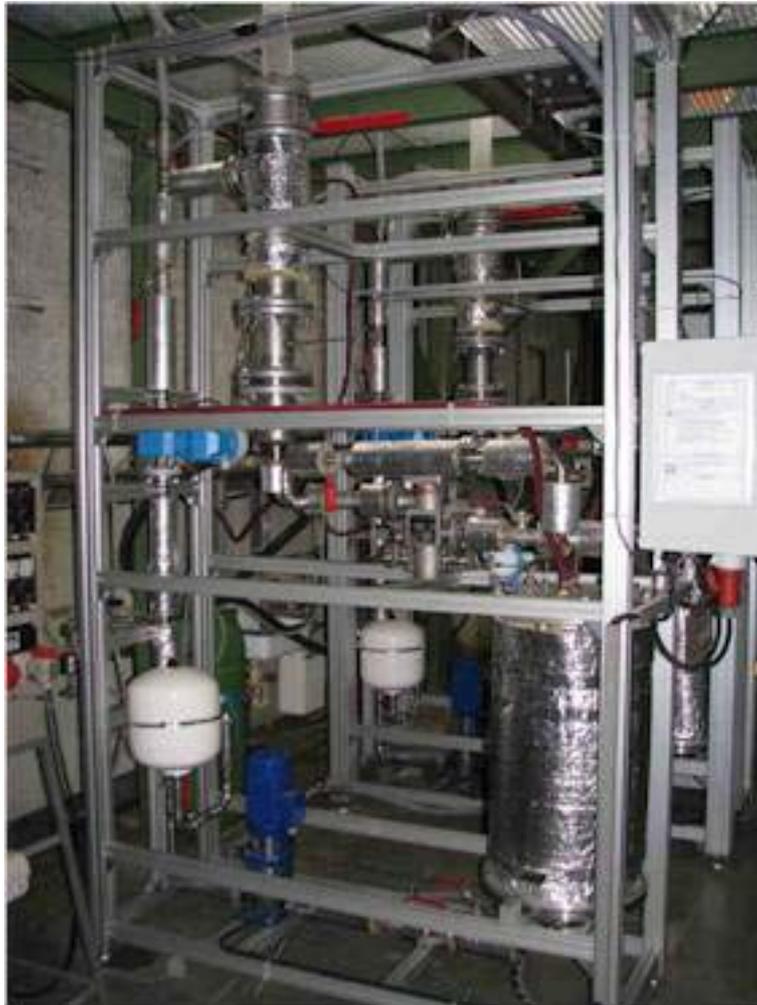
**Test Facility Picture**

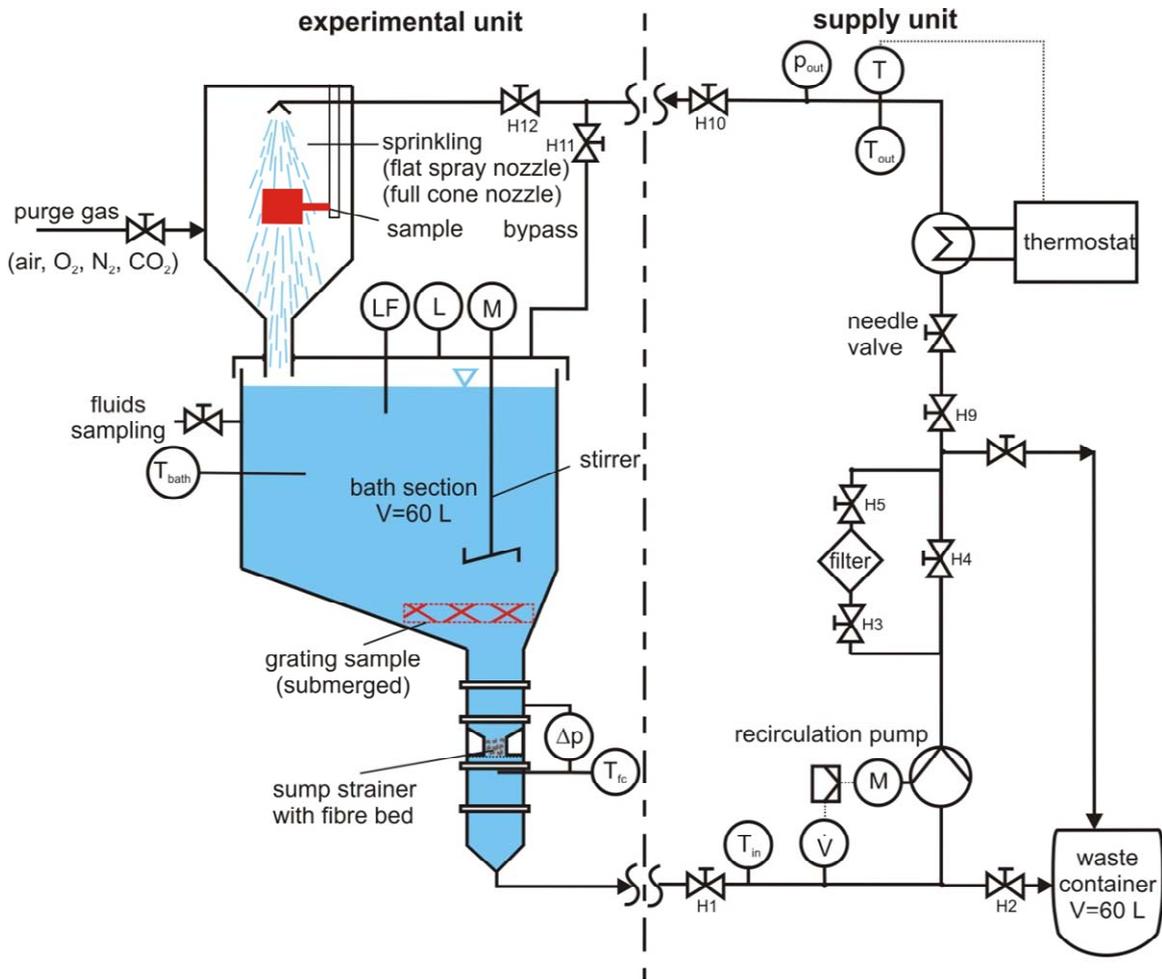
**KorrVA Test Facility Schematic**

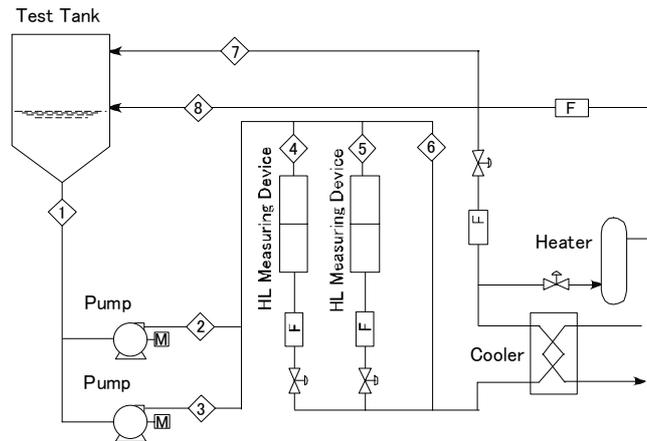
Figure 1: Flow diagram of a test loop (from JNES-SS-1004)

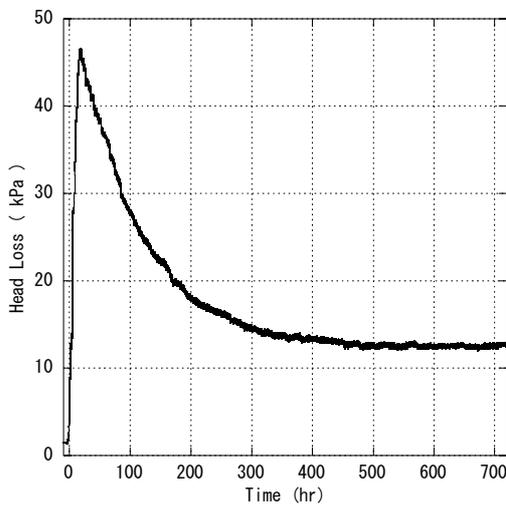
Figure 2: Head loss change in ICAN-10 test with approach velocity of 2 cm/s (from JNES-SS-1004)

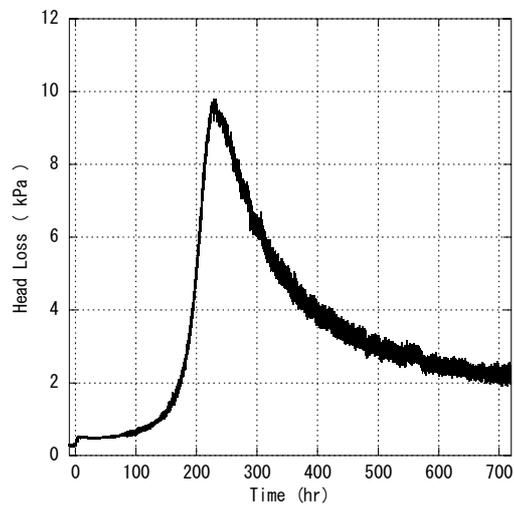
Figure 3: Head loss change in ICAN-10 test with approach velocity of 0.3 cm/s (from JNES-SS-1004)

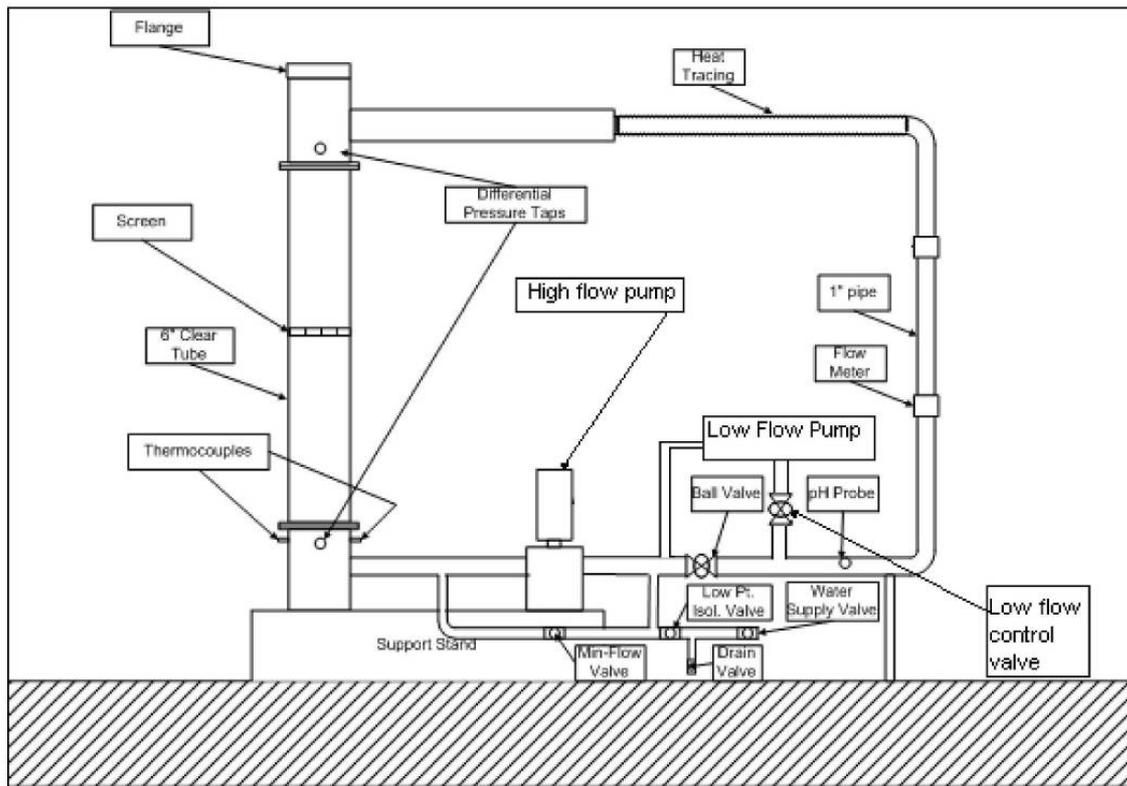
Figure 1: Schematic view of the test apparatus

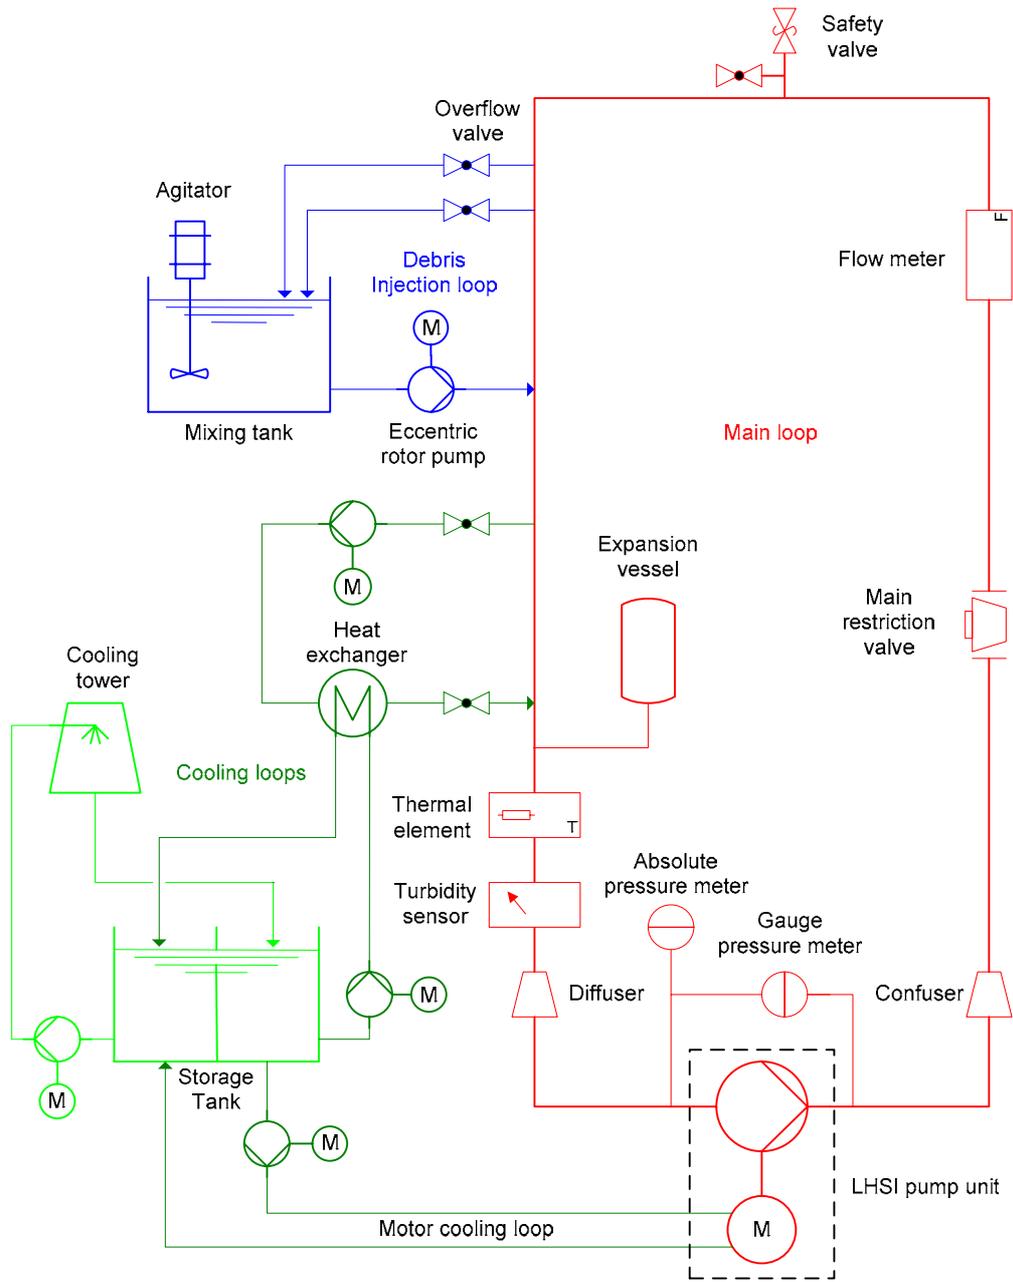
**Schematic of the Pump Test Facility**

Tests have been performed for an EPR™ LHSI pump in 2008/2009 with a maximum debris concentration of 1500 ppm at a water temperature of 40 °C. Test of hydraulic pump performance based on DIN EN ISO 9906 has been performed in addition.

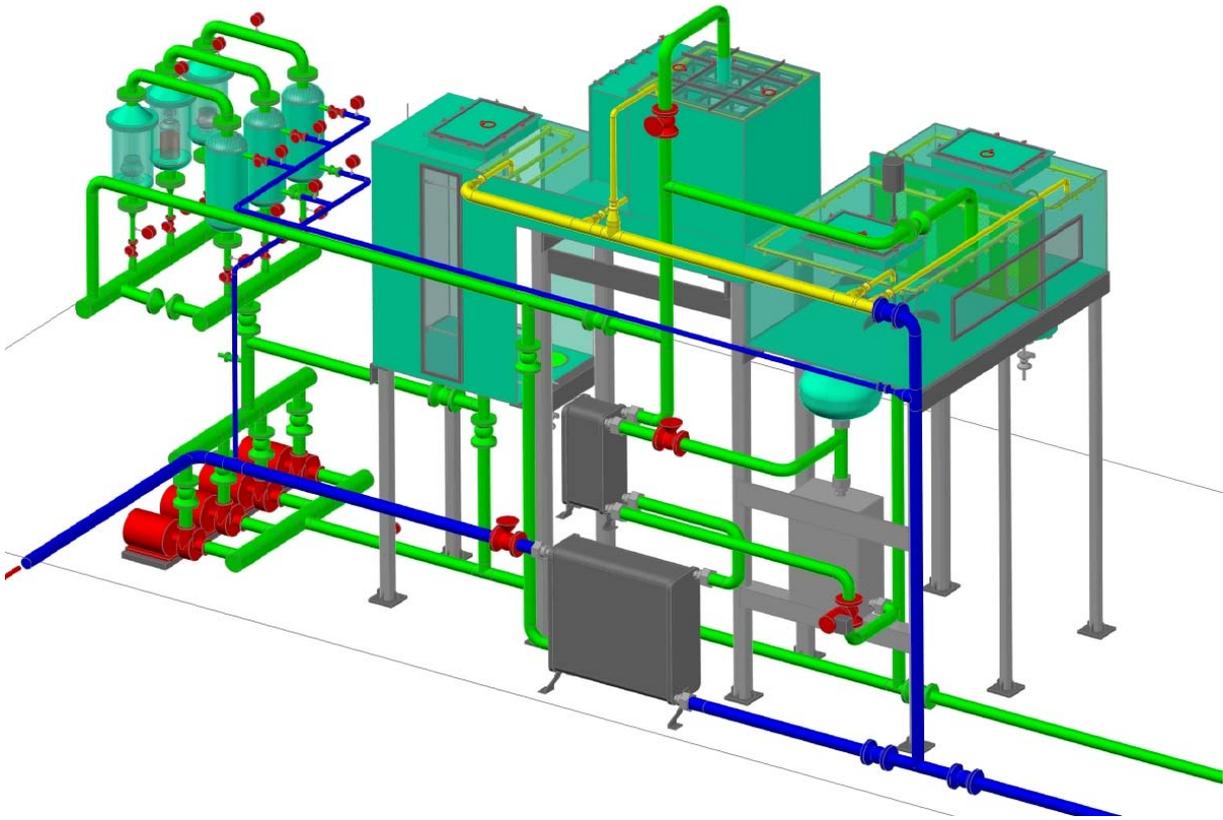
**Schematic of the Test Facility VIKTORIA**

<b>Volume:</b>	5 m <sup>3</sup>
<b>Operating Temperature:</b>	90 °C max.
<b>Mass flow:</b>	175 gpm (40 m <sup>3</sup> /h) max.
<b>Strainer design:</b>	All kinds of strainer designs applicable
<b>Fuel element Section:</b>	FA (fuel assembly) section to handle one or more FAs downstream sump strainer; flow direction in FA up- or downstream, pressure loss measurement on FA components
<b>Debris preparation:</b>	Fibers heated at 300 °C for 24 h, mechanically or high pressure water jet fragmented according to NEI guide “ZOI Fibrous Debris Preparation: Processing, Storage and Handling”; particulates sieved to different size classes
<b>Measured Variables:</b>	Flow rate (strainer and equipment as FA, heat exchanger, etc.) online Water temperature online Water pH online Water Turbidity online Pressure loss strainer online Pressure loss FA components online

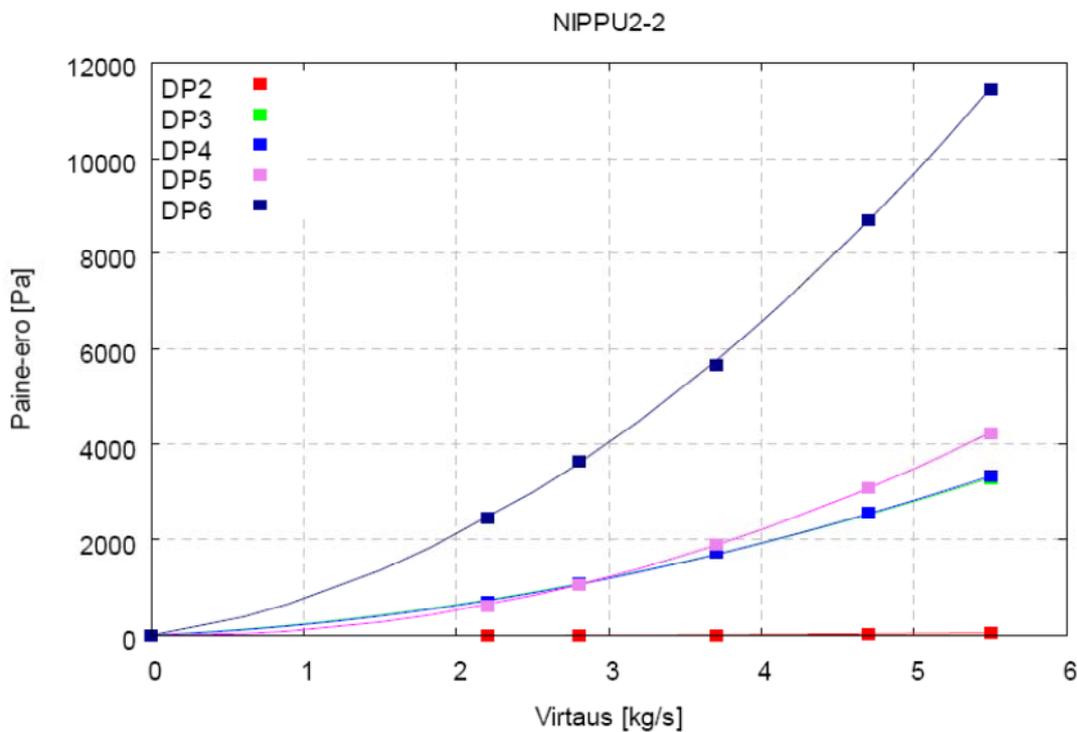
**Figure 1: dP Measurements over the Fuel Element before Cleaning the Filter with Air Blow**

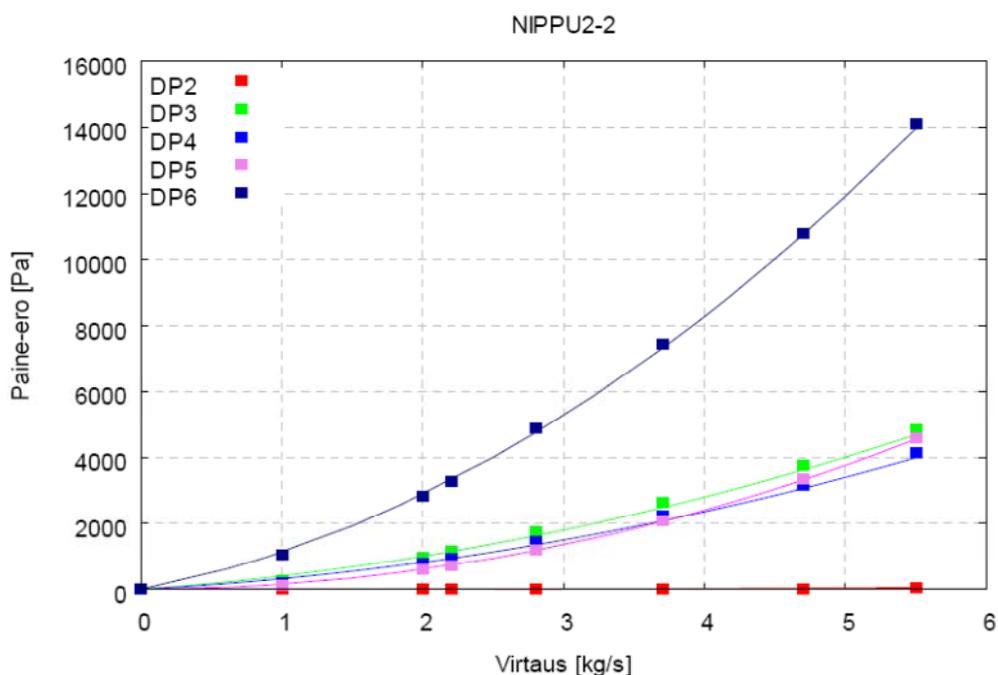
**Figure 2: dP Measurements over the Fuel Element after Cleaning the Filter with Air Blow**

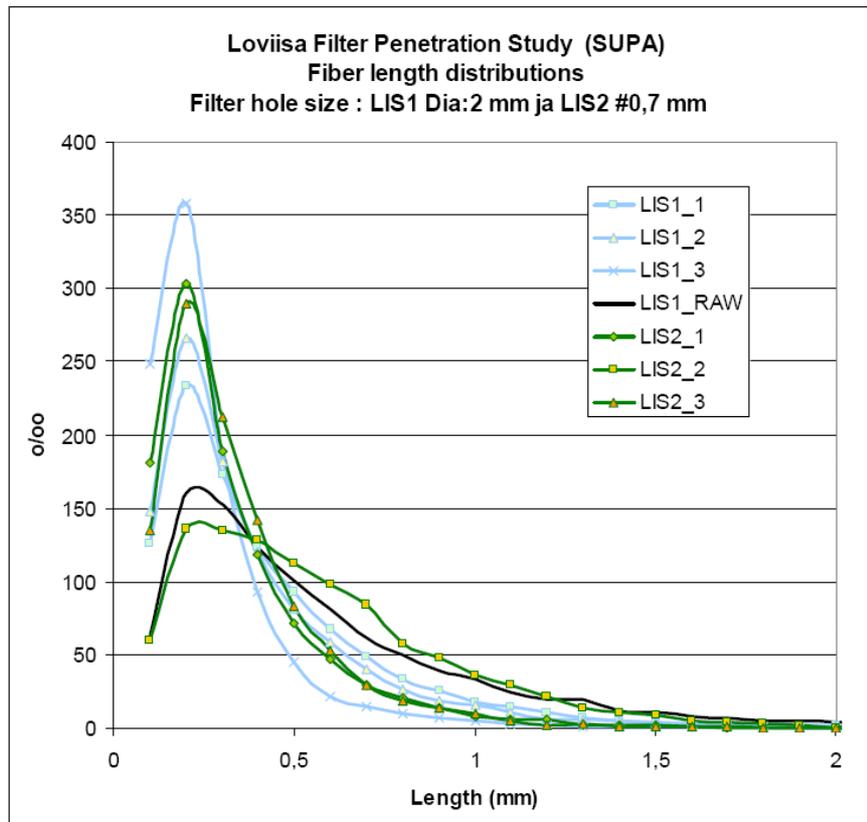
**Figure 3: Fiber Length Distribution for Tests LIS1 and LIS2, with Sample 1 always from the Initial Penetration Phase**

**Debris Size:** The material was destructed to a very homogenous slurry. The base material diameter is about  $5 \mu\text{m}$ , and the mean length from a sample from the slurry was about 0.7 mm. Distribution of the sample as well as the mean length of the fibres was analysed with Lorentzen and Wettre Fibertester, and combined results are presented from the raw datafiles. With smaller hole, the resulting mean length for penetrating fibres is smaller, but not significantly. Longer fibres from the raw sample can be seen disappearing with both filters, except in LIS2\_2 sample, which is very small (0.2 g, vs. 15 g in sample LIS1\_2) taken after first blowdown.
