**NEA/CSNI/R(2013)12/ADD1**

**Updated Knowledge Base for Long Term Core Cooling Reliability**

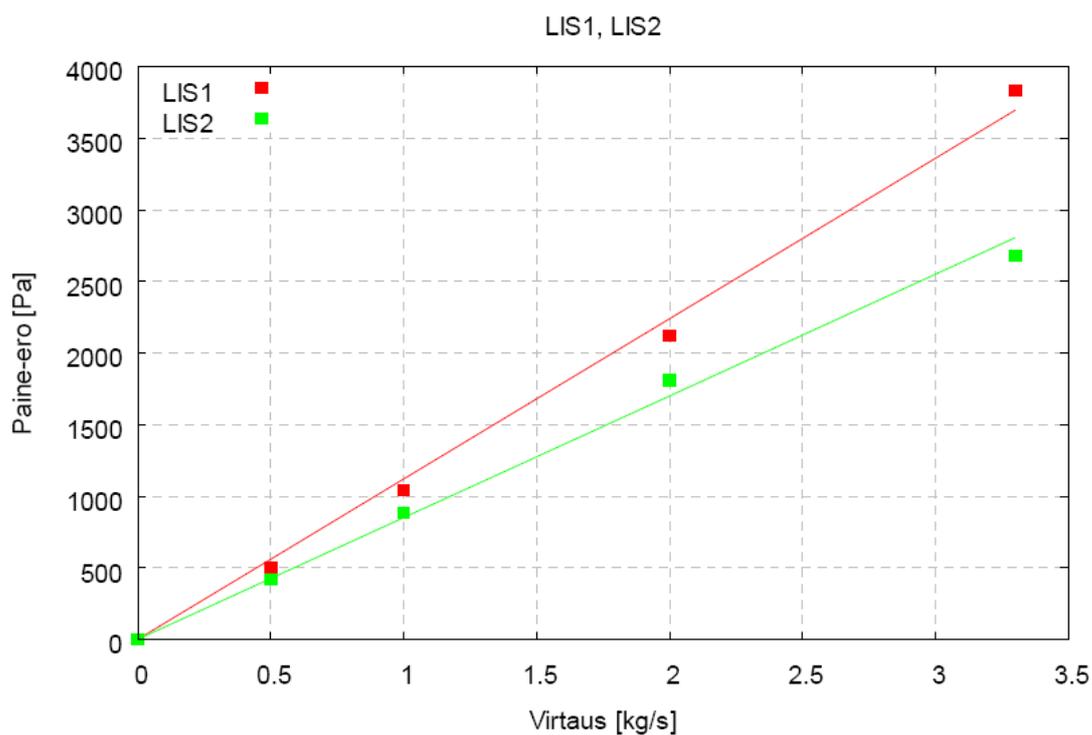
Figure 4: Pressure Loss over Filter Element against Flowrate (licensing experiments)

During the experiment, flow rate was varied to examine the behaviour of the debris bed with different flows.

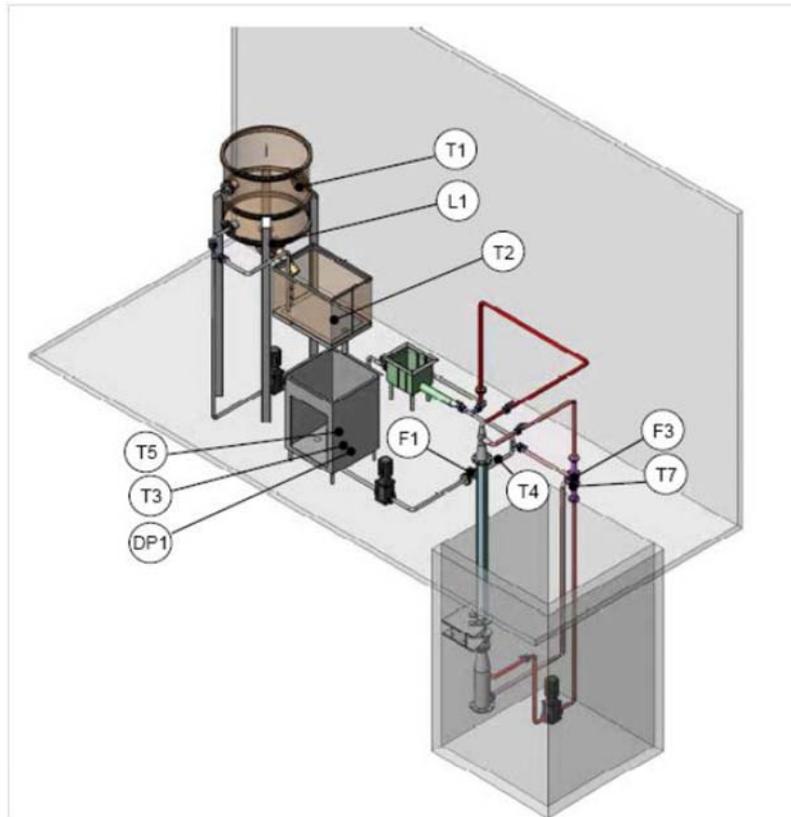
**Picture 1: The Test Facility for Phases 1 and 2**

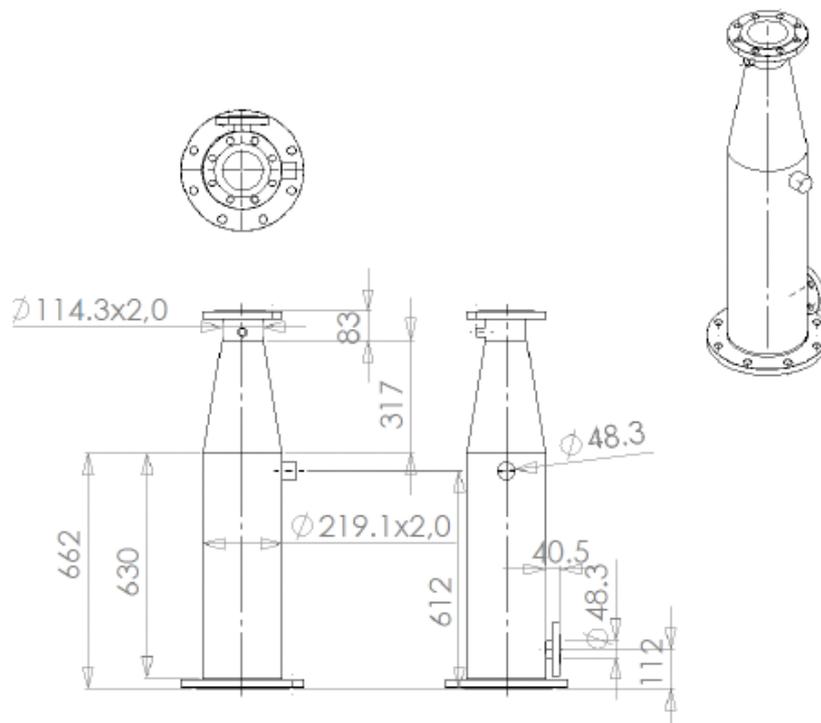
**Picture 2: Downcomer Modelling Volume**

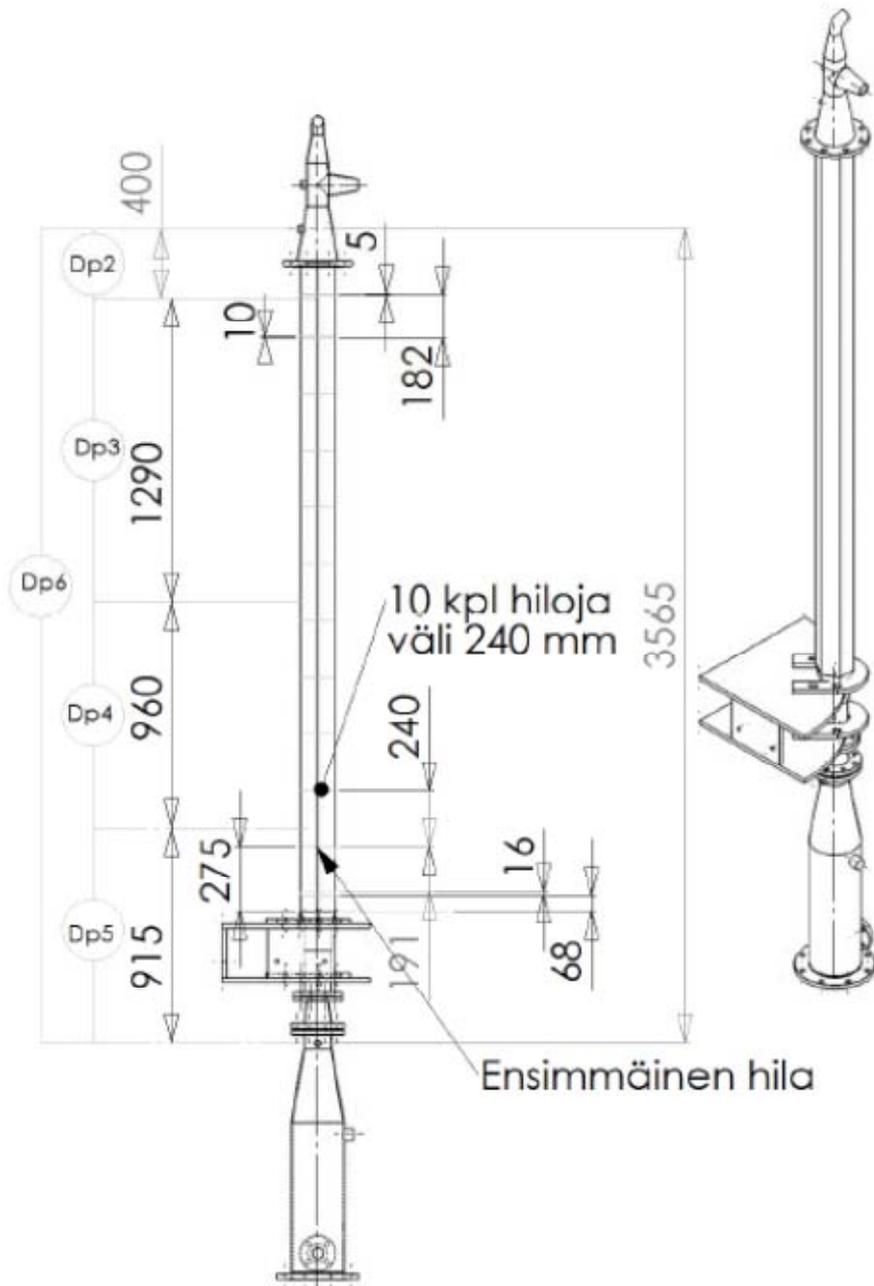
Picture 3: Phase 2 Measuring Instruments for Fuel Element Pressure Loss

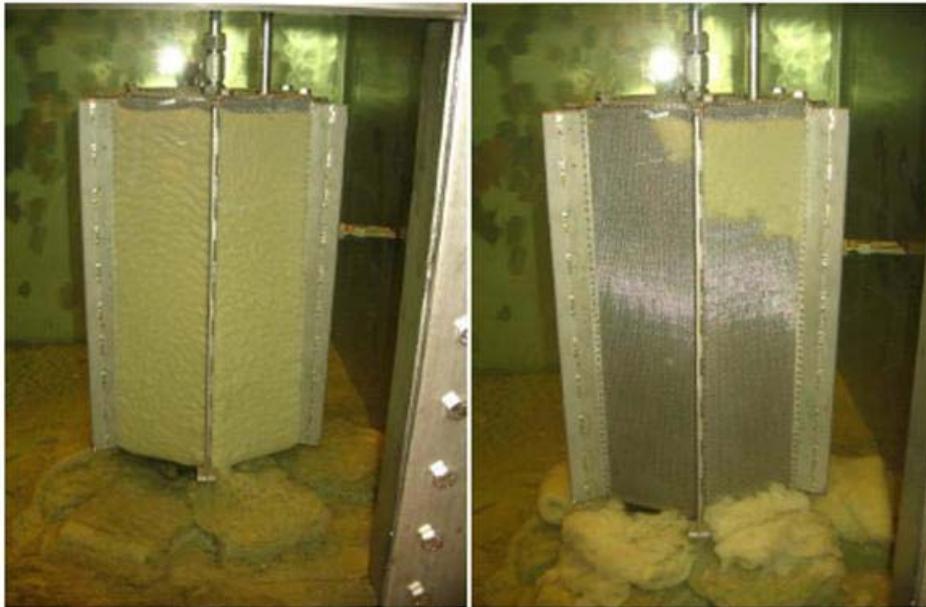
**Picture 4: The Filter before (left) and after Stopping the Flow at Time 216 min.**

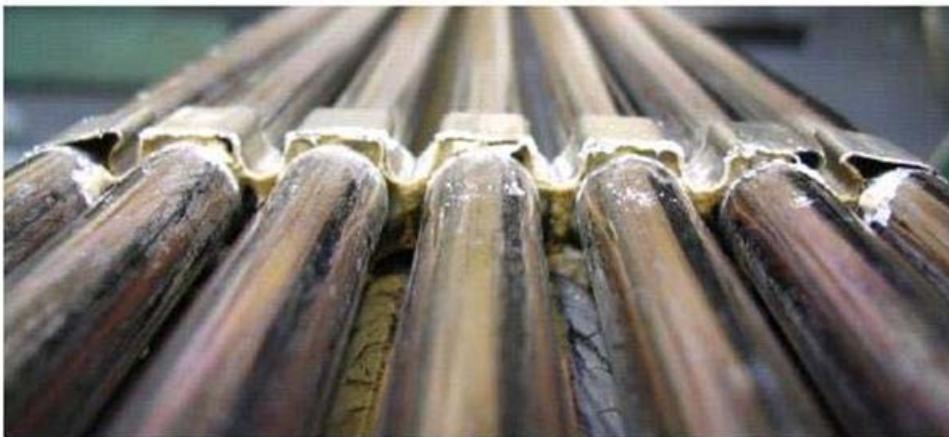
**Picture 5: The Dismantled Fuel Element and Collected Debris in Spacer Lower Part after the NIPPU2-2 Experiment.**

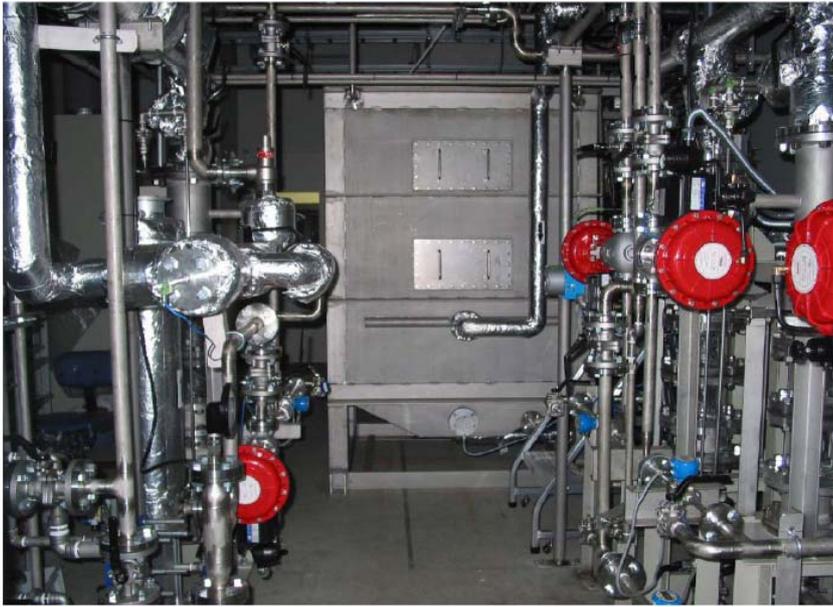
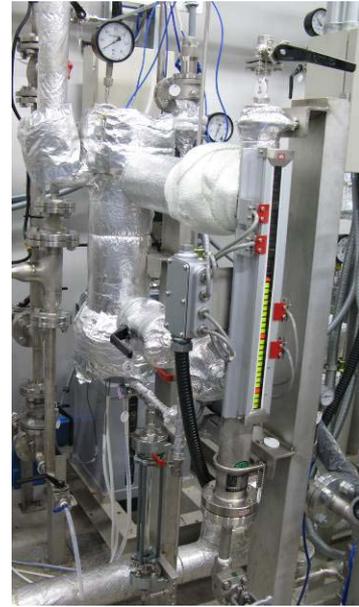
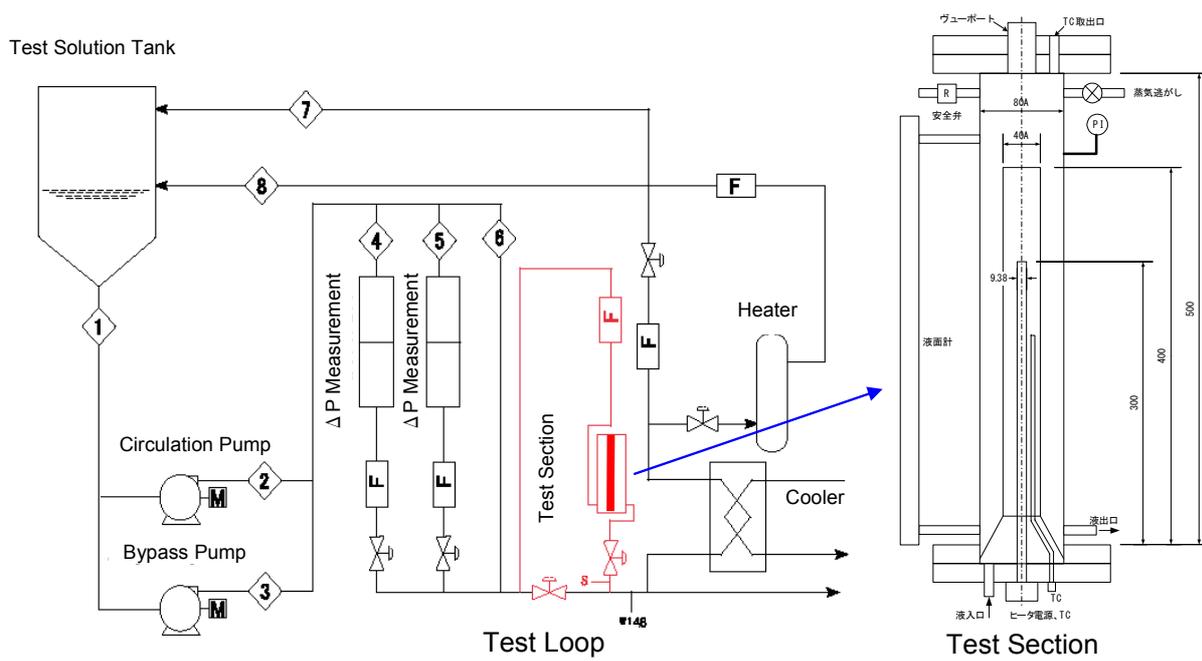
**Fig. 1: Test Facility for Chemical Precipitate Deposition on Fuel Cladding (from 10原熱報-0006 and JNES-RE-2012-0001).**

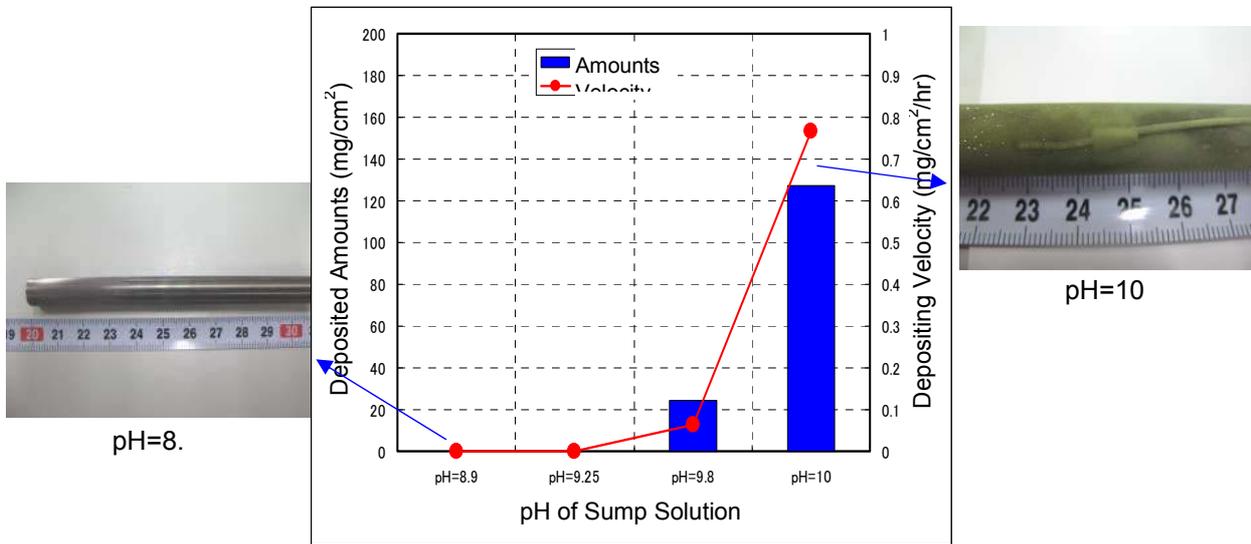
**Fig. 2: pH Dependencies of Deposition of Chemical Precipitates (from JNES-RE-2012-0001)**

1. Table 1 shows the basic data on the chemical precipitates. The deposits were analyzed to be Ca compounds ( $\text{CaCO}_3$ ) originating from insulation and their thermal conductivity was evaluated;
2. Chemical precipitates deposited on the cladding and the surface temperature increased by a few tens of a degree centigrade;
3. A deposition model in which the deposition rate was equal to the steaming rate multiplied by the chemical product concentration of the solution did not simulate the test results;
4. Figure 2 shows the pH dependencies of deposition of chemical precipitates. The deposition of chemical precipitates on the fuel cladding did not occur under conditions where the sump pH solution was less than 9. Therefore, it was recommended to keep the pH of the sump solution less than 9 in a plant using NaOH as the pH buffer.

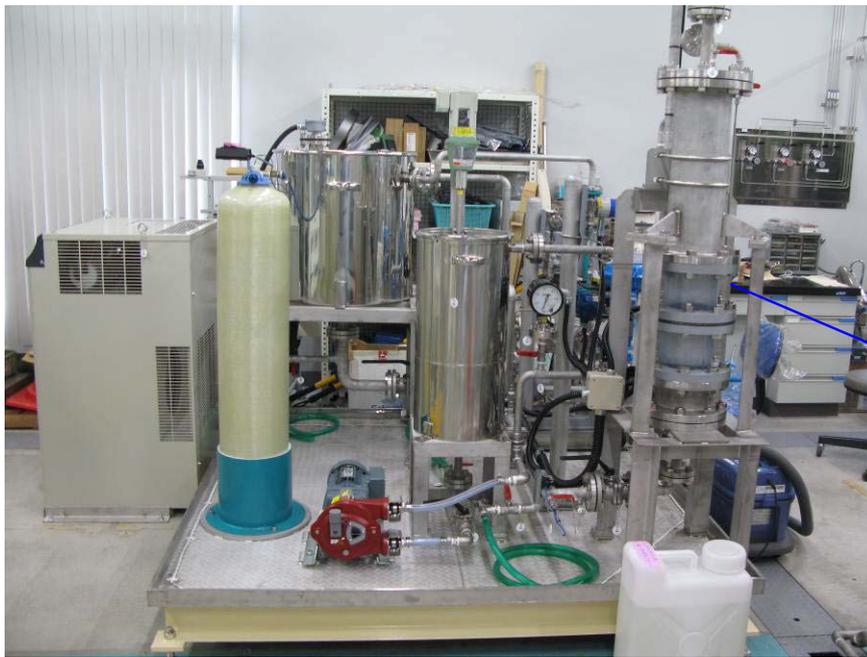
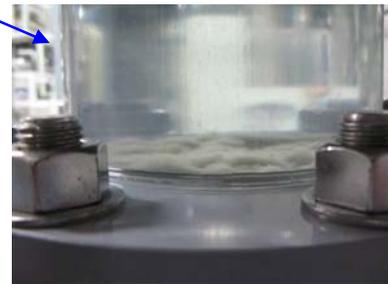
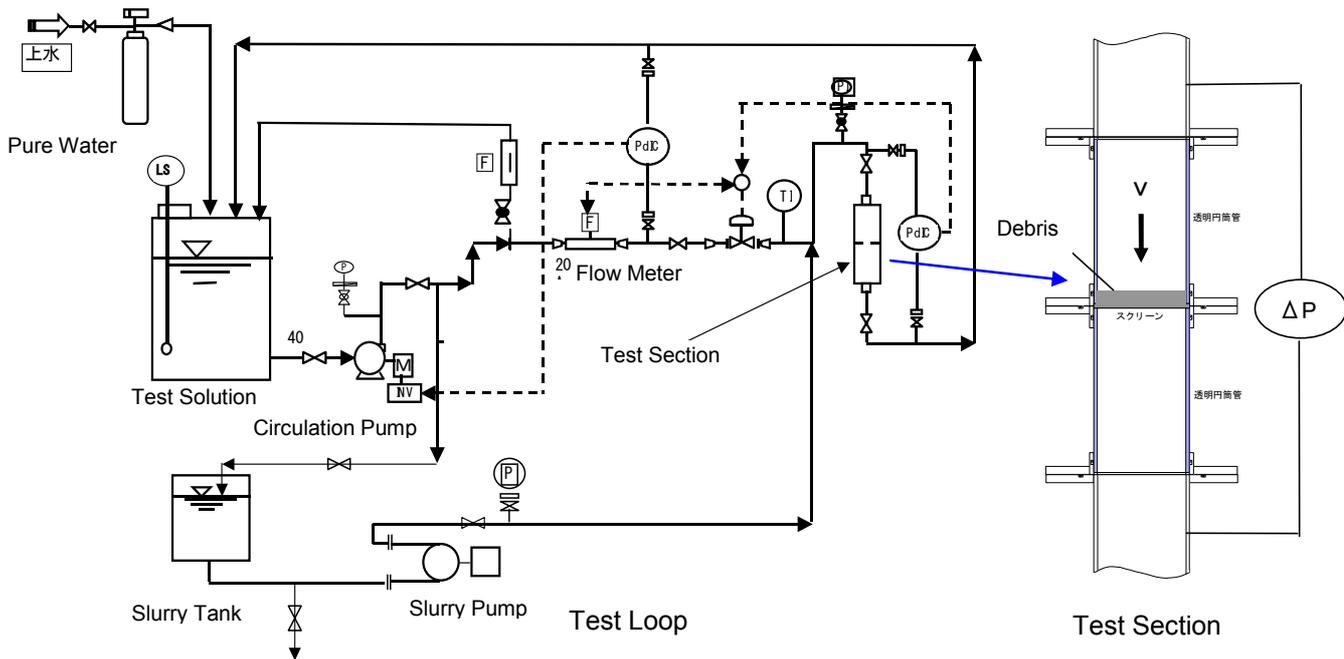
Figure 1: Test Facility for Downstream Flow Clogging due to Debris Accumulation (from 10原熱報-0006 and JNES-RE-2012-0001)

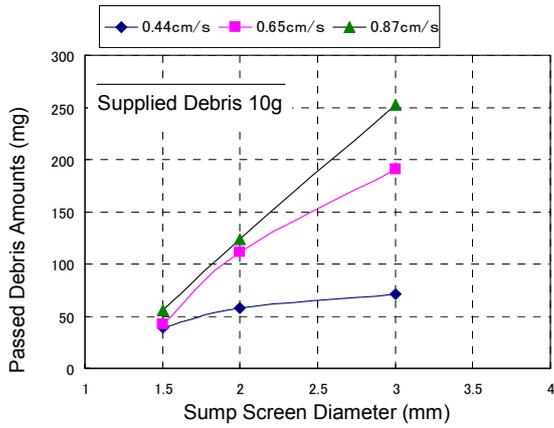
Figure 2: Fiber debris amounts passed through sump screen (from JNES-RE-2012-0001)

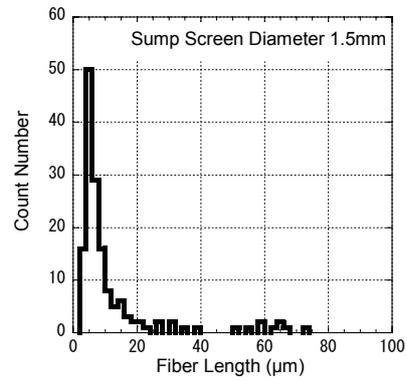
Figure 3: Distribution of fiber debris size passed through sump screen (from JNES-RE-2012-0001)

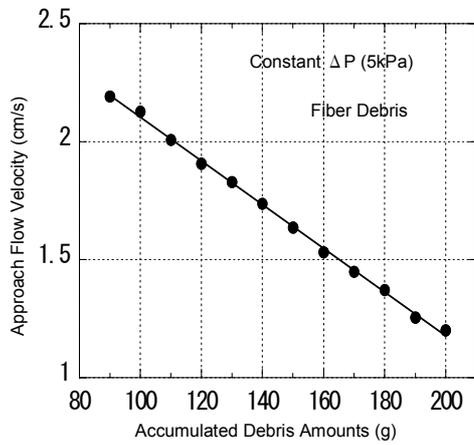
Figure 4: Relation between accumulated fiber debris amounts and approach flow velocity (from JNES-RE-2012-0001)

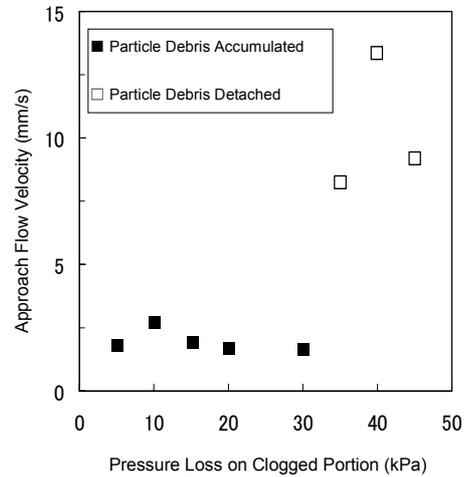
Figure 5: Relation of pressure loss and approach flow velocity during flow clogging (from JNES-RE-2012-0001)

4. The flow clogging condition was obtained under the test condition that assumed 100% debris passing through the sump screen to be conservative, where particle debris accumulated on a fiber debris layer when the pressure loss is less than 30 kPa and particle debris detached from a fiber debris layer when the pressure loss is more than 35 kPa. Figure 5 shows the relation between pressure loss and approaching flow velocity during the flow clogging condition.

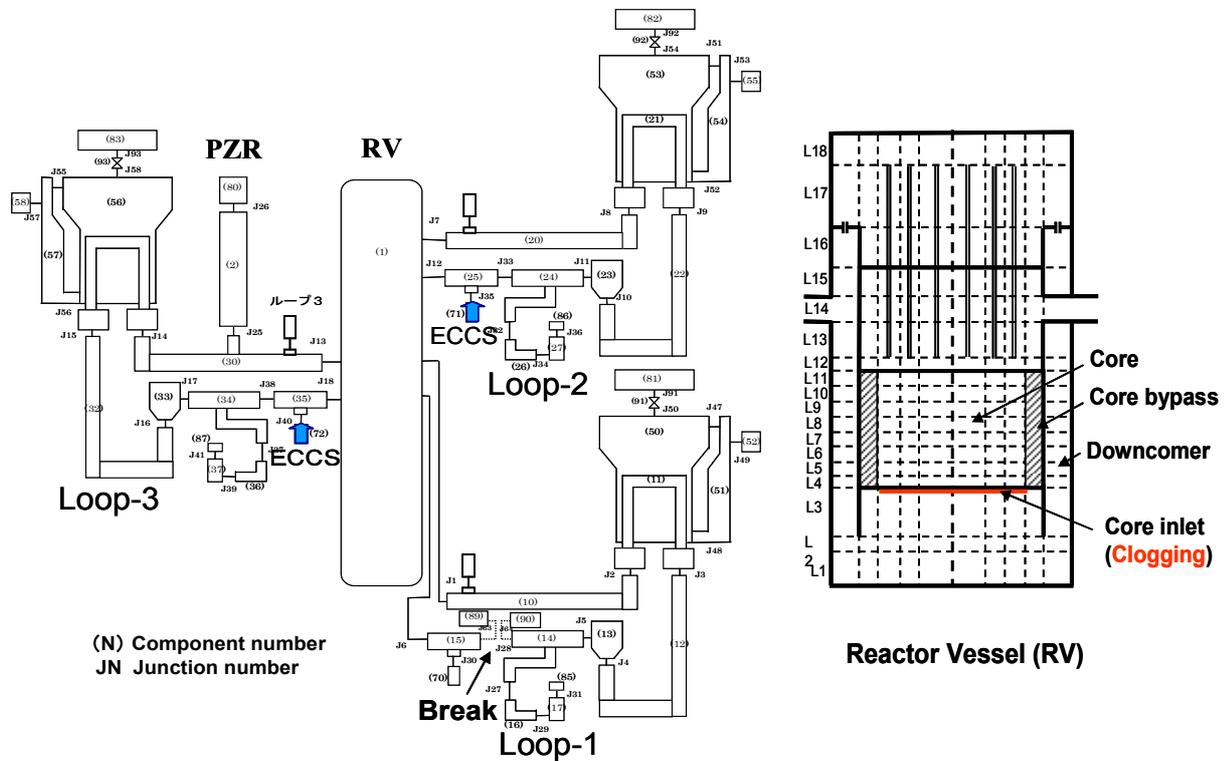
Figure 1: Three-loop PWR plant TRACE Analytical Model  
(from 10原熱報-0008)

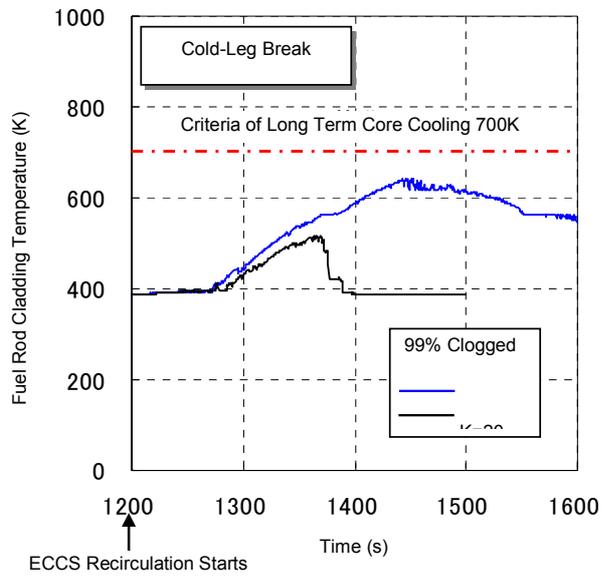
Figure 2: Analytical result for PCT in case of core inlet clogging during a cold-leg break LOCA in a PWR (from JNES-RE-2012-0001)

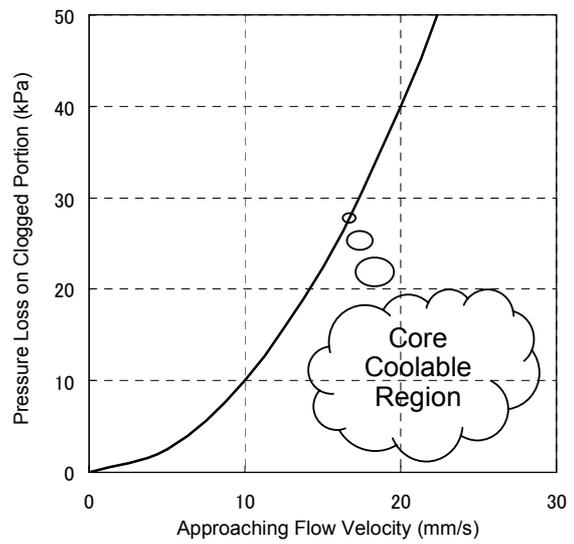
Figure 3: Long term core cooling condition on the clogged core inlet during a LOCA in a PWR (from JNES-RE-2012-0001)

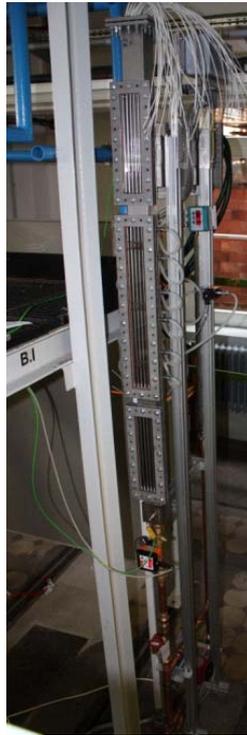
Figure 1: Test facility ISOTRAN

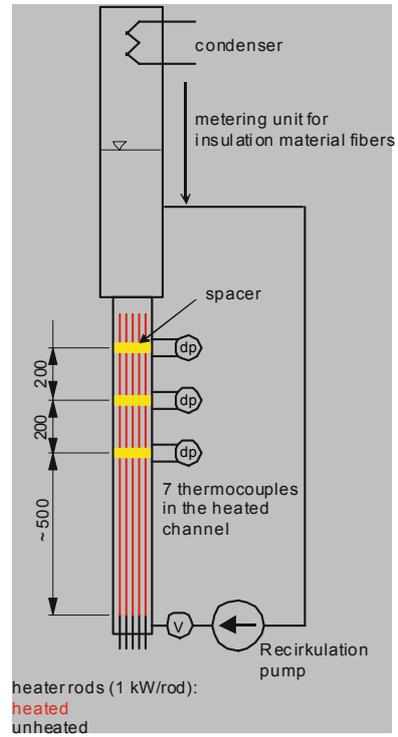
Figure 2: Schematic of ISOTRAN

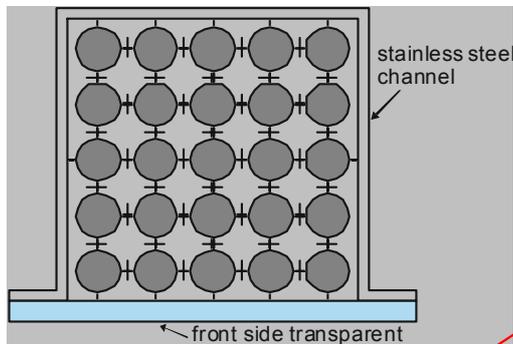
Figure 3: Cross section of the rod bundle

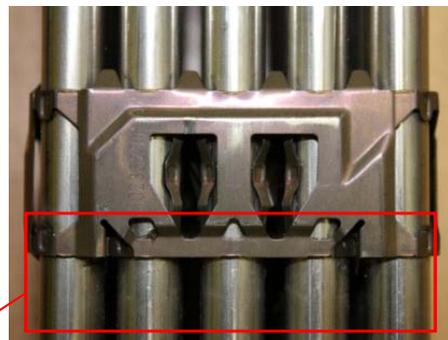
Figure 4: Rod bundle with original BWR spacer

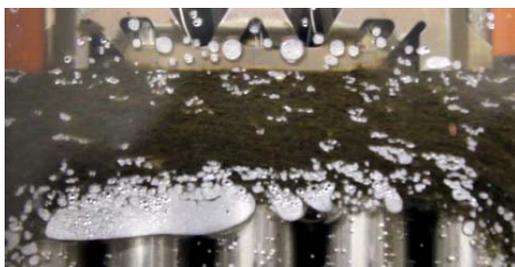
Figure 5: Fiber bed with steam bubbles

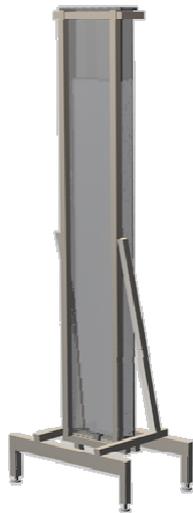
**Figure 1: Test facility “Column”**

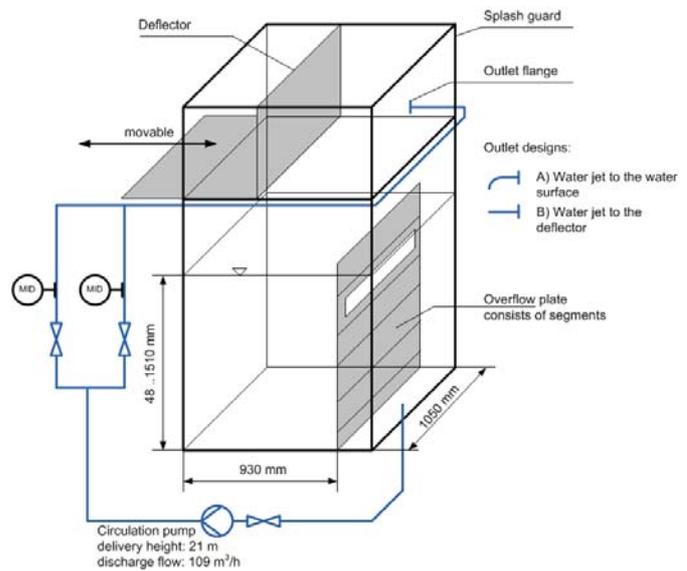
**Figure 2: Test facility “Tank”**

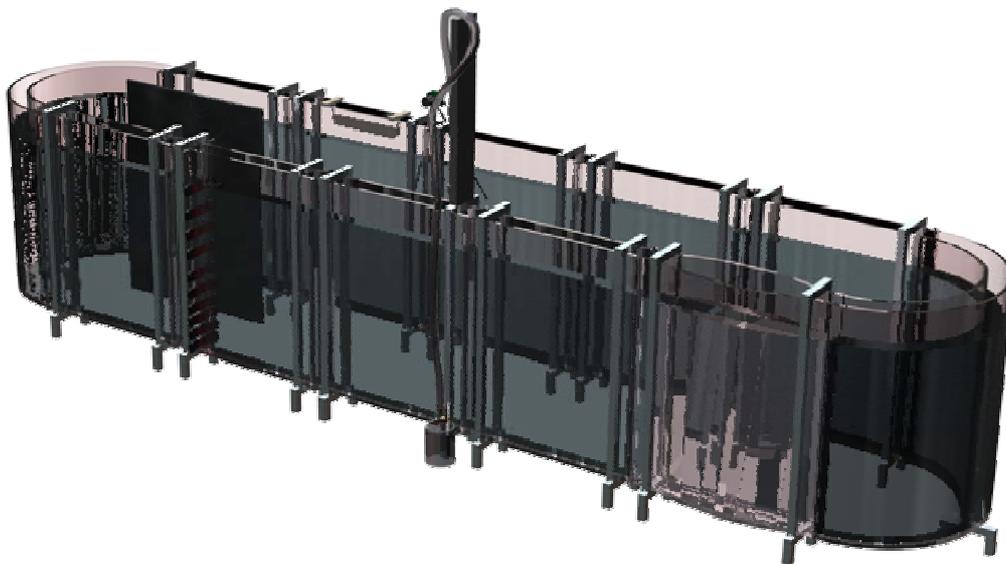
**Figure 3: Test facility “Ring Channel”**

The “Ring Channel” (Figure 3) was developed for the observation of insulation material transport in horizontal flows and different flow phenomena. The “Ring Channel” was designed as an oval acrylic glass flow channel. The channel consists of two straight sections with a length of 5 m, separated into single segments with a length of 1 m, and two semi-circular segments.

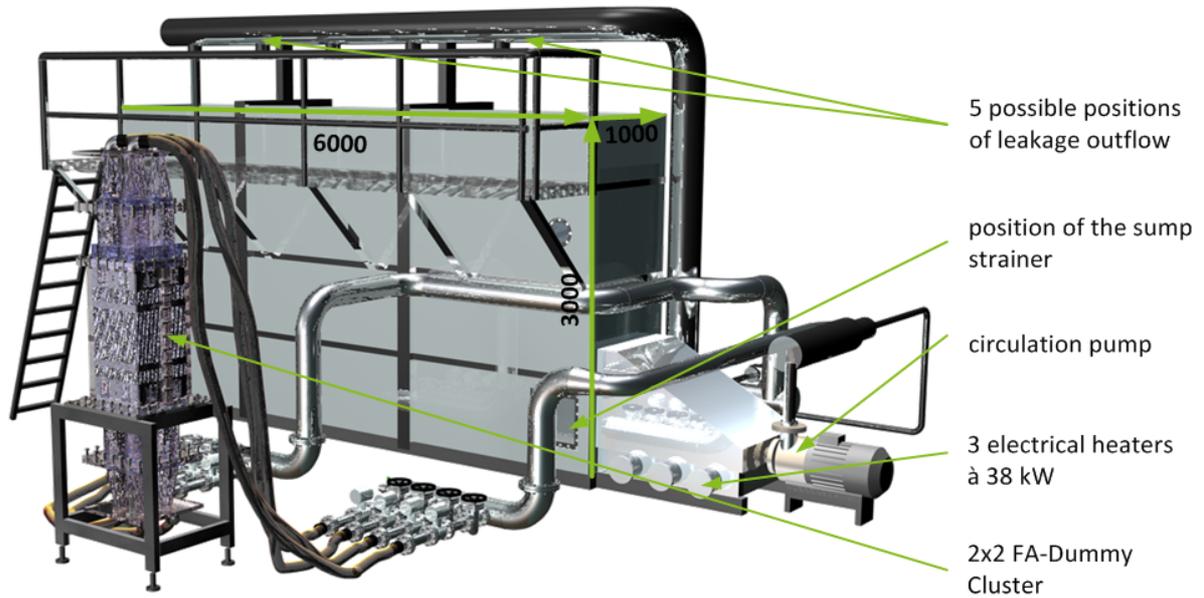
Figure 1: Zittau Flow Tray Test Facility 3-D view

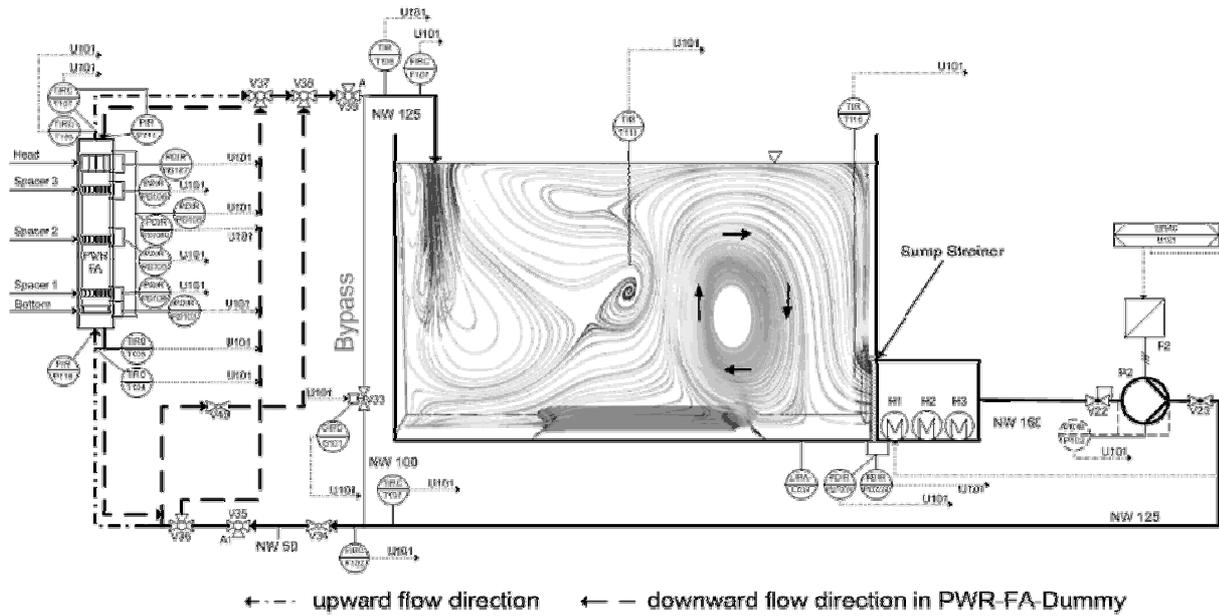
Figure 2: Test Facility Set Up with Flow Profile and Single FA Dummy

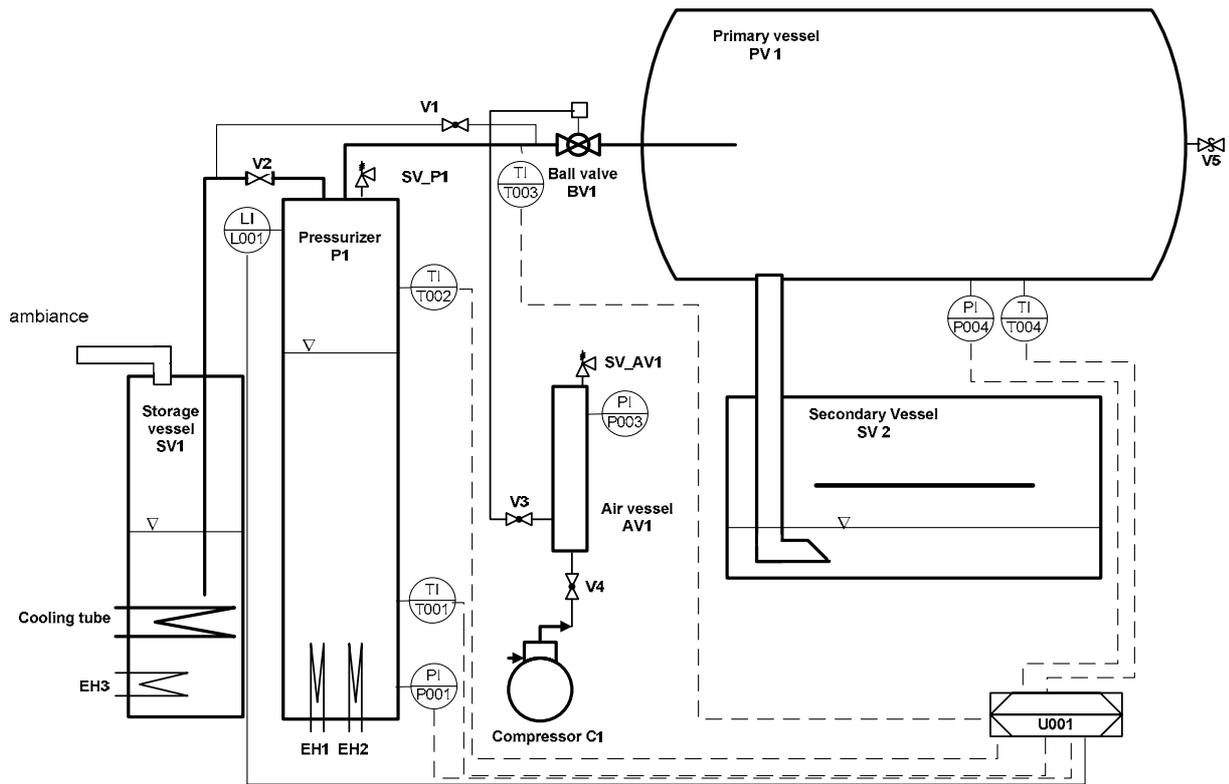
Figure 1: Scheme of the Test Rig “Fragmentation” with Pressurizer

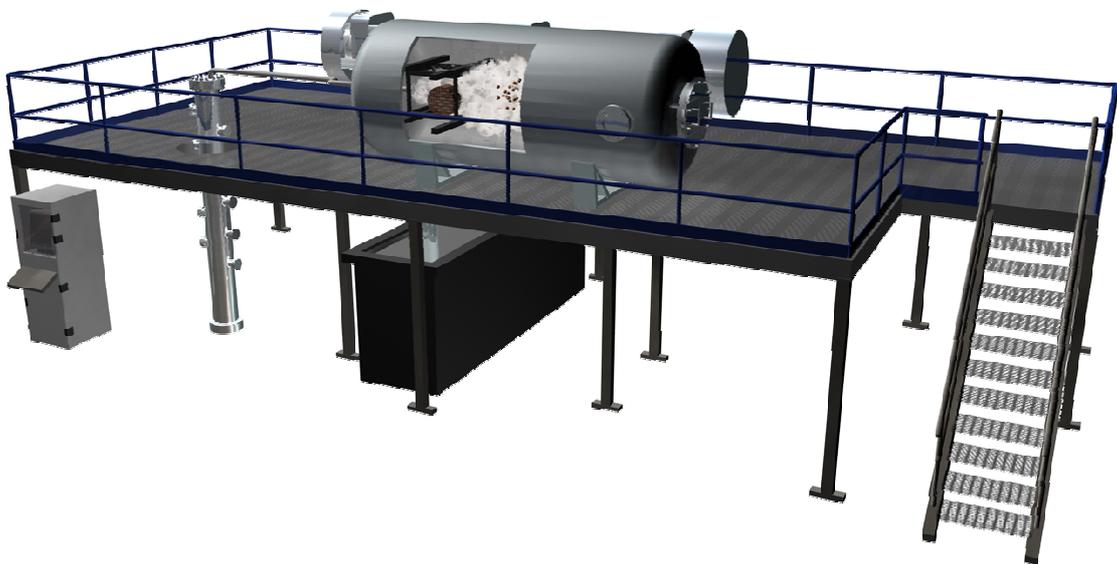
Figure 2: 3-D view of Test Rig “Fragmentation”

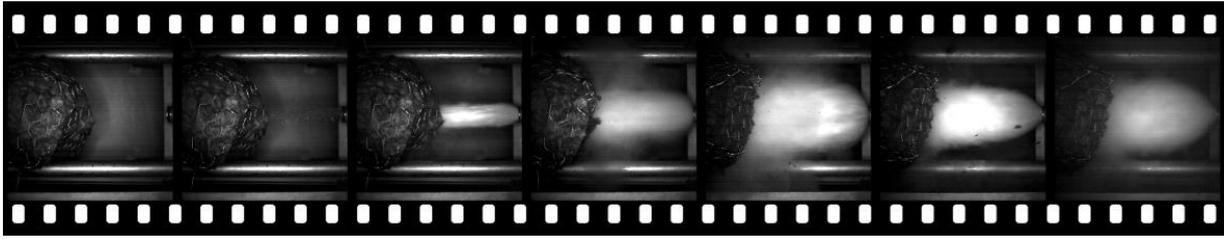
**Figure 3: Images of Free Jet and the Insulation Material Target Captured with a High Speed Camera**

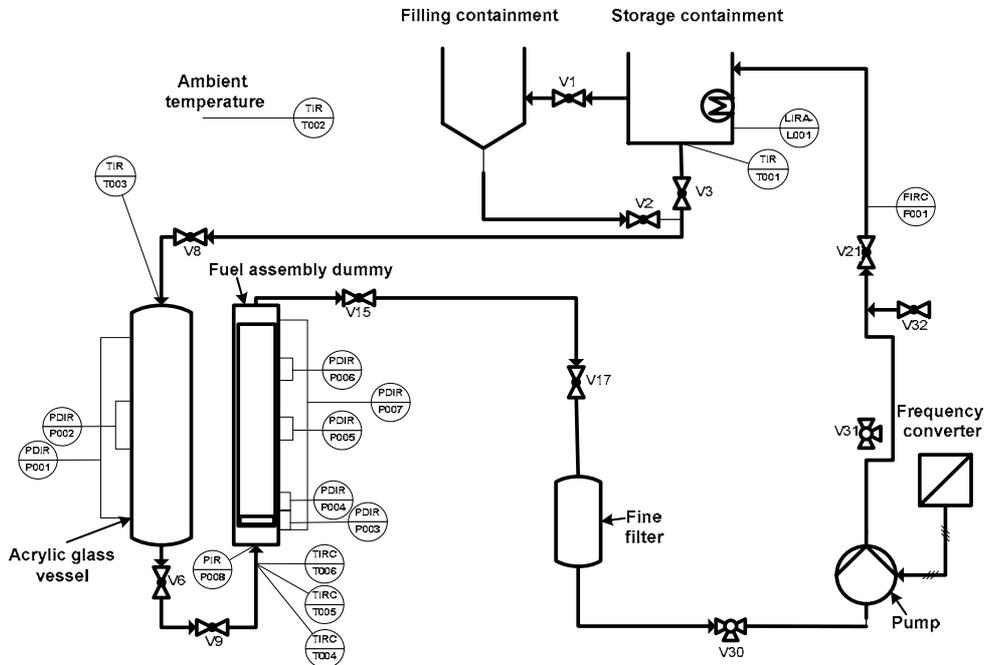
**Figure 1: Schematic of the Test Facility “Ring Line II” with FA Dummy (example)**

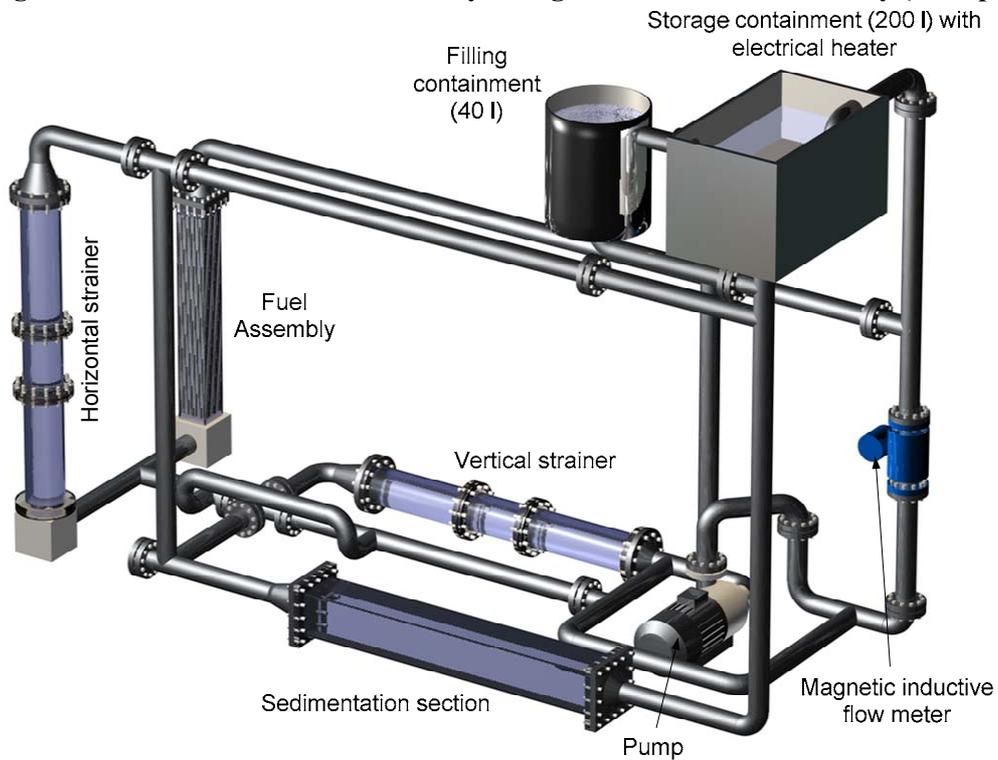
**Figure 2: 3-D View of Test Facility “Ring Line II”**

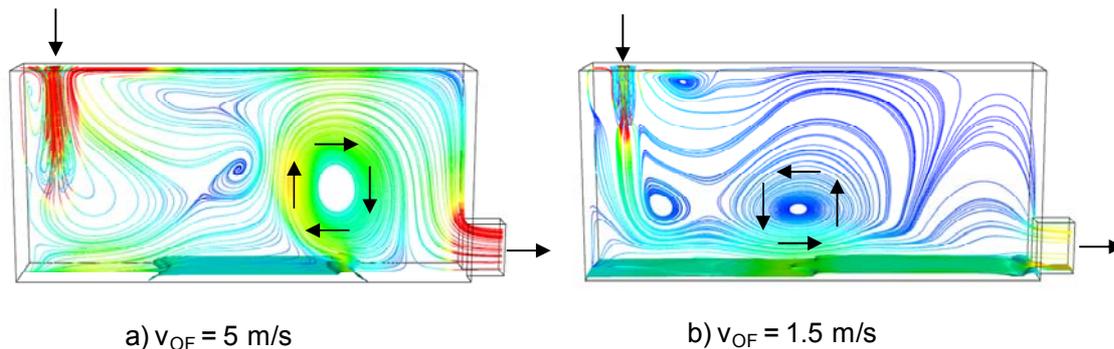
**Figure E-1: Water Streamlines Projected on a Middle Plane for Different Jet Inlet Velocities  $V_{OF}$ . Deposited fibers at the bottom of the pool are shown as iso-surfaces of the fiber phase [E.1].**

released materials will be transported to the sump of a PWR. The jet-induced flow into the sump will influence the fiber transport to the strainer and therefore the head-loss across the strainer [E.1].

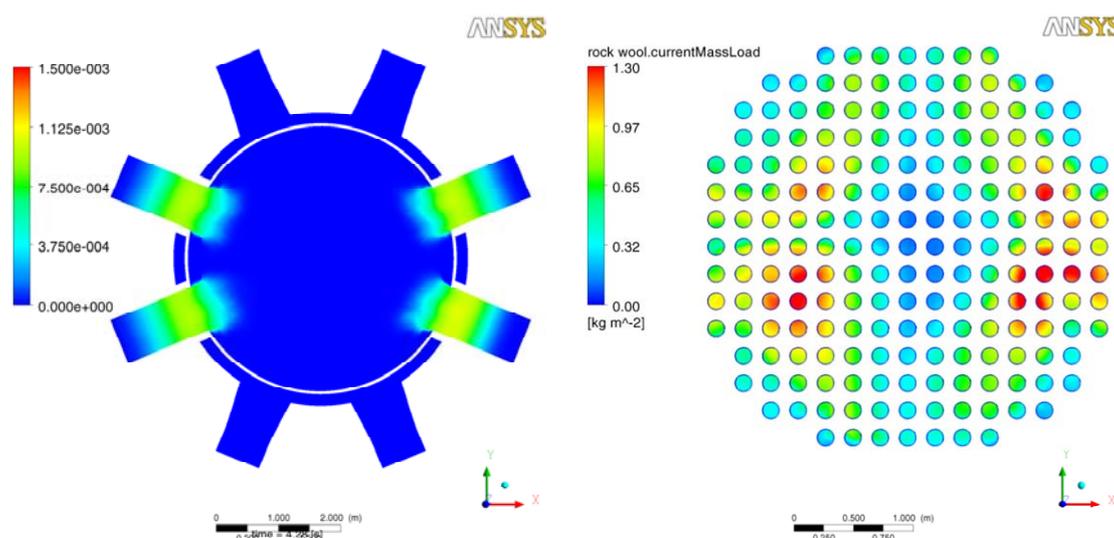
**Figure E-2: Rock Wool Concentration [ppm] after Start-up of ECC Injection, Nozzle Plane (left) and Rock Wool Mass Load on the Upper Spacer Grid (right) [E.2].**

CFD calculations of the head-loss across clogged spacers of fuel elements using the complete RPV geometry were performed at HZDR. Each fuel element was represented in a simplified manner. For the upper most spacer grid, the strainer model was applied. According to these investigations, in case of hot-leg injection at the beginning of sump cooling, the fibers accumulate at the spacers within down-flowing channels. Before the switch over of the ECC injection from flooding mode to sump mode, the coolant circulates in an inner convection loop in the core extending from the lower plenum to the upper plenum. The CFD simulations have shown that after starting the sump mode, the ECC water injected through the hot legs flows down into the core via so-called “break-through channels” located in the outer core region where the downward leg of the convection roll has established itself. The hotter, lighter coolant rises in the centre of the core. As a consequence, the insulation material is mostly deposited on the uppermost spacer grids positioned in the break-through zones. This means that the fibers are not uniformly deposited over the core cross section. Later, a redistribution of the fibrous material deposited on the spacers was calculated due to the reduced flow through clogged channels.

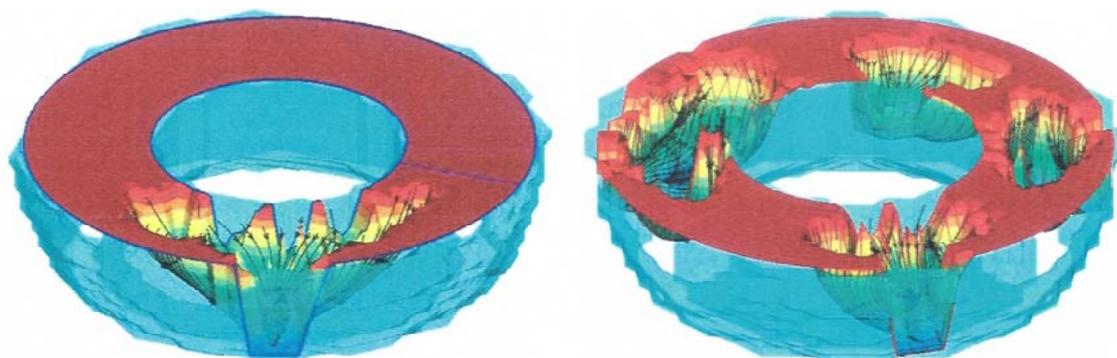
**Figure E-3: Suction of Suspended Particles in the Direction of the Strainers in the Case of One ECCS Pump Resp. 5 ECCS Pumps, BWR Type 69 Wetwell Pool [E.3].**

The program was validated by experimental data of the Harburg test facility. Four experiments with different flow velocities were performed. The sedimentation rate was calculated for 5 sedimentation velocities. Good agreement of the calculated sedimentation rate was reached for a sedimentation velocity of 8 mm/s.
