# **NRC / EPRI Steam Generator Task Force Meeting February 6, 2013**

## ***EPRI SGMP Steam Generator Task Force Update***

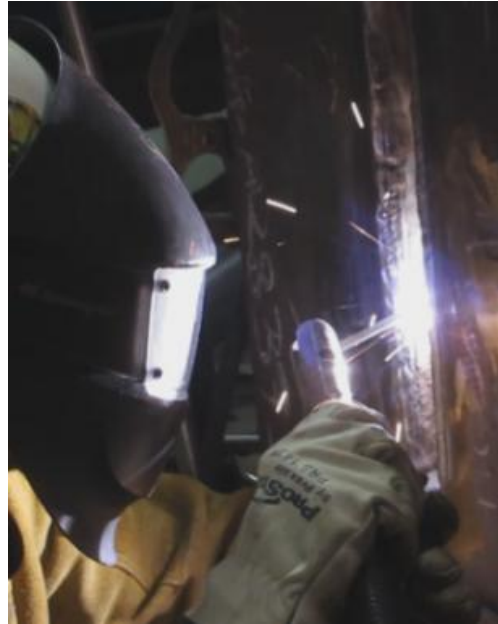
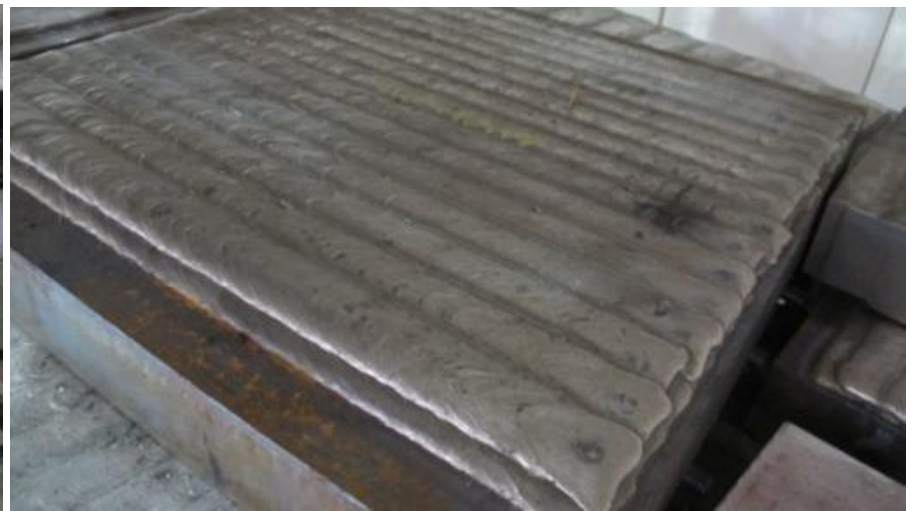
# Tube-To-Tubesheet Weld Mockup

EPRI developed  
prototypical tube-  
to-tubesheet  
mockups to  
analyze  
chromium levels

82 - Electroslag Welding (ESW)

182 SMAW process
