Remediation of Nuclear Regulatory Commission Burial Pits No. 1, 2, and 3 and Lessons Learned at the FUSRAP Maywood Superfund Site, Maywood, New Jersey - 11594

James Moore*, David Hays**

*United States Army Corps of Engineers, New York City, New York, 10278

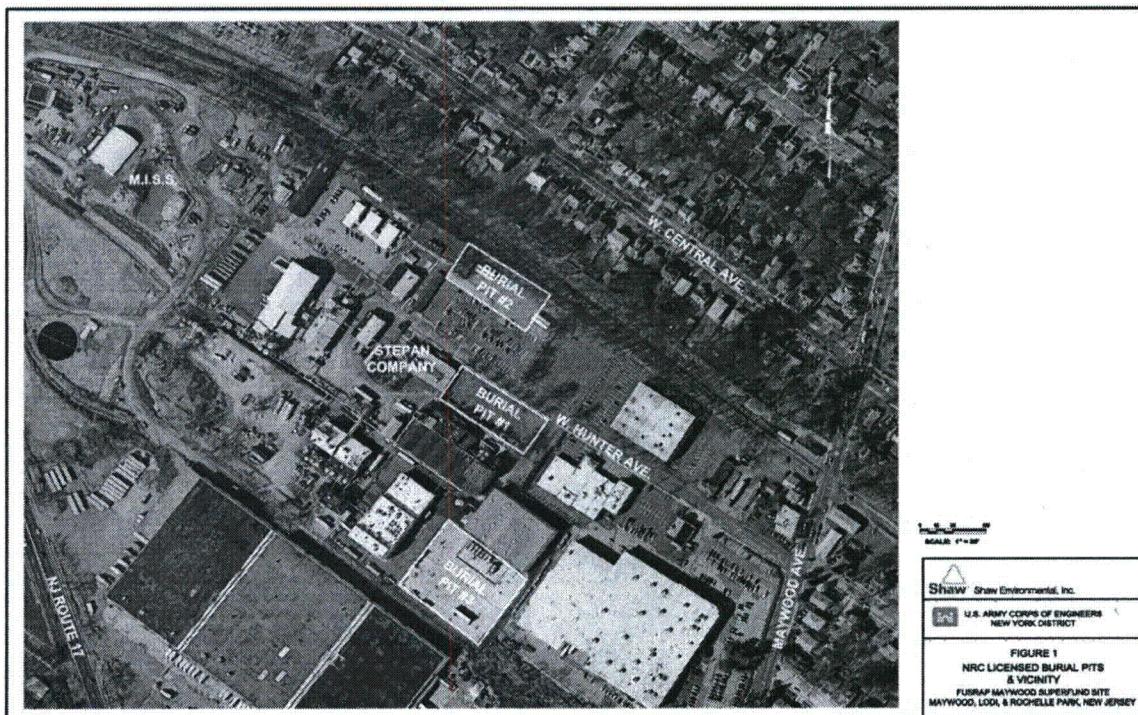
Figure 1. NRC-licensed burial pits and vicinity at the FUSRAP Maywood Superfund Site.

In the late 1960s, Stepan Company took corrective measures at some of the former disposal areas located on the original MCW property. These corrective measures included relocation and burial of approximately 19,100 yd³ of excavated waste materials. Between 1966 and 1968 these waste materials were relocated to three Burial Pits (BP) on the current Stepan Company Property (Figure 1). These burial pits were subsequently licensed by the NRC to Stepan Company pursuant to 10 CFR 40 on April 4, 1978. The "possession-only" license authorized Stepan to possess the material in underground storage.

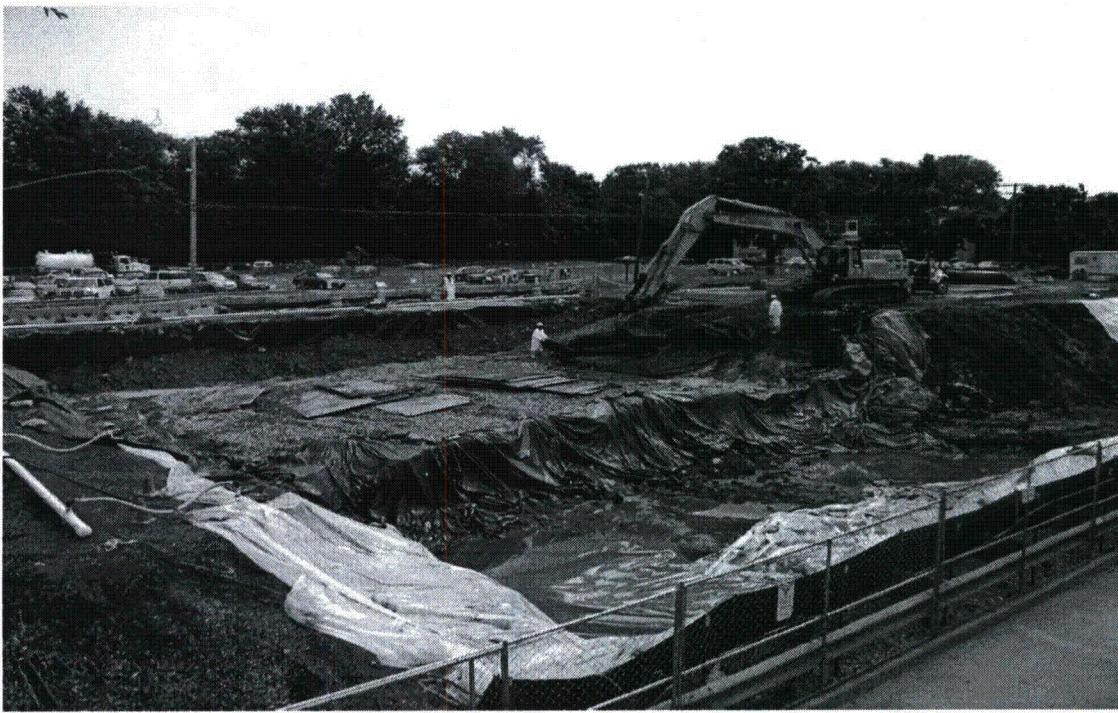
Figure 2. Ongoing remediation at NRC-licensed Burial Pit 2 in July 2010.

Just as early and consistent communication helped meet some of the technical challenges described above, communication was a key factor in the successful public outreach conducted during the pre-RA period. One example involved Burial Pit 2, which at its closest point is less than 200 feet from the nearest residences. Given that proximity, FMSS elected to hand-distribute notification letters to these nearby homes as well as those further east and west on the same street, West Central Avenue. In all, 26 residences received notices in July 2009 prior to the start of RA. Local officials and Stepan Company management were also copied on the letter in the event they received inquiries from the public regarding the burial pit remediation. The notification letters provided a brief FMSS site history, summarized the remediation scope and schedule, and included a central point of contact for more information. The letters prompted several residents to contact the project shortly thereafter regarding various aspects of the work, including: safety and health protection for workers and the public; onsite hazardous waste management during the remediation; construction noise and lighting; and restoration plans for lost vegetative screening. Two of the residents, among those closest the burial pit site, had particular concerns about potential health effects: one had a newborn in the house and another had recently been diagnosed with cancer. Together with project management and the project health physicist and construction supervisor, the FMSS Community Relations Coordinator developed responses to the community questions and concerns and communicated them to directly by telephone and in the case of one resident during personal meetings in the home. In addition, coordination with Stepan Company and New York, Susquehanna & Western Railway Company (NYS&W) representatives was required to address the property restoration questions. Stepan had plans to replace nearby fencing not impacted by the remediation in conjunction with FUSRAP restoration activities; NYS&W approval was required for restoration plantings to replace vegetation removed from their property bordering the Burial Pit 2 site. This coordination resulted in an equitable resolution to concerns over lost visual screening, through installation of 10-foot privacy fencing (at Stepan's cost) and planting of 14 evergreen trees (at FUSRAP cost) in the NYS&W right-of-way.
