**RESUBMITTAL – DEVIATION FROM BWRVIP FLAW EVALUATION
REQUIREMENTS FOR JET PUMP RISER INDICATION**
Enclosure 2

001N6043.5-NP
Revision 2
PLM Specification 001N6043 Revision 5
August 2015

**Energy Northwest
Columbia Generating Station
Jet Pump 17/18 Riser Evaluation at 106% Rated Core
Flow (115 Mlbs/hr)**

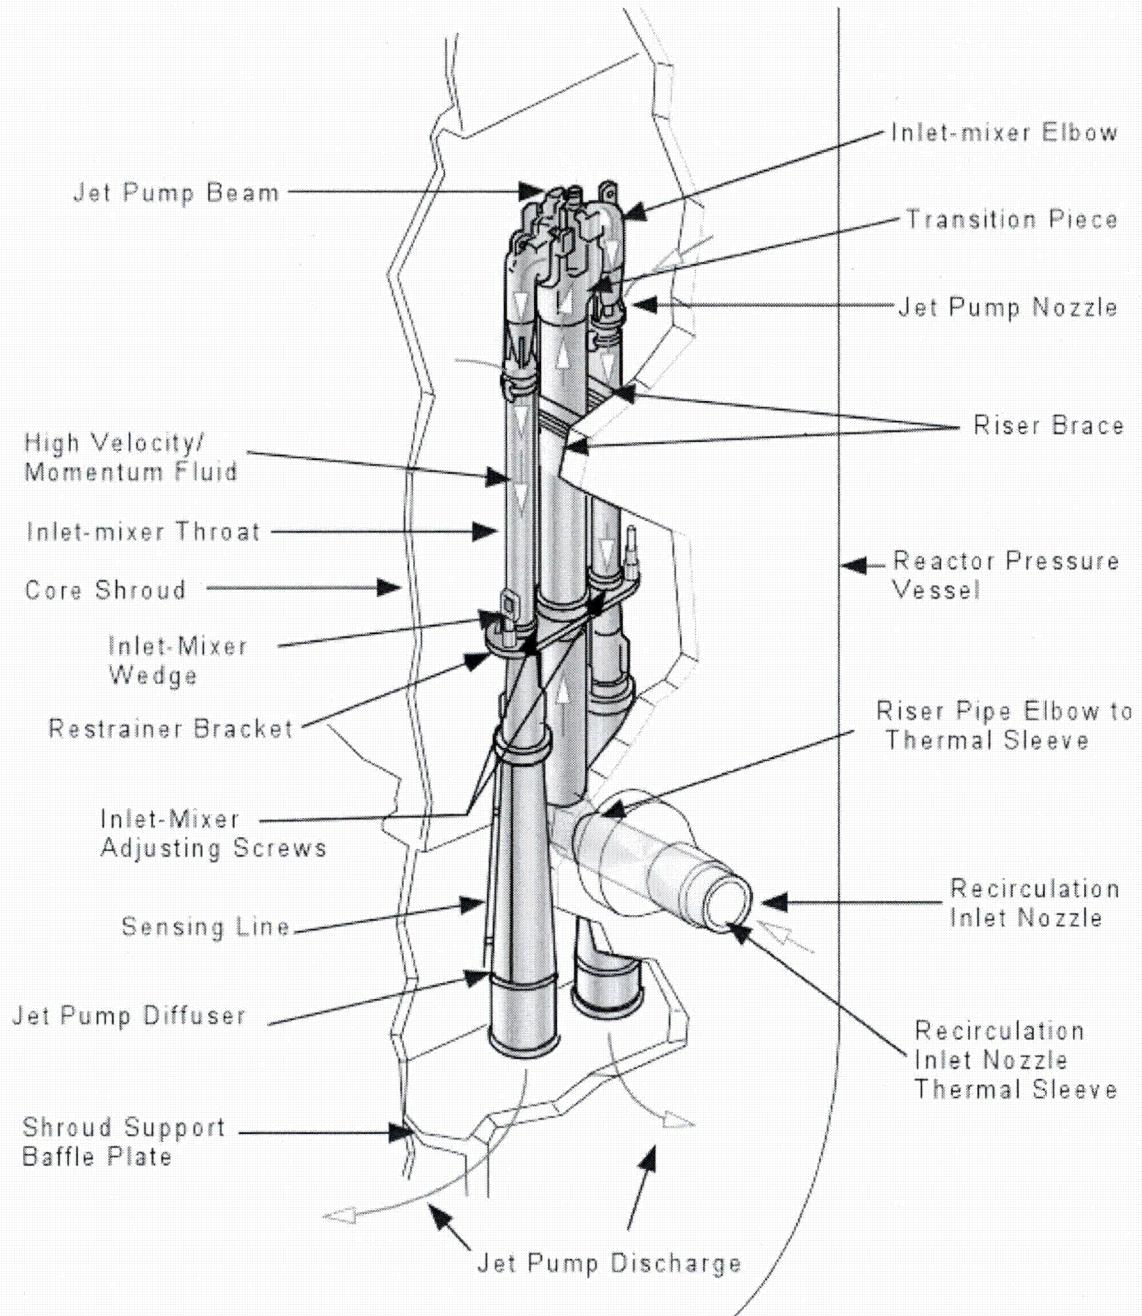
Figure 3-1 Typical JP Assembly (Reference 9)

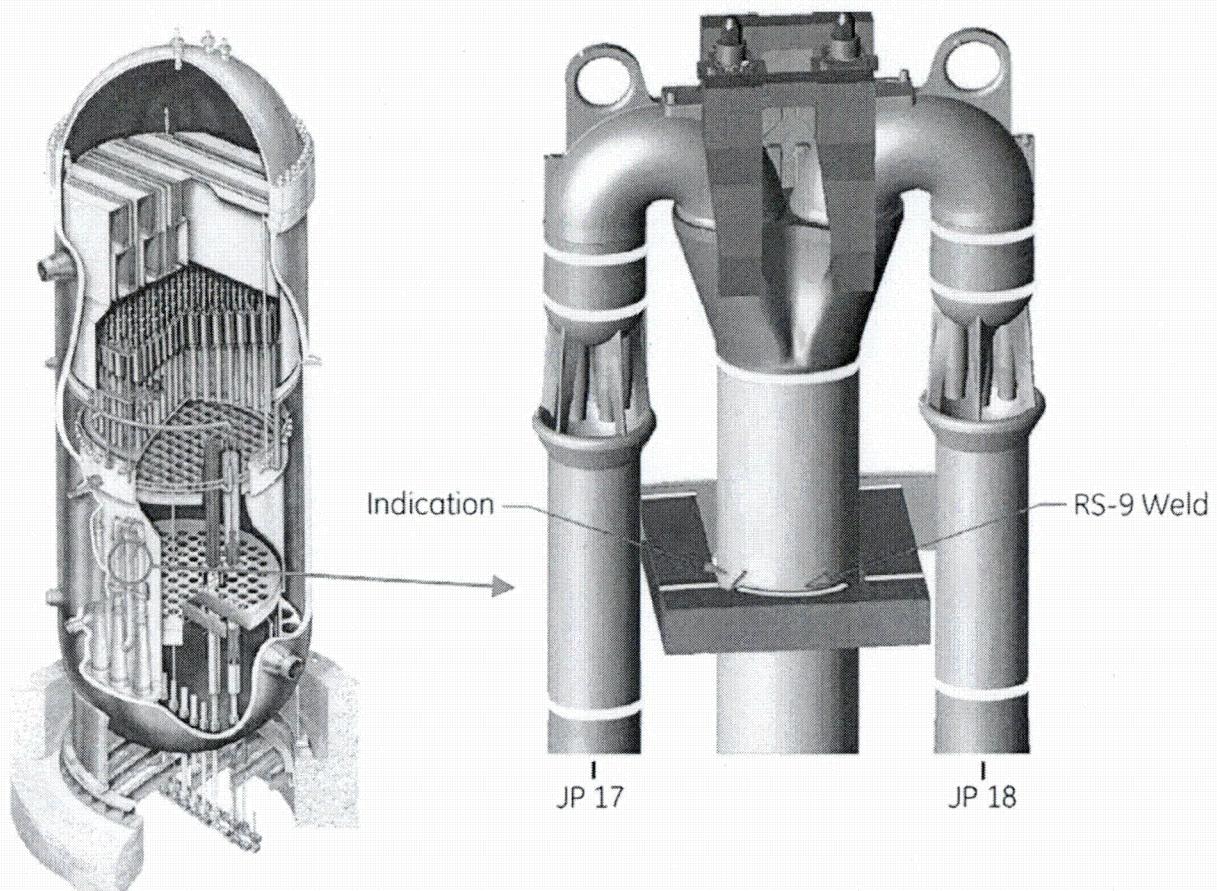
Figure 3-2 Schematic of JP-17/18 Riser Pipe Crack Indication (Reference 2)

During the CGS Spring 2011 refueling outage (RFO20) IVVI (Reference 1), a crack indication of 1.25 inches at an angle of 62.6 degrees off the horizontal (Reference 3) on JP-17/18 riser pipe in the proximity of the RS-9 weld (Reference 5) was reported. This flaw was evaluated in 2011 and was re-evaluated in 2013 for a long-term assessment. A summary of these previous evaluations is provided below.

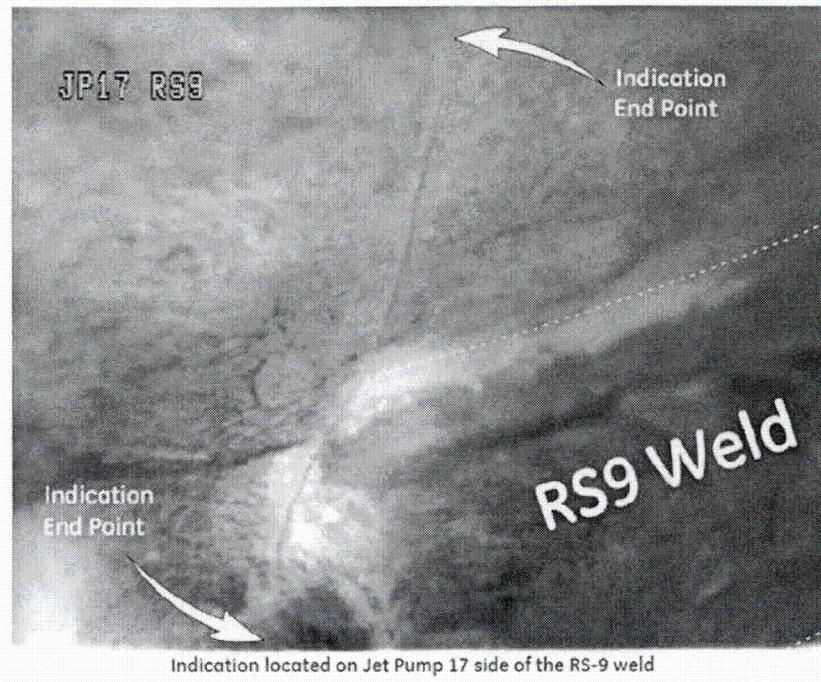
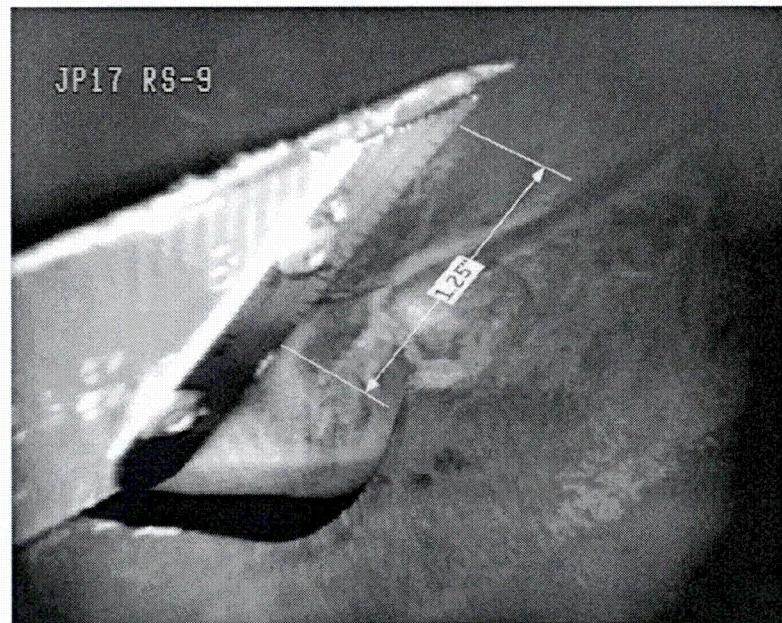
Figure 3-3 Inspection Results of JP-17/18 Riser Pipe Crack Indication (Reference 2)

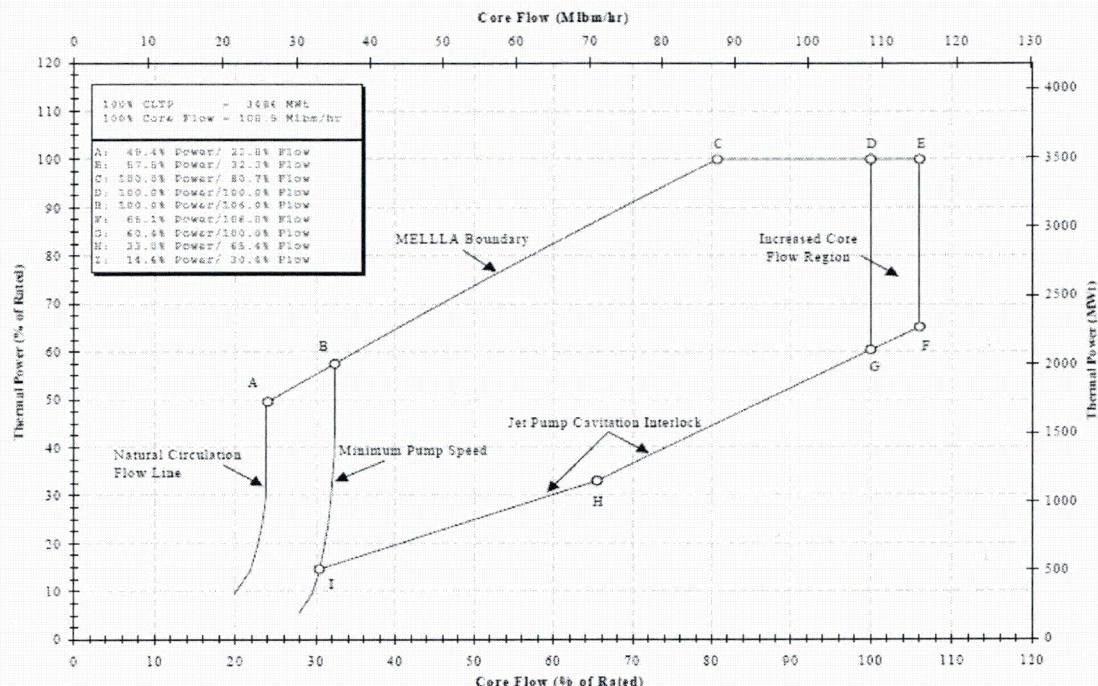
Figure 4-1 Power Flow Map Operating Conditions Evaluated (Reference 21)

]] The operating conditions considered for the loads are taken from the power/core flow map shown in Figure 4-1 (Reference 21).

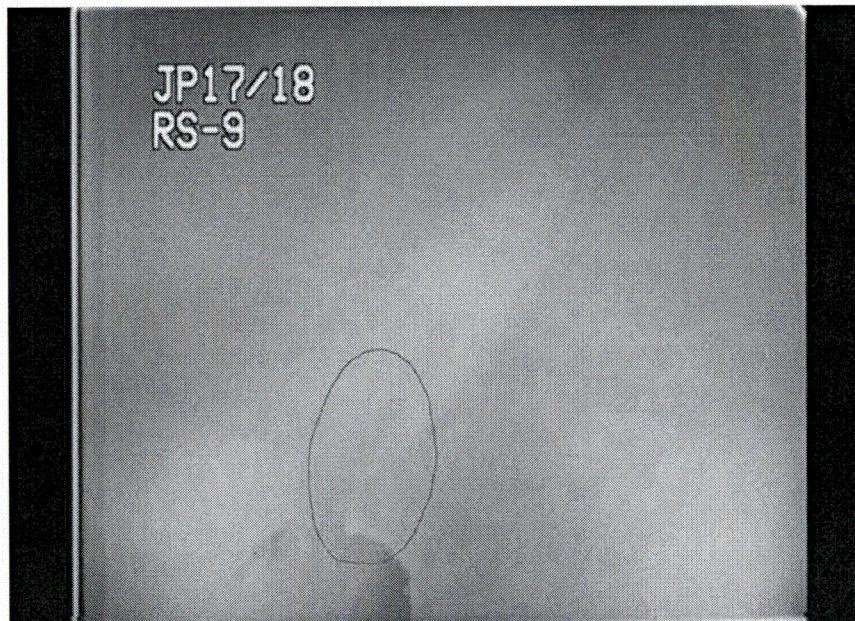
Figure 5-1a RFO15 Image Digitally Enhanced to Highlight the RS-9 Indication

The major factors prompting the re-evaluation of the crack growth rates are the results of the last two visual inspections as well as a re-assessment of the inspection results of the crack location performed several outages earlier. Table 5-1 lists the results of both of the documented inspections in 2011 and 2013 (Reference 30). The last two detailed enhanced VT-1 (EVT-1) inspections were documented and used to show there were no changes in crack length between inspections. Additionally, based on a review of earlier inspection tapes, the cracking was present as early as RFO15 conducted in 2001 even though no length could be determined (RS-9 comparison document from Reference 18). The last two detailed EVT-1 inspections were documented and used to show there were no changes in crack length between inspections. Both indication notification reports (INRs) characterized the total length to be 1.25 inches as stated earlier. In support of these assessments, Figures 5-1a, 5-1b and 5-2 show the images taken from the inspection tapes and INRs respectively. The last two clearly substantiate the statement that no growth has occurred, thereby establishing the primary basis for revising the crack lengthening rate that can be used in the fracture mechanics evaluation discussed in the next section of the report.

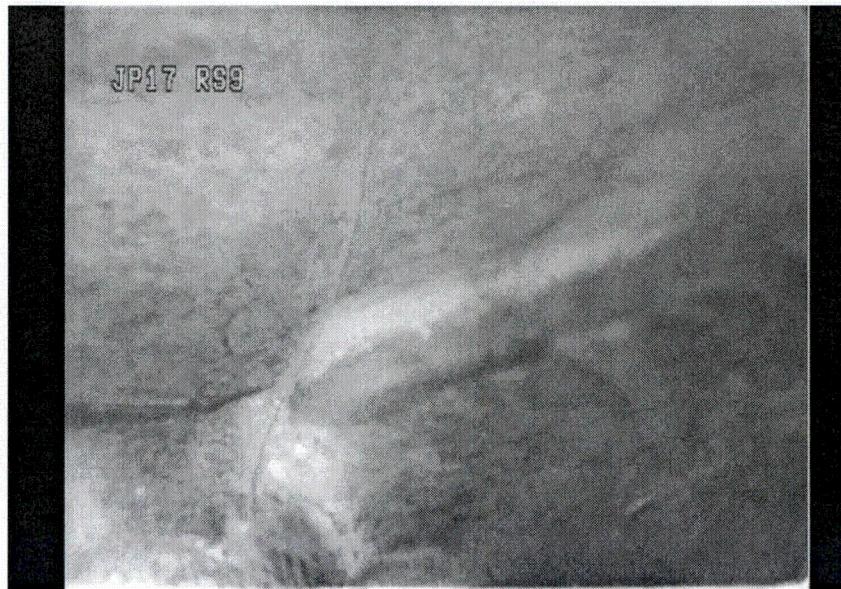
Figure 5-1b RFO20 Image of the Indication on JP-17/18 Riser RS-9 Weld

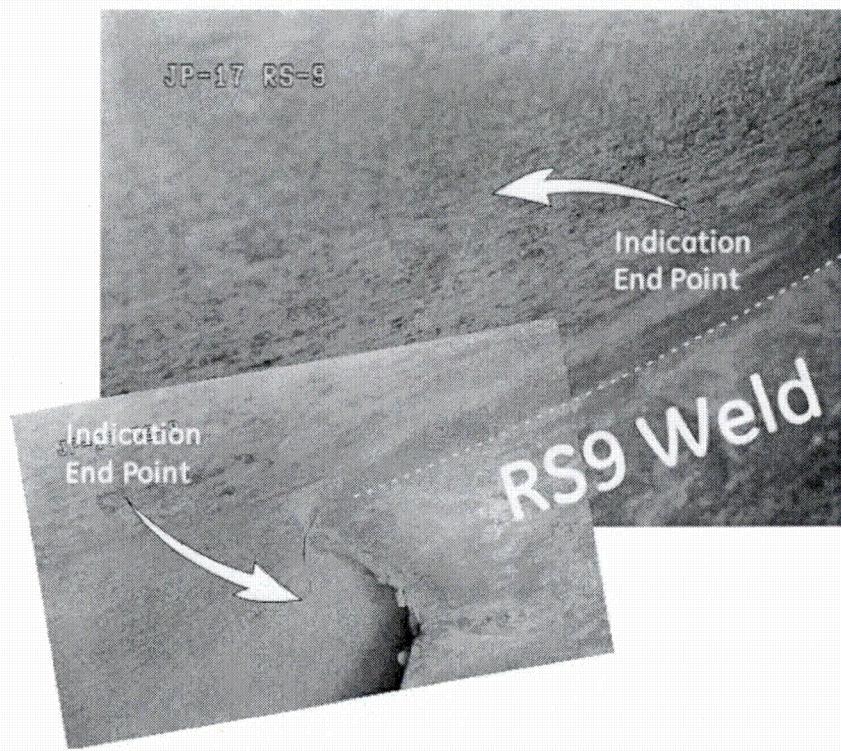
Figure 5-2 RFO21 Image of the Indication on JP-17/18 Riser RS-9 Weld
