Summary of Observations and Issues Identified During Environmental Readiness Assessment Visits (March 30-31, 2015 Site Visit, July 7-8 Alternative Site Visit and August 4-6 Readiness Assessment at TVA Headquarters)

Site Visit of March 30-31, 2015

Clinch River Boat Tour

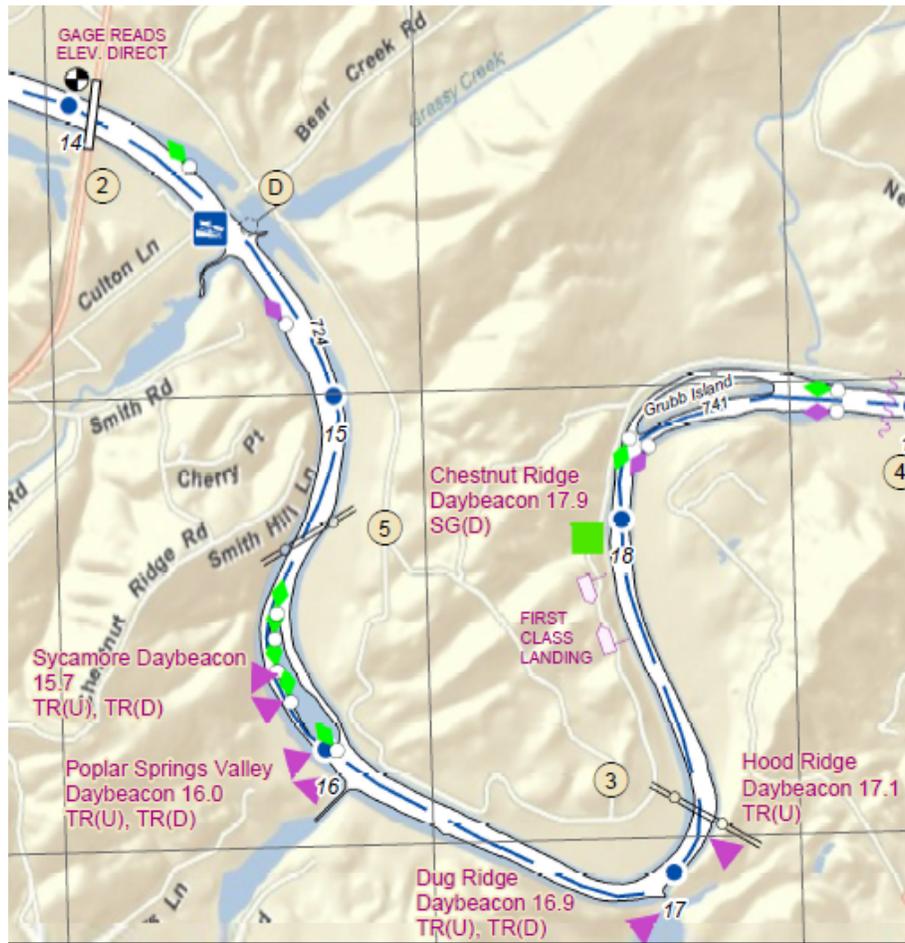
The review team participated in a boat tour of the Clinch River in the vicinity of the site, traveling from the barge loading location at River Mile (RM) 14 to Grubb Island, just upstream of the intake location at RM 18.2 (Figure 1). The tour included visual observation of stream banks along the entire CRN site boundaries and observation of the barge facility location, transmission line crossings, and the intake and discharge areas. Several archaeological sites along the river were also visited where participants disembarked for closer observation.

Figure 1: Detail from Navigation Chart Showing Extent of Boat Tour from RM 14 to RM 18.
