### 2.5.3 Surface Faulting

Subsection 2.5.3 contains an evaluation of the potential for tectonic and nontectonic surface deformation at the Fermi 3 site. Information contained in this subsection, which was developed in accordance with Regulatory Guides 1.165 and 1.208, is intended to demonstrate compliance with 10 CFR 100.23, Geologic and Seismic Siting Criteria.

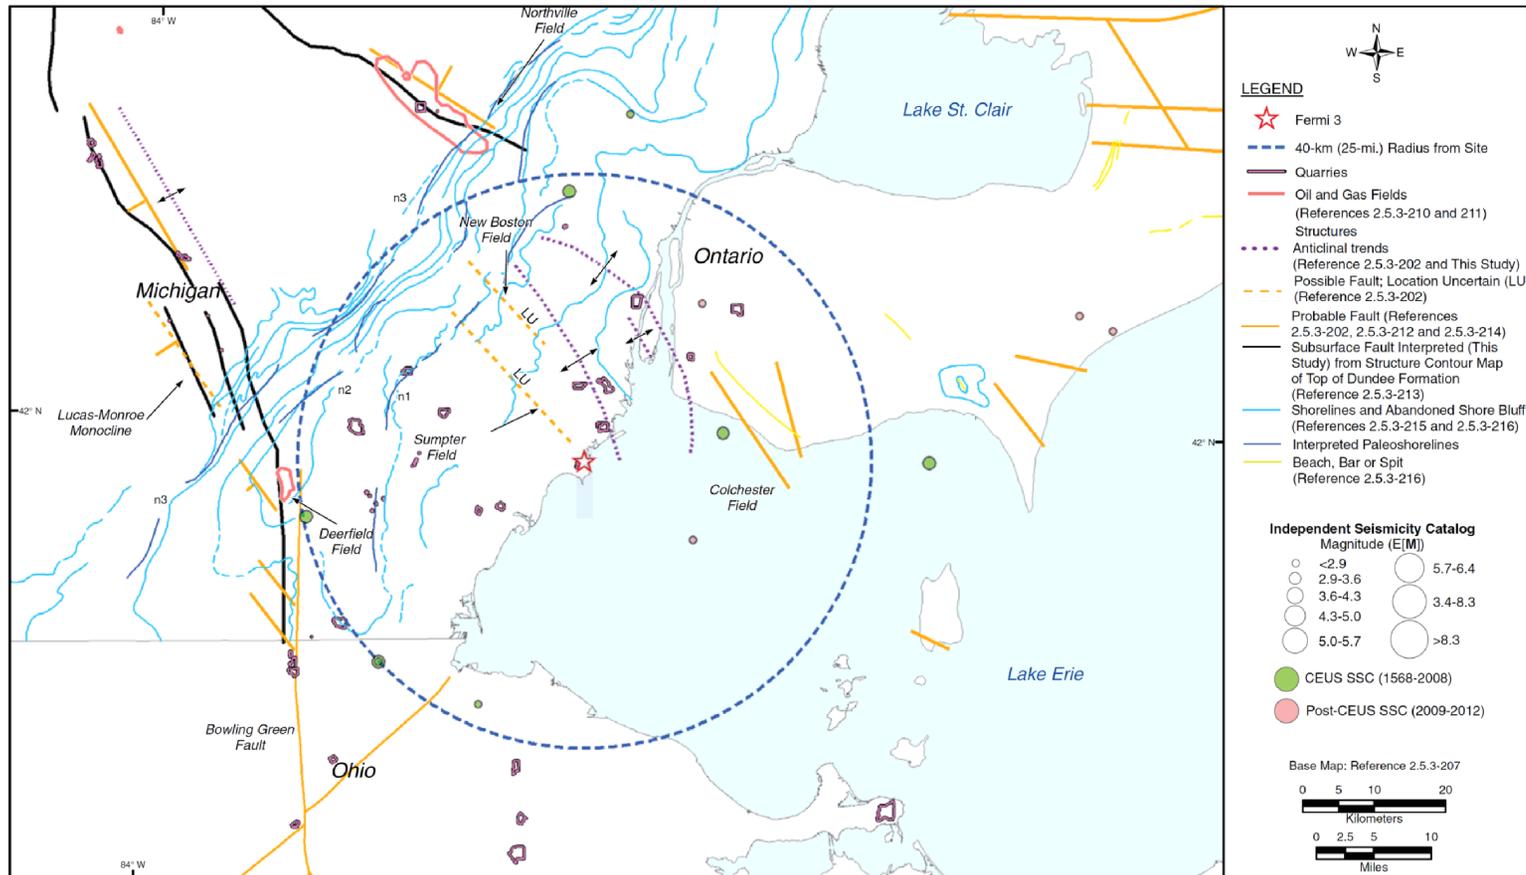
**Figure 2.5.3-201 Map Showing Mapped Structures and Seismicity in the Site Vicinity**

information collected for the Fermi 3 COLA. Mapped bedrock structures in the site vicinity are shown on [Figure 2.5.3-201](#).

interpretations of boring and geophysical data obtained primarily from oil and gas exploration indicates, however, that faults are present within Paleozoic rocks in the subsurface in the site vicinity. The location of known and postulated structures within the site vicinity is shown on [Figure 2.5.3-201](#) and discussed in [Subsection 2.5.1.2.4](#). The Bowling Green fault and the Maumee fault are subsurface bedrock faults mapped within 40-km (25-mi) of the site ([Figure 2.5.1-246](#)). The Howell anticline and associated fault, is mapped to within 45-km (28-mi) of the site. A series of folds are recognized in subsurface bedrock units along the southeastern projected trend of the Howell anticline/fault structure. Two poorly documented possible fault trends, associated with the New Boston and Sumpter oil and gas pools, are postulated along the southwestern flank of this series of folds ([Figure 2.5.1-203](#), [Figure 2.5.1-230](#)). Additional shorter faults are mapped in southwestern Ontario, including two subparallel unnamed faults, one of which is associated with the Colchester oil and gas field. A summary of the evidence for the location, timing, and displacement on these structures is provided in [Subsection 2.5.1.2.4.1](#) and [Table 2.5.1-201](#). Two minor faults, each having less than 1.4 m (4.6 ft) displacement, also are observed in the Silurian Bass Islands Group at the Denniston Quarry, located 16 km (10 mi) south of the Fermi 3 site ([Reference 2.5.1-498](#)). Displacement on one of the two faults dies out within the Bass Islands Group. Although the second fault extends to the top of the Bass Island Group, latest Pleistocene (approximately 13 – 12 ka) Quaternary till and lacustrine deposits overlying the projected trends of both faults are not deformed.

Shoreline features (n<sub>1</sub>, n<sub>2</sub>, and n<sub>3</sub>) (Figure 2.5.3-201) identified in the lineament analysis correlate to the Lake Wayne strandline (n<sub>1</sub>), Lake Warren I and II strandlines (n<sub>2</sub>), and the Whittlesey strandline or highest Arkona strandline (n<sub>3</sub>). The elevations of specific features associated with mapped shorelines (e.g., the top of apparent deltas formed at the intersection of major drainages and the highest Arkona shoreline, which are all at consistent elevations of 216 – 218 m), indicate the absence of significant vertical deformation across the site vicinity since formation of the features shortly before about 13,000 years BP (Figure 2.5.3-210, Figure 2.5.3-211 and Figure 2.5.3-212). Geomorphic surfaces associated with the Arkona deltas, and the Warren and younger strandlines that formed at progressively lower levels are most easily correlated across the site vicinity.

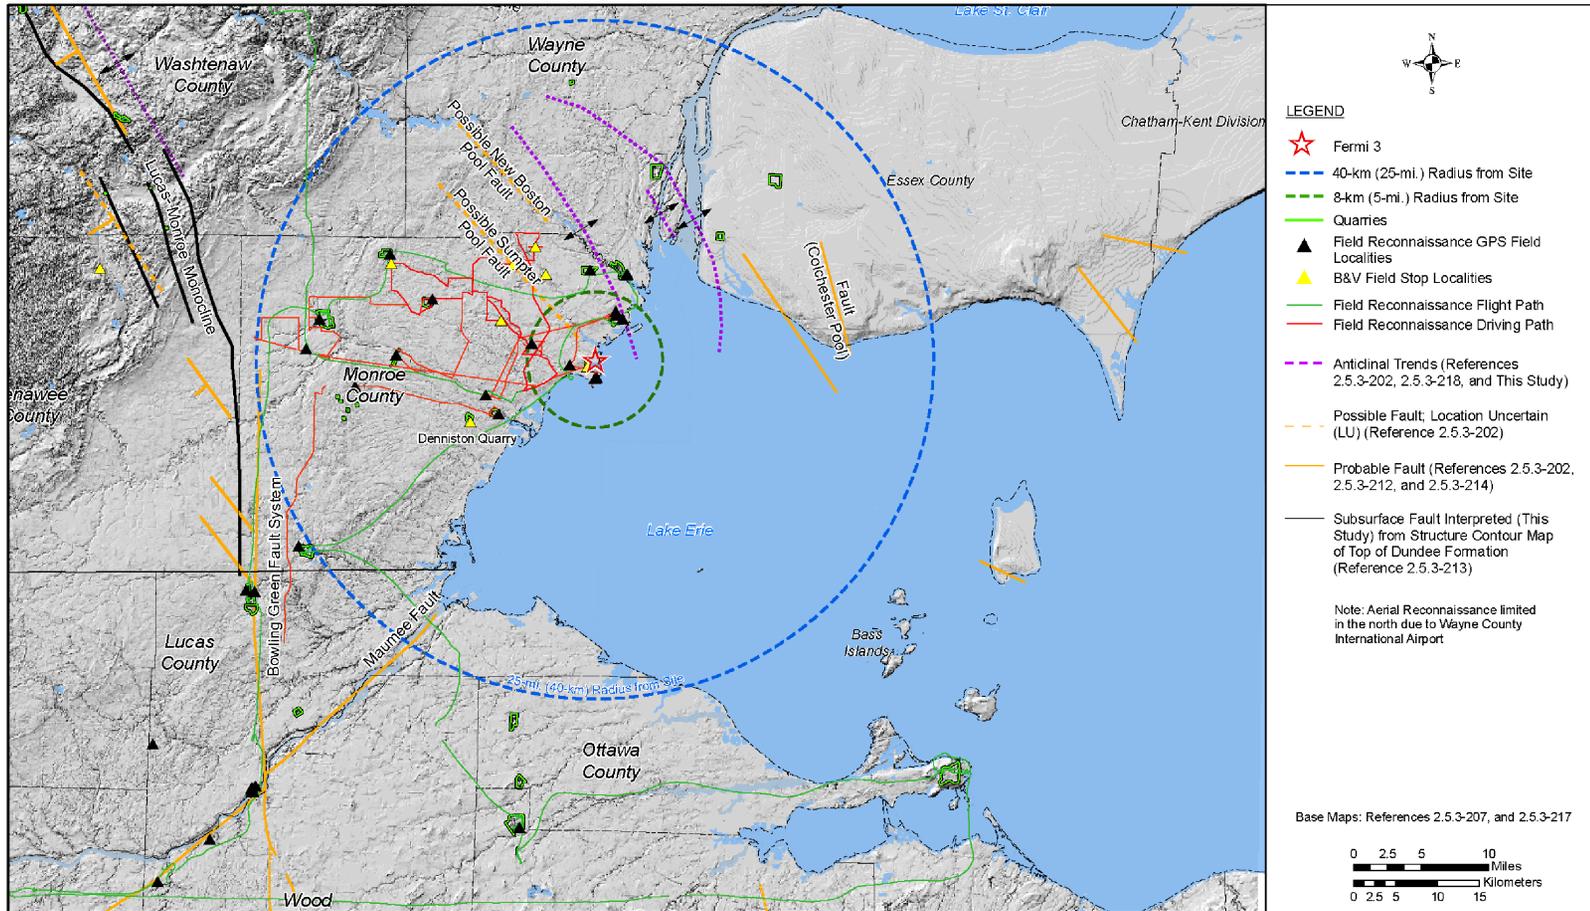
**Figure 2.5.3-202 Map Showing Field Reconnaissance Sites, Quarries, and Aerial Reconnaissance Route**

- Field and aerial reconnaissance. Field investigations were conducted during August 2007, and involved consultations and field trips with local experts, examination of known faults in the site vicinity, examination of well-documented exposures of stratigraphic units as described in previous publications, examination of exposures in quarries, and aerial (helicopter) reconnaissance. Additional field investigations were conducted at Denniston Quarry in 2009 to evaluate the origin and timing of deformation features (paleokarst and minor faults) observed in the Silurian Bass Islands Group. [Figure 2.5.3-202](#) shows field localities visited and the helicopter reconnaissance route.

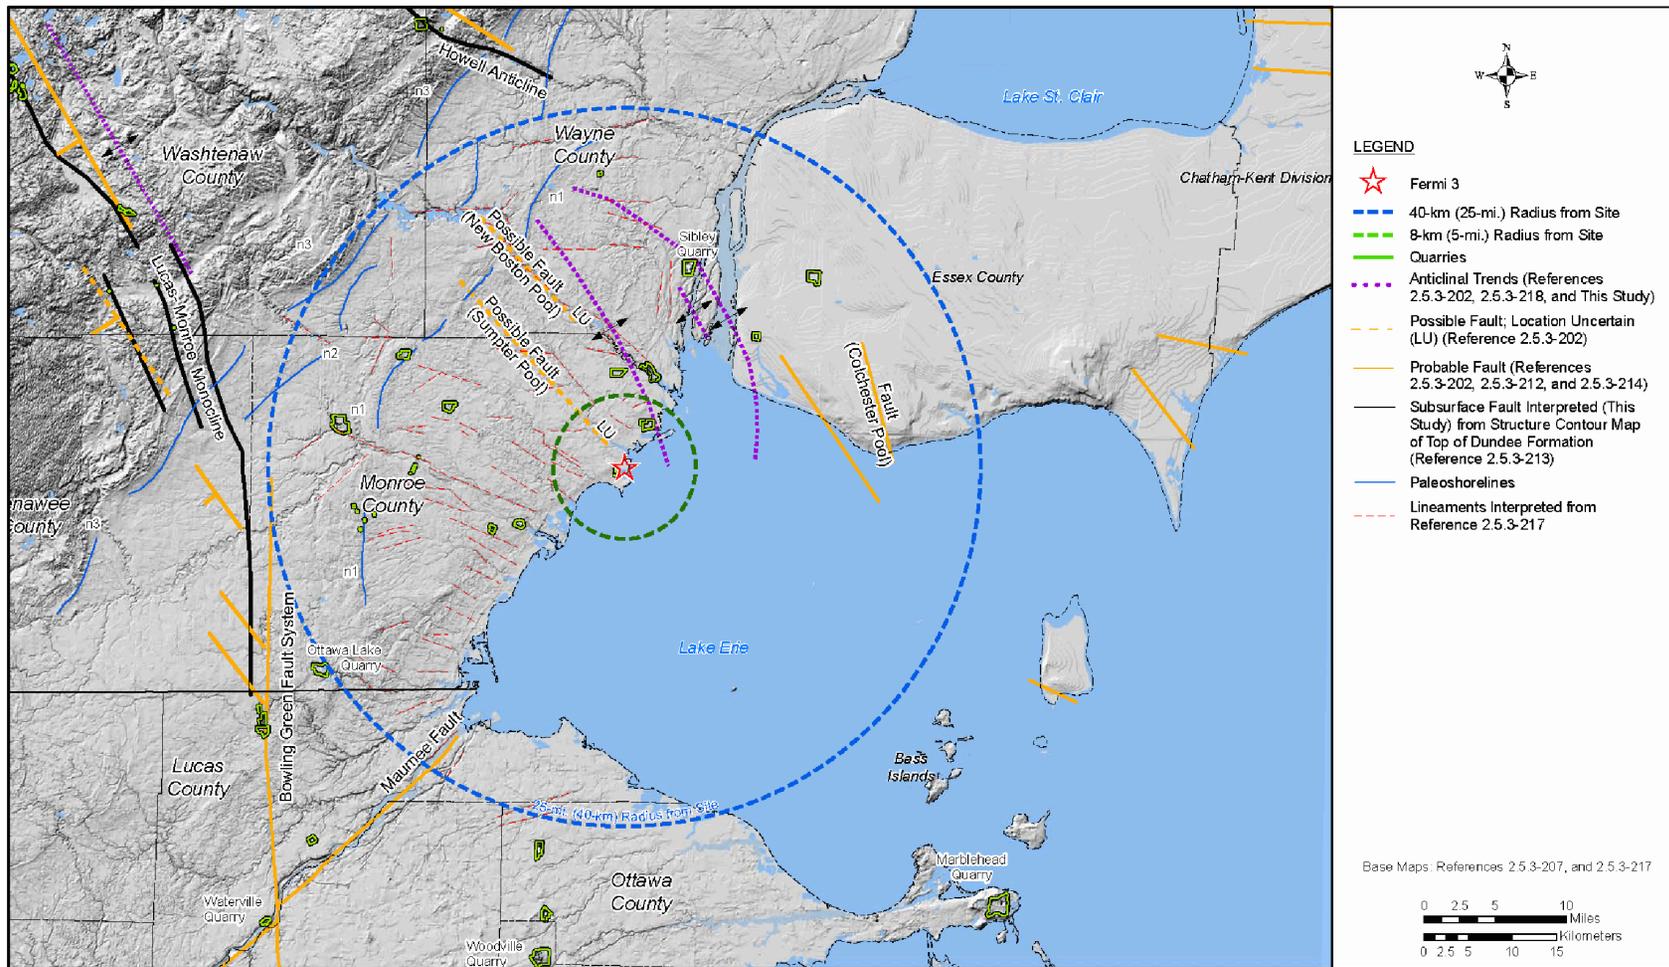
**Figure 2.5.3-203 Interpreted Hillshade Model (10-m DEM) Showing Lineaments in the Site Vicinity**

As shown on Figure 2.5.3-203, there are numerous topographic lineaments in the site vicinity that are evident on hillshade models derived from the USGS 10-m DEM. Most of the lineaments either coincide with linear stream segments or are shore-parallel lineations that appear to coincide with mapped paleo-shoreline features designated by  $n_1$ ,  $n_2$ , and  $n_3$  on Figure 2.5.3-203 (see Subsection 2.5.1.2.3.2.1 for discussion of paleoshoreline features). The majority of the lineaments generally trend N30W to N60W. Other trends are E-W, N-S, N30E, and N70E. These trends are consistent with regional joint and fracture trends described in Subsection 2.5.1.2.4.3. The dominant

Paleo-shoreline features cross the trend of the postulated Sumpter Pool and New Boston Pool possible fault trends with no apparent disruption (n<sub>3</sub> on Figure 2.5.3-203). A series of maps highlighting different contour interval ranges, as well as a series of topographic profiles was developed from the USGS 10-m DEM to evaluate the continuity and variability of paleo-shoreline features across the site vicinity and mapped locations of the Sumpter Pool and New Boston Pool possible faults. Figure 2.5.3-210 and Figure 2.5.3-213 provide maps highlighting contour interval ranges of 2 m and 0.5 m, and showing the locations of a series of topographic profiles that are provided on Figure 2.5.3-211, Figure 2.5.3-212, and Figure 2.5.3-214.

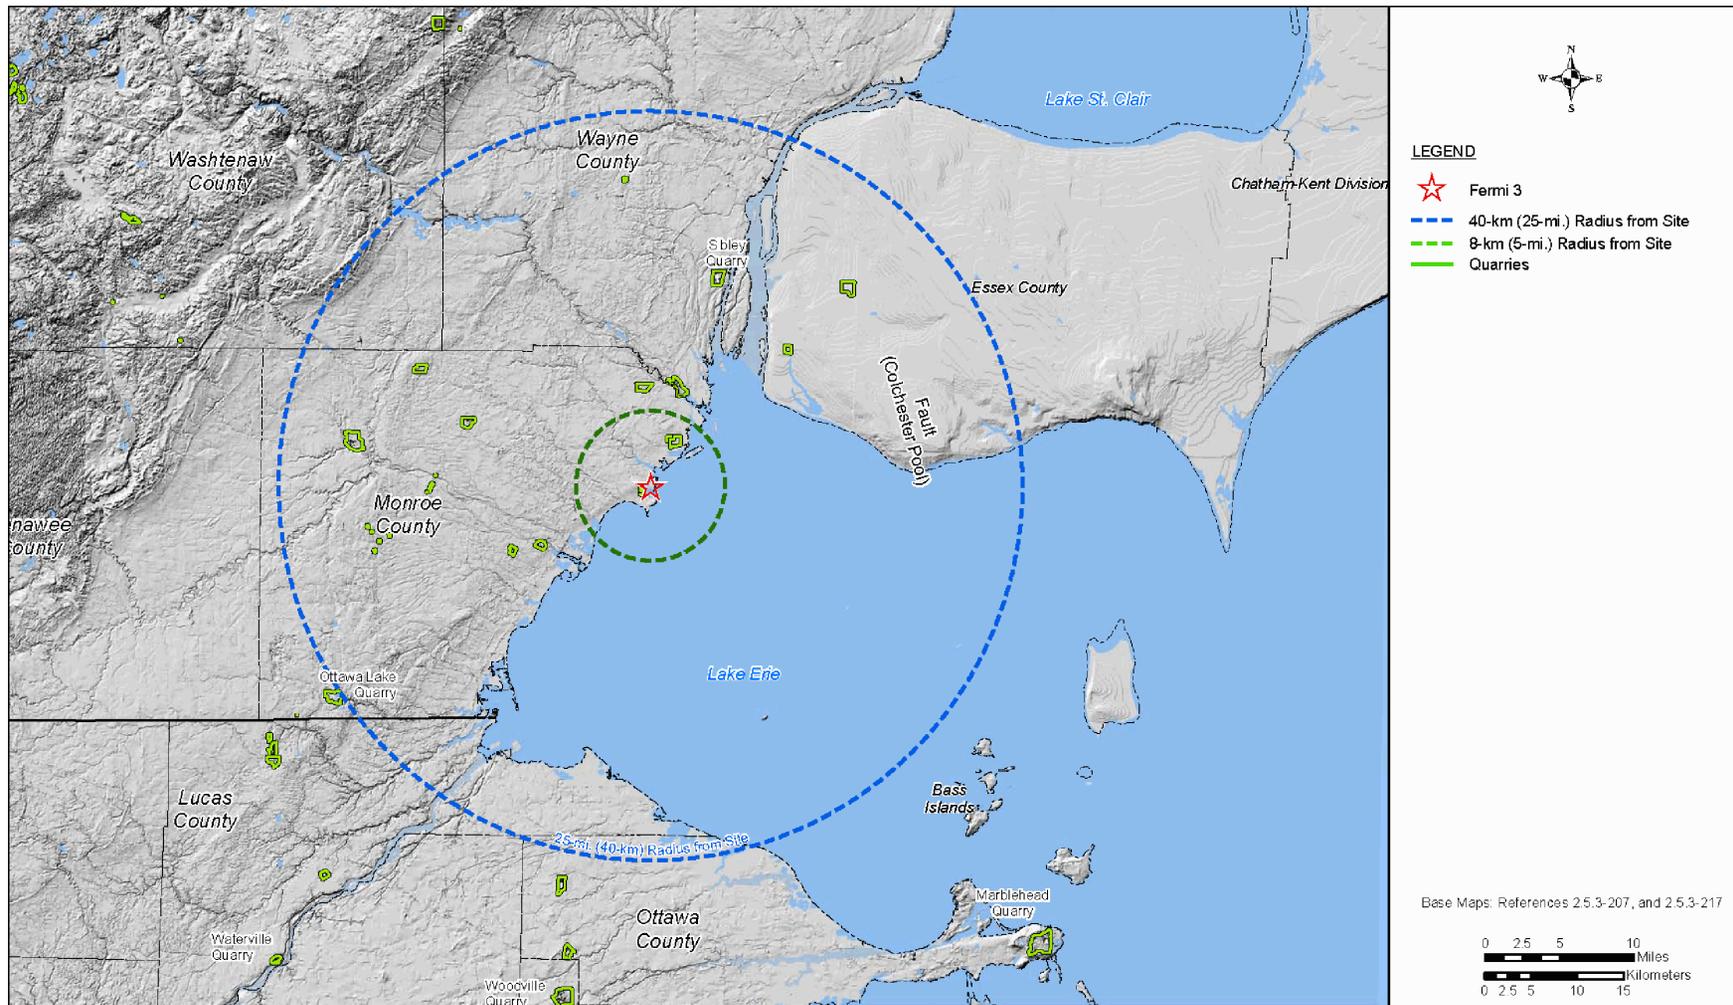
**Figure 2.5.3-204 Uninterpreted Hillshade Model (10-m DEM) of the Site Vicinity**

Faults and fractures can be expressed at the surface in a variety of ways, including regional lineaments, linear drainage lines, abrupt or anomalous changes in stream direction, vegetation changes, soil changes, changes in drainage density, abrupt topographic changes or scarps, and changes in land use. Lineaments can also be nontectonic in origin, relating to differential erosion, beach ridge formation, soil-type changes related to stratigraphic facies variations, and cultural features. Two different types of remote sensing imagery were used to identify lineaments in the site vicinity and site area. Hillshade models, based on the USGS 10-m digital elevation model (DEM), were used to identify topographic and linear stream segments in the site vicinity. Interpreted and uninterpreted hillshade model maps are shown on Figure 2.5.3-203 and Figure 2.5.3-204, respectively. Within the 8-km (5 mi) site area, 1:20,000-scale black and white stereo aerial photograph pairs also were interpreted. Interpreted and uninterpreted aerial photograph mosaics are shown on Figure 2.5.3-205 and Figure 2.5.3-206, respectively. Lineaments identified in the 1955 aerial photographs were also compared to more recent color infrared aerial photographs of the site location (Figure 2.5.3-207 and Figure 2.5.3-208). Figure 2.5.3-209 presents recent color infrared aerial photographs for the site location.

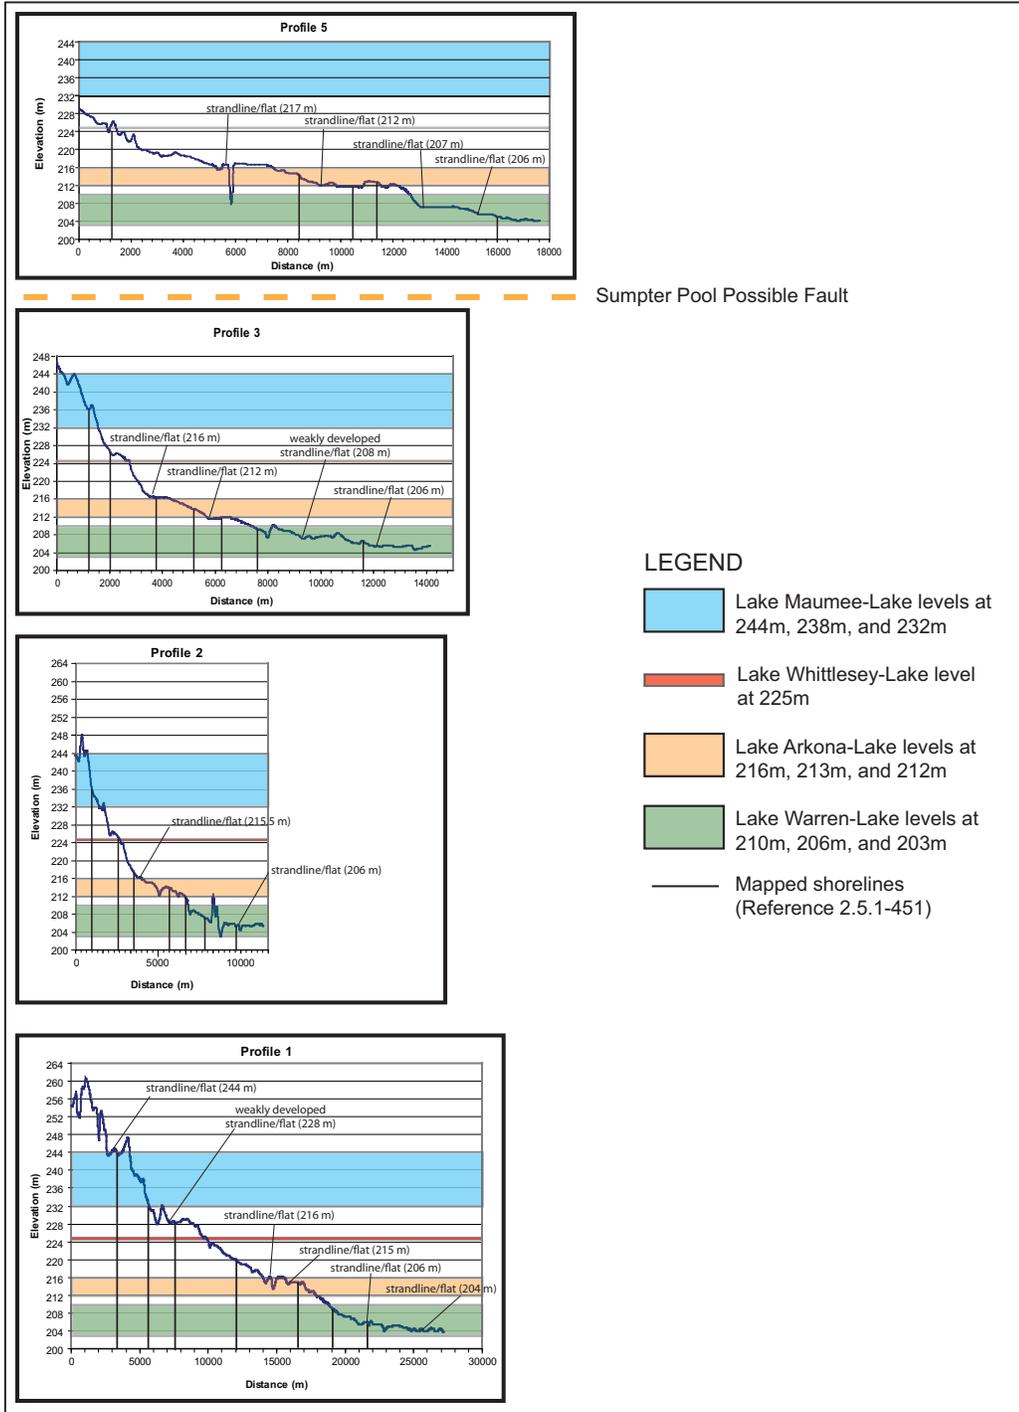
**Figure 2.5.3-211 Topographic Profiles 1, 2, 3, and 5 Across the Sumpter Pool Possible Fault**

The topographic profiles illustrate that although the published locations of the the individual shorelines may not consistently follow the same feature, the morphology of the features associated with the mapped shorelines is similar, and that these features occur at similar elevations across the postulated Sumpter Pool and New Boston Pool faults.

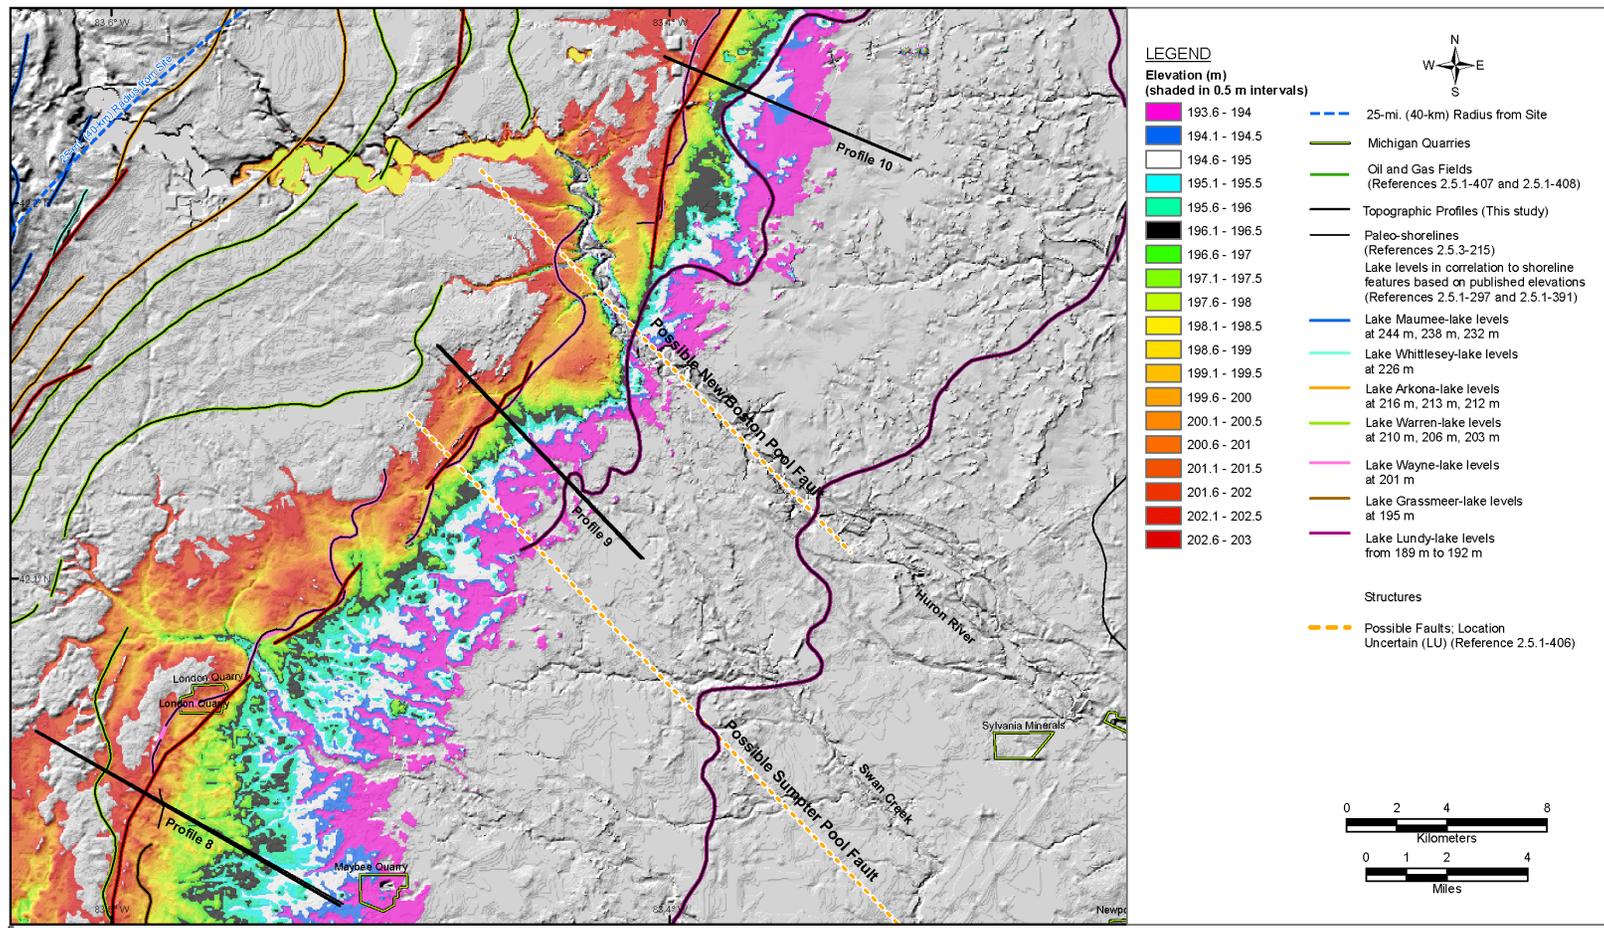
**Figure 2.5.3-213 Colored Contour Interval (0.5-m Increments) Map Highlighting Surfaces Associated with the Lake Grassmere Lake Level (Elevation 195 m)**

Evidence for the absence of tilting and/or localized differential vertical movement across possible faults mapped in the site vicinity is illustrated by [Figure 2.5.3-213](#) and [Figure 2.5.3-214](#). The locations of topographic profiles on opposite sides of the Sumpter Pool and New Boston Pool possible faults are shown on [Figure 2.5.3-213](#), with the topographic profiles shown on [Figure 2.5.3-214](#). The topographic profiles in [Figure 2.5.3-214](#) show three surfaces associated with the Grassmere Lake level (approximately 195 m (640 ft)). The elevations of the three surfaces are indicated on [Figure 2.5.3-213](#) in pink for elevations 193.6 – 194 m (635 - 636 ft) in white for elevations 194.6 – 195 m (638 – 640 ft), and in black for elevations 196.1 – 196.5 m (643 – 645 ft), with these surfaces separated by slight risers (blue intervals). The brown band in [Figure 2.5.3-214](#) corresponds to the range in estimated elevations from 193.6 to 196.5 m (635 – 645 ft) for the Grassmere Lake levels. The three surfaces identified on the topographic profiles; all lie within the brown band representing the estimated elevation range of Grassmere Lake ([Figure 2.5.3-214](#)).
