Subject: Westinghouse Hematite Decommissioning Project - Request for NRC Review of  
Final Status Survey Final Report Volume 2, Chapter 1 – Reuse Soil and Off-site  
Borrow Material Overview (License No. SNM-00033, Docket No. 070-00036)

**Final Status Survey Final Report Volume 2, Chapter 1**  
**Reuse Soil and Off-site Borrow Material Overview**

**Westinghouse Electric Company LLC, Hematite Decommissioning Project**

**Docket No. 070-00036**

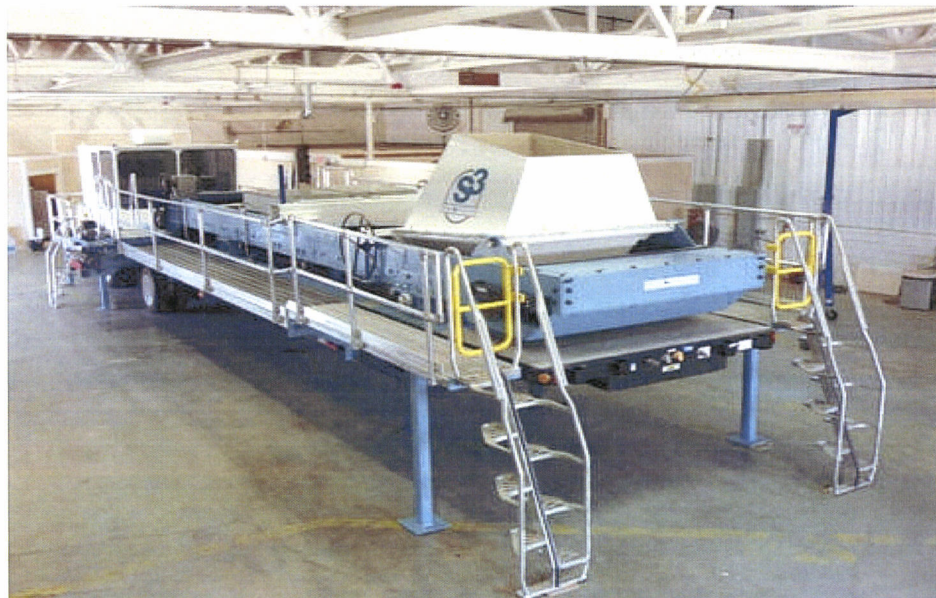
**Figure 6-1**  
**Trailer-Mounted S3 Soil Sorting System**

Upon completion of the evaluation Westinghouse directed ISO-Pacific to mobilize the S3 Soil Sorting System in order to screen the accumulated soils from the seven initial reuse stockpiles. The S3 system used at HDP was designed as a mobile, trailer mounted configuration (see below).

Prior to commencement of soil sorting operations, the S3 system was initialized and calibrated in accordance with the procedures required in *ISO-01 "Hematite Calibration Procedure" November 2013, ISO-Pacific*. All equipment calibrations were performed using National Institute of Standards and Technology traceable reference radionuclide standards.
