Duke Energy Florida  
**Levy Nuclear Plant**  
**Units 1 and 2**  
**Part 2, Final Safety Analysis Report**

Caribbean Plate Boundaries and  
 Interactions and Tsunamigenic Source  
 Regions  
 FIGURE 2.4.6-202 Rev 6

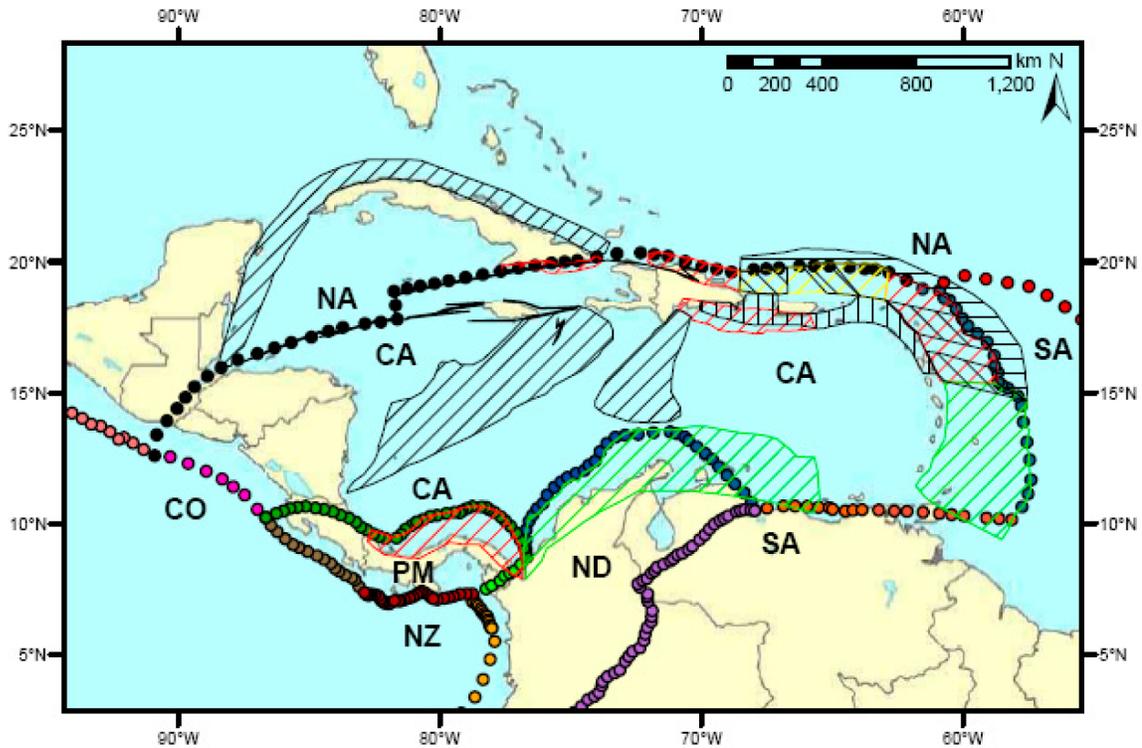
- CO subducting under NA
- SA subducting under CA
- CO subducting under CA
- NZ subducting under ND
- CA subducting under ND
- CO subducting under PM
- CA-NA slide
- PM-ND slide
- CA-SA slide
- NA-SA slide
- NZ-PM slide
- PM-CA slide
- ND-SA slide
- Active Fault
- ▨ Plate Bending
- ▨ Slow Earthquake
- ▨ Platform Deformation
- ▨ Yuc-Cuba Belt; Holcombe Ext Belt; Beata Ridge
- ▨ High Risk
- ▨ Med Risk
- ▨ Low Risk

Notes:  
 CO - Cocos plate  
 NA - North American plate  
 CA - Caribbean plate  
 SA - South American plate  
 ND - North Andes plate  
 PM - Panama plate
