DIABLO CANYON UNIT 1  
INDEPENDENT DESIGN VERIFICATION PROGRAM  
ELECTRICAL EQUIPMENT ANALYSIS  
ITR #33  
REVISION 1

Docket No. 50-275  
License No. DPR-76

ELECTRICAL EQUIPMENT BY ANALYSIS

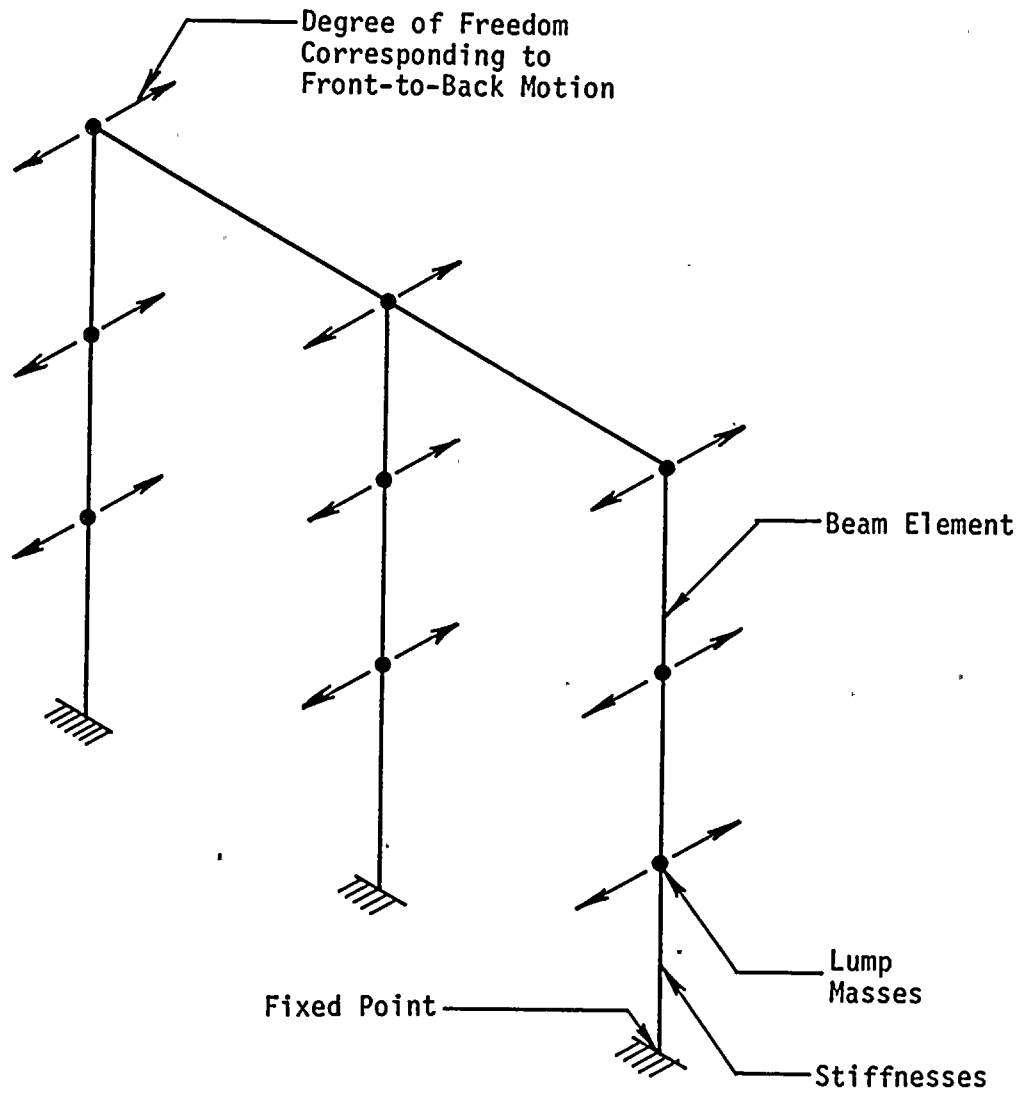
Figure 4  
 Design Analysis Dynamic Model For  
 Hot Shutdown Remote Control Cabinet

The verification analysis used a single degree of freedom model using a stiffness calculated from a reduced cross section. The total mass of the cabinet was lumped at the center of gravity. The design analysis used a more refined model with nine distributed lump masses.

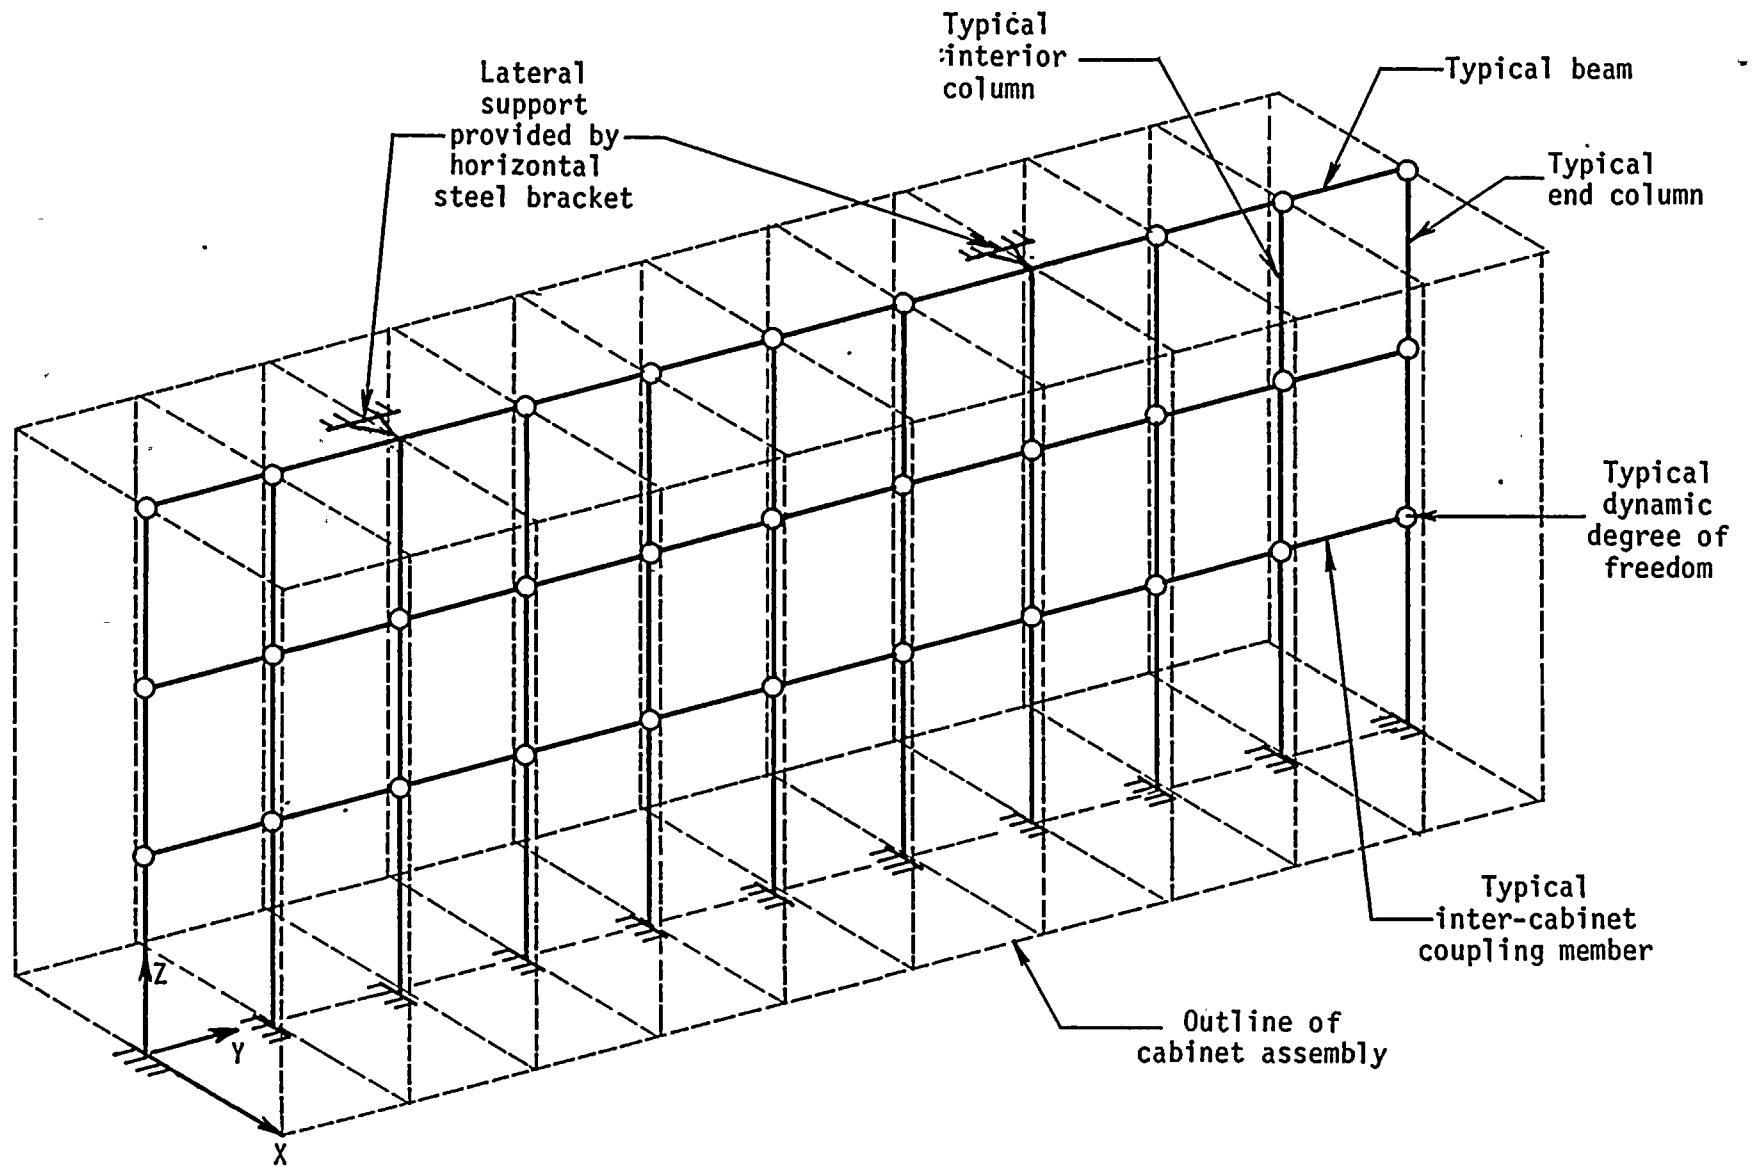
Figure 8

For boundary conditions, the design analysis assumed that the bottom of the cabinet assembly is fixed to the floor slab. At the top of the cabinet assembly, the model was laterally restrained at the brace attachment points.

Natural frequencies in the rigid range were calculated from this lump mass model. Seismic loadings for the assembly location at elevation 127 feet were obtained by interpolating between elevation 115 feet and 140 feet spectra. The seismic inputs used in the design analysis were compared to the Hosgri spectra. EO 1008 was issued to note that the design analysis seismic inputs were taken from preliminary spectra. These seismic loadings were used to calculate stresses at four key locations. These stresses were then compared to the allowable stresses.

Design Analysis Computer Model
