Recent Issues with VE of Upper-Head Nozzles

Industry / NRC Nondestructive Examination Technical
Information Exchange Public Meeting
January 19, 2017

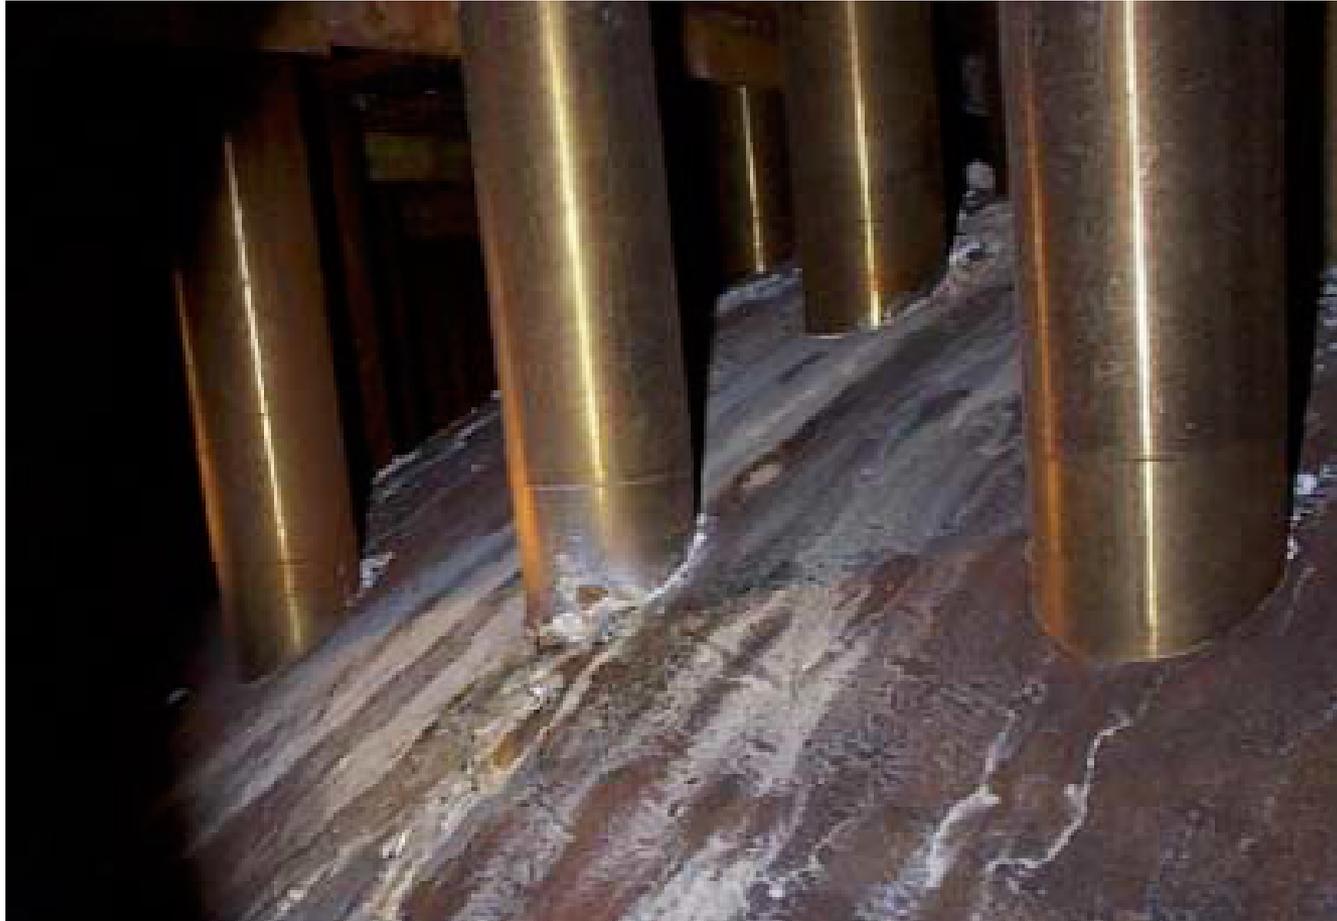
Examples

From 07/10/2001 Public Meeting
