Rancho Seco
Final Status Survey Summary Report
October 20, 2016
IOSB Storage Cell A-3
Survey Unit F8300183

FINAL STATUS SURVEY F8300183

F8300183, Interim Onsite Storage Building (IOSB) Storage Cell A-3

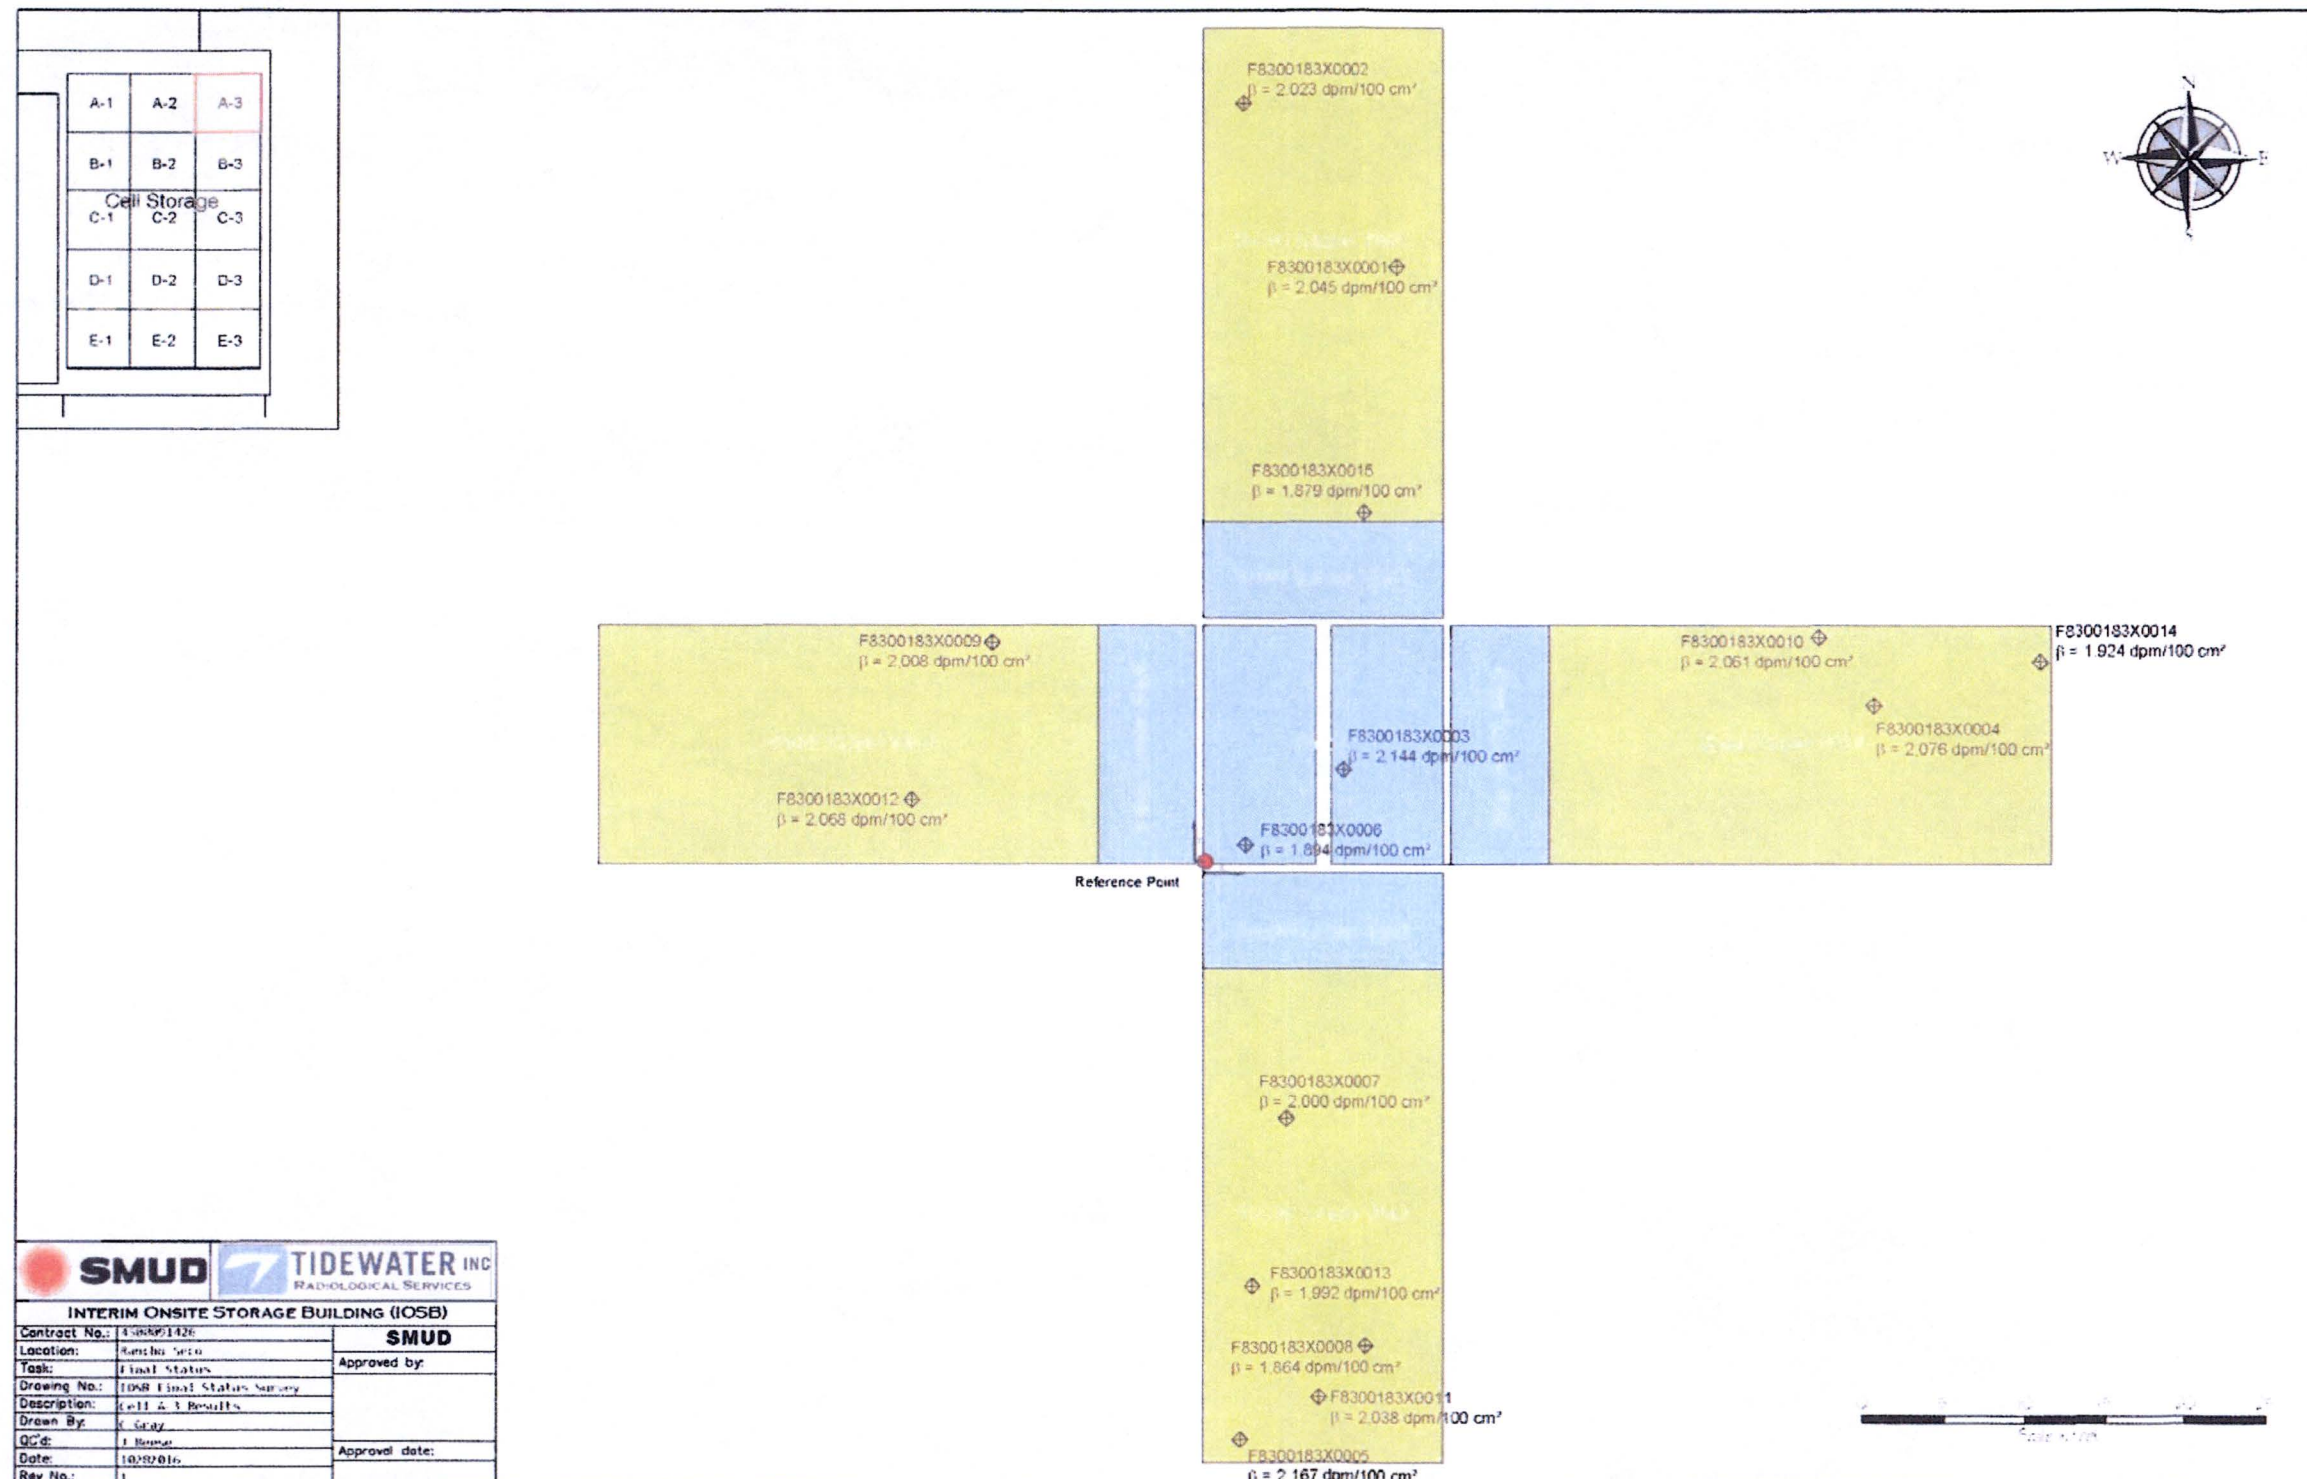
Survey Unit F8300183

The Survey Unit Design Parameters are presented in **Table 1** below. The survey unit and measurement locations are depicted on the maps in **Attachment 1**. Static measurement locations were randomly determined and approximately 27% of the area scanned. The instrumentation used for the survey along with the MDC values are listed in **Table 2-1 Attachment 2**.

TIDEWATER INC RADIOLOGICAL SERVICES	
INTERIM ONSITE STORAGE BUILDING (IOSB)			
Contract No.: 4-00001426		SMUD	
Location: Sancho Area		Approved by:	
Task: Final Status			
Drawing No.: IOSB Final Status Survey			
Description: Cell A-3 Results			
Drawn By: C. Gray			
QC'd: J. Bower		Approval date:	
Date: 10/29/06			
Rev No.: 1
