SUBJECT: INGRAHAM CLOCK COMPANY-6—RESULTS AND CONCLUSIONS OF THE  
U.S. NUCLEAR REGULATORY COMMISSION'S INITIAL SITE VISIT

**SITE STATUS REPORT FOR THE INGRAHAM CLOCK COMPANY AT  
THE NORTH MAIN STREET PARKING LOT, BRISTOL, CONNECTICUT**

Property: Former Ingraham Clock Company  
North Main Street Parking Lot  
Bristol, Connecticut 06010

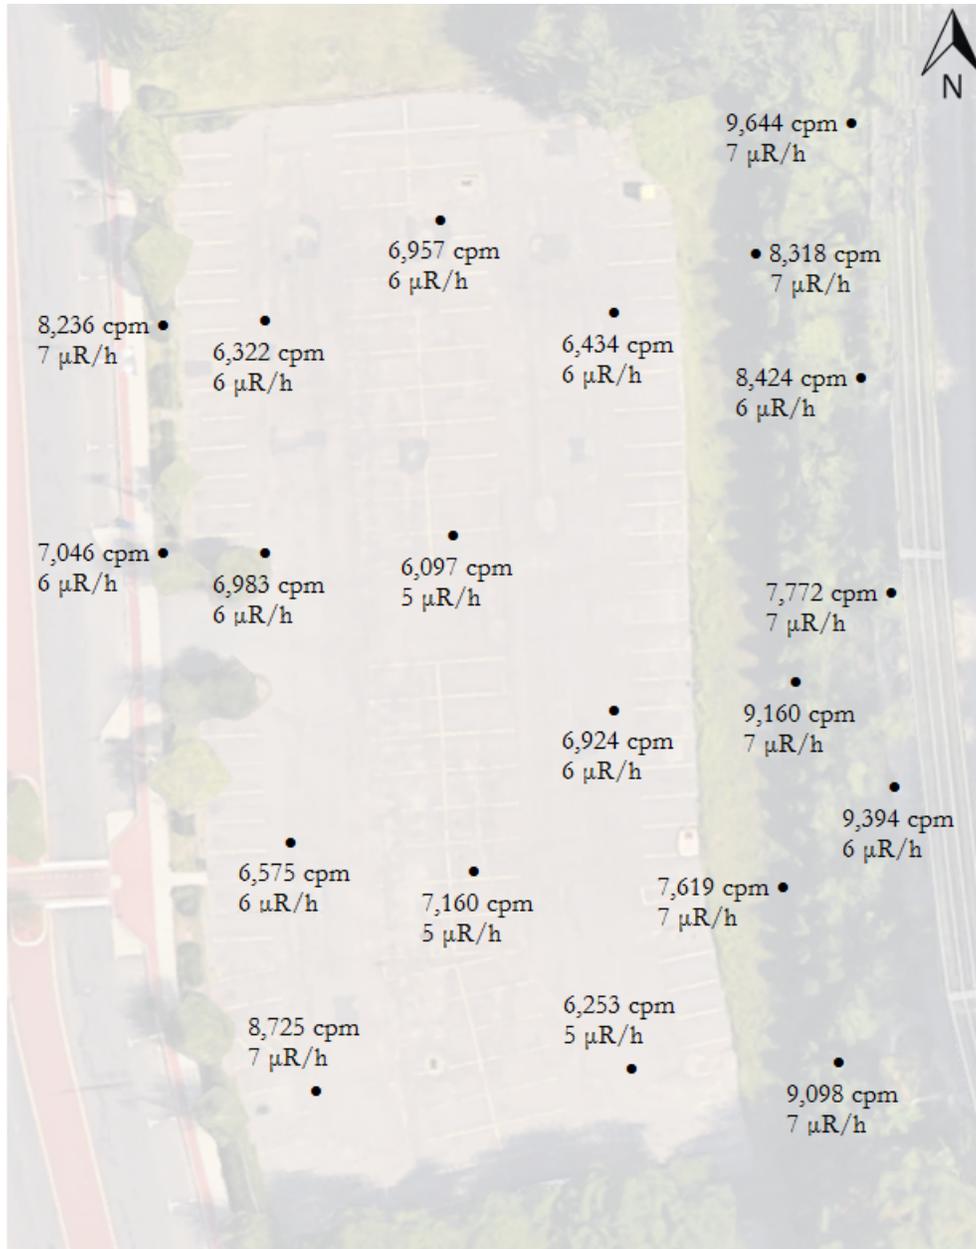
Figure 2. Survey Results for the North Main Street Parking Lot

Figure 2 presents a summary of results from the November 17, 2016 site visit. Inspectors identified no anomalous gamma radiation measurements. Surveys covered approximately 25% of the accessible land area, noting that most of the outdoor area is covered by concrete, asphalt, cars, etc. Because there were no anomalous readings, the SAM-940 was not used, and no samples were collected.

The 2×2 sodium iodide detector gamma radiation responses ranged from about 6,000 to 8,500 counts per minute (cpm) over asphalt which is consistent with background levels. In grassy areas, the 2×2 sodium iodide detector responses ranged from approximately 7,000 to 9,500 cpm which is consistent with background levels. Exposure rates ranged from 5 to 7 microRoentgens per hour ( $\mu\text{R}/\text{h}^1$ ) over asphalt. In grassy areas, the exposure rates ranged from about 6 to 7  $\mu\text{R}/\text{h}$ . No areas of elevated direct gamma radiation were identified.

<b>SITE:</b> Ingraham Clock Company	<b>AREA:</b> North Main Street Parking Lot	<b>DATE:</b> 11/17/16	<b>TIME:</b> 11:00 – 11:30
<b>SURVEYOR(S):</b> David King		<b>PURPOSE:</b> Site Visit

TYPE	INSTRUMENT	DETECTOR	BACKGROUND
Gamma	2221 #590	44-10 #908	*
Gamma	192 #1127	N/A	*

\* Readings varied from 5 to 7  $\mu\text{R/hr}$  and 6,000 to 9,500 cpm depending on proximity to red brick buildings and ground materials such as concrete, asphalt, and natural media (e.g., landscaping). Surveyors noted no radiological anomalies, which is consistent with background levels.

Therefore, the recommendation to the NRC staff is that a more detailed scoping survey is not necessary at this time and that the NRC should not pursue additional action at the North Main Street parking lot.
