Subject: Dresden Nuclear Power Station Unit 3  
Reactor Head Inspection Plan  
NRC Docket No. 50-249

Attachment A: Proposed Reactor Head Inspection Plan (Dresden Unit 3)

PROPOSED REACTOR HEAD INSPECTION PLAN  
(DRESDEN UNIT 3)

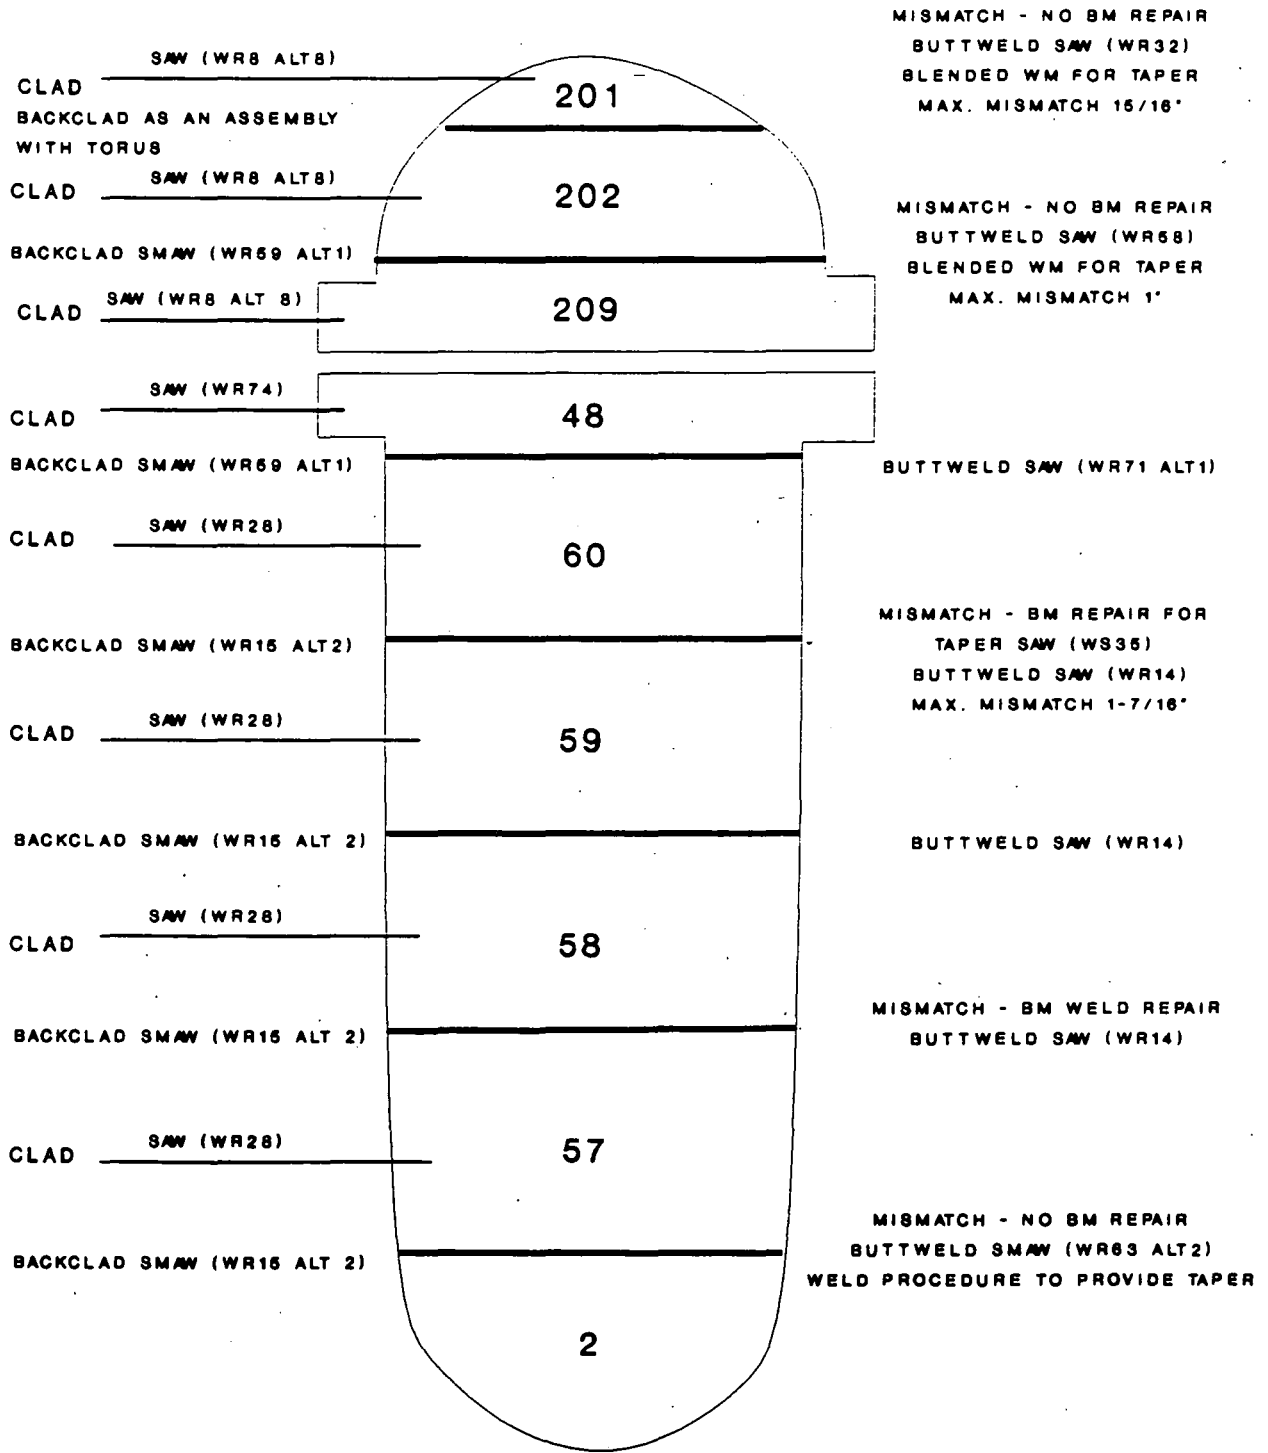
# FIGURE 1 - SUMMARY OF DRESDEN UNIT 3 REACTOR VESSEL FABRICATION

Attachment 'A' to this letter presents the Dresden Unit 3 Reactor Head Inspection Plan which was developed from the upper vessel fabrication history review. The Unit 3 fabrication history review revealed major mismatches at the upper head dollar plate-to-torus, upper head torus-to-flange, and uppermost shell-to-shell welds (see Figure 1). The inspection will encompass the entire reactor head, which includes the dollar plate-to-torus and torus-to-flange welds. The Inspection Plan delineates that visual examinations be performed on the inner diameter of the reactor head to identify any evidence of potential cracks. All cracks identified by visual and/or dye penetrant examinations, will receive an ultrasonic examination. The Inspection Plan will be implemented during the upcoming Unit 3 refueling outage which is currently scheduled to begin in March 1991.
