**Assessment of Hydrogeologic Conditions and  
Need for Long-Term Groundwater Monitoring  
at the Former Durita Uranium Mill, Naturita, Colorado**

**Assessment of Hydrogeologic Conditions  
and Need for Long-Term Groundwater Monitoring  
at the Former Durita Uranium Mill, Naturita, Colorado**

Gene Peters and Randall Fedors

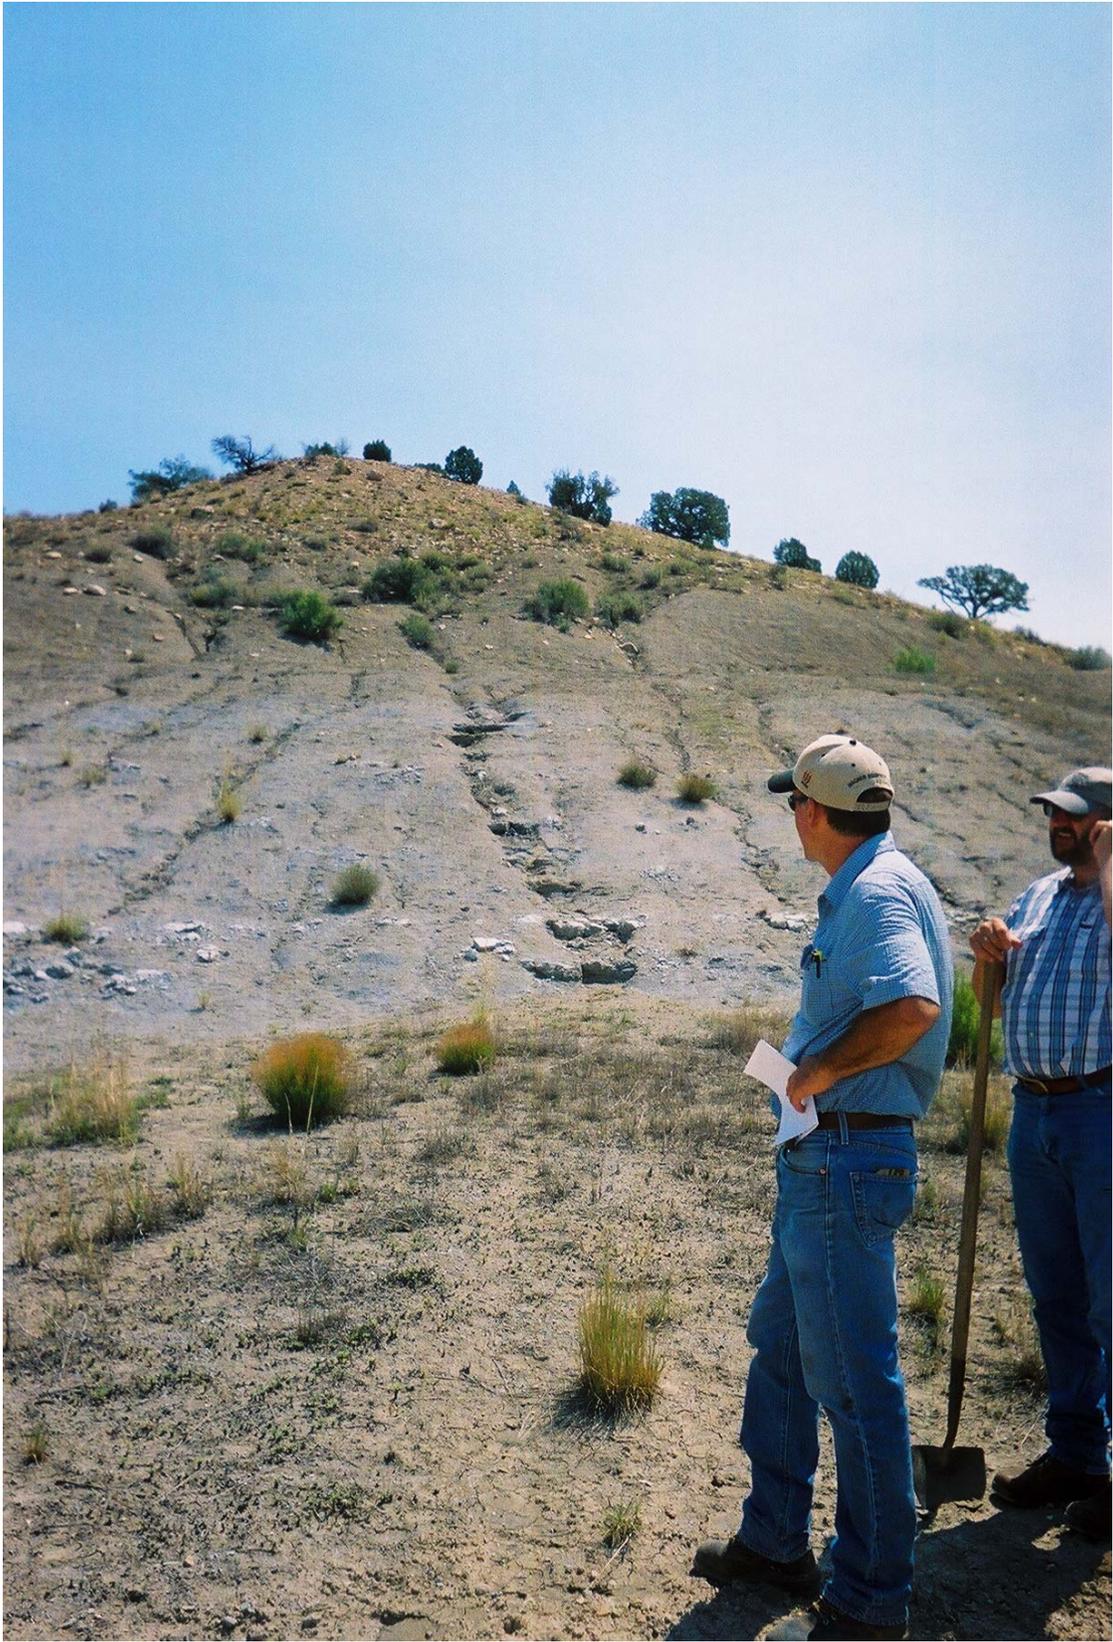
Photograph 16A

- 16A Photo of base of Mancos Hill, north and northwest sides. Absence of vegetation may be related to reclamation activities, though no processes are reported to have occurred in this immediate area. Note prominent drainage rills, which are absent on other sides of Mancos Hill, exposing several layers of more competent, resistant claystone/shale. Visible in upper portion of photo, near top of Mancos Hill are much larger rock fragments of sandstone, ranging up to cobble-sized. Ground surface, in foreground of photo, more clay-rich; note desiccation cracks. Visible in photo are Earl Reams (left, of Ream Construction, representing Hecla) and Ed ???, DOE contractor.
