Clinch River Nuclear Site
Early Site Permit Application
Part 2, Site Safety Analysis Report

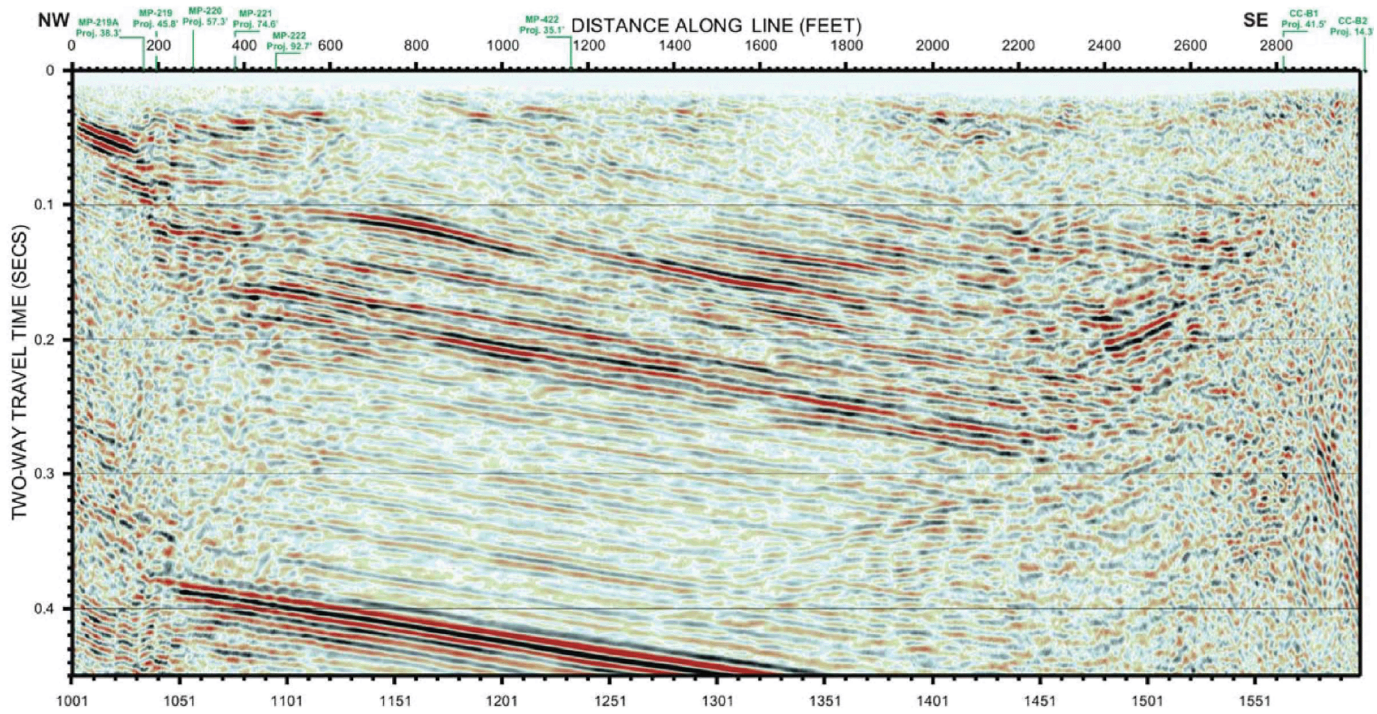
Figure 2.5.1-36. (Sheet 1 of 5) Seismic Reflection SRL-1—Without Interpretation

Notes: Seismic reflection profile SRL-1 (Reference 2.5.1-214).

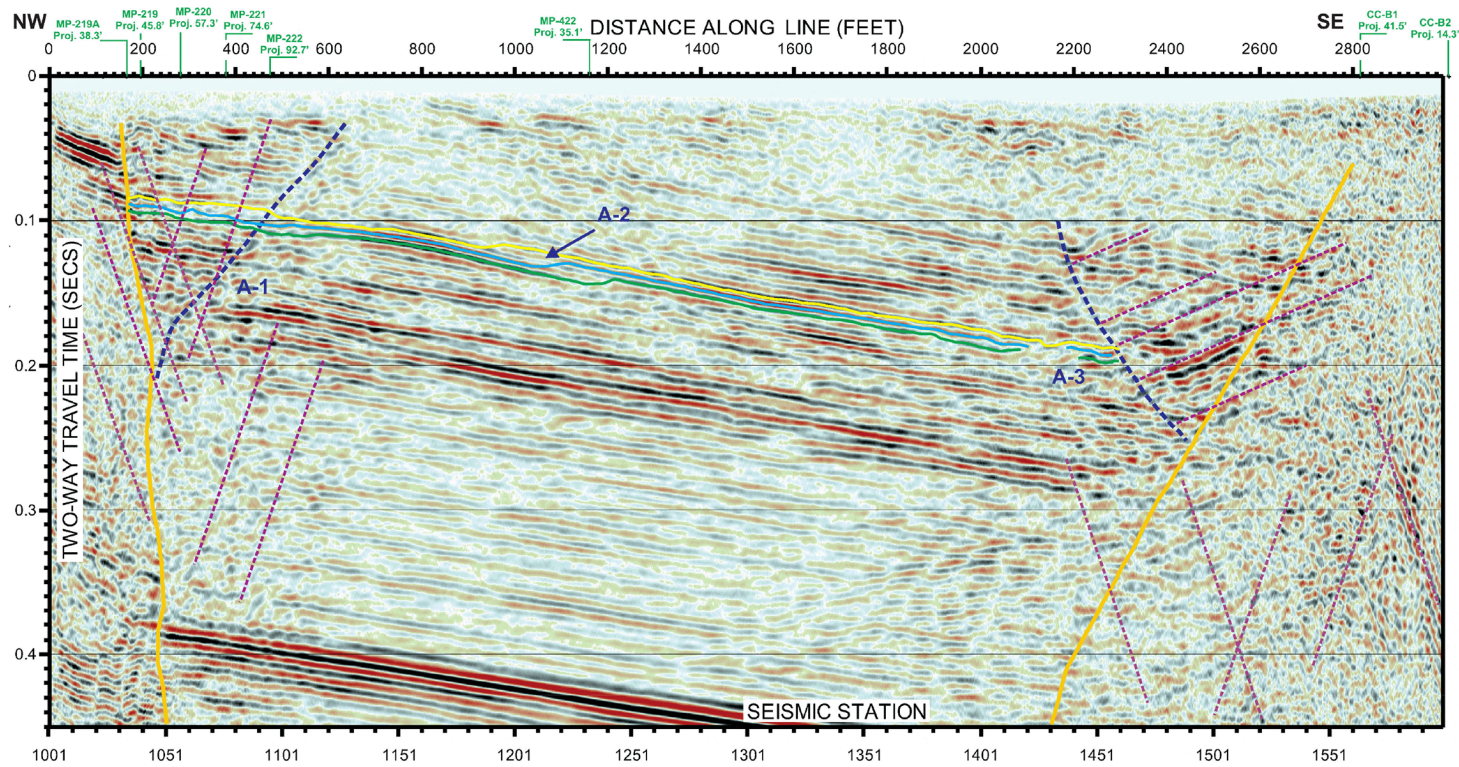
Figure 2.5.1-36. (Sheet 2 of 5) Seismic Reflection SRL-1—With Interpretation

Notes: Seismic reflection profile SRL-1 (Reference 2.5.1-214).

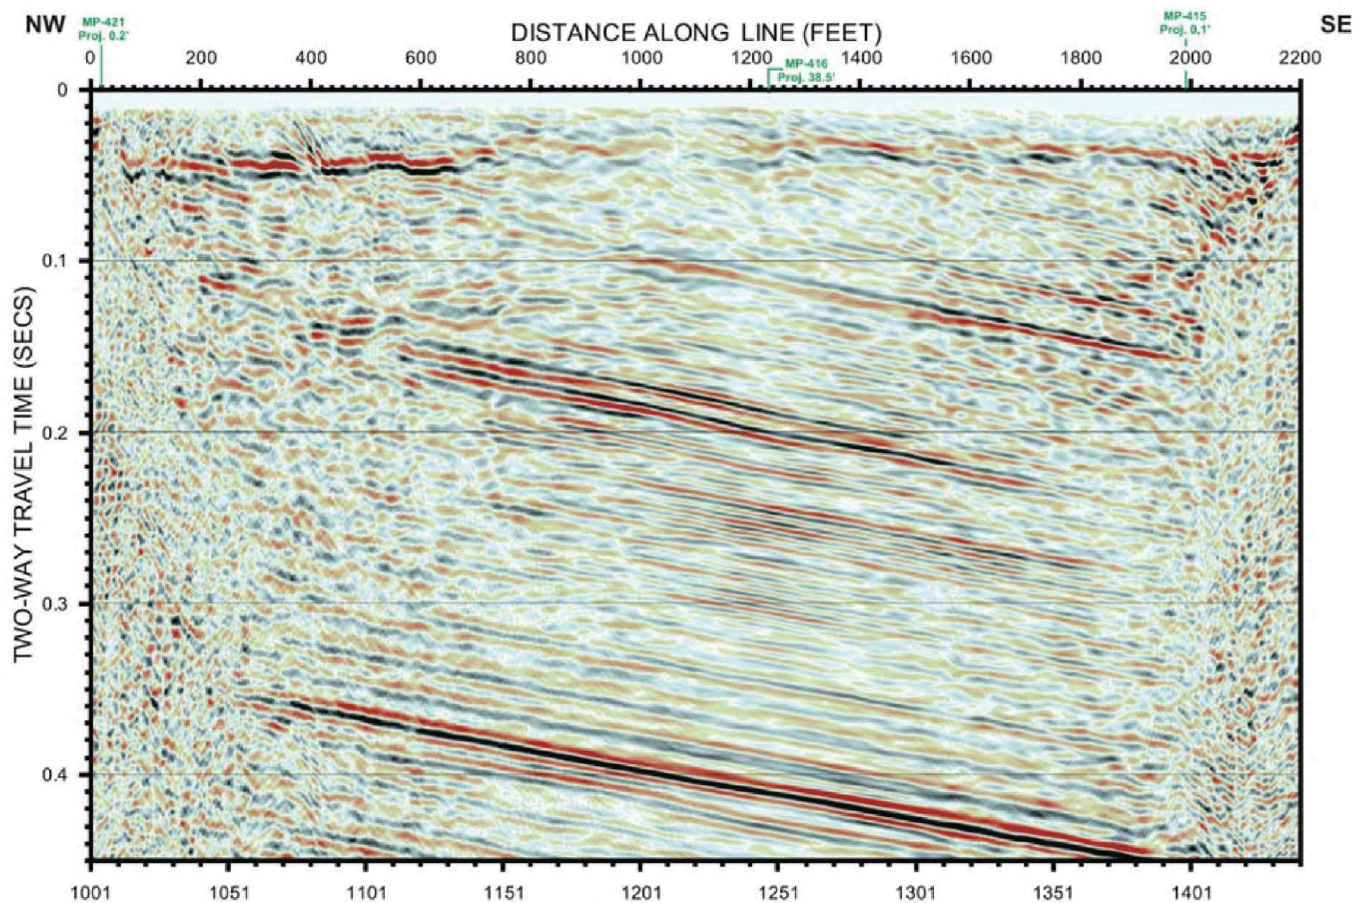
Figure 2.5.1-36. (Sheet 3 of 5) Seismic Reflection SRL-2—Without Interpretation

Note: Seismic reflection profile SRL-2 (Reference 2.5.1-214).

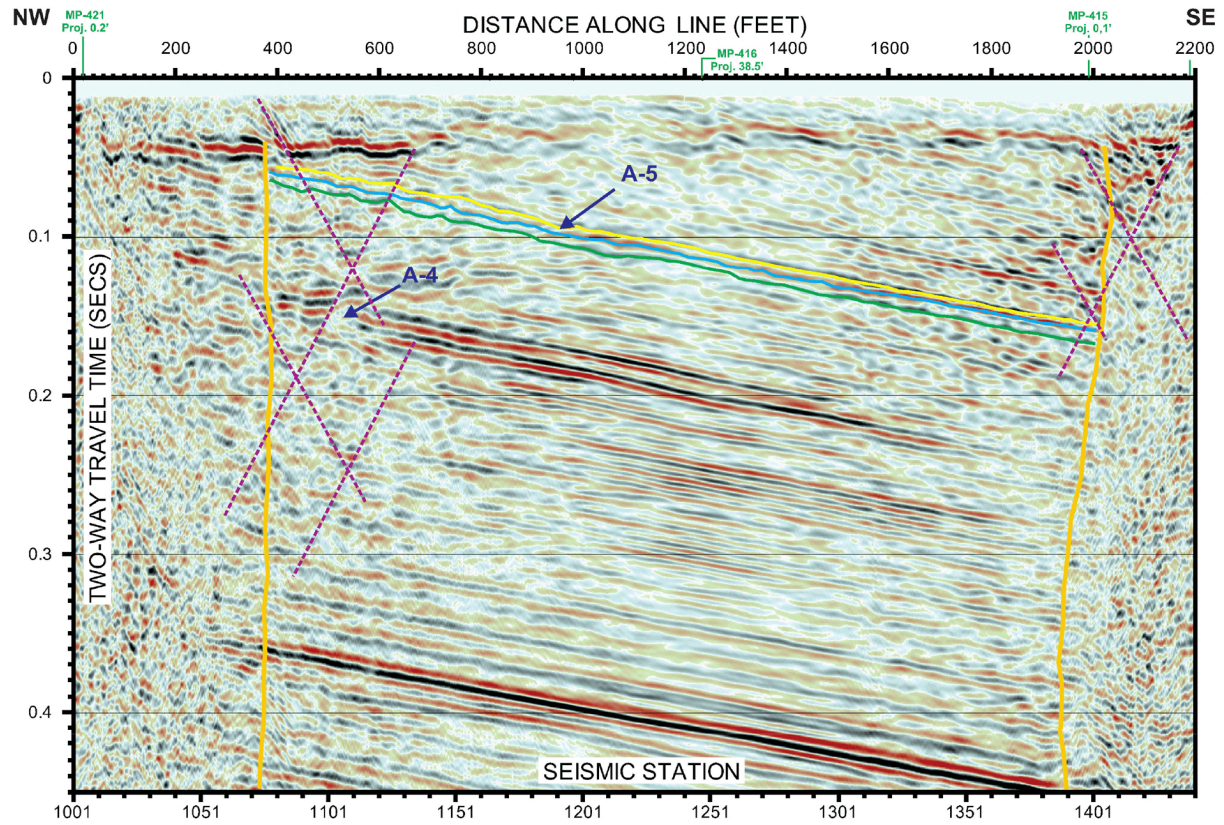
Figure 2.5.1-36. (Sheet 4 of 5) Seismic Reflection SRL-2—With Interpretation

Note: Seismic reflection profile SRL-2 (Reference 2.5.1-214).

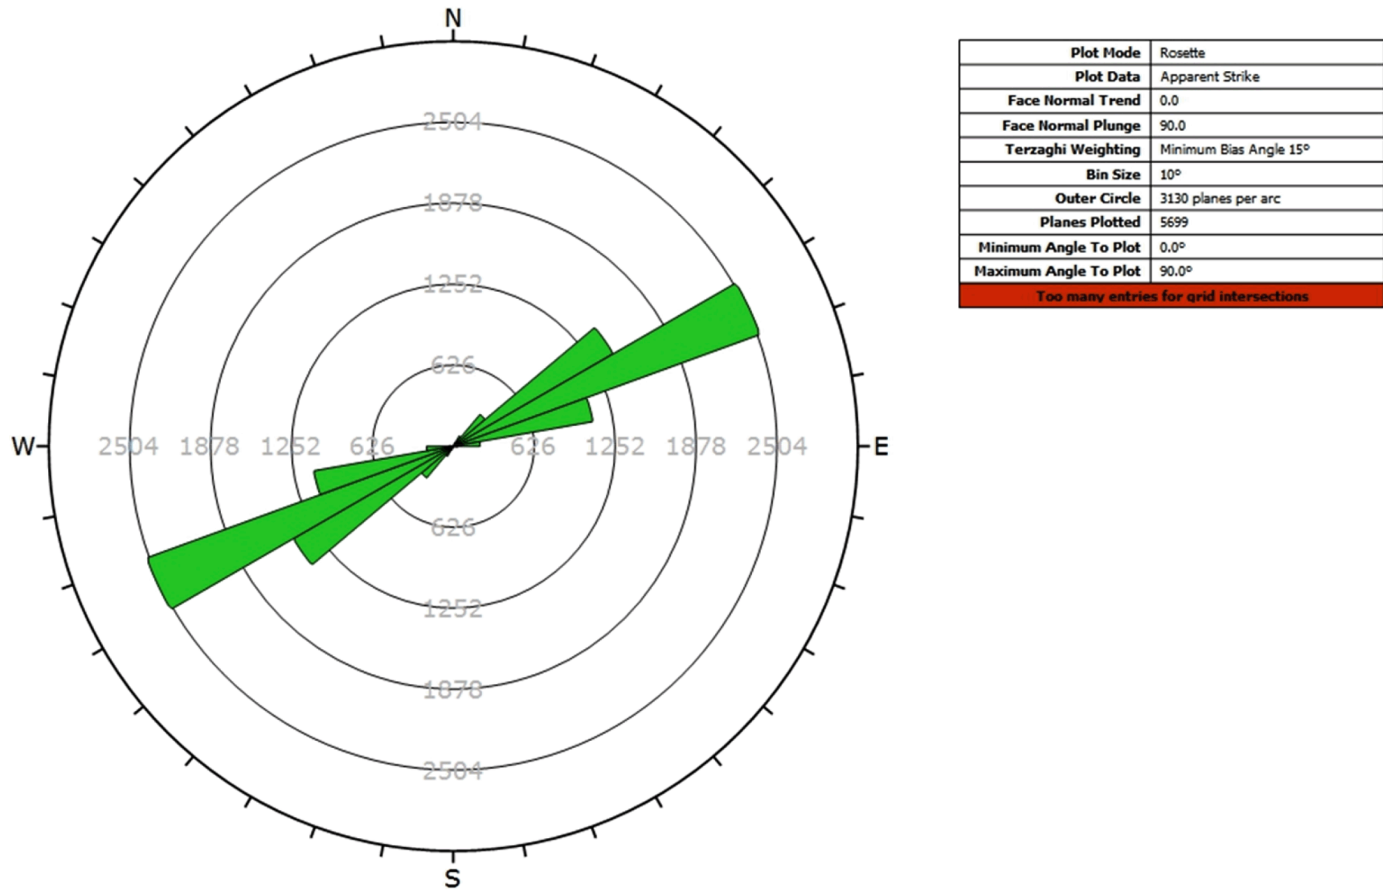
Figure 2.5.1-38. (Sheet 1 of 11) Acoustic Televiewer Data and Outcrop Mapping—Strike of Bedding

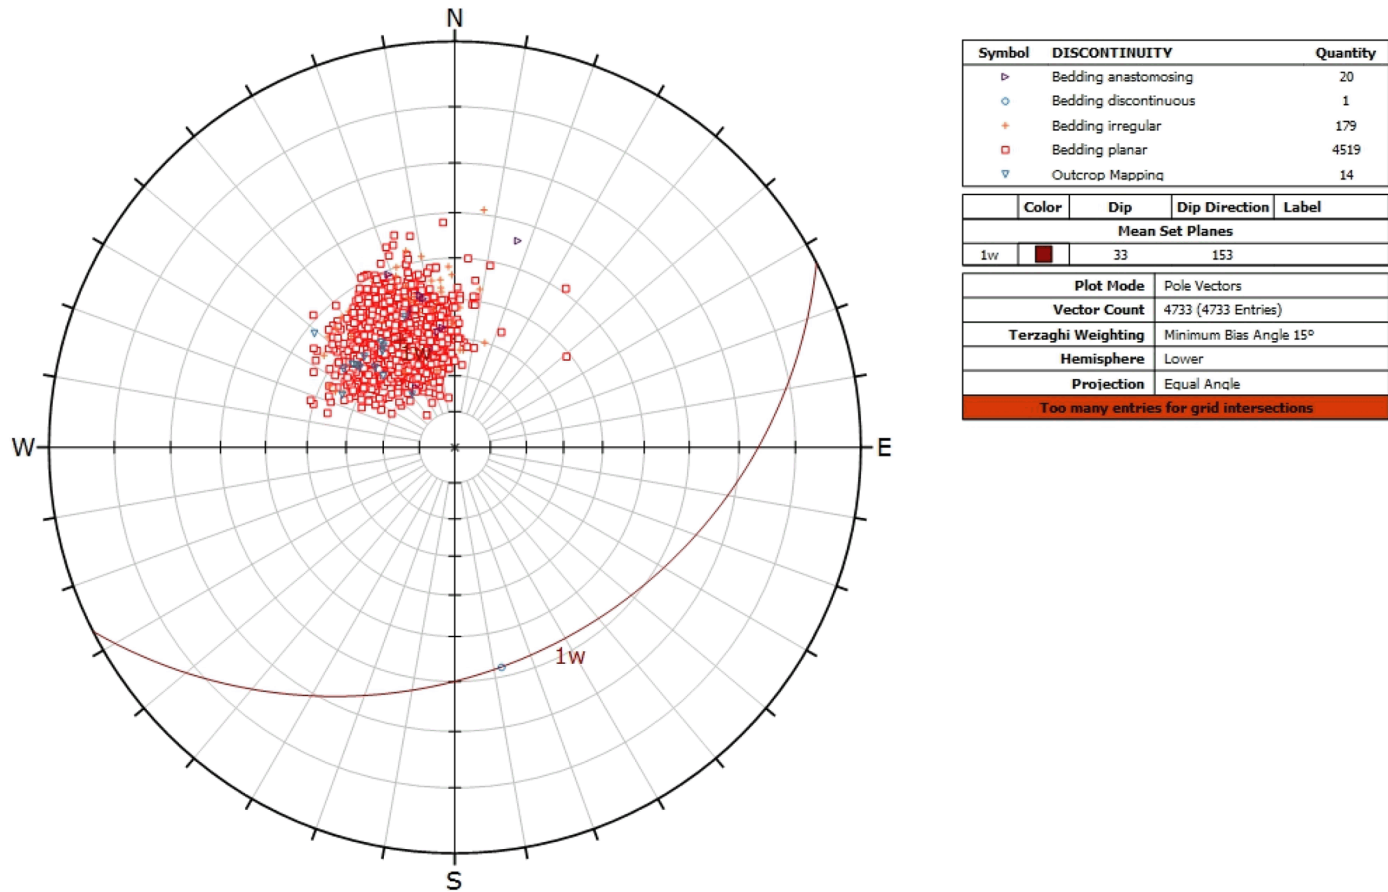
Figure 2.5.1-38. (Sheet 2 of 11) Acoustic Televiewer Data and Outcrop Mapping—Strike and Dip of Bedding Planes

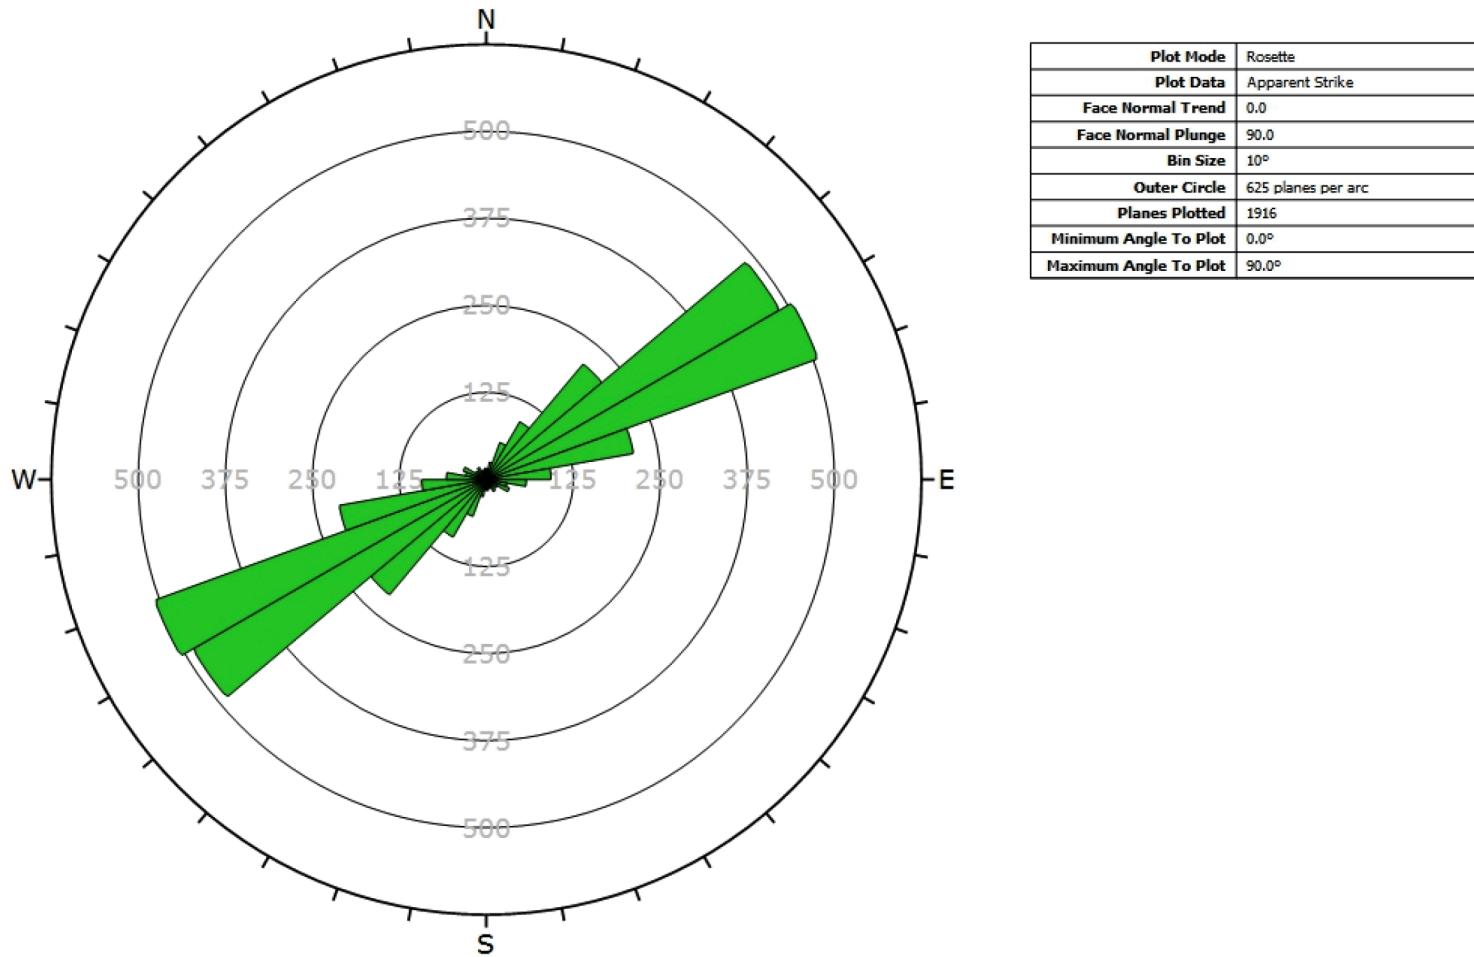
Figure 2.5.1-38. (Sheet 3 of 11) Acoustic Televiewer Data and Outcrop Mapping—Strike of Fractures

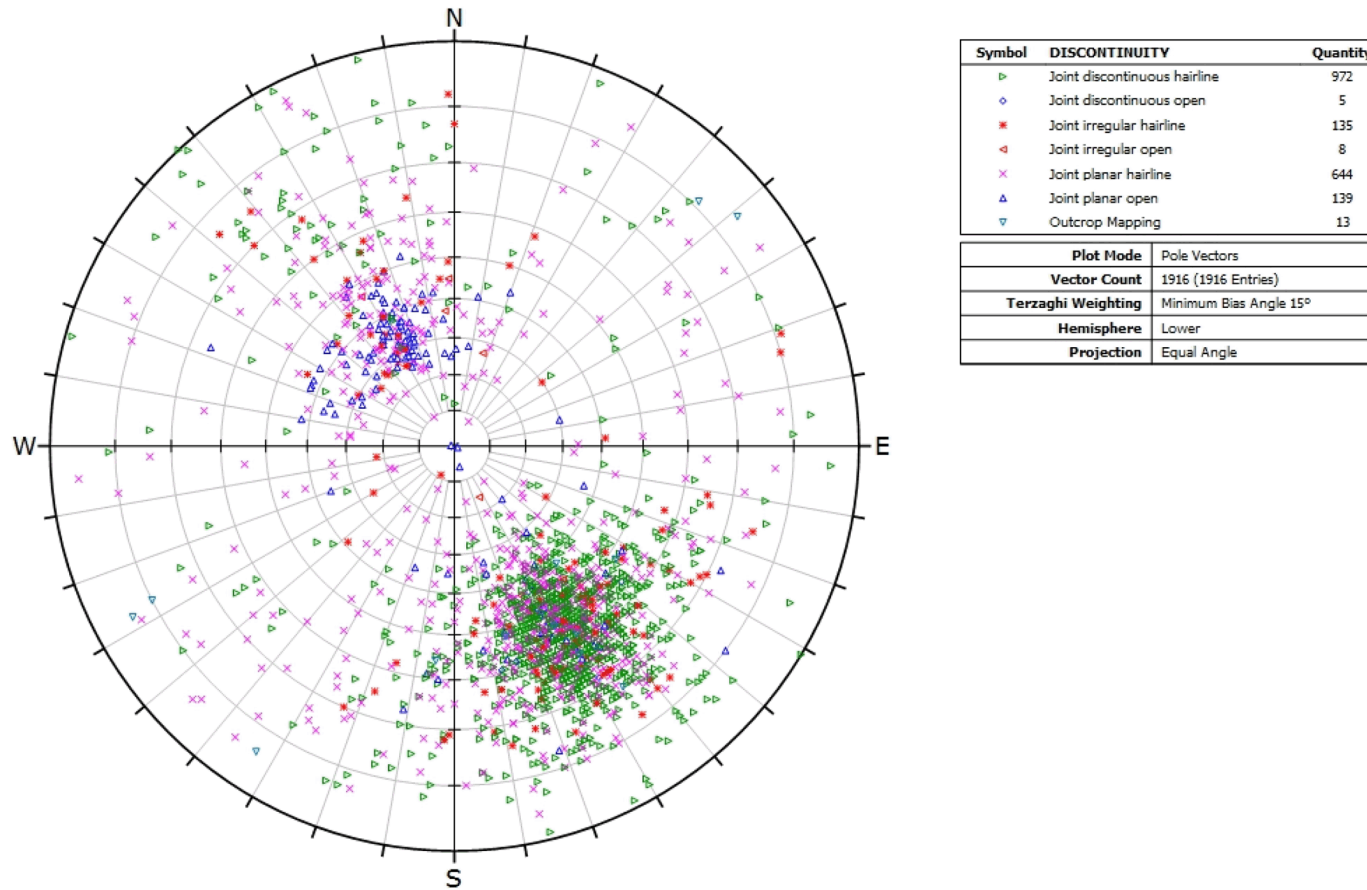
Figure 2.5.1-38. (Sheet 4 of 11) Acoustic Televiwer Data and Outcrop Mapping—Orientation of all Fractures

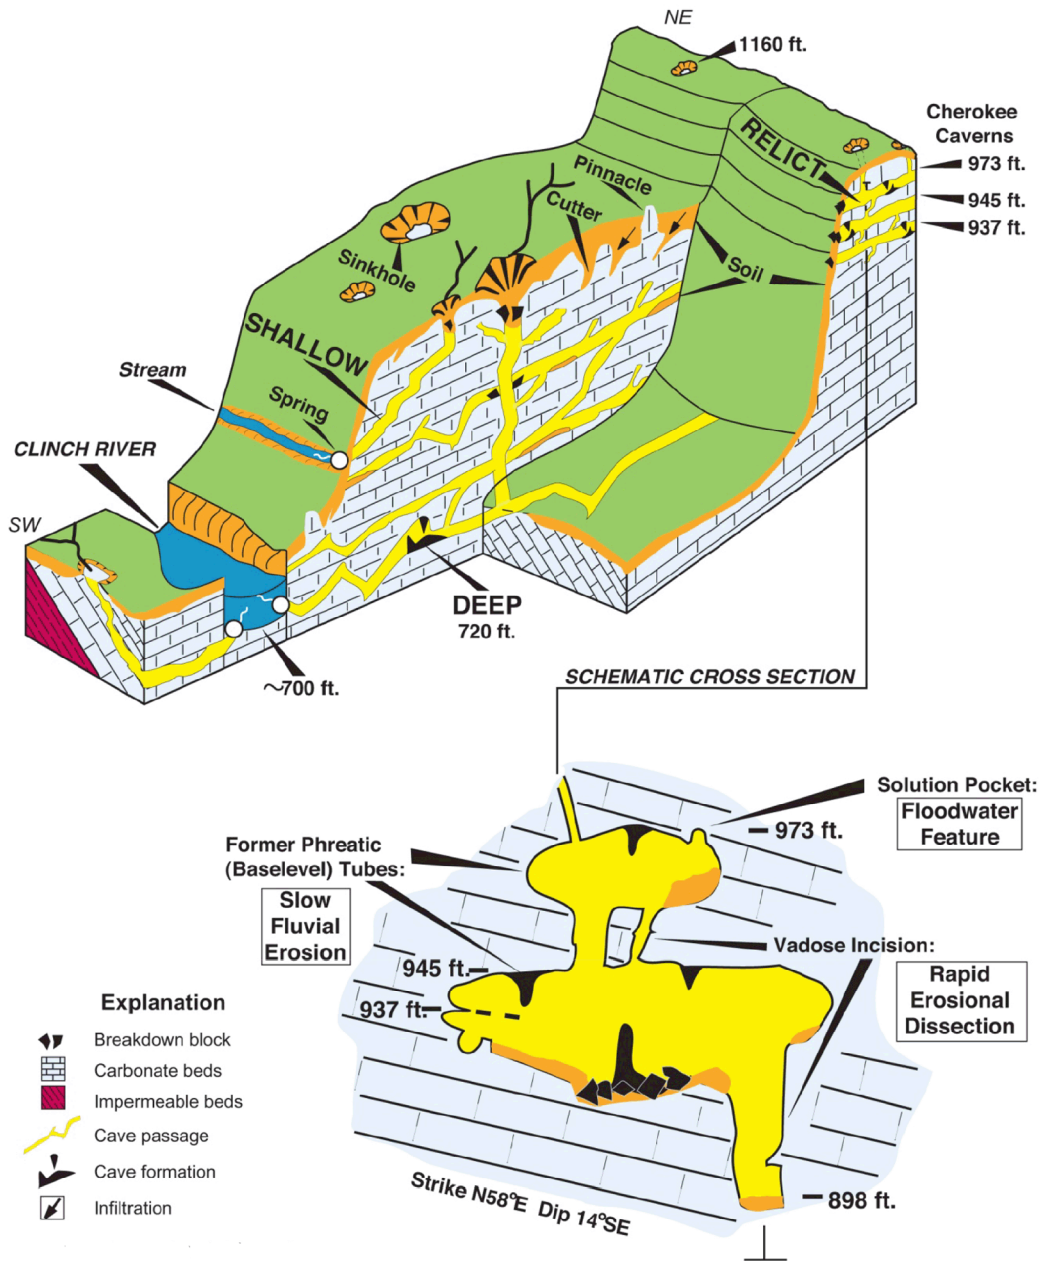
Figure 2.5.1-42. Conceptual Model for Karst Systems in the Oak Ridge Area

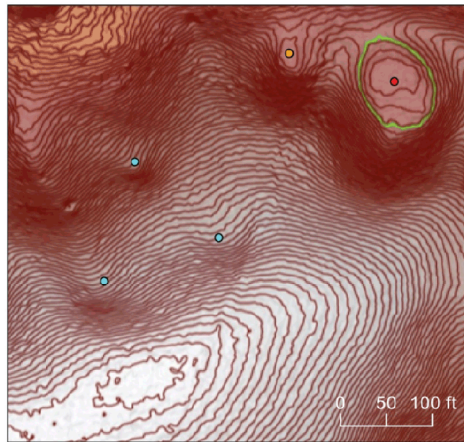
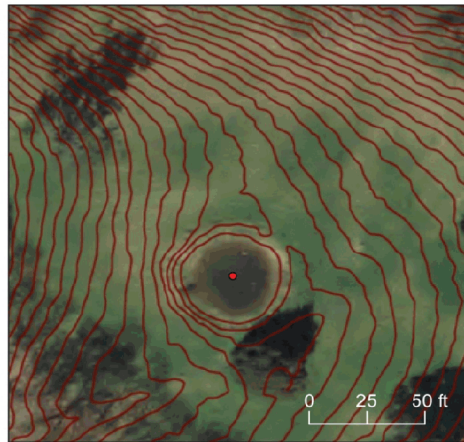
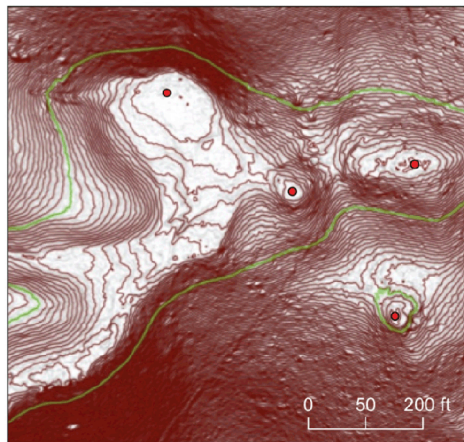
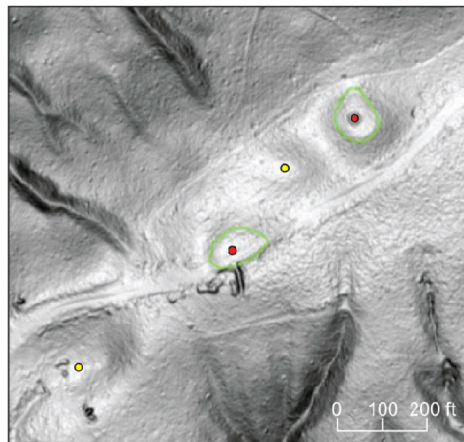
A. Karst depressions on a hillside with 1-foot contours and color ramp DEM

B. Water-filled sinkhole in an open field with 1-foot contours on 2013 aerial photography

C. Multiple sinks within a larger closed depression with 1-foot contours

D. Depressions on ridge top, hillshade DEM

Figure 2.5.1-43. Examples of Karst Depressions Mapped from LIDAR Data

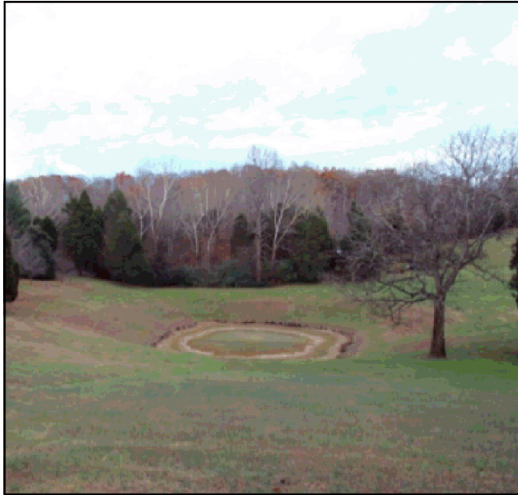
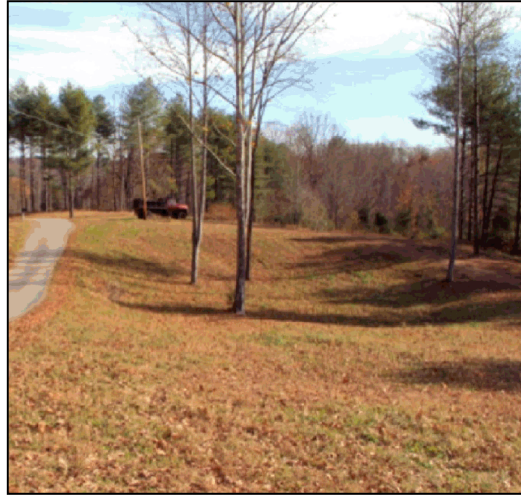
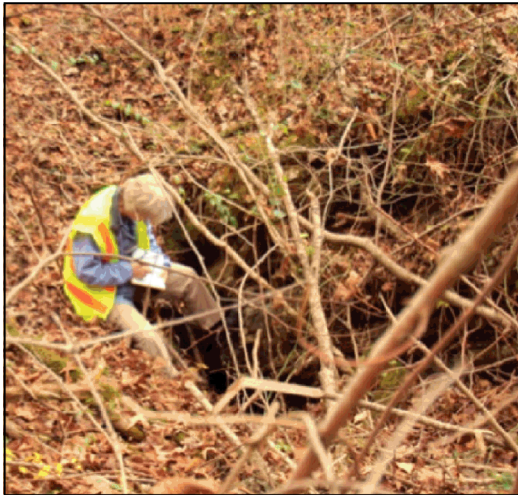
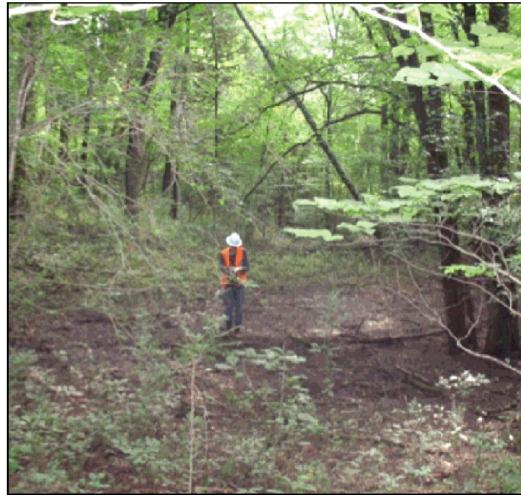
A. Pond in depression, Knox Group

B. Gentle depression, Knox Group

C. Active swallet, Witten Formation

D. Flat floor of depression, Witten Formation

Figure 2.5.1-45. Field Photographs of Karst Depressions

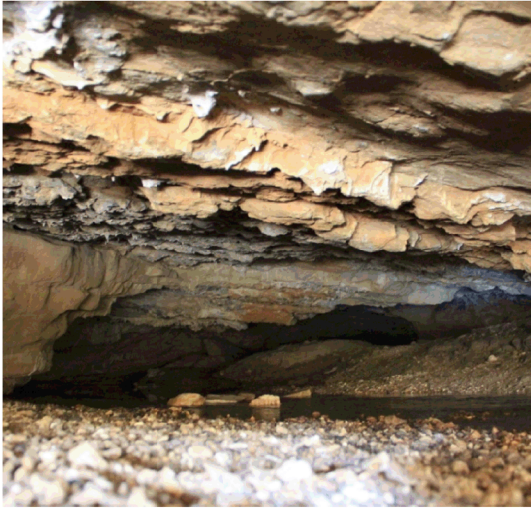
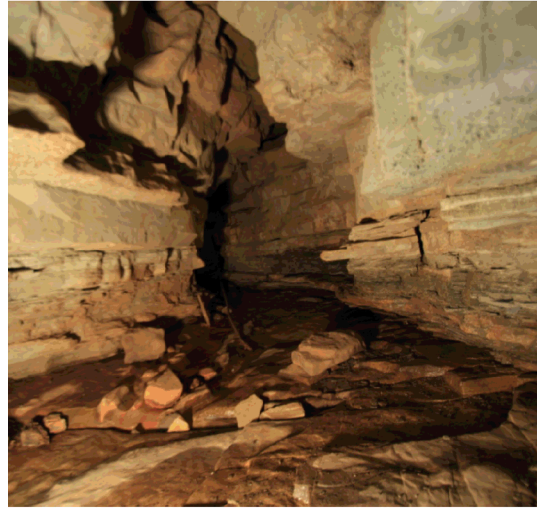
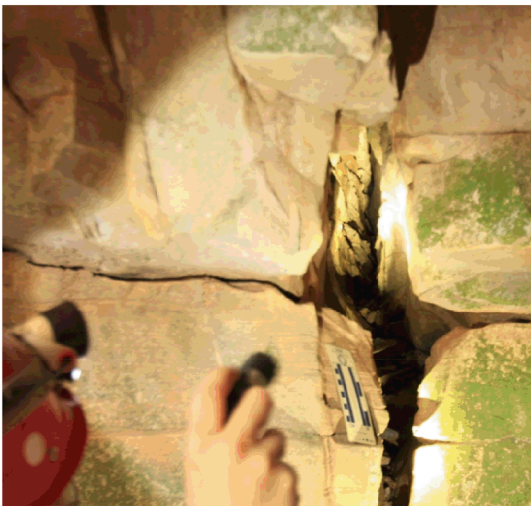
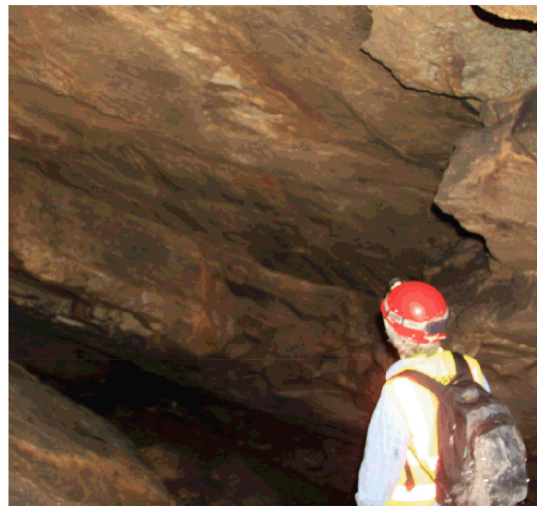
A. Small stream passage, 3 ft-high, with alluvial deposits on floor

B. Large stream passage, 16 ft-wide, following bedding dip

C. Solution enlargement at the intersection of joint and bedding plane

D. Ceiling collapse along bedding plane.

Figure 2.5.1-48. Field Photographs of Cave Features

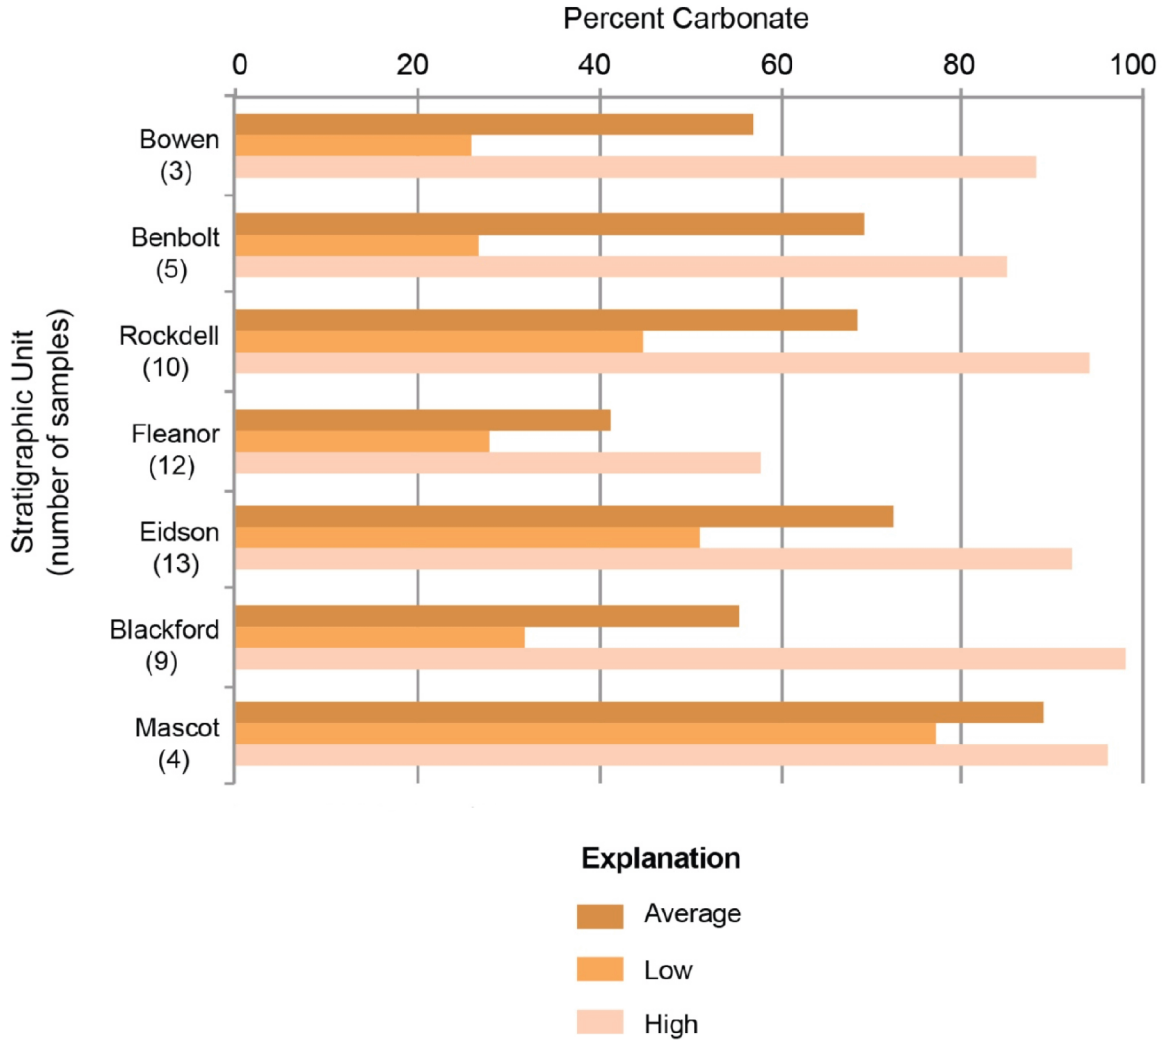
Figure 2.5.1-49. Carbonate Content of Rock Core Samples by Stratigraphic Unit

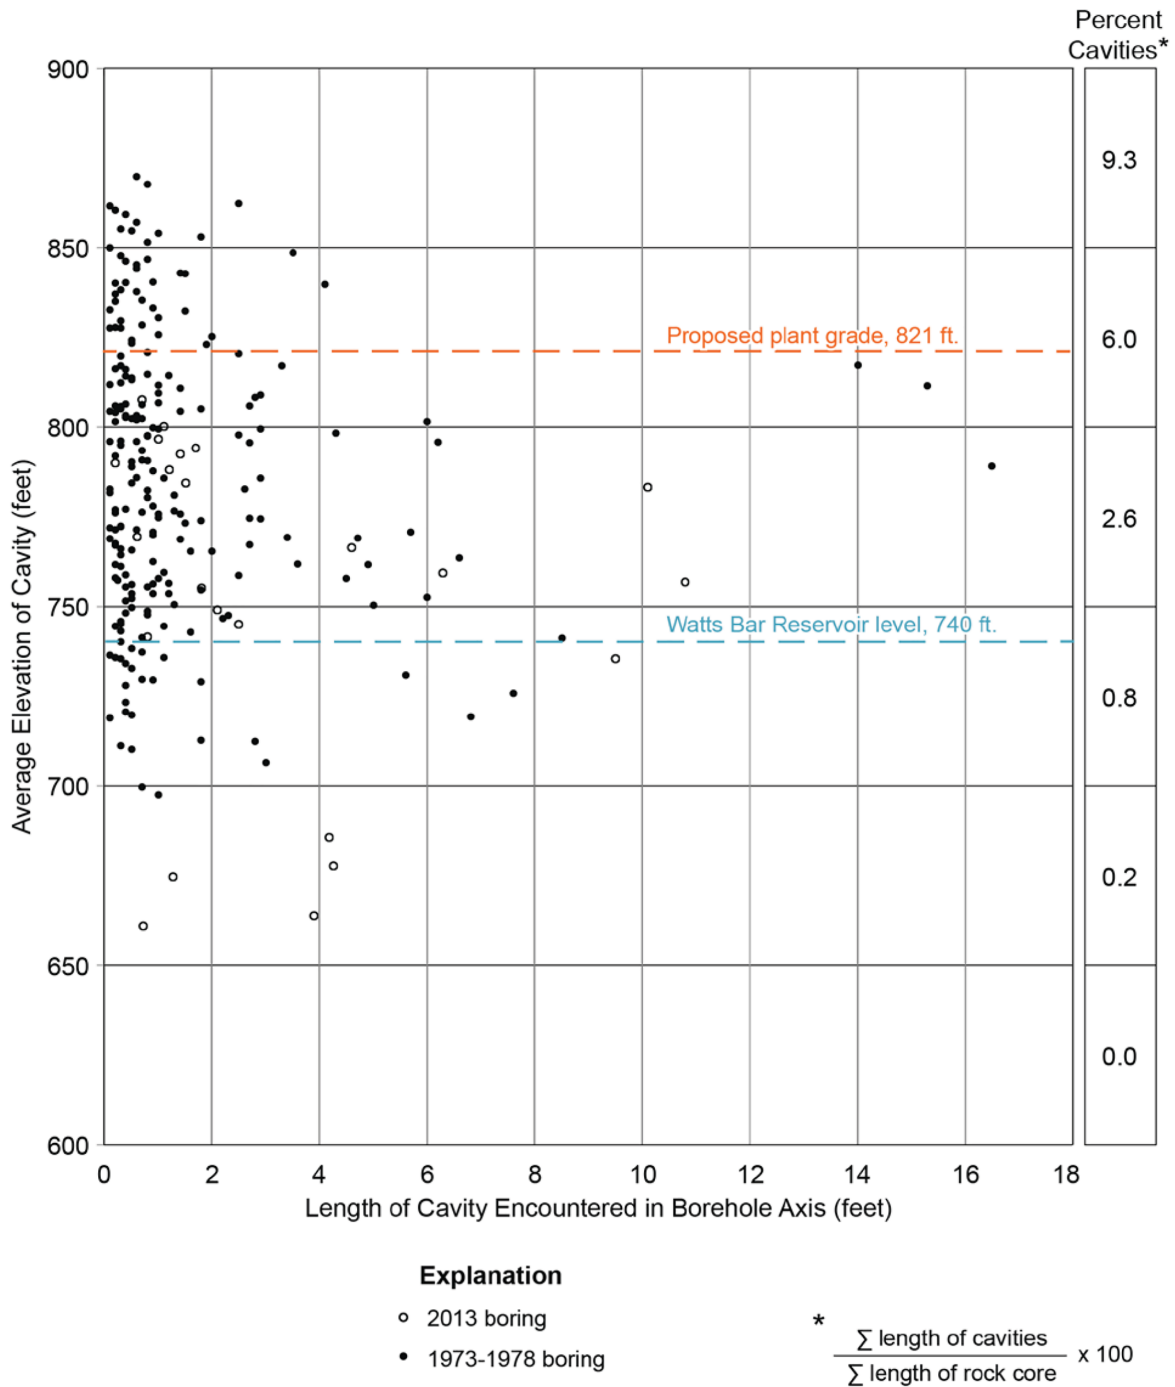
Figure 2.5.1-52. Cavity Size and Elevation in Borings

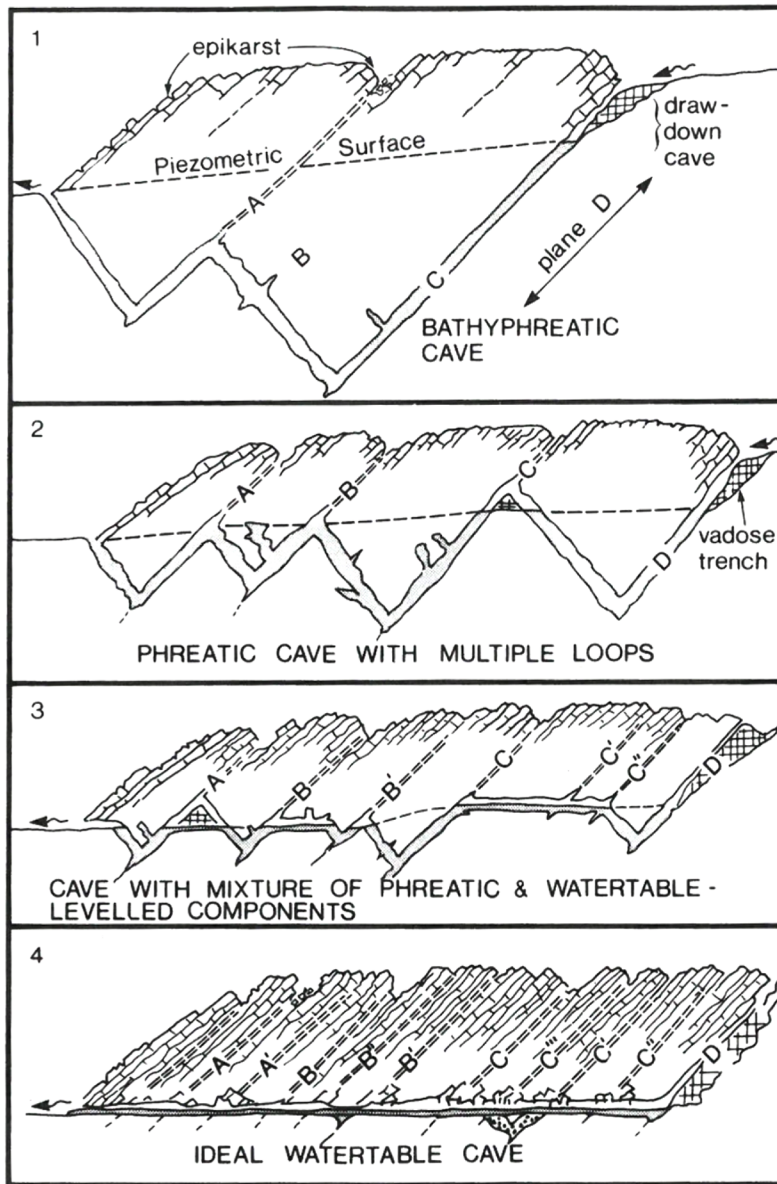
Figure 2.5.1-53. Model Showing Types of Phreatic and Water Table Caves

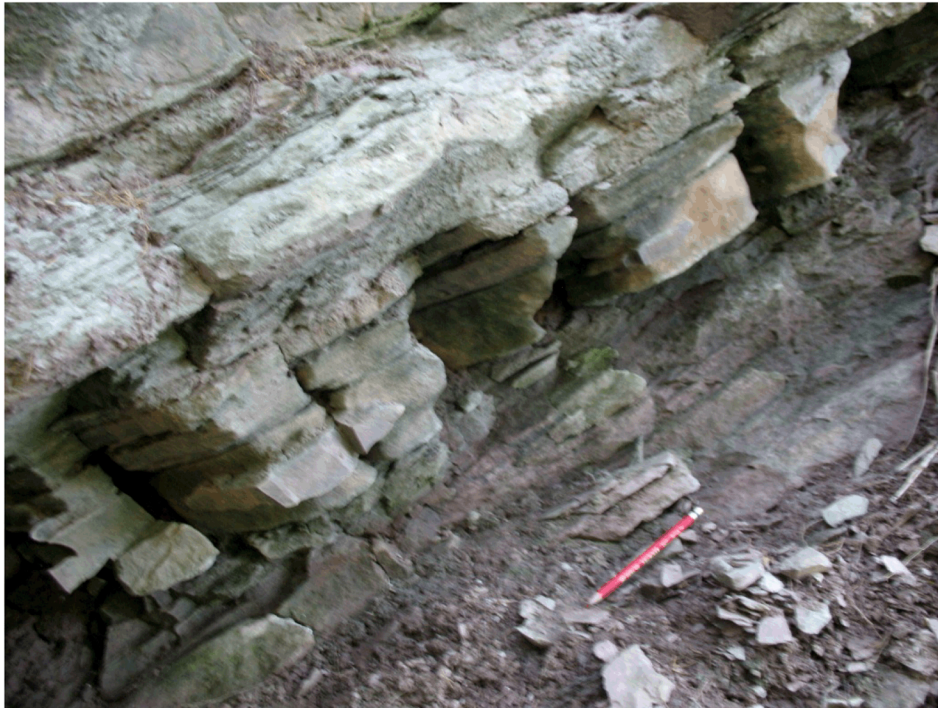
Figure 2.5.1-55. Dissolution of Limestone Interbeds in the Blackford Formation

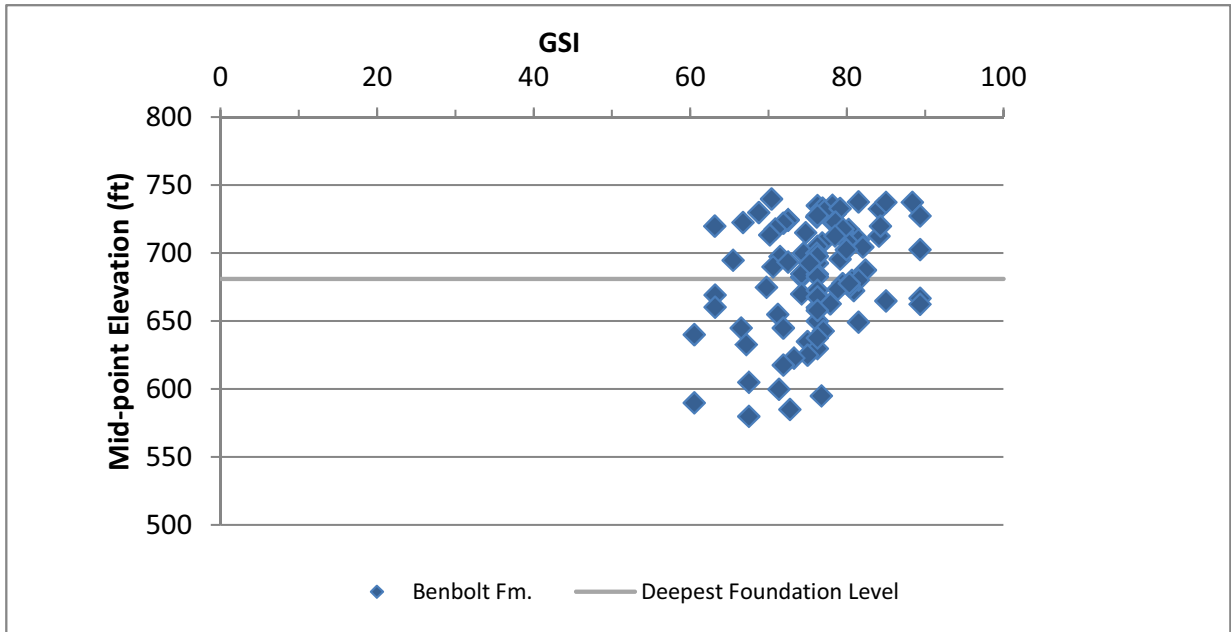
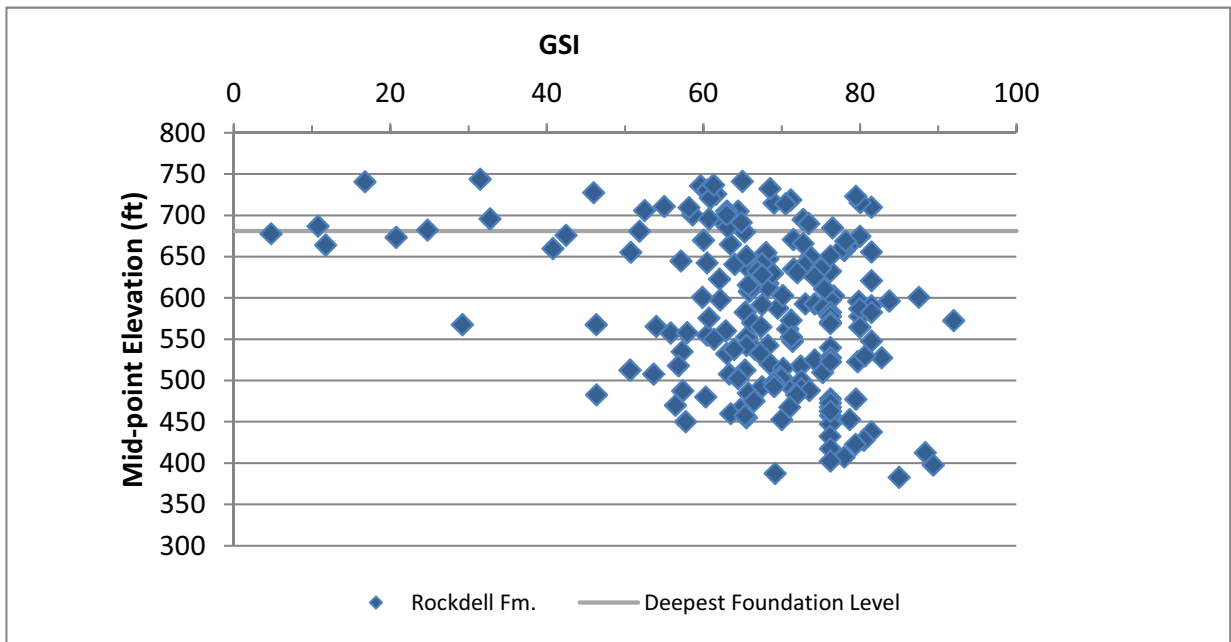
Figure 2.5.1-56. (Sheet 1 of 3) Scatter Plots of Geological Strength Index per Bedrock Unit

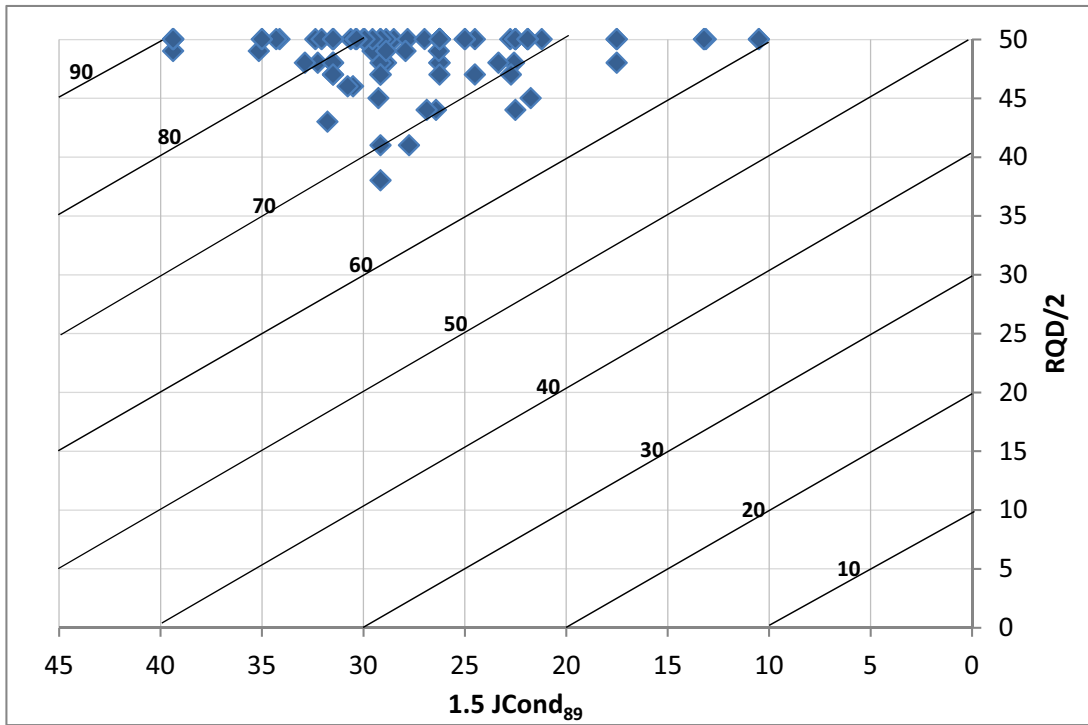
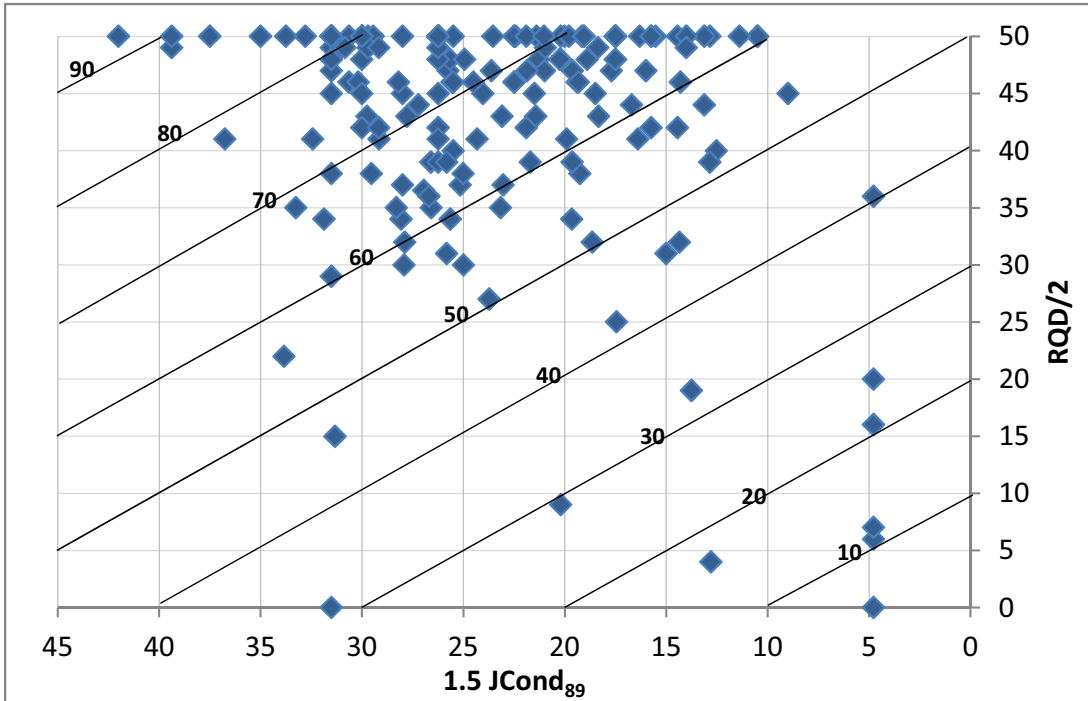
Note: JCond₈₉ = Joint Condition Rating; GSI = Geological Strength Index; RQD = Rock Quality Designation

Figure 2.5.1-57. (Sheet 1 of 3) Portion of GSI Chart Showing 1.5 JCond₈₉ Against RQD/2 and GSI per Bedrock Unit (Extended to Show RQD/2 > 40)

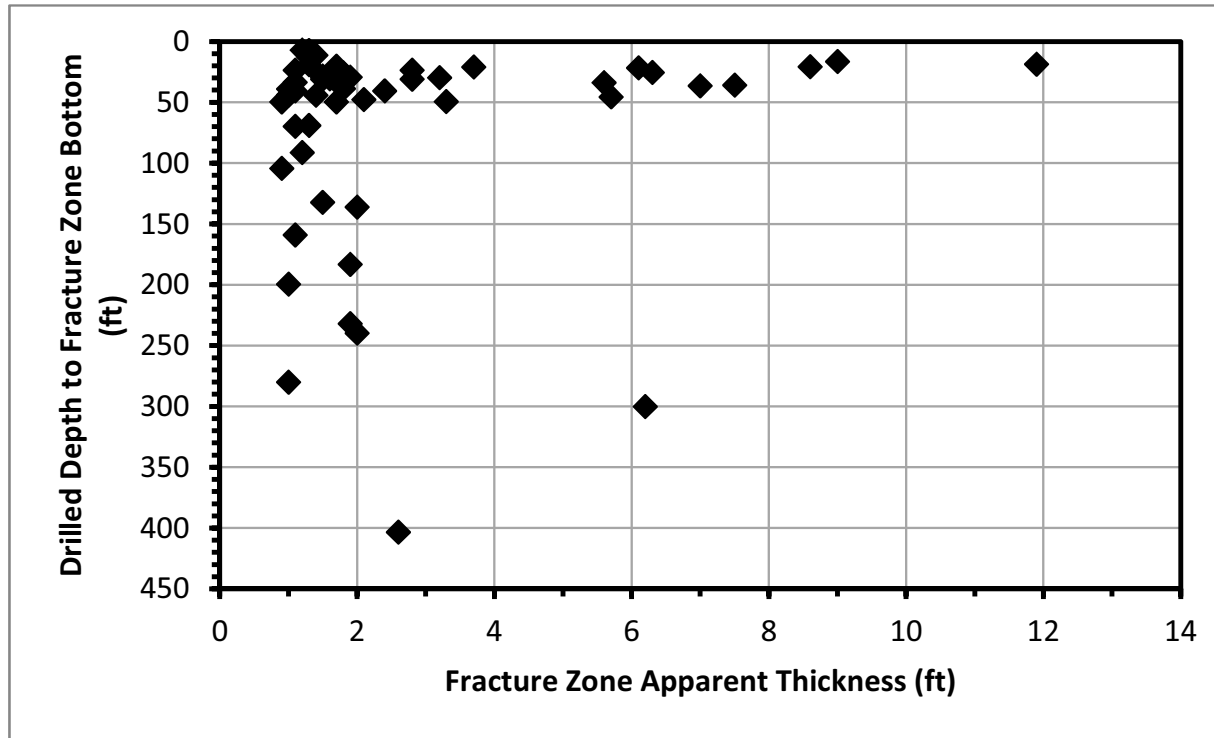
Figure 2.5.1-59. (Sheet 1 of 2) Scatter Plot of Fracture Zone Apparent Thickness—Against Drilled Depth to Fracture Zone Bottom (Using the 100- and 200-Series Borings)
