Clinch River Nuclear Site
Early Site Permit Application
Part 2, Site Safety Analysis Report

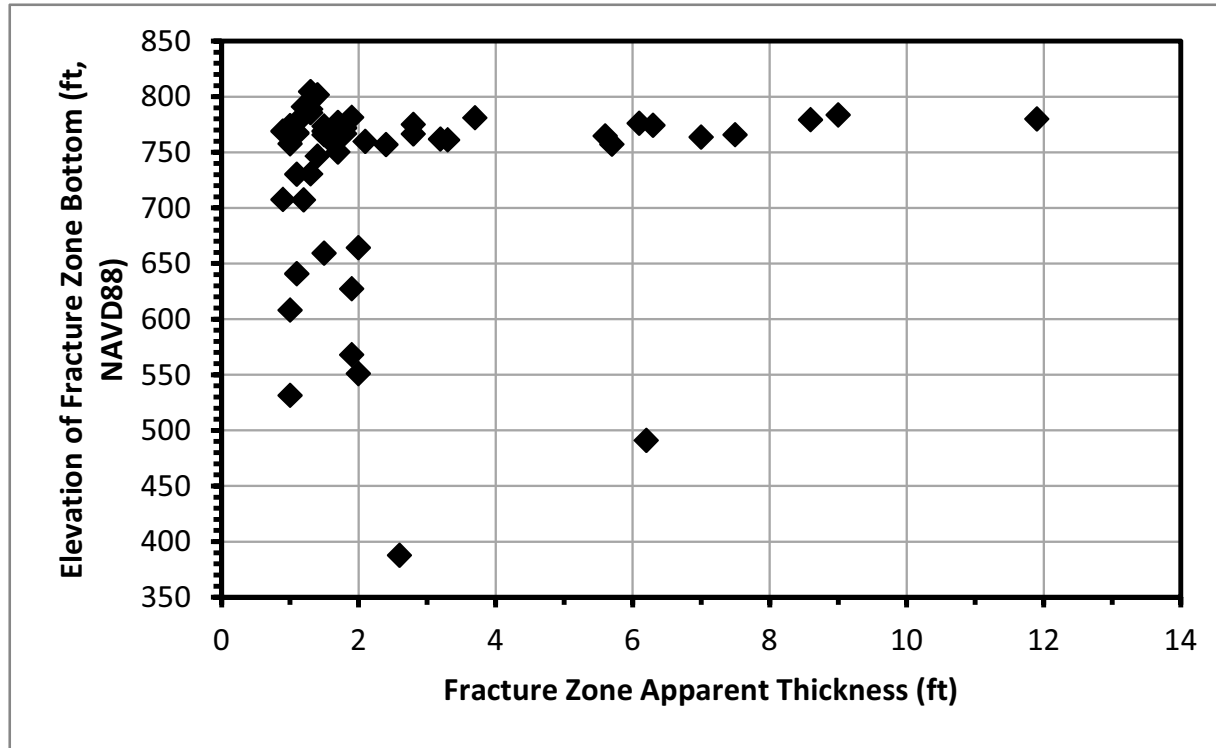
Figure 2.5.1-59. (Sheet 2 of 2) Scatter Plot of Fracture Zone Apparent Thickness—Against Elevation of Fracture Zone Bottom (Using the 100- and 200-Series Borings)

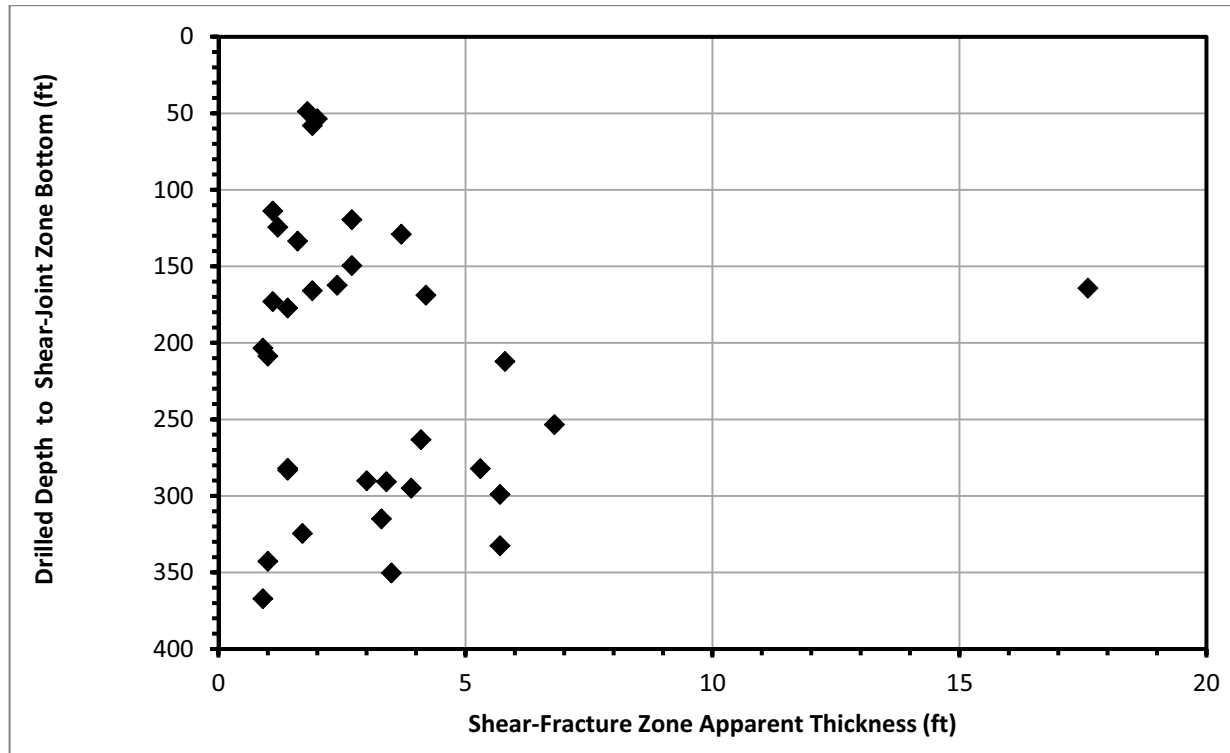
Figure 2.5.1-60. (Sheet 1 of 2) Scatter Plot of Shear-Fracture Zone Apparent Thickness—Against Drilled Depth to Shear-Fracture Zone Bottom (Using 100- and 200-Series Borings)

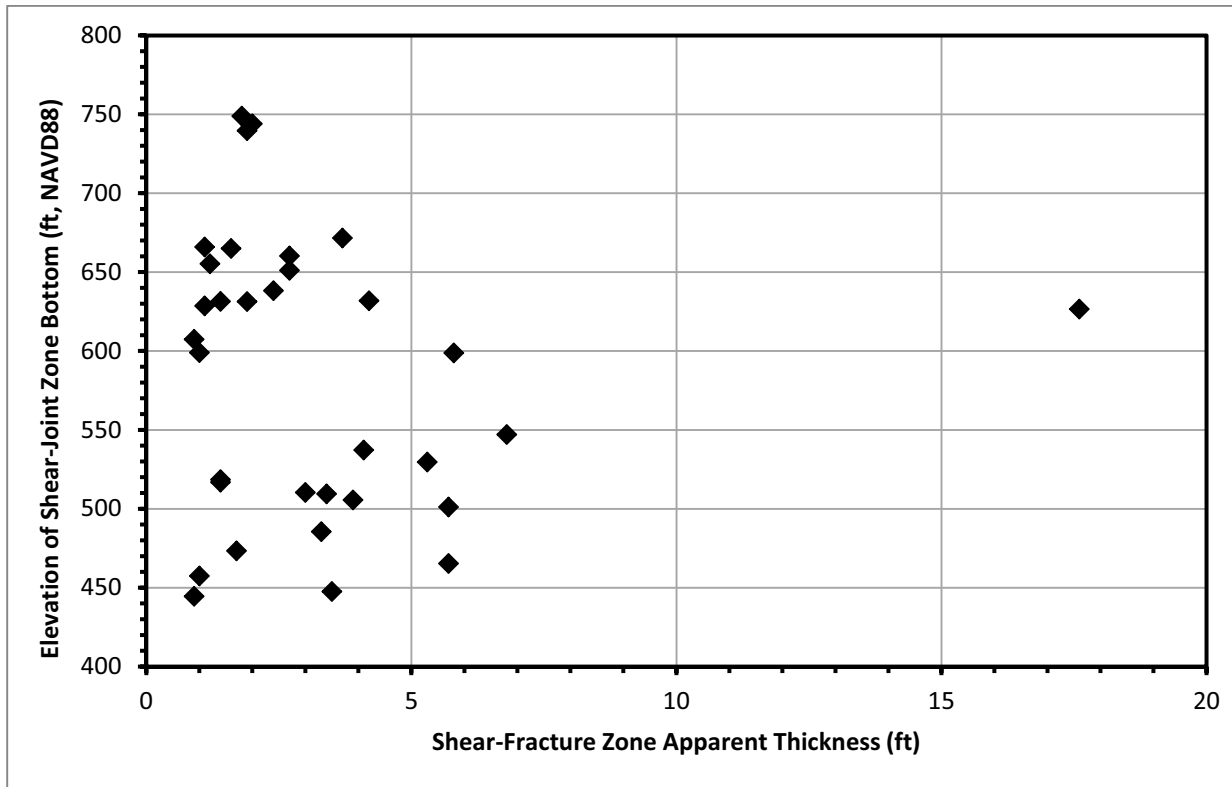
Figure 2.5.1-60. (Sheet 2 of 2) Scatter Plot of Shear-Fracture Zone Apparent Thickness—Against Elevation of Shear-Fracture Zone Bottom (Using 100- and 200-Series Borings)

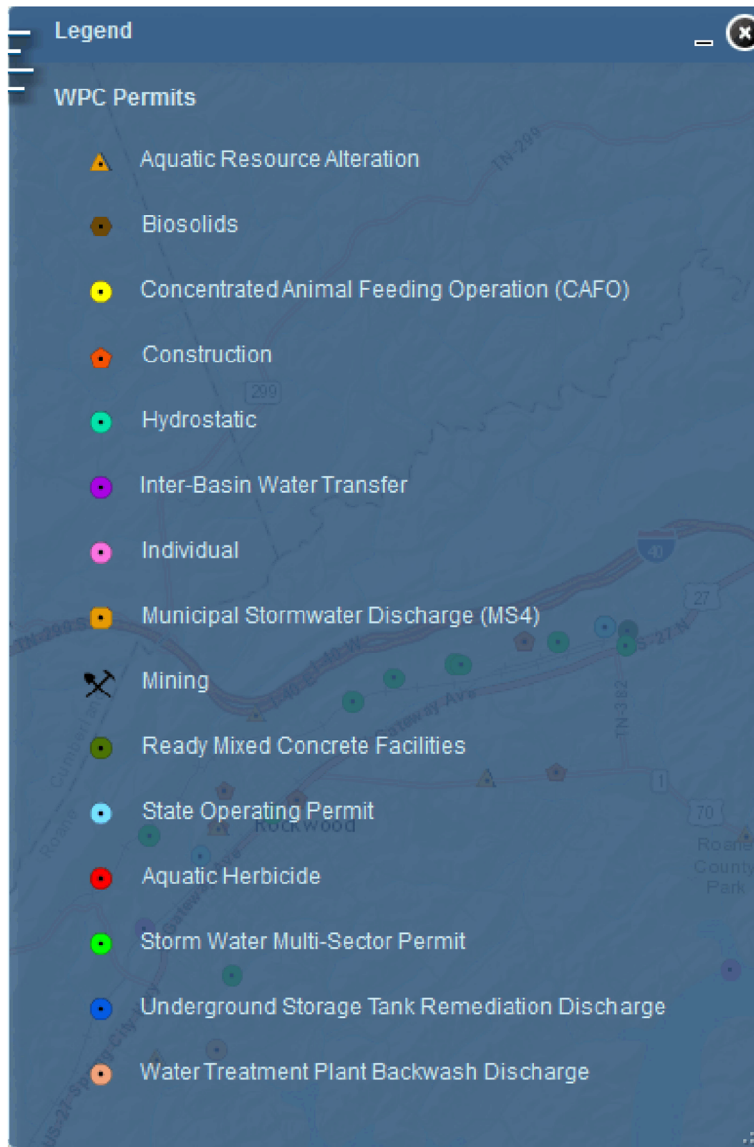
Figure 2.5.1-61. (Sheet 2 of 2) Map Showing the Water Resource Permit Application Sites Within Approximately 10 Miles of the Clinch River Nuclear Site

The symbols shown on this map represent water resource permits for various applications such as construction, water treatment plants, individual wells, hydrostatic purposes etc. See the legend to this figure on the next sheet.
