Geometry Composer Report

Date: Thursday, October 26, 2017 - 09:47:16
Description: CRIBHOUSE 3M
Comment: CRIBHOUSE 3M
File Name: C:\GENIE2K\isocs\data\GEOMETRY\In-Situ\CIRCULAR_PLANE\CRIBHOUSE 3M.geo
Software: ISOCS
Template: CIRCULAR_PLANE, Version: (default)
Detector: 5456
Collimator: 50mm-90d new (newISOCS 50mm side 90deg collimation [large hole collimator])
Environment: Temperature = 22 °C, Pressure = 760 mm Hg, Relative Humidity = 30%
Integration: Convergence = 1.00%, MDRPN = 2⁴ (16), CRPN = 2⁴ (16)

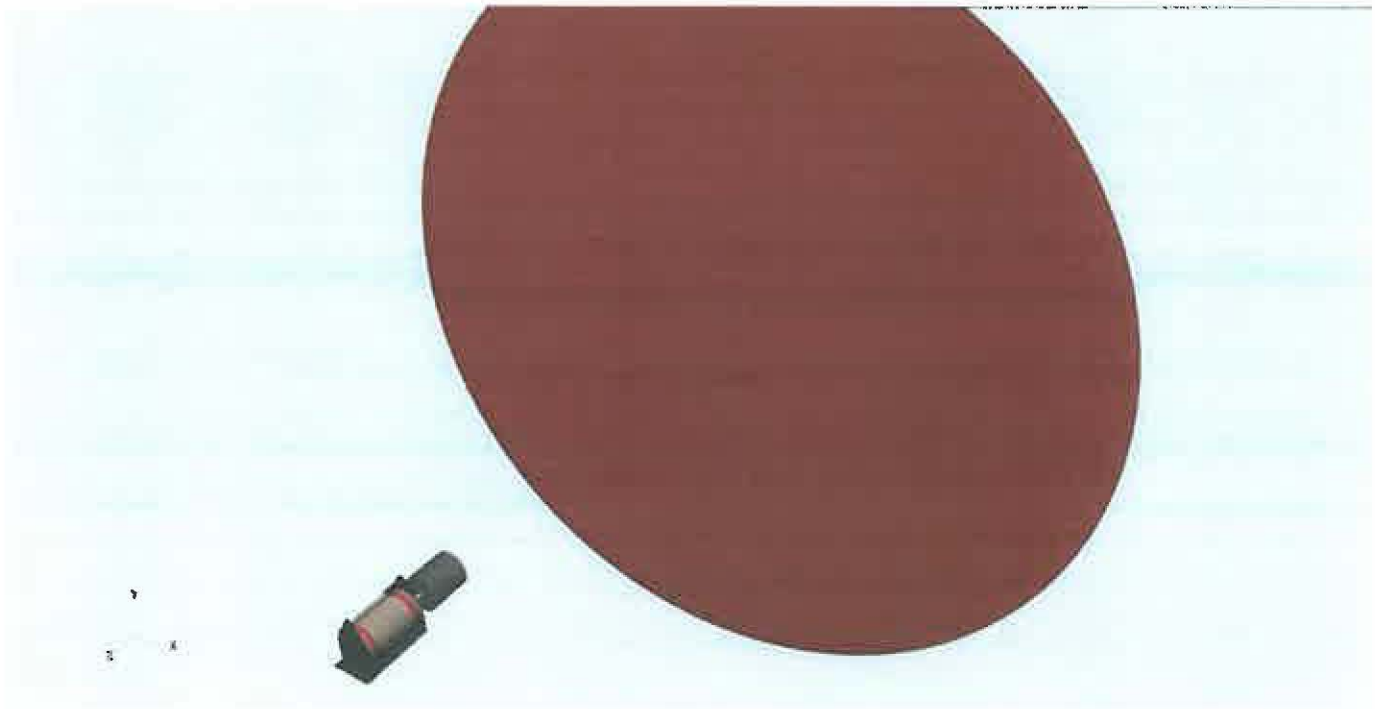
Date: Thursday, October 26, 2017 - 09:47:16
Description: CRIBHOUSE 3M
Comment: CRIBHOUSE 3M
File Name: C:\GENIE2K\isocs\data\GEOMETRY\In-Situ\CIRCULAR_PLANE\CRIBHOUSE 3M.geo
Software: ISOCS
Template: CIRCULAR_PLANE, Version: (default)
