Field Performance of a Compacted Clay Landfill Final Cover at a Humid Site

Abstract: A study was conducted in southern Georgia, USA, to evaluate how the hydraulic properties of the compacted clay barrier layer in a final landfill cover changed over a 4-year service life. The cover was part of a test section constructed in a large drainage lysimeter that allowed continuous monitoring of the water balance. Patterns in the drainage (i.e., flow from the bottom of the cover) record suggest that preferential flow paths developed in the clay barrier soon after construction, apparently in response to desiccation cracking. After four years, the clay barrier was excavated and examined for changes in soil structure and hydraulic conductivity. Tests were conducted in situ with a sealed double-ring infiltrometer and two-stage borehole permeameters and in the laboratory on hand-carved blocks taken during construction and after four years of service. The in situ and laboratory tests indicated that the hydraulic conductivity increased approximately three orders of magnitude (from $\approx 10^{-7}$ to $\approx 10^{-4}$ cm·s⁻¹) during the service life. A dye tracer test and soil structure analysis

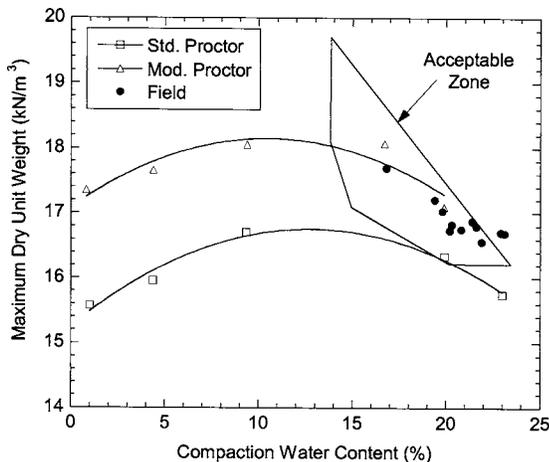
Fig. 2. Standard and modified Proctor compaction curves for clayey sand used for the barrier layer along with the acceptable zone defining combinations of water content and dry unit weight yielding hydraulic conductivity $< 1 \times 10^{-7} \text{ cm} \cdot \text{s}^{-1}$. The acceptable zone was developed using the method described in Daniel and Benson (1990). Field measurements made with a nuclear density gauge. Two of the field data points fall directly on top of each other (water content=21.5% and dry unit weight=16.5 kN/m³).

During construction, water content and dry unit weight were measured at four locations in each lift with a nuclear density gauge following methods described in ASTM D 2922 (ASTM 2005a). All measurements were made within the perimeter of the lysimeter. As shown in Fig. 2, all but two of the water content-dry unit weight measurements made during construction fall within the acceptable zone. The two outliers are slightly wet of the acceptable zone and are aligned with the compaction curve corresponding to modified Proctor effort.

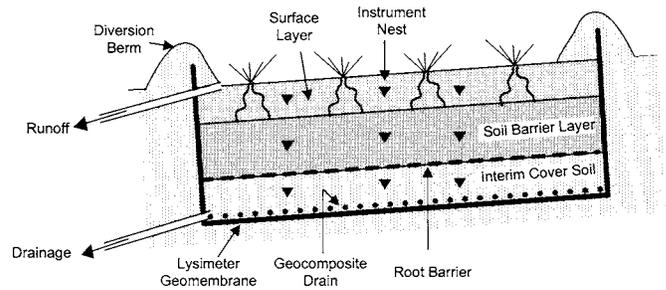
Fig. 3. Schematic of ACAP lysimeter

A $10 \times 20 \text{ m}$ instrumented pan-type lysimeter (Fig. 3) constructed of 1.5-mm linear low-density polyethylene was used for direct measurement of the water balance. Methods used to install the lysimeter are described in Benson et al. (1999a) and Bolen et al. (2001). Seams in the geomembrane were tested using air pressure and vacuum box methods. A leak test was also conducted with water pooled in the lysimeter in accordance with the test procedure in Benson et al. (1999a).

A geocomposite drainage layer was placed on top of the lysimeter geomembrane to rapidly transmit water draining from the soil profile to the measurement system and to protect the geomembrane during placement of the cover soils. A surface berm was used to collect surface water runoff for measurement and to prevent surface water run-on. Drainage and surface runoff were conveyed through pipes to basins where flows were measured. Both collection basins were equipped with a pressure transducer and, for the drainage system, a tipping bucket gauge. The collection systems permit resolution of runoff to better than 1 mm year^{-1} and drainage to less than 0.1 mm year^{-1} (Benson et al. 2001).

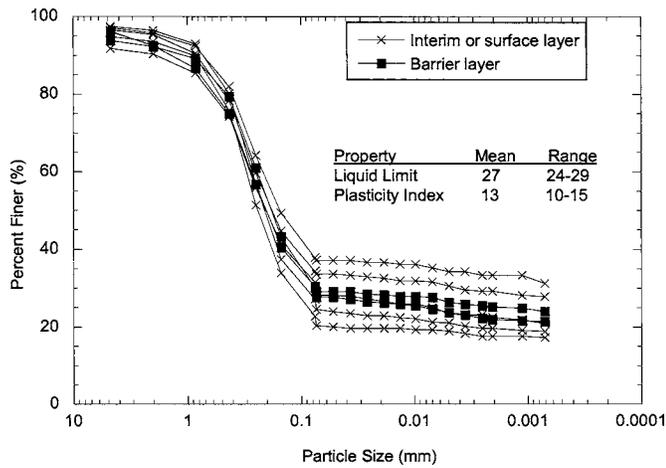
Fig. 4. Particle size distribution and Atterberg limits of soils used in the test section

A sampling program was conducted during construction to characterize the in-place cover soils. Four disturbed samples (20-L buckets) were removed from each lift immediately after placement. The disturbed samples were analyzed for particle size distribution (ASTM D 422) (ASTM 2002c), Atterberg limits (ASTM D 4318) (ASTM 2005b) and compaction behavior (ASTM D 698) (ASTM 2000). The particle size distribution curves and Atterberg limits are shown in Fig. 4.

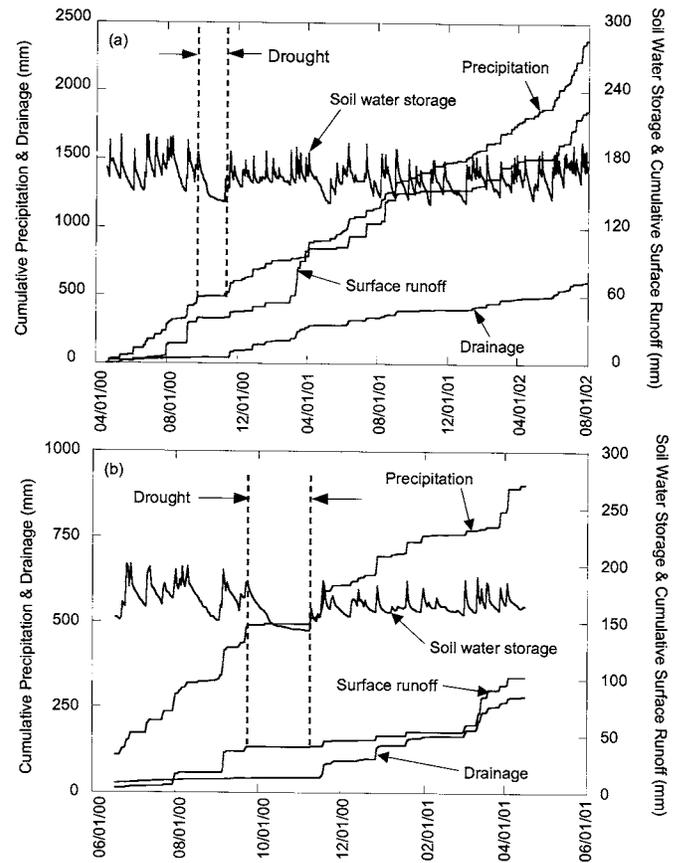
Fig. 5. Water balance components of the compacted clay cover for (a) the entire field test; (b) the period immediately prior to and following the drought in fall 2000

The water balance of the test section (precipitation, surface runoff, drainage, and soil water storage) was monitored for 864 days immediately following construction (April 19, 2000, to August 1, 2002). The water balance quantities are shown as a function of time in Fig. 5(a) and are tabulated in Table 2. Annual precipitation during the first two complete years (April 19–April 18) of monitoring was 72% and 68% of the long-term average annual precipitation (1273 mm) recorded at the nearby Albany National Oceanographic and Atmospheric Administration (NOAA) station. Irrigation was applied after the first year of monitoring to stimulate growth of the vegetative cover. Over the monitoring period, drainage was 25.6% (608 mm) of the applied water (precipitation+irrigation) and surface runoff was 9.4% (223 mm) of the applied water.

A noticeable change in the drainage rate occurred during the fall of 2000, approximately eight months following construction [Fig. 5(b)]. The change followed a 7-week drought between September 23 and November 15, 2000, during which time the soil water storage decreased monotonically. Desiccation cracks were observed in the soil surface at the end of this period (Albright and Benson 2003). The amount of drainage, relative to precipitation, increased following the drought, and at the same time, there was a change in temporal response of drainage to individual precipitation events (Fig. 5(b)). Following the drought, drainage was often observed within 1 h of precipitation events and exhibited a “stair-step” pattern indicative of preferential flow, whereas drainage occurred at a relatively steady rate prior to the drought.

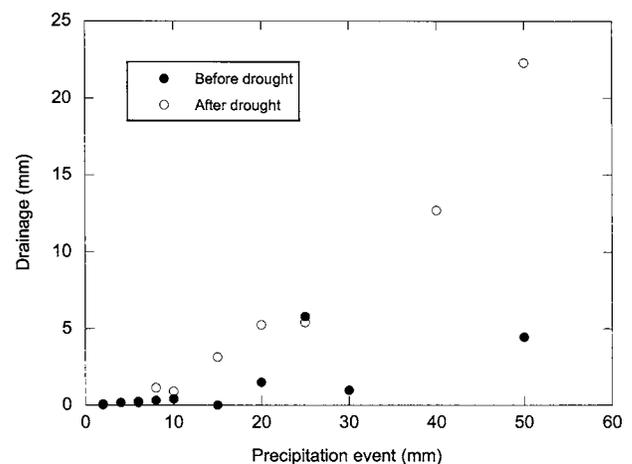
Fig. 6. Drainage before and after drought as a function of magnitude of precipitation event. Precipitation events were grouped in increments according to size (2 mm increments for events <10 mm, 5 mm increments for events 10–30 mm, 10 mm increments for events 30–50 mm). For each increment, average resulting drainage was calculated for all precipitation events in that increment.

The influence of the 7-week drought is also evident in the quantity of drainage resulting from individual precipitation events, as shown in Fig. 6 in terms of the average daily drainage rate for precipitation events of different size before and after the drought. The precipitation events in Fig. 6 were defined as periods of precipitation separated by at least 12 h of no recorded precipitation and were grouped in increments according to size (2-mm

increments for events <10 mm, 5 mm increments for events between 10 and 30 mm, and 10 mm increments for events between 30 and 50 mm). The data points in Fig. 6 relate all precipitation events in a given increment to the average total drainage resulting from those precipitation events for time periods before and after the drought.

Drainage was essentially the same before and after the drought for precipitation events <5 mm (Fig. 6). In contrast, greater drainage occurred after the drought for nearly all precipitation events and the difference between drainage before and after the drought increased with increasing size of the precipitation event. For example, precipitation events between 5 mm and 30 mm generally resulted in more drainage after the drought than before by at least a factor of 2 (with one outlier at the 25-mm precipitation increment). The sensitivity of the difference in drainage rates before and after the drought may be due to the amount of infiltration stored in the surface layer because of a precipitation event. For small (<5 mm) precipitation events, nearly all of the infiltration was stored in the surface layer, preventing flow into the barrier layer. In contrast, infiltration from larger storms was sufficient to initiate flow into to the barrier layer.

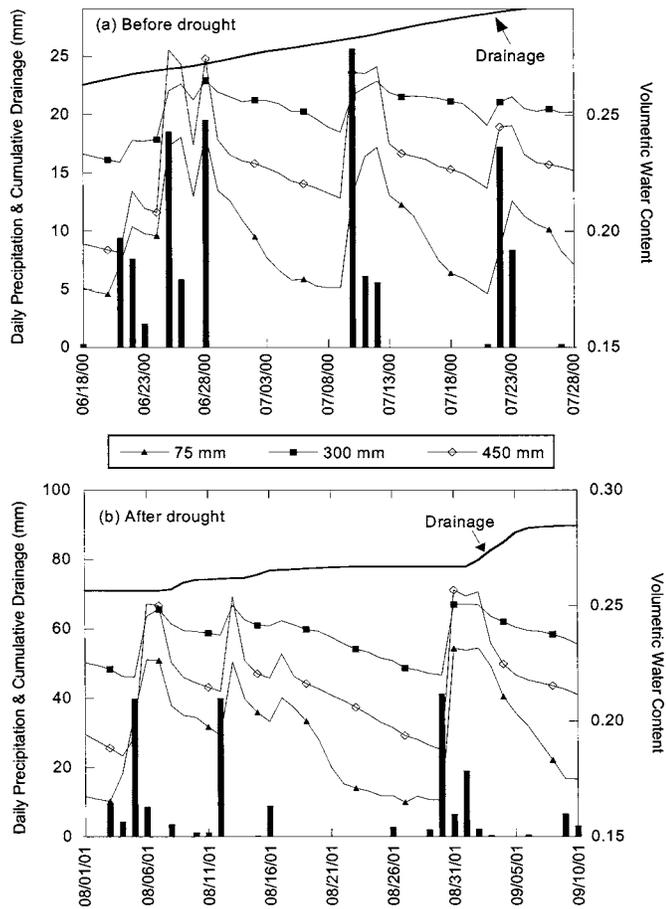
Fig. 7. Water content of cover soils, daily precipitation, and cumulative drainage (a) before; (b) after the drought. Legend indicates depth of probe placement. Precipitation shown as vertical bars.

The temporal response of drainage and soil water content to precipitation is shown in Fig. 7 for conditions before [Fig. 7(a)]

and after [Fig. 7(b)] the drought. Daily precipitation is shown as vertical bars. The lines correspond to cumulative drainage and spatially averaged water content at three depths in the soil profile (75, 300, and 450 mm). Water content at the 300 and 450 mm depths typically varied <0.05 between the three sensors at each depth whereas water contents reported by the surface sensors varied by as much as 0.15. During the summer of 2000 (the first few months after construction and before the drought), drainage occurred at a relatively steady rate and showed little variation in response to daily precipitation events, even those in excess of 25 mm day^{-1} , indicating that there was little or no preferential flow. In contrast, during the following summer (after the drought), the drainage rate increased rapidly following most precipitation events, and most of the drainage occurred within 24 h of a precipitation event. Following the drought, drainage rates typically returned to near-zero within 1–2 days of precipitation events.

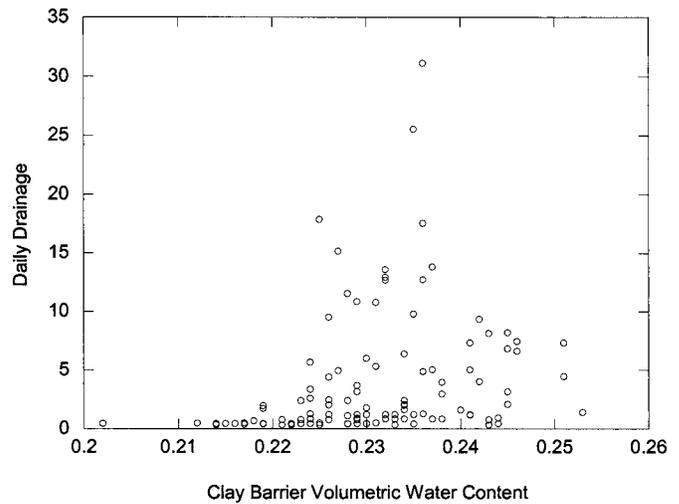
Fig. 8. Preferential flow after the drought as a function of water content of the clay barrier. For each day with recorded precipitation, daily drainage was plotted against volumetric water content of the clay barrier just prior to the precipitation event.

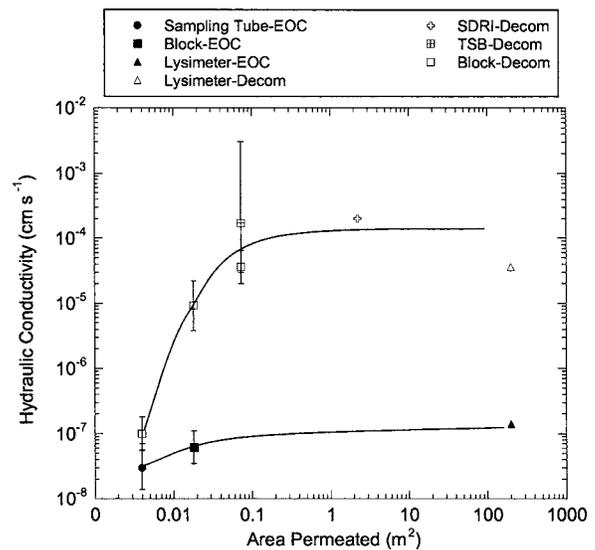
Fig. 9. Hydraulic conductivity of barrier layer as a function of area permeated for conditions at the end of construction after four years of service. EOC=end of construction. Decom=at the time of decommissioning.

The saturated hydraulic conductivity after four years was also scale dependent, as shown in Fig. 9 as a function of the permeated cross-sectional area. The geometric mean hydraulic conductivity increases nearly two orders of magnitude as the permeated cross-sectional area of soil that was permeated increases from 0.04 m 2 to 0.73 m 2 . For larger areas, the hydraulic conductivity appears scale independent. The scale dependence at Albany is

consistent with previous studies by Daniel (1984), Day and Daniel (1985), and Benson et al. (1994), which have shown that the hydraulic conductivity of small-scale laboratory specimens can be orders of magnitude lower than the field-scale hydraulic conductivity when clay barriers contain macroscopic defects. Similar results were noted in a study of a field soil by Sisson and Wierenga (1981), who found that small-scale (50 mm) measurements did not adequately represent field-scale (6.35 m) infiltration and that measurements at 250 mm and 1270 mm were much more representative.

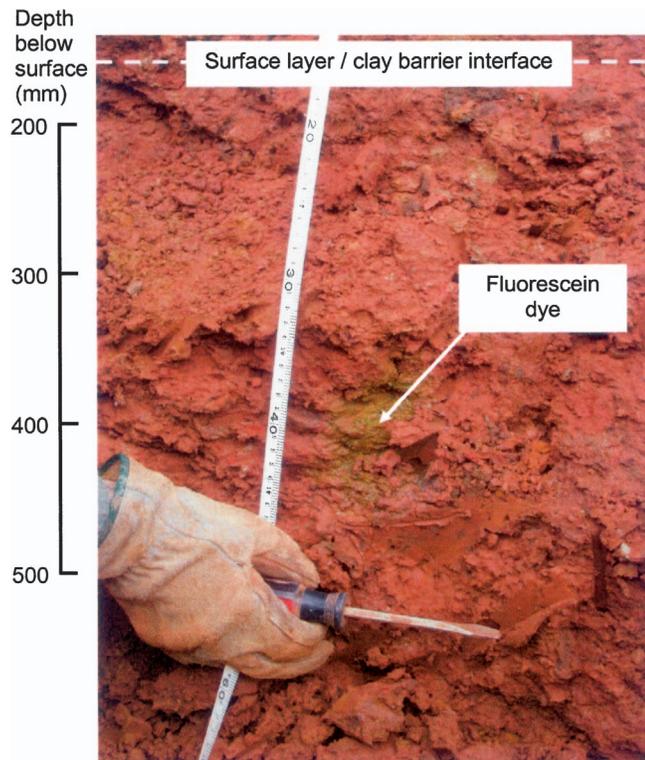
Fig. 10. (Color) Photograph of wall of trench in clay barrier showing presence of green fluorescein dye flowing through a preferential flow path. The depth of the dye is 400 mm, which is below 150 mm of surface layer and 250 mm of clay barrier.

Examination of the trench walls in the regions where dye was pooled showed that dye was flowing from numerous cracks throughout the depth of the barrier layer. Fluorescein does not stain the soil to leave a visual record. Therefore, the presence of dye flowing from these cracks was strong evidence that preferential flow was occurring. Dye was also clearly visible in water draining from the lysimeter, indicating that the dyed water pooled on the surface passed through the soil barrier quickly. A typical example of dyed water flowing from a crack in a trench wall is shown in Fig. 10. Green dye is flowing from a crack at a depth of 400 mm (250 mm below the interface between the surface and barrier layers).

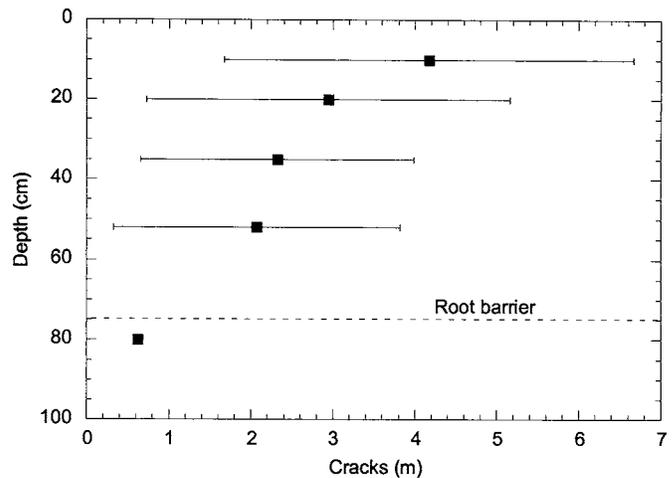
Fig. 11. Spacing of vertical cracks in the compacted clay cover after four years of service. Horizontal bars indicate one standard deviation. Below the root barrier, only one crack was recorded.

Inspection of the exposed trench wall also revealed numerous cracks in the soil barrier layer with the density of cracks generally decreasing with depth (Fig. 11). The cracks were spaced at intervals of approximately 100–300 mm. Roots were also observed throughout the barrier layer and typically existed in cracks. Soil structure formed in the clay barrier consisted of platy and blocky types. Platy structure was most common and best developed between the surface and about 400 mm depth, with the strongest development between about 50 and 260 mm depth. Blocky structure was most common between 50 and 600 mm depth (to the top of the root barrier) with the strongest development between 50 and 140 mm depth. Most of the cracks found in the soil barrier
