Properties of geosynthetics exhumed from a final cover at a solid waste landfill

Samples of geocomposite drain (GCD), geomembrane (GM), and geosynthetic clay liner (GCL) were exhumed from a final cover at a solid waste landfill to assess their condition after 4.7–5.8 yr of service. Permittivity of the GCD diminished by a factor of 3.9, but the transmissivity was higher than published by the manufacturer. Ply adhesion of the GCD diminished by a factor of 2.0. Geonet ribs in the geocomposite drain (GCD) contained a light coating of fines and plant roots, but there was no evidence of significant clogging. The geotextile on the upper surface of the GCD met the commonly used criterion for filtration (AOS < 0.6 mm for adjacent soil with <50% fines), indicating that this filtration criterion was satisfactory. Tensile yield strength of the GM diminished by a factor of 1.2, but the melt flow index was unchanged and the oxidation induction time exceeded the manufacturer's specification. GCD-geomembrane interface strength appeared unchanged. Four GCL samples had hydraulic conductivities 1000–10,000 times higher than the hydraulic conductivity measured during construction, whereas hydraulic c

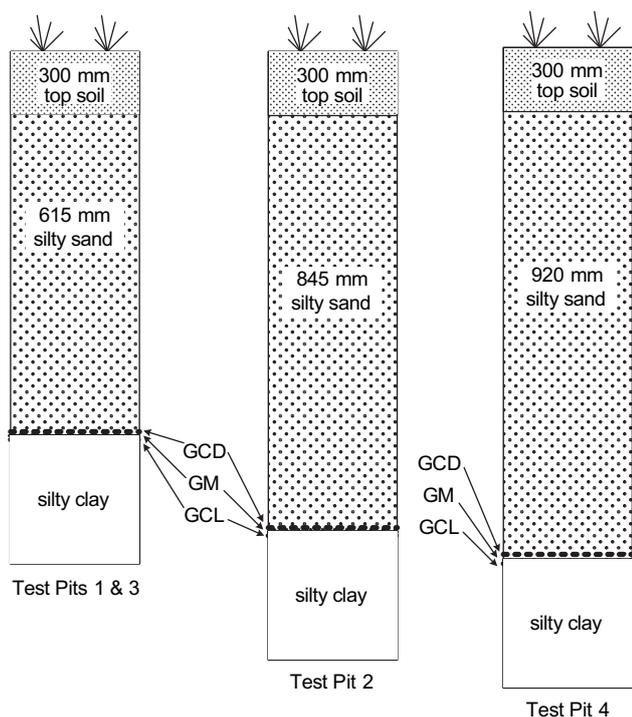
Fig. 1. Profiles of the final cover observed in Test Pits 1 through 4. GCD = geocomposite drain, GM = geomembrane, and GCL = geosynthetic clay liner.

A schematic of the final cover profile observed in test pits is shown in Fig. 1. The final cover consists of (top–bottom) a surface layer of top soil (300 mm), a silty sand (615–920 mm) protective layer, a geocomposite drain (GCD), a geomembrane (GM), and a geosynthetic clay liner (GCL). The GCL was placed on top of a layer of fine-grained subgrade. General characteristics of the geosynthetics exhumed from the test pits are summarized in Table 1.

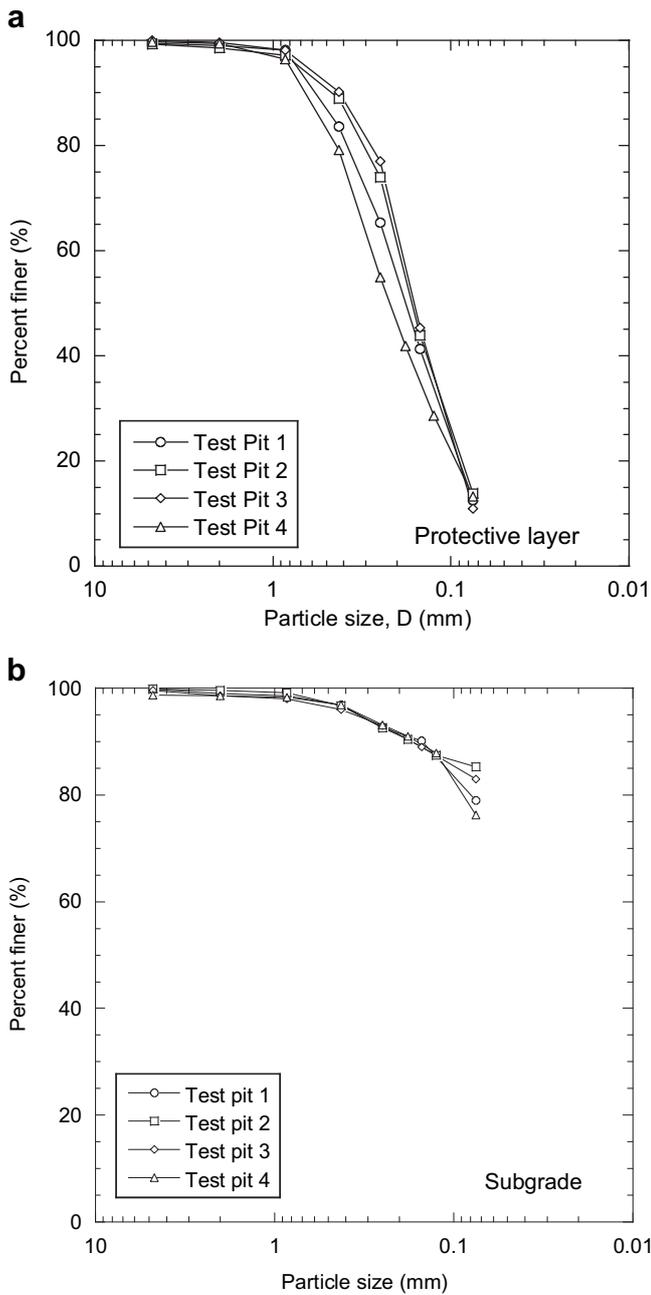
Fig. 2. Particle size distributions of the protective layer (a) and subgrade (b).

Bulk soil samples were collected from soil layers directly adjacent to the geosynthetics (protective layer and subgrade) for particle size analysis. Ionic strength and relative abundance of monovalent and divalent cations in the pore water of the subgrade were determined using the batch elution method in ASTM D 6141 (*Standard Guide for Screening Clay Portion of Geosynthetic Clay Liner (GCL) for Chemical Compatibility to Liquids*, ASTM, 2007). Particle size distributions of the soils are shown in Fig. 2. Similar soils were present in each layer in all four test pits. The protective layer was comprised of clayey sand with a USCS designation of SP–SC, whereas the subgrade was a silty clay with a USCS designation of CL–ML. Water content of the subgrade, which was in direct contact with the GCL, fell within a narrow range (14.5–16.2%, Table 2), with a median of 15.4%. Chemical characteristics of the subgrade pore water are also summarized in Table 2. The pore water is dominated by divalent cations ($RMD \ll 1 M^{0.5}$), which is characteristic of most cover soils (Meer and Benson, 2007; Benson and Meer, 2009).

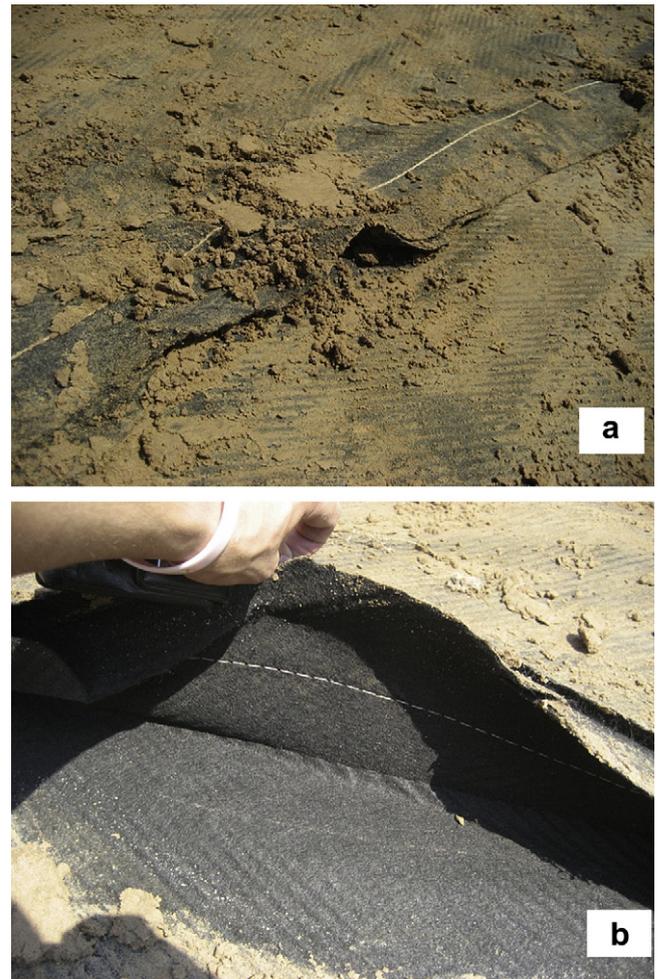
None of the geosynthetic materials had visible defects. Seams joining the GCD panels were flat and stitches bonding the geotextiles appeared to be un-weathered (Fig. 3). The geotextile was effective in retaining the overlying soil, as the overlapped areas were free of soil penetration (Fig. 3b). Roots extended throughout the soil profile, and were present in the geonet component of the GCD (Fig. 4). However, no roots were found beneath the geomembrane. A light coating of fines was present on the geonet ribs, but there was no indication of severe clogging. Geomembrane seams (Fig. 5) and GCL overlaps (Fig. 6) appeared similar to conditions typically observed during installation. No distortion or separation of the GCL was observed. Alignment of the GCLs followed the match points provided by the manufacturer (Fig. 6a), suggesting no movement of the GCL after placement. Hydrated supplemental bentonite was also present in each overlap (Fig. 6b).

Fig. 3. Seam joining geotextiles in adjacent GCD panels in Test Pit 1: (a) seam after removing cover soil (fish mouth in middle is due to disturbance during excavation) and (b) close up showing stitching of geotextiles and clean geotextiles in the overlap.

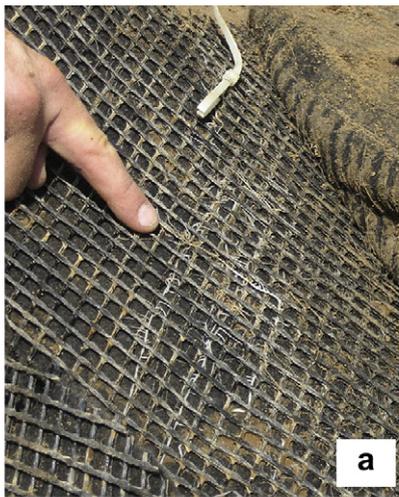
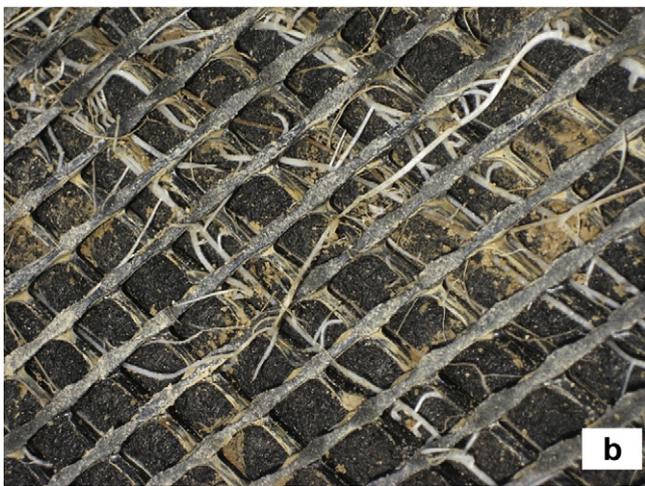
Fig. 4. Roots in the GCD and fines coating the ribs of the geonet in Test Pit 1: (a) overview and (b) close up.

The modest reduction in permittivity that occurred while in service was probably due to penetration of soil into the upper geotextile, which retained 18–323 g/m^2 of soil (Benson et al., 2008). AOS of the exhumed geotextile was also lower than the AOS published by the manufacturer (Fig. 8), which is consistent with retention of soil within the pores of the geotextile (i.e., soil in the pores of the geotextile reduces the AOS). Variation in the amount of soil retained within the geotextile probably was responsible for the variation in permittivity in each test pit. Roots in the geonet (Fig. 4) may also have contributed to the reduction in permittivity.

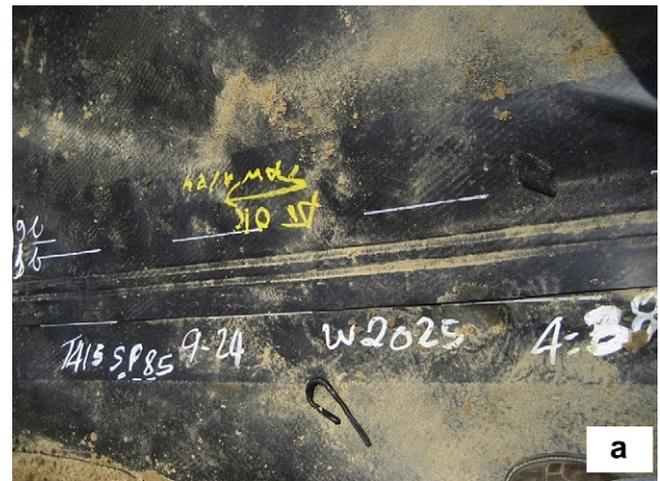
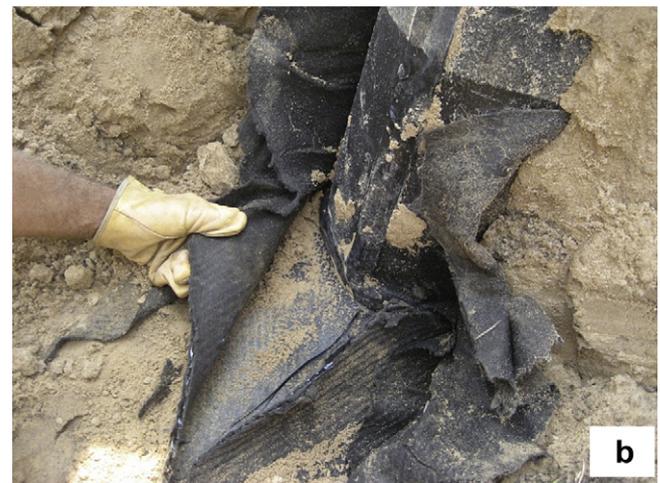
Fig. 5. Examples of seams observed during exhumation: (a) dual-track wedge well uncovered in Test Pit 4 and (b) extrusion well to boot for gas well near Test Pit 4.

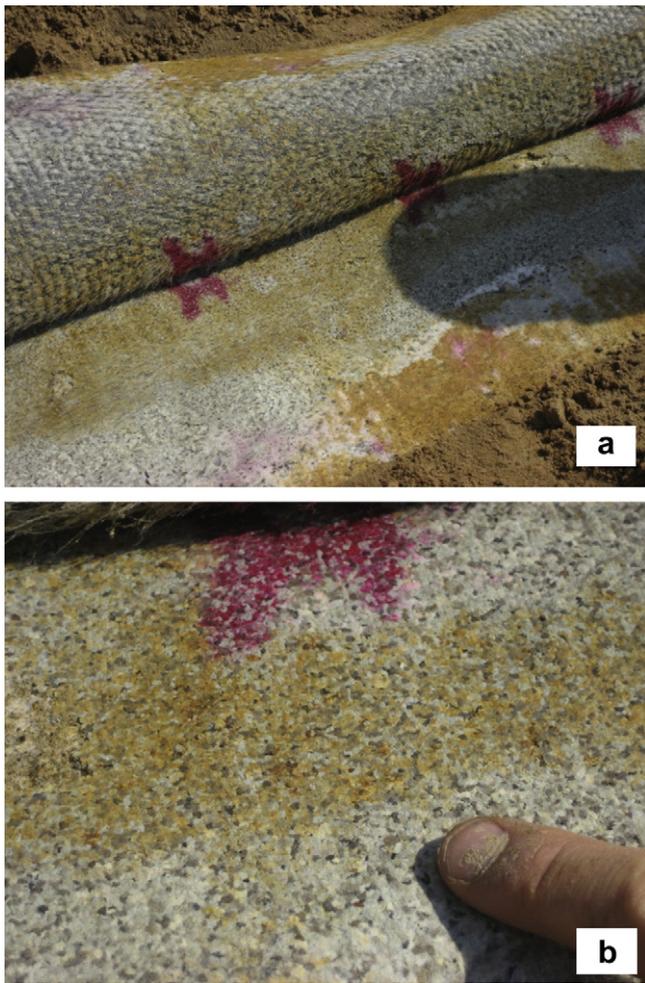
Fig. 6. GCL overlap in Test Pit 3: (a) match point along marks on original product and (b) close up showing hydrated bentonite granules in the overlap.

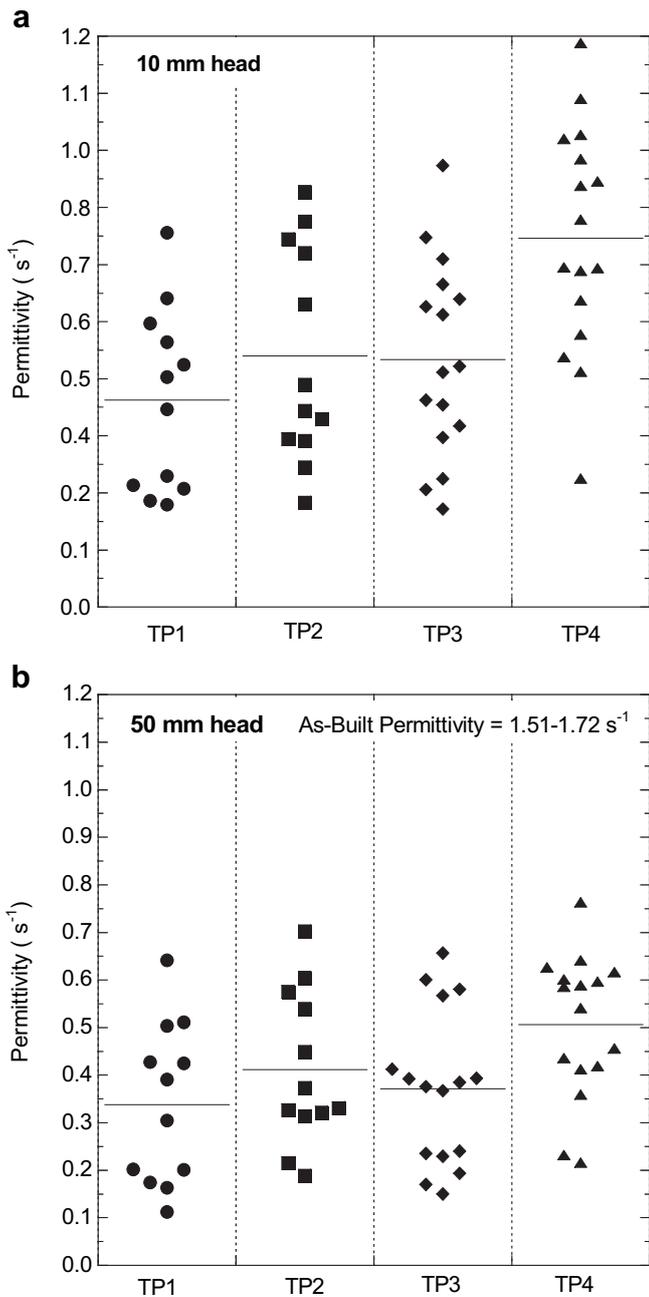
Permittivity of the GCD is shown in Fig. 7. The permittivity in each test pit ranged nearly one order of magnitude at 10 mm head and approximately one-half order of magnitude at 50 mm head. Samples from Test Pit 4 had slightly higher permittivity than those from the other test pits, but in general the permittivity did not vary appreciably (<50%) between test pits. In addition, there is no systematic difference between the permittivities of samples from Test Pits 1 and 2 and those from Test Pits 3 and 4, suggesting that there was no practical difference between the permittivity on the top deck and the slopes.

A direct comparison between permittivity of the exhumed GCD and the as-built condition can only be made for tests conducted with 50 mm head (tests at 10 mm head were not conducted during construction). At 50 mm head, all of the exhumed samples had permittivity lower than the permittivity measured during CQC, which ranged between 1.51 and 1.72 s^{-1} (1.61 s^{-1} , on average). Permittivity of the exhumed samples was at most 14.6 times lower, and 3.9 times lower on average, than the average as-built permittivity. Nevertheless, the permittivity of the exhumed GCD was still at least ten times higher than necessary to conduct unit gradient flow from the overlying silty sand (saturated hydraulic conductivity $< 10^{-5} \text{ m/s}$, Benson et al., 2008). Reitz and Holtz (1997) report similar reductions in permittivity for four geotextiles exhumed from landfill final covers in Washington State that were in service from 5 to 9 yr.

Fig. 7. Permittivity of GCD measured using 10 mm head (a) and 50 mm head (b). Horizontal bars in each column represent the average for the data in the column.

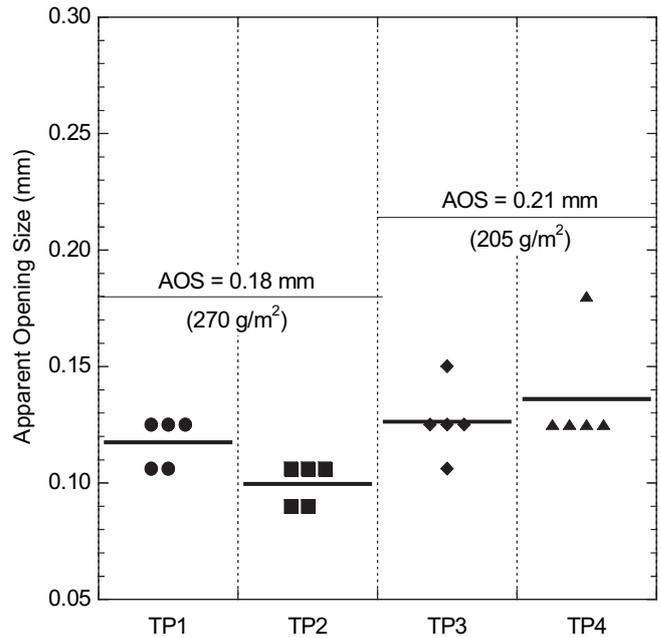
Fig. 8. Apparent opening size of the upper geotextile in the GCD. Horizontal bars in each column represent the average for the data in the column.

A comparison with the as-built transmissivity could not be made, as transmissivity tests were not conducted on the GCD as part of CQC testing. However, at 480 kPa, the transmissivity of the exhumed GCD is higher than the transmissivity published by the manufacturer ($4.0 \times 10^{-5} \text{ m}^2/\text{s}$ for the GCD in Test Pits 1 and 2; $6.0 \times 10^{-5} \text{ m}^2/\text{s}$ for the GCD in Test Pits 3 and 4, Fig. 9b). As noted previously, the geotextile was effective in filtering the overlying soil, as only a light coating of fines was present on the ribs of the geonet. This satisfactory filtration is consistent with the AOS of the geotextile, which met the common criterion for filtration (AOS < 0.6 mm for adjacent soils with less than 50% fines, Koerner, 1998) (Fig. 8).

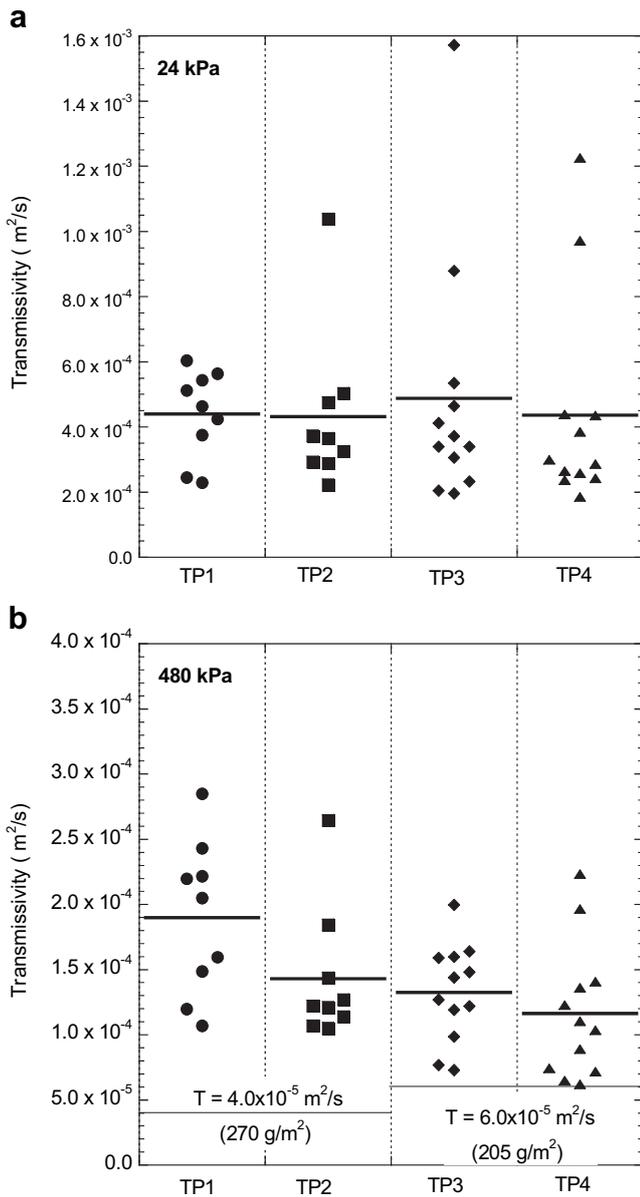
Transmissivity of the GCD at a hydraulic gradient of 1.0 and at confining stresses of 24 and 480 kPa is shown in Fig. 9. Within a test pit, the transmissivity varies by at most a factor of 6 (24 kPa) or 8 (480 kPa), and between test pits the average transmissivity varies less than a factor of 2. Moreover, as with permittivity, there is no systematic difference between transmissivities for samples from Test Pits 1 and 2 and those from Test Pits 3 and 4, suggesting that there is no practical difference between the transmissivity on the top deck and the side slopes.

Fig. 9. Transmissivity of GCD under a normal stress of (a) 24 kPa and (b) 480 kPa. Horizontal bars in each column represent the average for the data in the column.

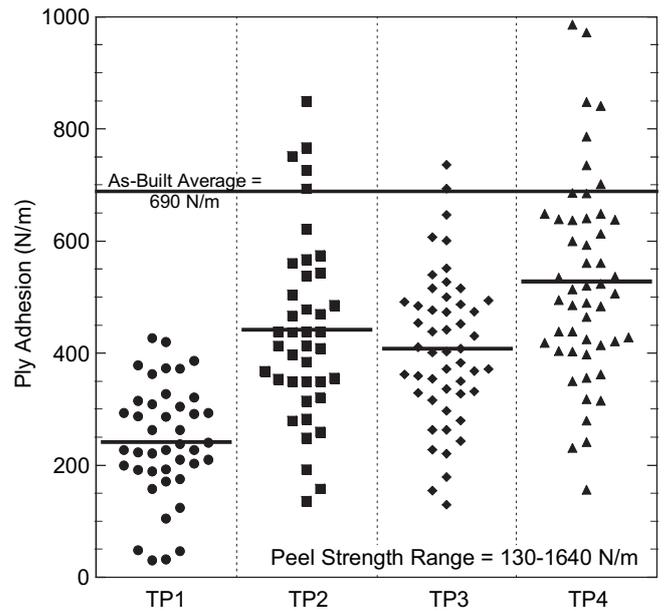
Ply adhesion of the exhumed GCD measured at UW and TRI is shown in Fig. 10. Data sets from both laboratories fell in similar clusters. Thus, the data from both laboratories were combined for analysis.

Ply adhesion varies by as much as a factor of 6 within each test pit, with the maximum variation in Test Pit 4. Samples of the GCD exhumed in Test Pit 1 (side slope) have 2 times lower ply adhesion, on average, than those from the other test pits. However, the ply adhesion is similar in Test Pits 2–4. Thus, there is no apparent difference in ply adhesion than can be attributed to the GCD being exhumed from the side slope (Test Pits 1 and 2) or the top deck (Test Pits 3 and 4).

Fig. 10. Ply adhesion of GCD in each test pit. Horizontal bars in each column represent the average for the data in the column.

The average ply adhesion in each test pit is 1.7–2.2 times lower than the average ply adhesion measured during CQC (690 N/m). Inspection of specimens prior to testing showed that the bond between the geotextile and geonet had separated in some regions, and specimens with greater bond separation had lower ply adhesion. In addition, a clean separation occurred between the geotextile and geonet in the specimens with low ply adhesion (e.g., Test Pit 1, Fig. 10), suggesting that the bond between the geosynthetics in these specimens may never have been viable.

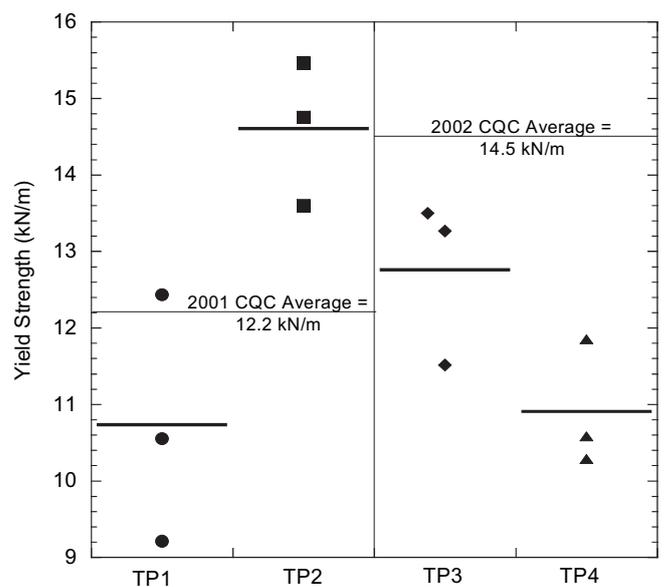
Tensile strengths of the geomembrane are shown with dot plots in Fig. 11. Average tensile strengths measured with ASTM D 638

during CQC in 2001 and 2002 are shown as horizontal lines in Fig. 11. Except for Test Pit 2, average tensile strengths of the exhumed geomembranes are lower than the average tensile strengths measured during CQC (12.2 kN/m in 2001, 14.5 kN/m in 2002). When Test Pit 2 is excluded, the average tensile strength in each test pit was a factor of 1.15–1.22 lower than the average tensile strength measured during CQC.

Fig. 11. Tensile yield strengths of exhumed geomembrane samples. Solid horizontal bars are average tensile strength for a given test pit.

A definitive reason for this reduction in tensile strength was not apparent when the specimens were exhumed (e.g., they did not contain visible defects), but damage incurred during installation, exhumation, and in-service conditions may be responsible. These reductions in tensile strength apparently are not due to degradation of the polymer. MFI of the exhumed geomembranes is essentially the same as the MFI measured for manufacturer quality control (MQC) and CQC (Fig. 12), and the OIT of the exhumed geomembranes exceeded the 100 min MQC specification (Table 4).

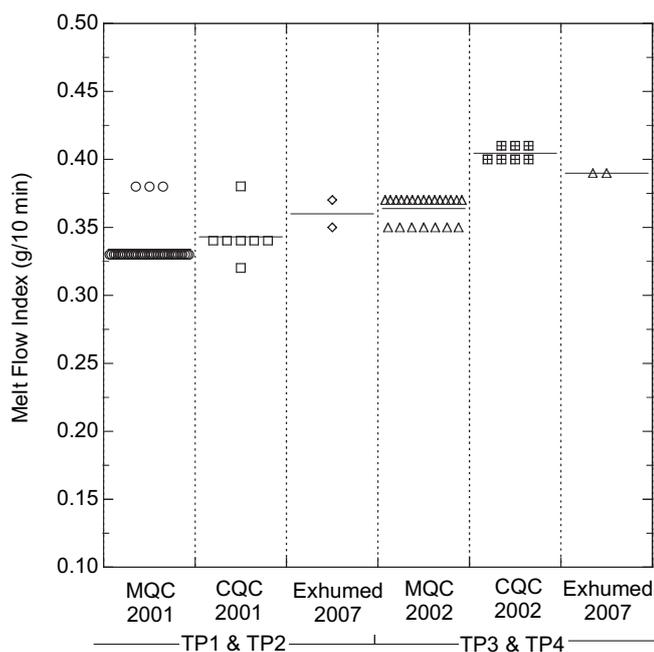
Fig. 12. Melt flow index of the geomembrane determined by the manufacturer, during CQC, and after exhumation in 2007. Horizontal bars in each column represent the average for the data in the group.

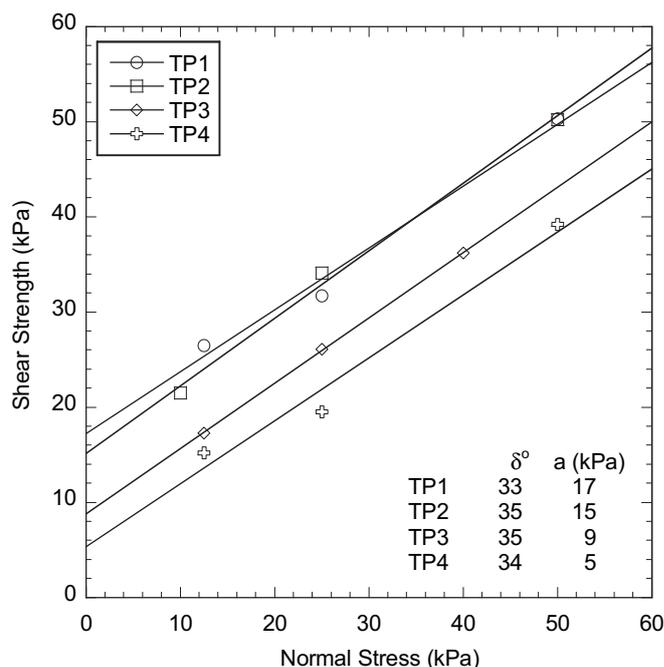
Peak-strength envelopes for the GCD-geomembrane interface are shown in Fig. 13. One strength envelope was determined for each test pit. Similar interface friction angles, δ , were obtained from each pit (33–35°), but the adhesion, a , was 2 times larger for the geosynthetics exhumed from Test Pits 1 and 2 compared to Test Pits 3 and 4. Greater adhesion may have been obtained for the samples from Test Pits 1 and 2 because the GCD on the side slope contained a heavier geotextile (270 vs. 205 g/m², Table 1). No visible difference in texturing was evident in the exhumed geomembrane samples that could explain the differences in adhesion. Deployment on the slope (Test Pits 1 and 2) versus the top deck (Test Pit 3 and 4) probably was not responsible for the differences in adhesion.

Fig. 13. Peak interface shear strength envelopes for geomembrane-GCD interface.

No interface shear tests were conducted during CQC. Thus, a direct comparison between interface shear strengths of the exhumed and as-built conditions cannot be made. However, for similar materials, Stark et al. (1996) report peak interface friction angles ranging between 30 and 32° and adhesions ranging between 5 and 17 kPa. Given the similarity of the strength parameters of the

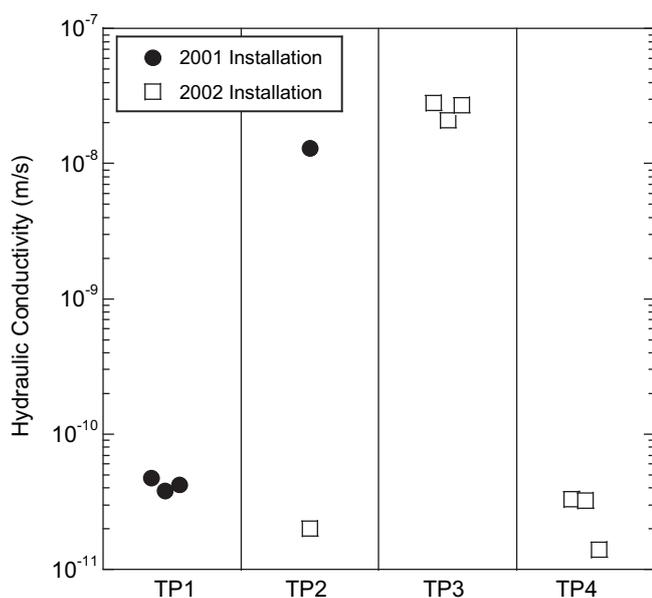
Hydraulic conductivities of exhumed GCLs are shown in Fig. 14. The average hydraulic conductivities of the GCLs in Test Pits 1 and 4

are similar (average = 4.2×10^{-11} and 2.6×10^{-11} m/s), even though the GCLs from these test pits represent different GCL products, installation periods (2001 vs. 2002), and service lives (4.7 vs. 5.8 yr). Additionally, the average hydraulic conductivities of the GCLs from Test Pits 1 and 4 are only slightly higher than the average hydraulic conductivity of new GCL samples measured during CQC (1.6×10^{-11} m/s) and by Meer and Benson (2007) (1.5×10^{-11} m/s). One of the GCLs exhumed from Test Pit 2 also had comparable hydraulic conductivity (average = 2.3×10^{-11} m/s) as those from Test Pits 1 and 4.

All GCLs exhumed from Test Pit 3 and one GCL from Test Pit 2 exhibited hydraulic conductivities 3–4 orders of magnitude higher than the hydraulic conductivity of the new GCL tested by Meer and

Fig. 14. Hydraulic conductivity of GCLs exhumed from Test Pits 1–4.

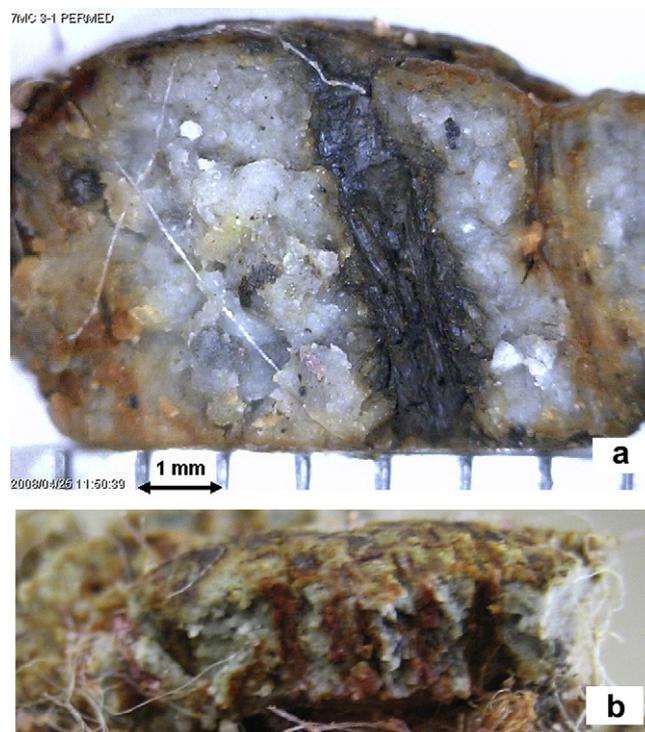
To evaluate what mechanism might be altering the hydraulic conductivity of the GCLs, the interior of each GCL specimen was inspected after testing. Specimens that had high hydraulic conductivity contained dark vertical stains that followed bundles of needle-punching fibers (Fig. 15a). Similar stains were not present in specimens with low hydraulic conductivity. Rhodamine WT dye was coincident with these dark stains (Fig. 15b), indicating that they formed or coincided with preferential pathways through the GCL that are responsible for the high hydraulic conductivity. The darkly stained material was analyzed by X-ray diffraction and determined to be manganese oxide (MnO). Mechanisms underlying the formation of these stains are being explored (Scalia and Benson, 2010).

Fig. 15. Photograph in (a) is close up of the interior showing dark stain (near center) where bundle of needle-punching fibers had passed through the bentonite. Divisions along lower edge of (a) are 1-mm apart. Photograph in (b) is cross-section of GCL showing red-stained vertical streaks where preferential flow occurred along needle-punching fibers containing dark stain. Red stain is from dye added to permeant water after detecting high hydraulic conductivity. Both photographs are of GCL TP 3–1. These photographs are representative of all GCLs with high (>10⁻⁹ m/s) hydraulic conductivity.
