The Hanford Site 1000-Year Cap Design Test

December 2002

Prepared for the U.S. Department of Energy
under Contract DE-AC06-76RL01830

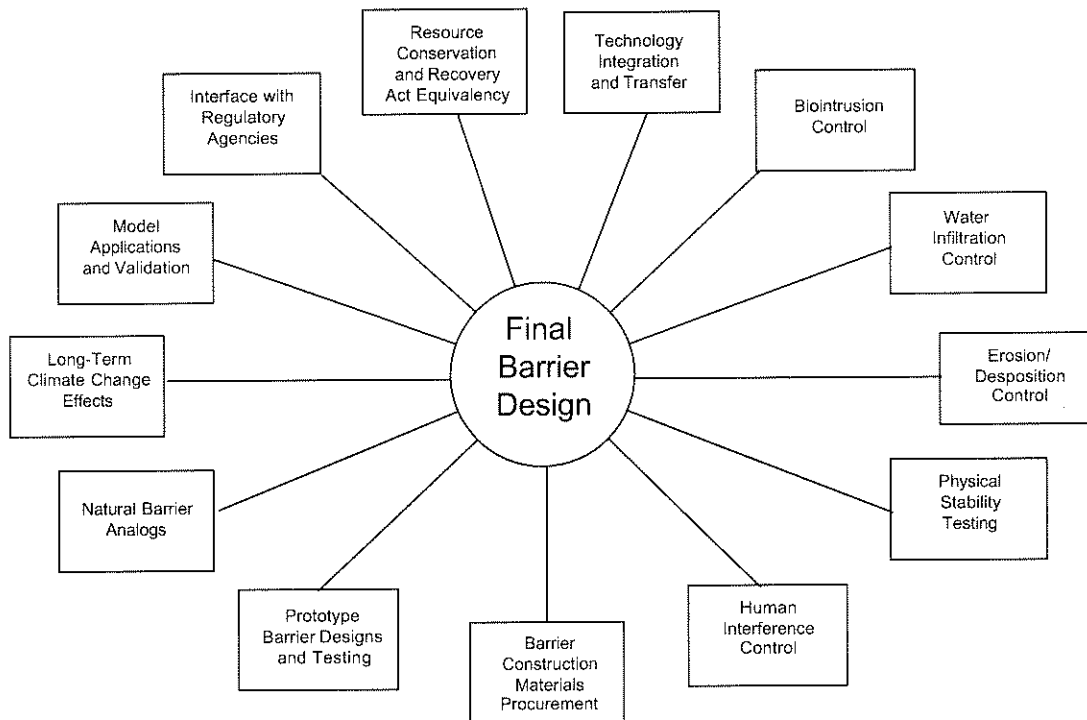
Figure 2.1. Hanford Surface Barrier (cap) -Development Tasks

Figure 2.1 shows the scope of work undertaken during the past 17 years that has been leading toward a final cap design. As part of the overall development effort, a prototype barrier, incorporating all essential elements of a long-term surface barrier, was constructed at the Hanford Site in 1994.

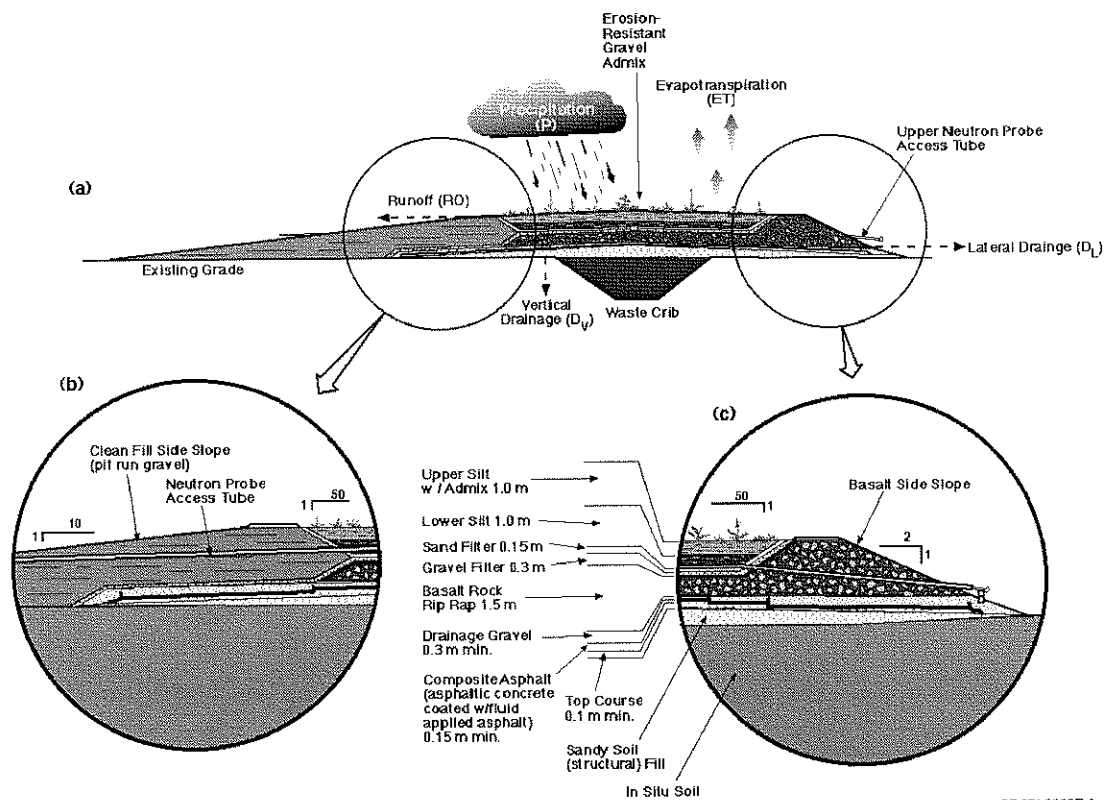
Figure 2.2. Hanford Prototype Cap (1000-year cap) Cross Section Showing (a) Interactive Water Balance Processes, (b) Gravel Sideslope, and (c) Basalt Rip-Rap Sideslope

Because of the demand for a cap that could perform for at least 1,000 years without maintenance, natural construction materials, for example, fine soil, sand, gravel, cobble, basalt riprap, and asphalt, were selected to optimize cap performance and longevity. Most of these natural construction materials are available in large quantities on the Hanford Site and are known to have existed in place for thousands of years, for example, basalt. The current cap consists of a fine-soil layer overlying other layers of coarser materials, such as sands, gravels, and basalt riprap, and is designed to limit recharge to < 0.5 mm/yr (Figure 2.2).

Each layer serves a distinct purpose. The fine-soil (silt) layer acts as a sponge or reservoir in which moisture is stored until the processes of evaporation and transpiration (ET) recycle any excess water back to the atmosphere. The fine-soil layer also provides the medium for establishing plants that are necessary for transpiration to take place. The coarser materials (sand, gravel, rock) placed directly below the fine-soil layer create a capillary break that inhibits the downward percolation of water through the barrier. The placement of fine soils directly over coarser materials also creates a favorable environment that encourages plants and animals to limit their natural biological activities to the upper, fine-soil portion of the barrier, thereby reducing biointrusion into the lower layers. The coarser materials also help to deter inadvertent human intruders from digging deeper into the cap profile. Low-permeability (composite asphalt) layers, placed in the cap profile below the capillary break, also are used in the barrier. The purpose of the low-permeability layers is (1) to divert away from the waste zone any percolating water that crosses the capillary break and (2) to limit the upward movement of noxious gases from the waste zone. The coarse materials located above the low-permeability layers serve as a drainage medium to channel any percolating water horizontally to the edges of the barrier.

In addition to testing the performance of a capillary cap design, the prototype is being used to test two different sideslope designs: (1) a relatively flat apron (10:1, horizontal: vertical) of pit-run gravel and (2) a relatively steep (2:1) embankment of fractured basalt riprap (Gee et al. 1993b; Ward and Gee 1997). Figure 2.2 also shows details of the two sideslope configurations used in the prototype barrier. A shrub and grass

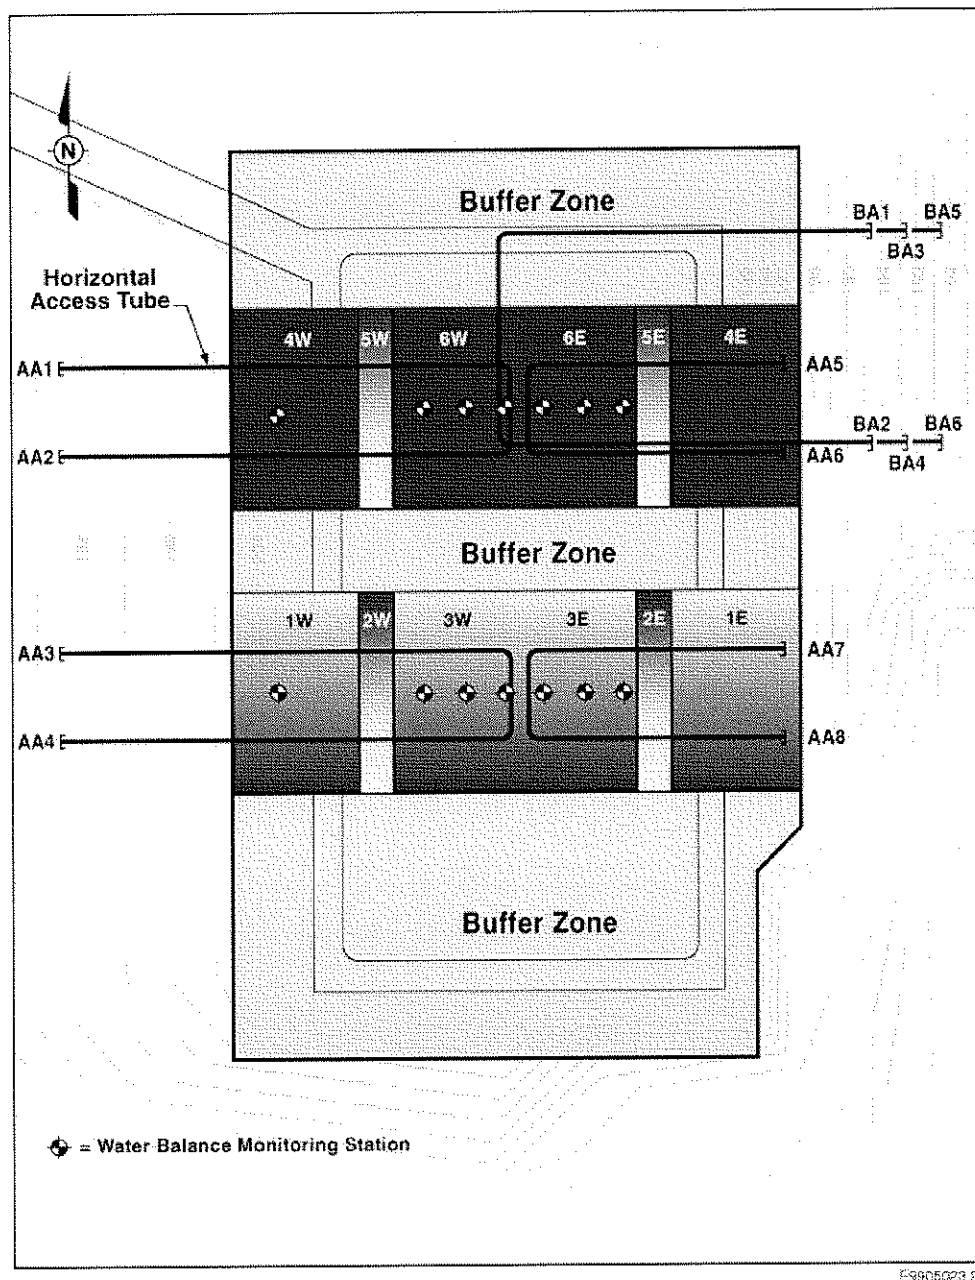
liters or less (i.e., less than 0.1 mm). Figure 2.3 shows a plan view of the cap surface and the collection zones, six each for irrigated (north end) and nonirrigated (south end) areas. Details of the monitoring are described elsewhere (Ward and Gee 1997; DOE 1999).

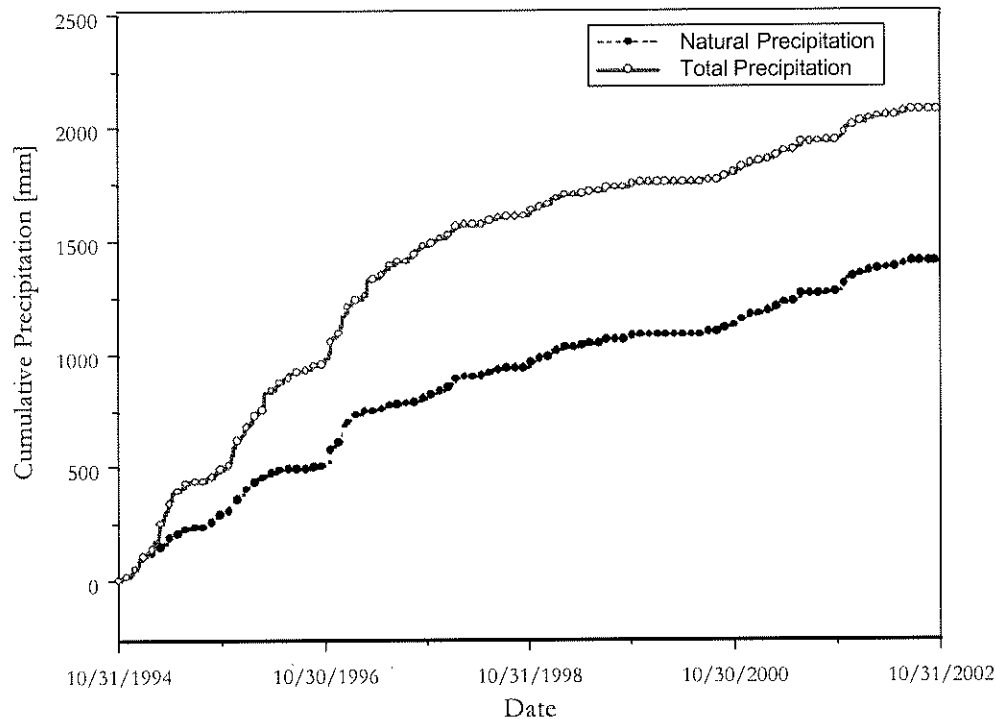
Figure 3.1. Cumulative Precipitation for the Hanford Cap Test. Solid circles are cumulative natural (ambient) precipitation. Open circles are total precipitation (irrigation plus precipitation). Irrigation continued for 3 years (1995 through 1997).

From Nov. 1994 through Oct. 1997, fine soil over sand (capillary barrier) plots on the northern half of the prototype cap were subjected to an irrigation regime of three times the long-term average annual precipitation (3X). Figure 3.1 shows the cumulative water application (irrigation plus precipitation for the 8-year test).

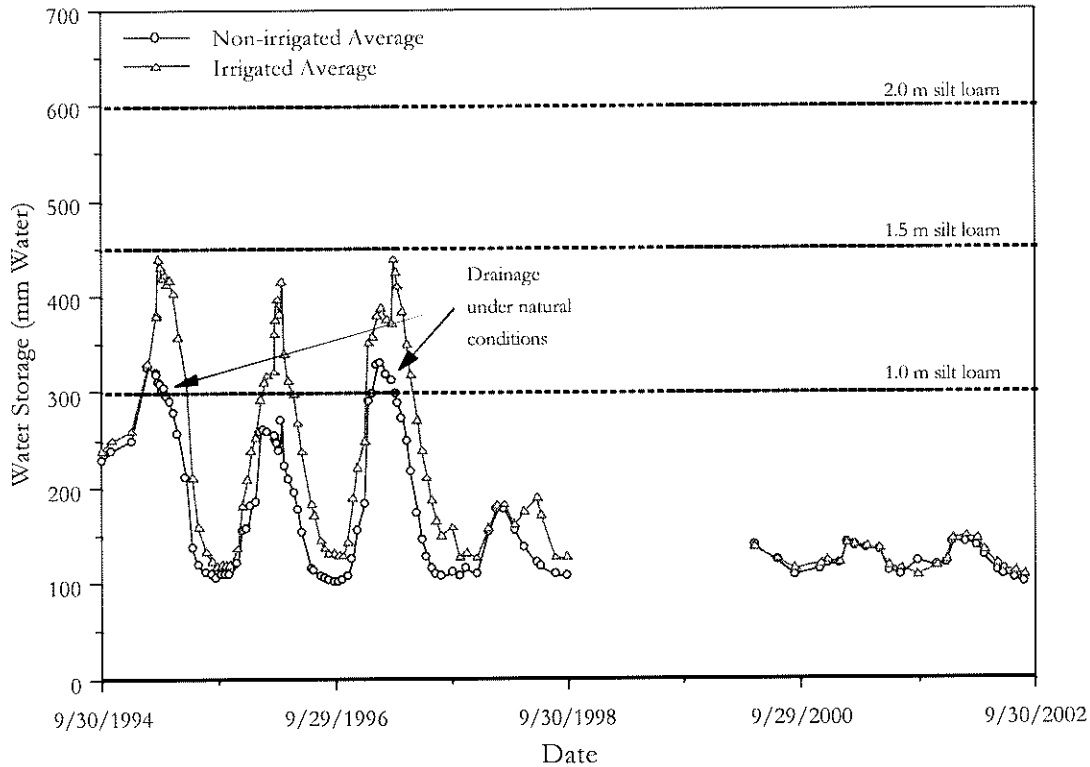
Figure 3.2 compares temporal changes in mean water storage for the fine-soil layer on the irrigated and nonirrigated treatments at the prototype cap for 8 years (Sept. 1994 through Sept. 2002).

All irrigation and natural precipitation plus all available stored soil water was removed via ET during the first year on the fine-soil surface. This process was repeated so that over the remaining years, water was annually removed from the entire soil profile by late summer. ET was effective in preventing all but a minute amount of drainage from one irrigated plot after three years of the wettest treatment, as will be discussed later. There was a hiatus of water-storage monitoring between Sept. 1998 and May of 2000, so no data are available for that time period. However, the trends before and after clearly show that ET was effective in keeping the water storage well below the estimated drainage limit of 600 mm for the 2-m silt-loam layer. The upper limit of water storage was based on an estimated field capacity of 0.3 for the silt loam soil. Thus, the water stored in 1.5 m is reduced to 450 mm and to 300 mm for a 1.0-m thick soil as shown in Figure 3.2. Soil water content in both irrigated and non-irrigated plots reached a relatively uniform lower limit of 5 to 8 vol% throughout the soil profile by September of each year. Correspondingly, water storage was reduced to levels of 100 to 150 mm, i.e., the lower-limit of plant-available water, for both the irrigated and non-irrigated soil surfaces.

The amount of water stored in the fall, within the 2-m silt-loam soil cap, is about one-fifth the amount of water required for drainage. This suggests that extreme winter precipitation, the prime cause of drainage at Hanford, can be readily stored in the fine-soil profile until spring when it is subsequently extracted from the soil by ET. Considering the irrigation treatment to represent the extreme in wet climate, the 2-m-thick soil cover would not be expected to drain, even under the wettest Hanford climate conditions. If the cover thickness were reduced from 2 m to 1.5 m, it appears that little or no drainage would be expected. However, if the cover were reduced to 1 m, it appears that under irrigated (extreme wet) conditions, the soil would be expected to drain, as indicated in Figure 3.2.

The positive response of the cap in its capability to remove water and limit drainage demonstrates the continued benefits of having vegetation on the surface. ET for the irrigated plots was nearly double that for the non-irrigated (ambient) plots, suggesting that vegetation is capable of adjusting to water applications. It is apparent that the capacity of vegetation for water consumption was not exceeded even at the 3X precipitation rates. This further supports the hypothesis that the combination of vegetation and soil storage capacity is more than sufficient to remove all applied water under the imposed test conditions. Within a year after the irrigation was terminated, the water storage in the irrigated and nonirrigated plots became similar. During the past 2.5 years, the water storage in all soil plots was virtually the same (Figure 3.2).

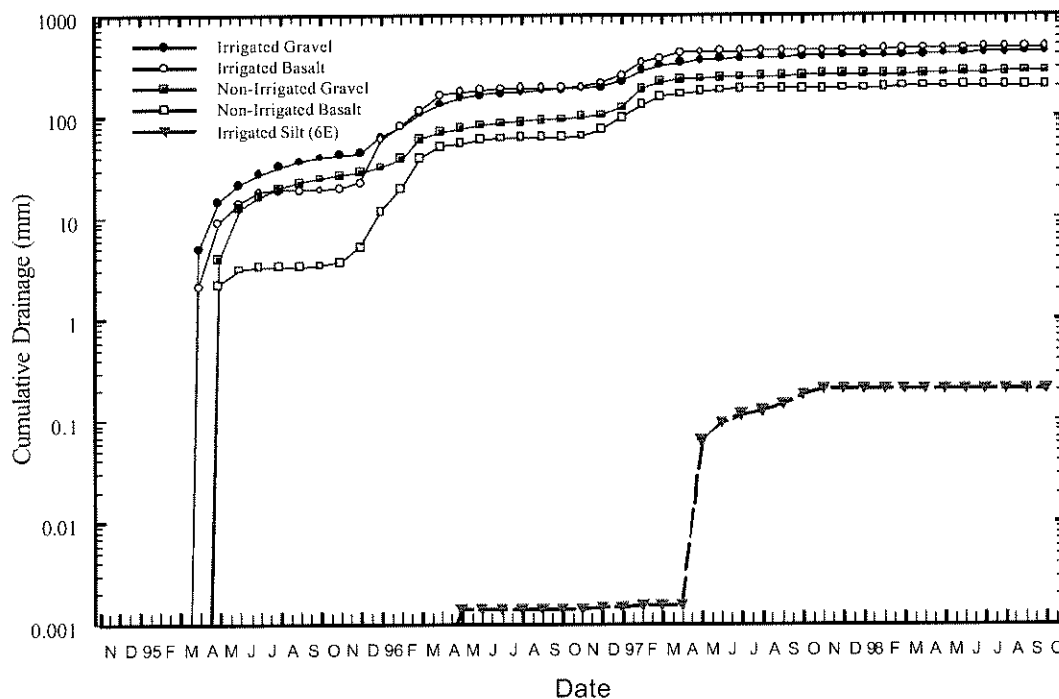
Figure 3.3. Cumulative Drainage from Sideslopes Compared to Irrigated Silt-Loam Drainage at the Hanford (1000-year) Cap Test During the First 4 Years of Testing

Drainage did not occur from the soil-covered part of the prototype cap until the third year, and then only a small amount (less than 0.2 mm) for one of the soil plots was subjected to the 3X irrigation treatment. No additional drainage has occurred from this silt-loam covered collection area (6E, Figure 3.3), so the total drainage over the 8 years of testing is less than 5% of the prescribed limit of 0.5 mm/yr. The drainage was attributed to lateral flow from water diverted off an adjacent roadway. These observations from the prototype cap agree with the results of extensive lysimeter testing of capillary-cap designs (Campbell et al. 1990; Gee et al. 1993b) and suggest that the water-storage capacity of the 2-m-thick, silt-loam layer is in excess of the 3X (480-mm) precipitation. In contrast, both sideslope configurations drained, although the amount of drainage was significantly less than predicted, based on lysimeter testing with coarse materials (Gee et al. 1993a).

Sideslope drainage was expected since the surfaces are coarse and bare with no vegetation growing on the basalt riprap and only a sparse (less than 10%) cover growing on the clean-fill gravel (Gee et al. 1993a; Sackschewsky et al. 1995). Figure 3.3 compares cumulative drainage from the gravel and riprap slopes through Oct. 1998. On the nonirrigated treatments, the total amount of drainage from the clean-fill sideslope was greater than that from the basalt riprap sideslopes. A similar trend was observed on the irrigated slopes up until Nov. 1995. While irrigation of the silt-loam surfaces started in February 1995, direct irrigation applications to the sideslopes did not start until Nov. 1995, when the irrigation system was modified to apply water directly to the sideslope plots at the same rates as applied to the silt-loam surfaces. A closer look at these results shows a seasonal dependence of drainage. While drainage from the clean-fill gravel sideslope was continuous, there was essentially no drainage from the riprap in the summer. In the winter, both sideslope configurations drained at similar rates. These trends have continued through 2002. It is our hypothesis that advective drying similar to that described by Stormont et al. (1994) and Rose and Guo (1995) and recently tested by Albrecht and Benson (2002) may be partly responsible for the lower drainage on the riprap sideslopes and may also have an effect on water storage in the fine-soil layer. Additional testing and numerical modeling will be helpful in testing this hypothesis.
