PLANT NAME: TURKEY PT # 3 & 4

ENCLOSURE
ANSWERS TO QUETIONS #'S 2 AND 3, AND REVISED ANSWERS TO QUESTIONS 8 AND 9 PERTAINING TO THE STEAM GENERATORS TUBE INTEGRITY SUPPLEMENTAL INFORMATION.....

Re: Turkey Point Units 3 and 4
Docket Nos. 50-250 and 50-251
Steam Generator Tube Integrity
Supplemental Information

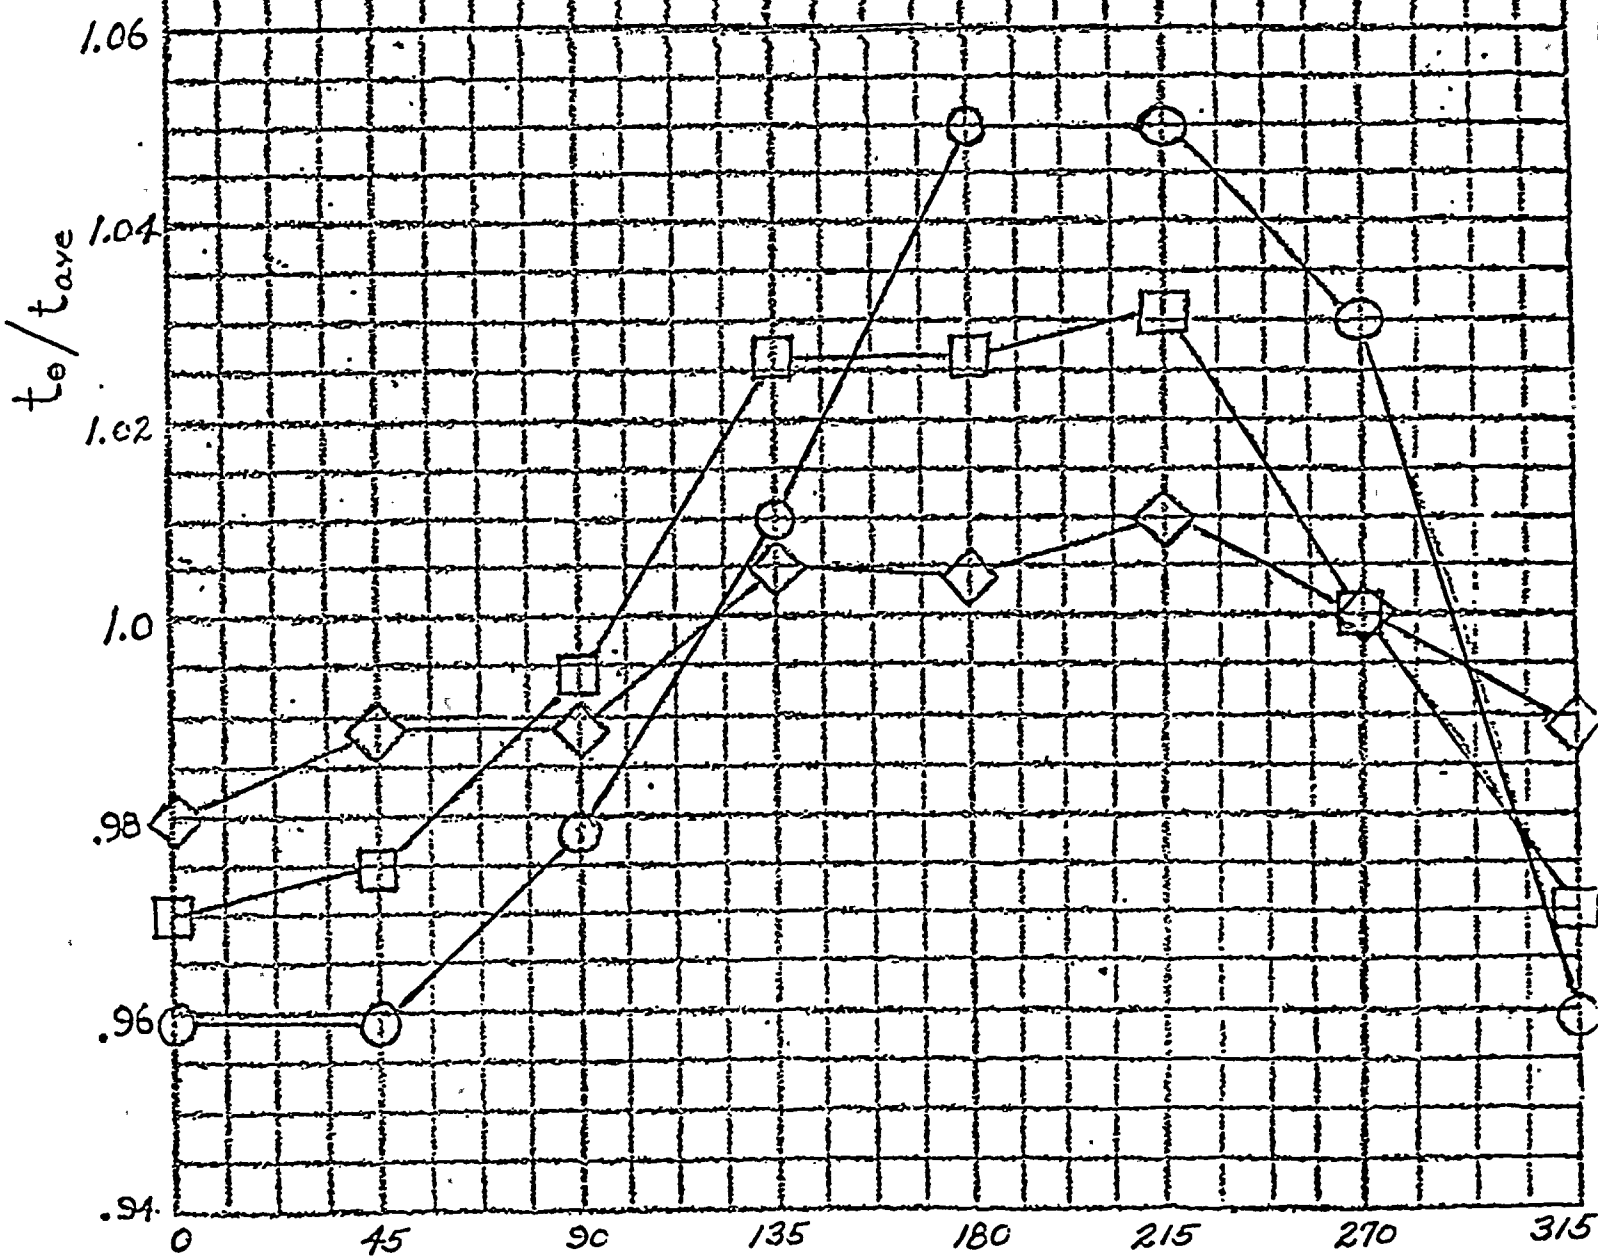
FIGURE 2-1
RELATIVE WALL THICKNESS VS. ANGLE
ROWS 1, 2, 3

$$t_{ave} = \frac{\sum t_e}{n}$$

- ROW 1
- ROW 2
- ◇ ROW 3

3. Since the tube wall is always thinned at the extrados, the ratio of $t_{\theta}/t_{\text{ave}}$ taken from mill data (Figure 2-1) will be used in the strain tolerance calculations. From Figure 2-1 the tolerance on this quantity is less than $\pm .01$. Therefore,
