Strata Energy, Inc.
Ross ISR Project

**Semi-Annual Effluent and Environmental
Monitoring Report**

January 1 – June 30, 2018

Appendix B. Annual Technical Inspection of Lined Retention Ponds Report

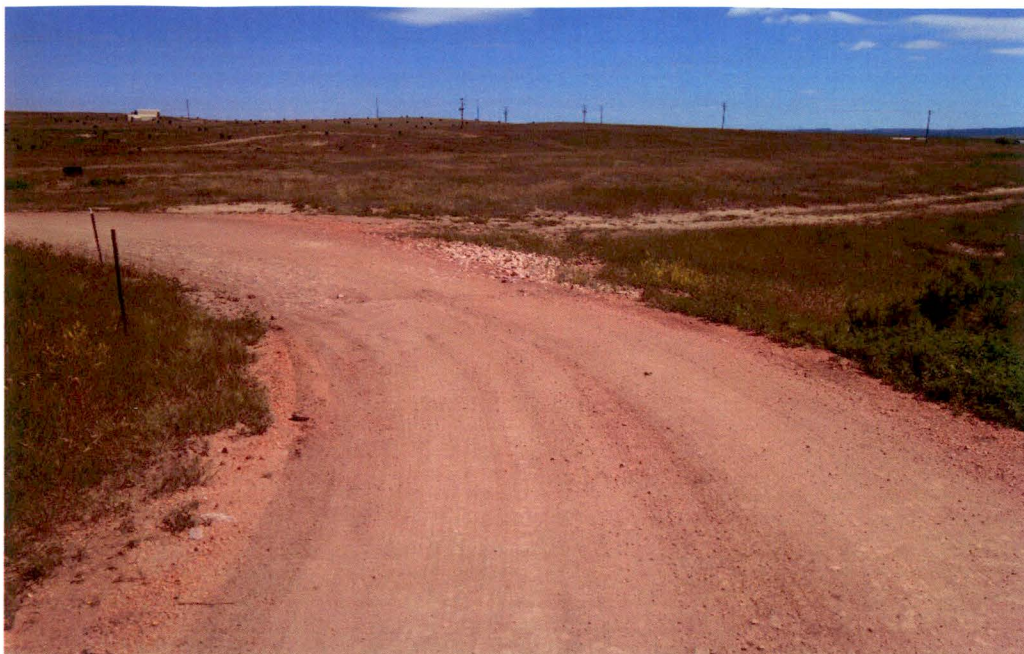
Silted Riprap at the Road Crossing of the Emergency Spillway

Repairs and improvements made to the dam in 2012 that included placement of riprap on the upstream embankment face and repairs to the downstream embankment slope appeared to be intact and stable. Improvements to the embankment and emergency spillway for the purpose of accessing wellfields across the embankment appeared to be stable; however, the riprap on the emergency spillway road crossing is silted in. WWC recommends replacing riprap in this area. As noted on the inspection form, historic seepage on the downstream toe of the embankment should continue to be monitored. The headcuts on the downstream embankment face and in the emergency spillway should also continue to be monitored. As noted in previous inspections, these headcuts are well vegetated and stable. The only corrective action for the impoundment required at this time is to replace or add riprap on the emergency spillway road crossing.

Recommended Corrective Actions: Continue to monitor seepage on downstream toe. Seepage has occurred historically based on vegetation type present and previous inspections. Also continue to monitor minor headcuts on downstream slope. Replace riprap at road crossing of emergency spillway As in-place riprap is mostly silted in.

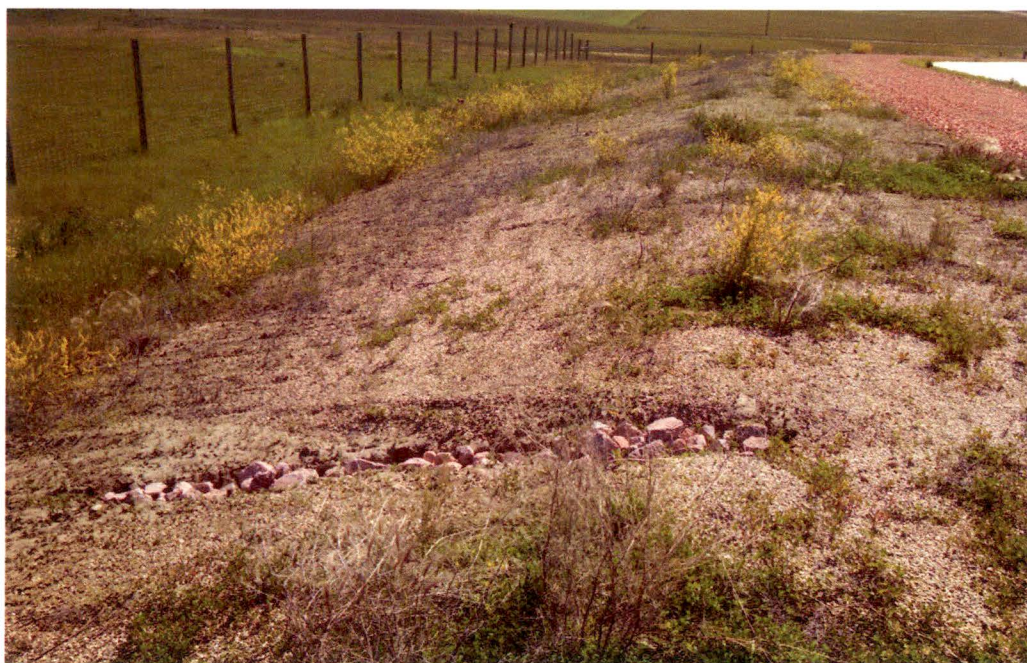
Repaired Gullies on North Side of Cell 3

d. Daily/Monthly/Quarterly Inspection/Review of Inspections:		Yes
Notes: Cells 2 and 3 are currently being used to store wastewater from the plant and wellfields. Cell 1 only contains rainwater.		
Recommended Corrective Actions: Monitor repaired gullies on north side of Cell 3 and on east side of shared embankment. Repair flow totalizer display for underdrain on Cell 1.

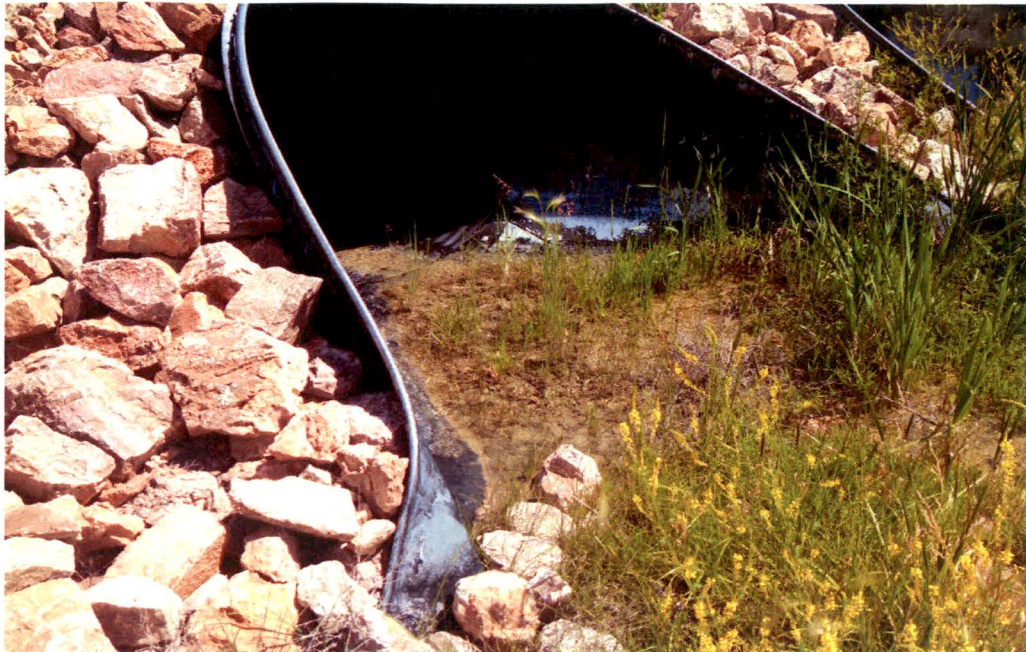
Grass and Sediment in the Outlet of the Diversion Culvert

The diversion berm and channel are stable and well vegetated. The area is generally free of gullies, rills, and minor surface erosion. The only corrective action recommended is to remove grass and sediment from the downstream culvert flared end sections and to remove the shrub growing on top of the west culvert on the downstream side. Strata should continue to monitor for erosion on the embankment and sideslopes.

Recommended Corrective Actions: Remove grass and sediment from downstream culvert flared end
section. Also remove shrub growing on top of west culvert on downstream side. Continue to monitor for
erosion on embankment and sideslopes.

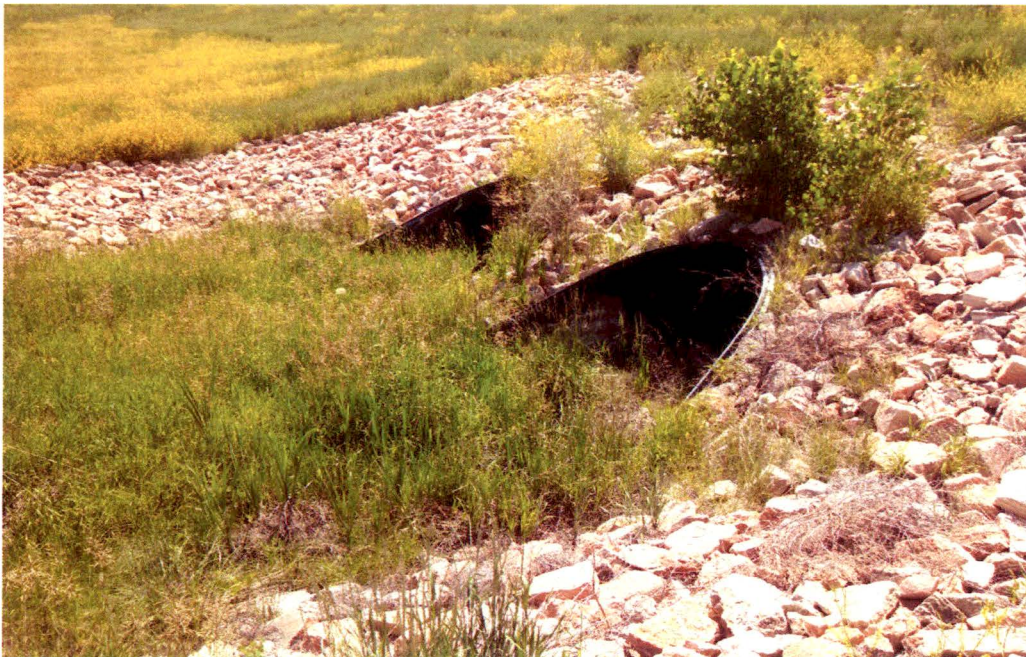
Shrub on Top of the Outlet of the Diversion Culvert

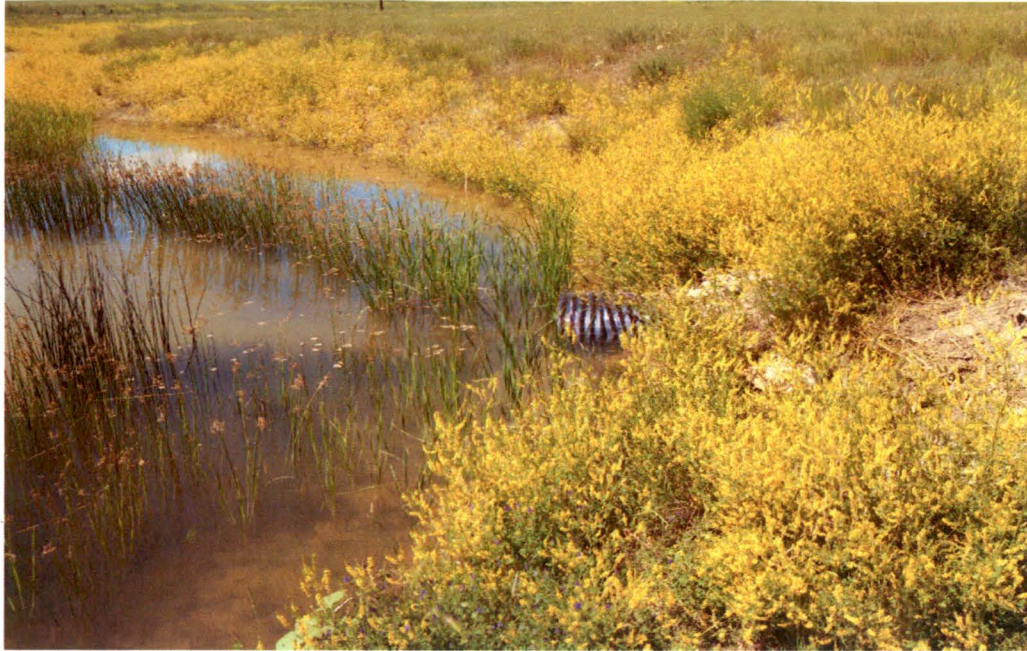
The water level in the sediment pond during the inspection was 2/3 of the way up the northwest inlet culvert. The sediment pond should always be maintained at a level at or below the invert of the lowest inlet culvert (northwest inlet culvert). As noted during the inspection, recent precipitation had raised the level of the pond, and it was being dewatered with a portable pump. The water level in the pond was estimated at 2-3 feet and the sediment level was also estimated at 2-3 feet. Strata should consider cleaning the sediment from the pond and possibly excavating deeper to allow for more runoff capacity for precipitation events. Prior to cleaning the sediment pond and disposing of the sediment, WDEQ should be notified. Strata should continue to monitor the repaired gullies on the north side of the pond and reinstall an animal/trash rack on the sediment pond discharge pipe located in the diversion channel.

Sediment Pond Water and Sediment Level

Recommended Corrective Actions: Continue to monitor repaired gullies on north side of pond.
Reinstall an animal/trash rack on the pond discharge pipe located in the diversion channel. Maintain
water level below invert of northwest inlet culvert. Consider cleaning sediment as pond only has
several feet of capacity below the lowest inlet culvert invert (northwest).
