Holtec's Input to the PEC Proceedings on NRC's Inspection Report #07201014/2018-201

USNRC, White Flint, MD
9 January 2019

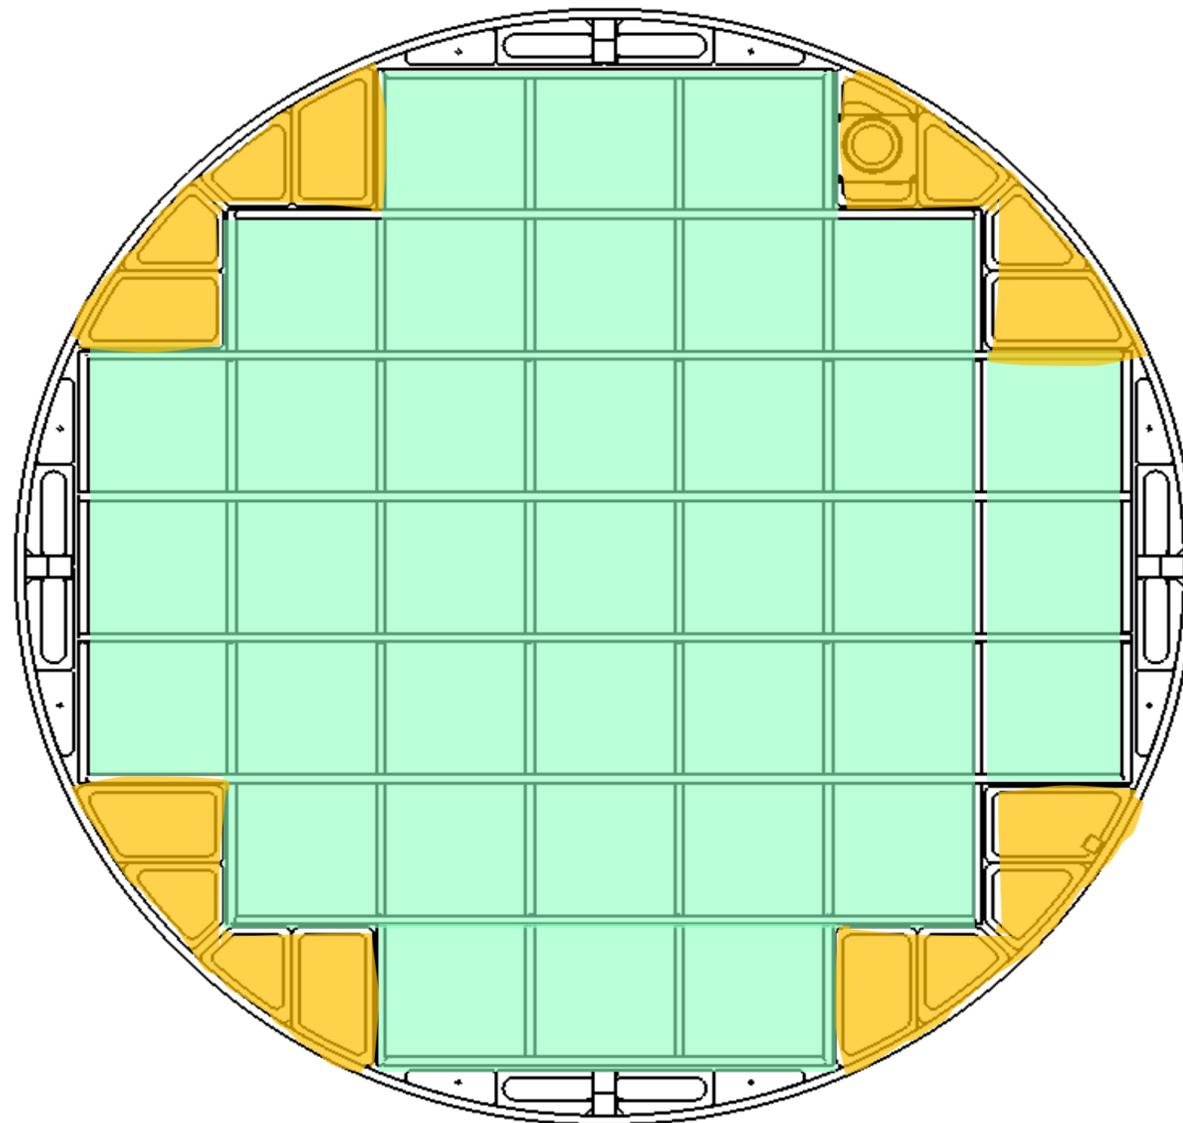
- Occupy the circumferential space between the Basket and the MPC Shell
- Discrete *Basket Shim Assemblies* surround the periphery of the Fuel Basket as shown in the illustration below for MPC-37

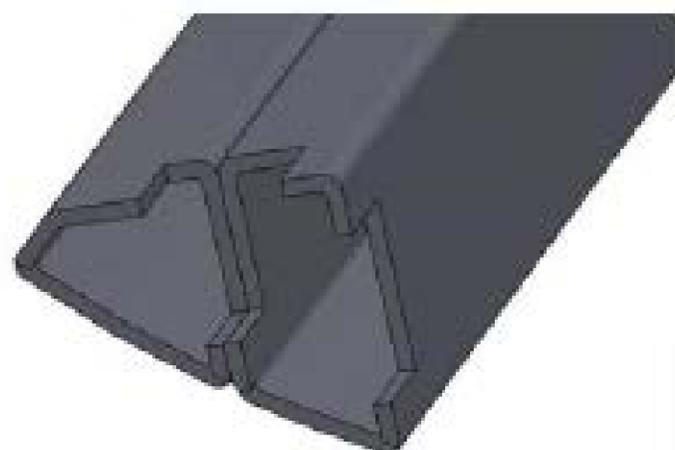
Original Design

- The *Basket Shim Assembly* consists of *shim stand-offs (SSOs)* made of stainless steel end-threaded bars, typically three in number, fastened to the bottom of the *Basket Shim*.
- The SSOs were designed to improve fabricability and evaluated under the 72.48 process and to boost the native heat rejection capacity of the MPCs with the intent to seek a higher heat load rating through a future LAR
- The SSOs, shown below, increase the open helium flow area in the MPC's down-comer space to enhance heat rejection

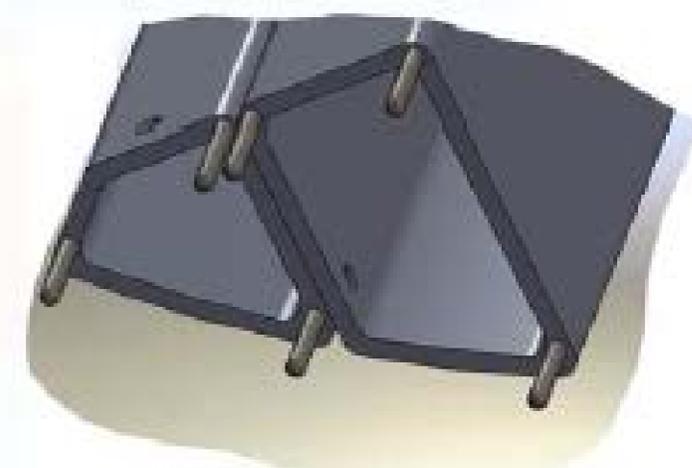
New Design

- The SSOs consist of multiple stainless steel bars tapped into the bottom face of each shim column to elevate them above the MPC Baseplate to further promote natural convection of helium inside the MPC
- Each MPC type has multiple Basket Shim Assemblies, and each Shim has multiple SSOs (for redundancy).
