Clinch River Nuclear Site  
Early Site Permit Application  
Part 2, Site Safety Analysis Report

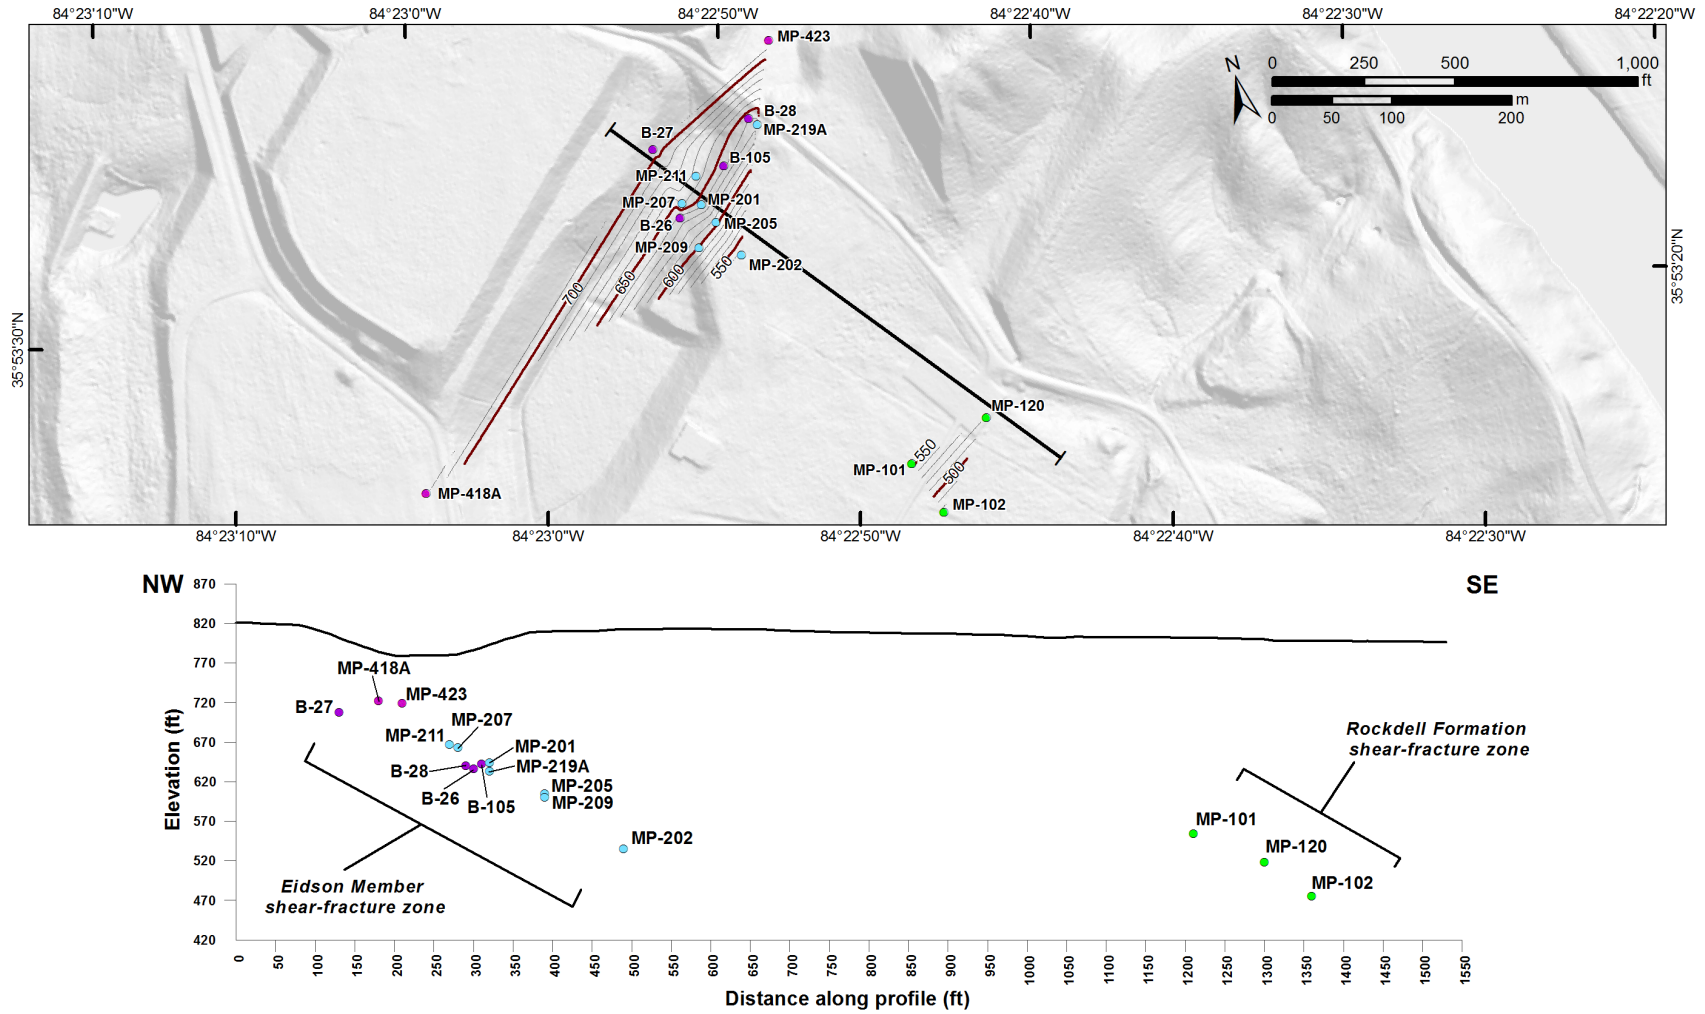
Notes:  
 See [Table 2.5.1-17](#) for MP-Series boring data. B-series boring data from [Reference 2.5.1-100](#).  
 Geometry of shear-fracture zones are shown on [Figures 2.5.1-66](#) and [2.5.1-67](#).

**Figure 2.5.1-65. (Sheet 1 of 2) Structure Contour Map of Shear Fracture Zones and Associated Profile**

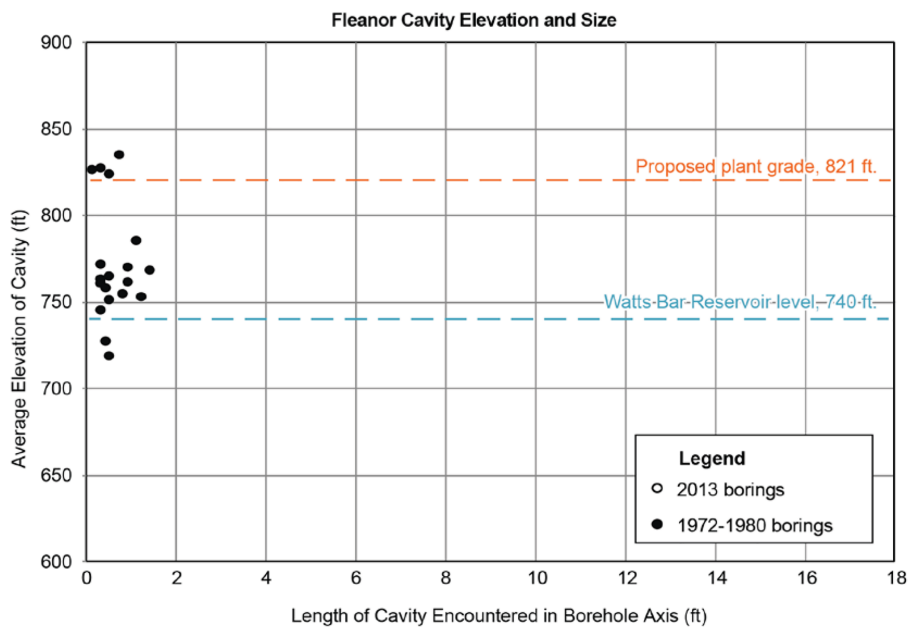
**Figure 2.5.1-76. Cavity Size and Elevation: Benbolt Formation and Fleanor Member**

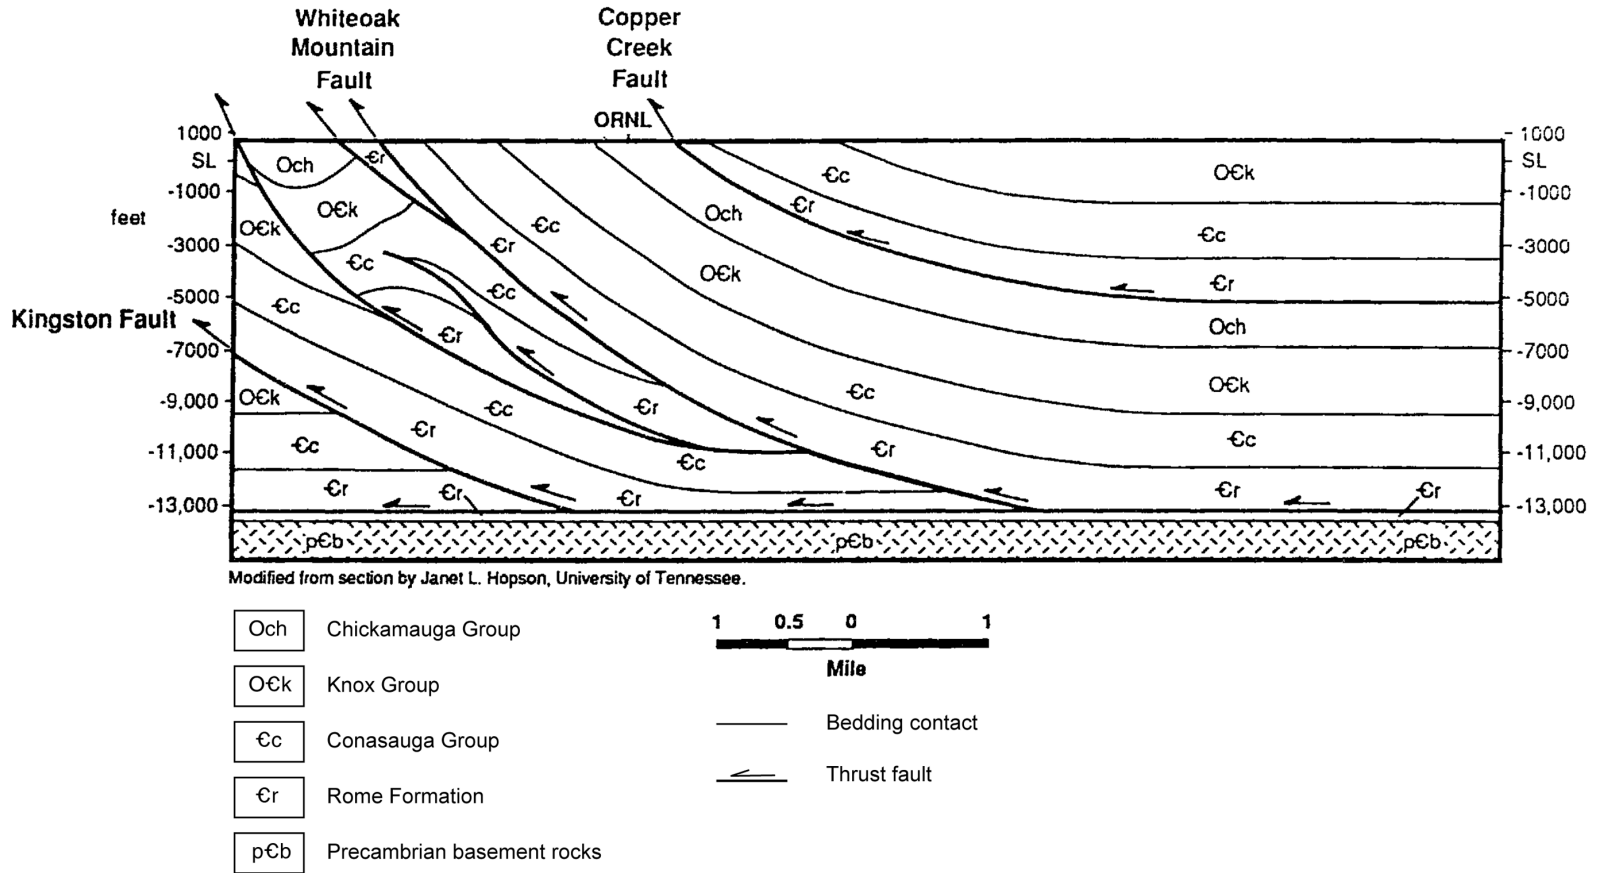
Figure 2.5.1-83. (Sheet 2 of 2) Geologic Cross Section Based on Seismic Reflection Profile from Tennessee Highway 95

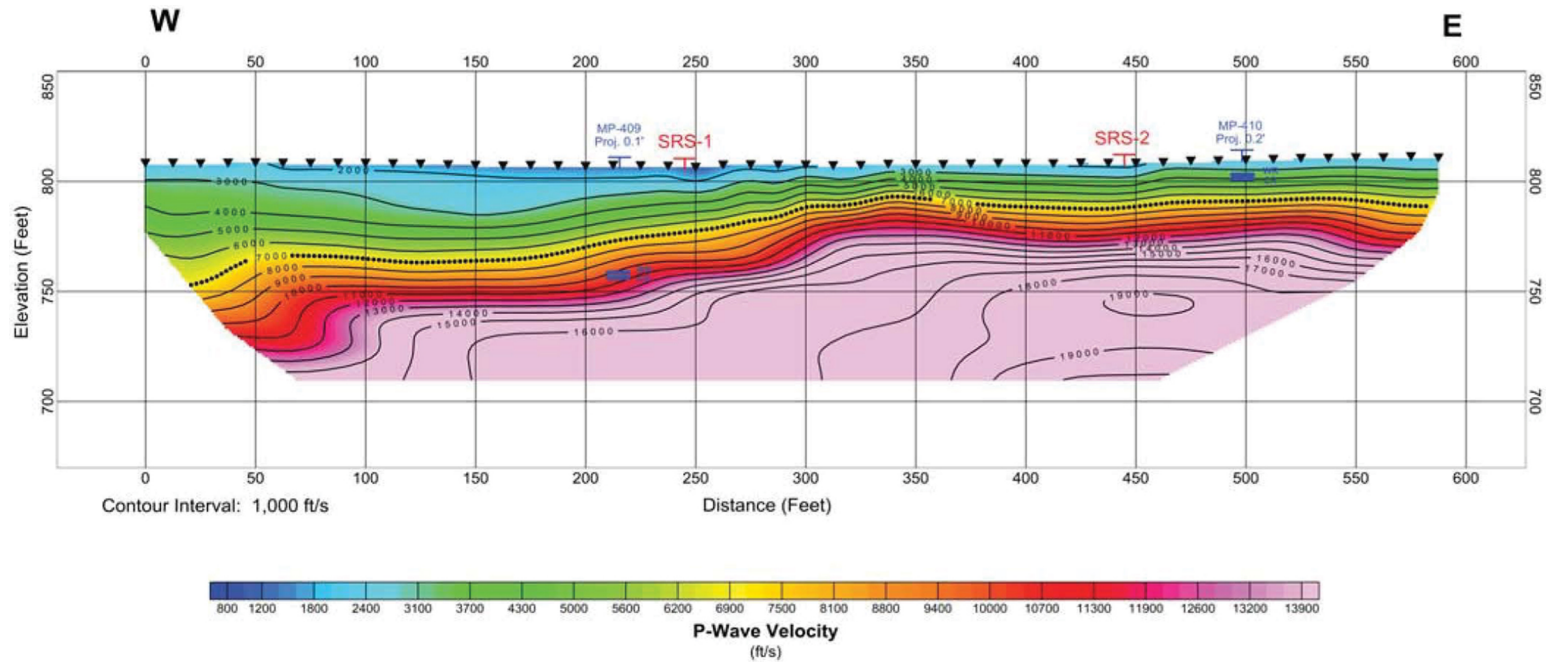
Figure 2.5.1-86. (Sheet 5 of 7) Seismic Tomography Model SRS-5

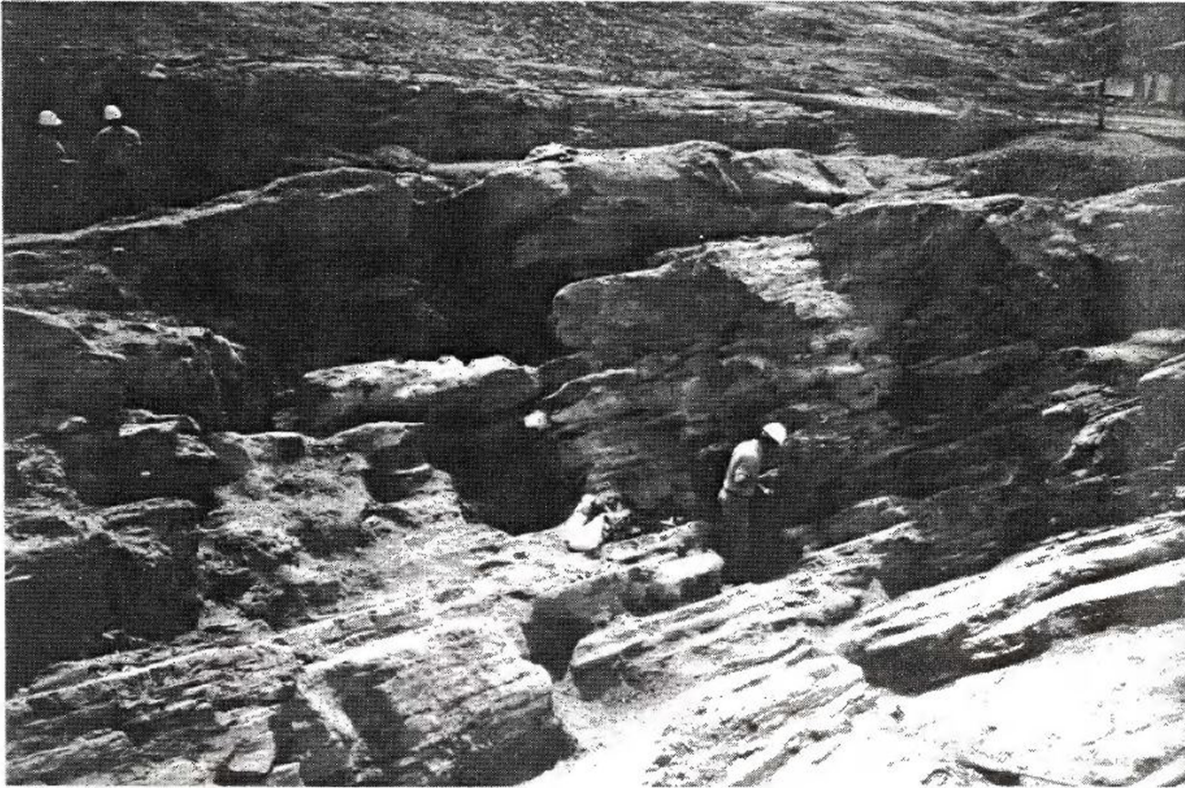
**PHOTOGRAPH 26**

**SOLUTION CAVITIES ALONG BEDDING AND STRIKE-JOINTS ON THE BENCH (EL. 780 FT) ABOVE FACE IV (UPPER), AND KARSTIFIED LIMESTONE IN THE EQUALIZATION BASIN, WITH NUMEROUS CAVITIES**

**Figure 2.5.1-89. Cavities in the Rockdell Formation Exposed in the 1983 CRBRP Excavations**

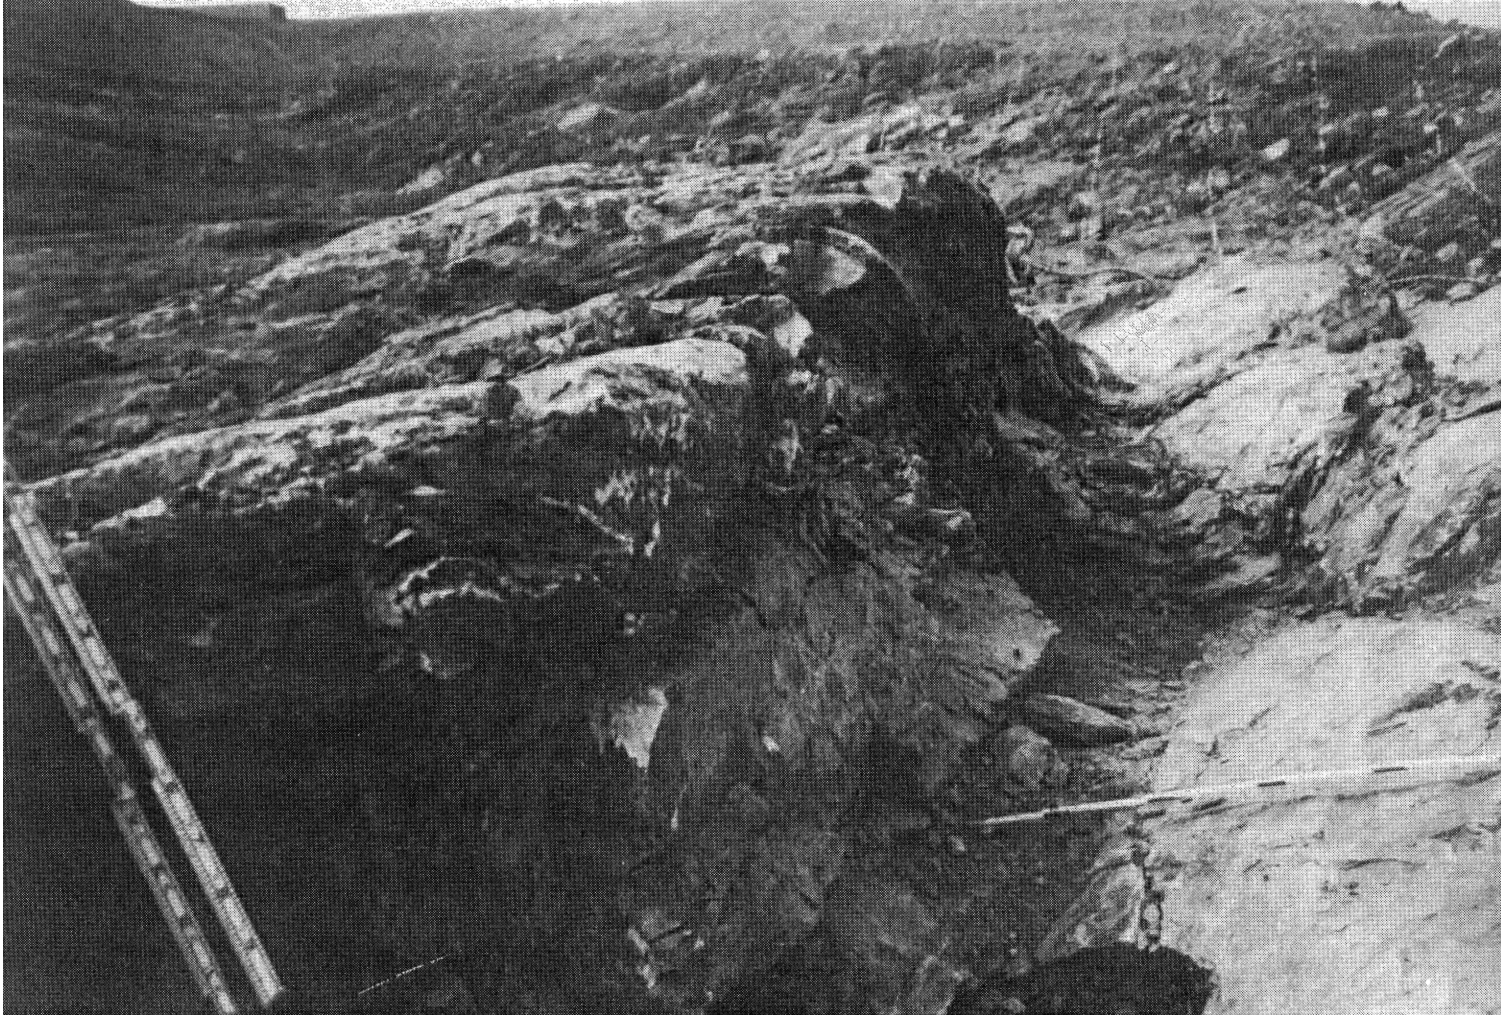
**Figure 2.5.1-92. Apparent Fault Propagation Fold Exposed in CRBRP Excavation**
