REPORT ON ROCK FILL TEST SECTIONS

MAIN DAM

SHEARON HARRIS NUCLEAR POWER PLANT

CAROLINA POWER & LIGHT COMPANY

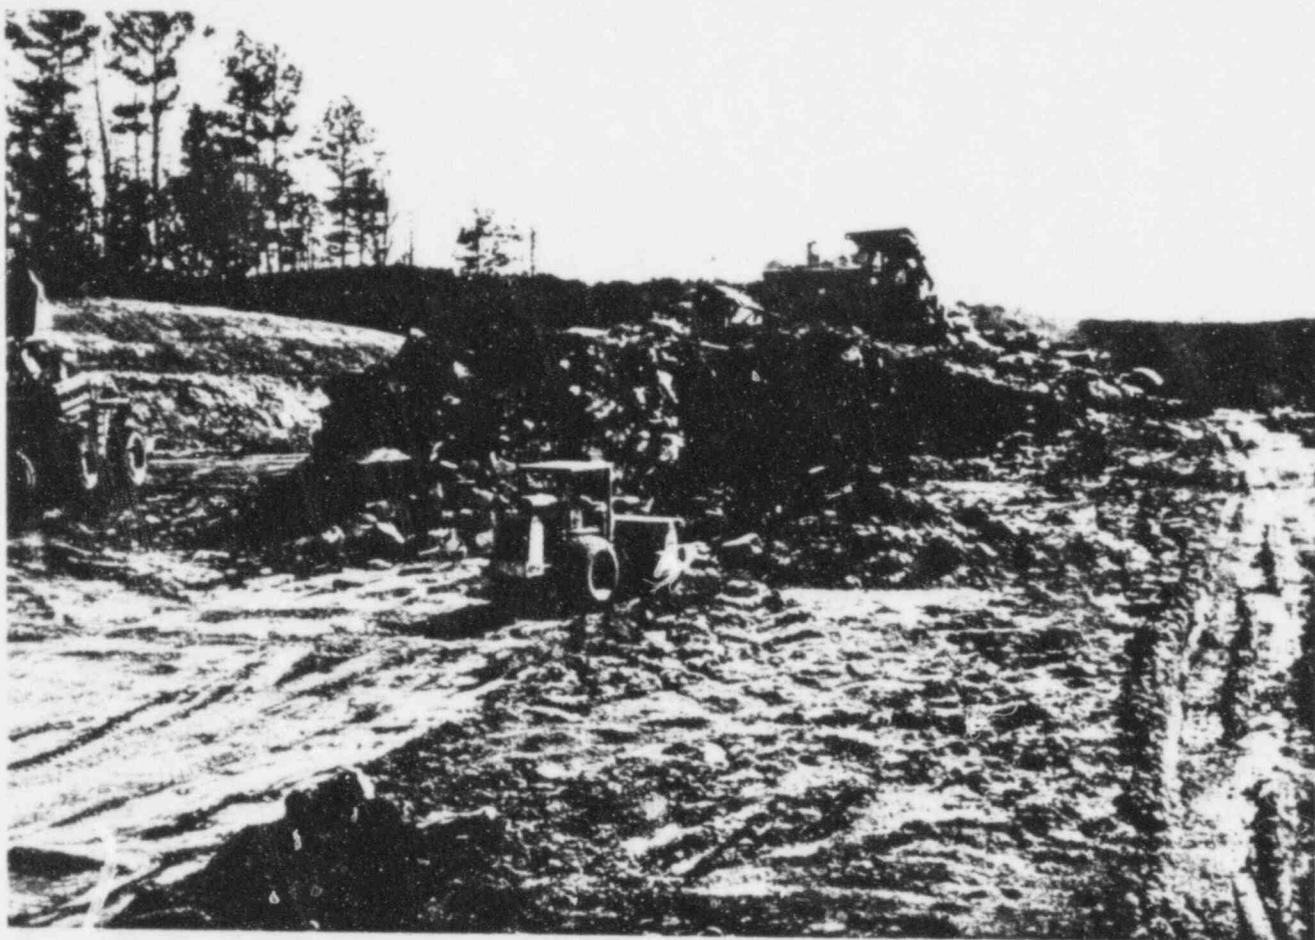
Photo 1

Stockpile of blasted rock used in
construction of Test Sections.
Base of stockpile is at El 250+.
Spillway Excavation invert to be
El 203 at this location.

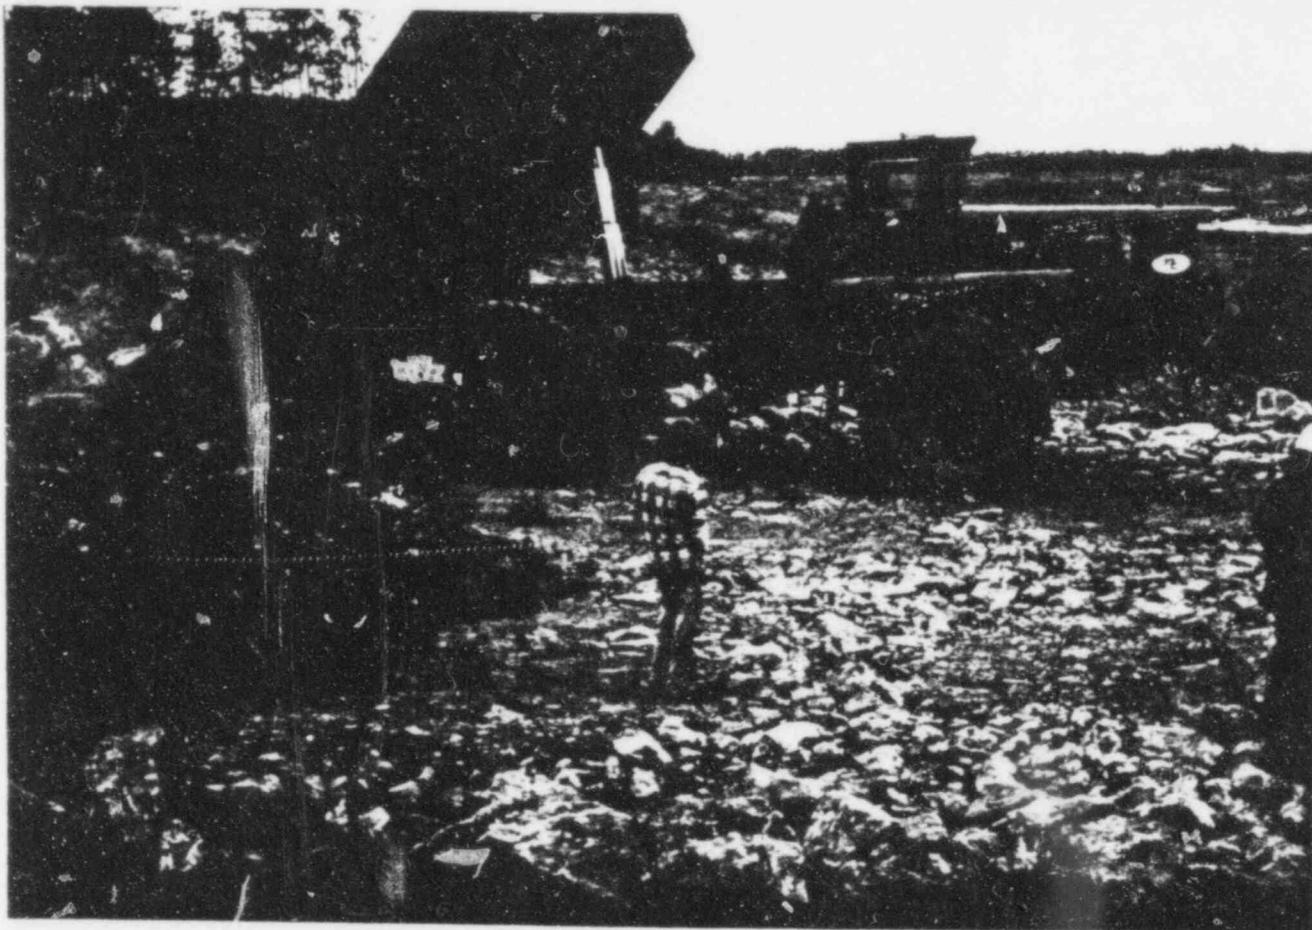
Photo 2 End dumping of Rock on Test Section V.P. 1D 24-4-3. **POOR ORIGINAL**

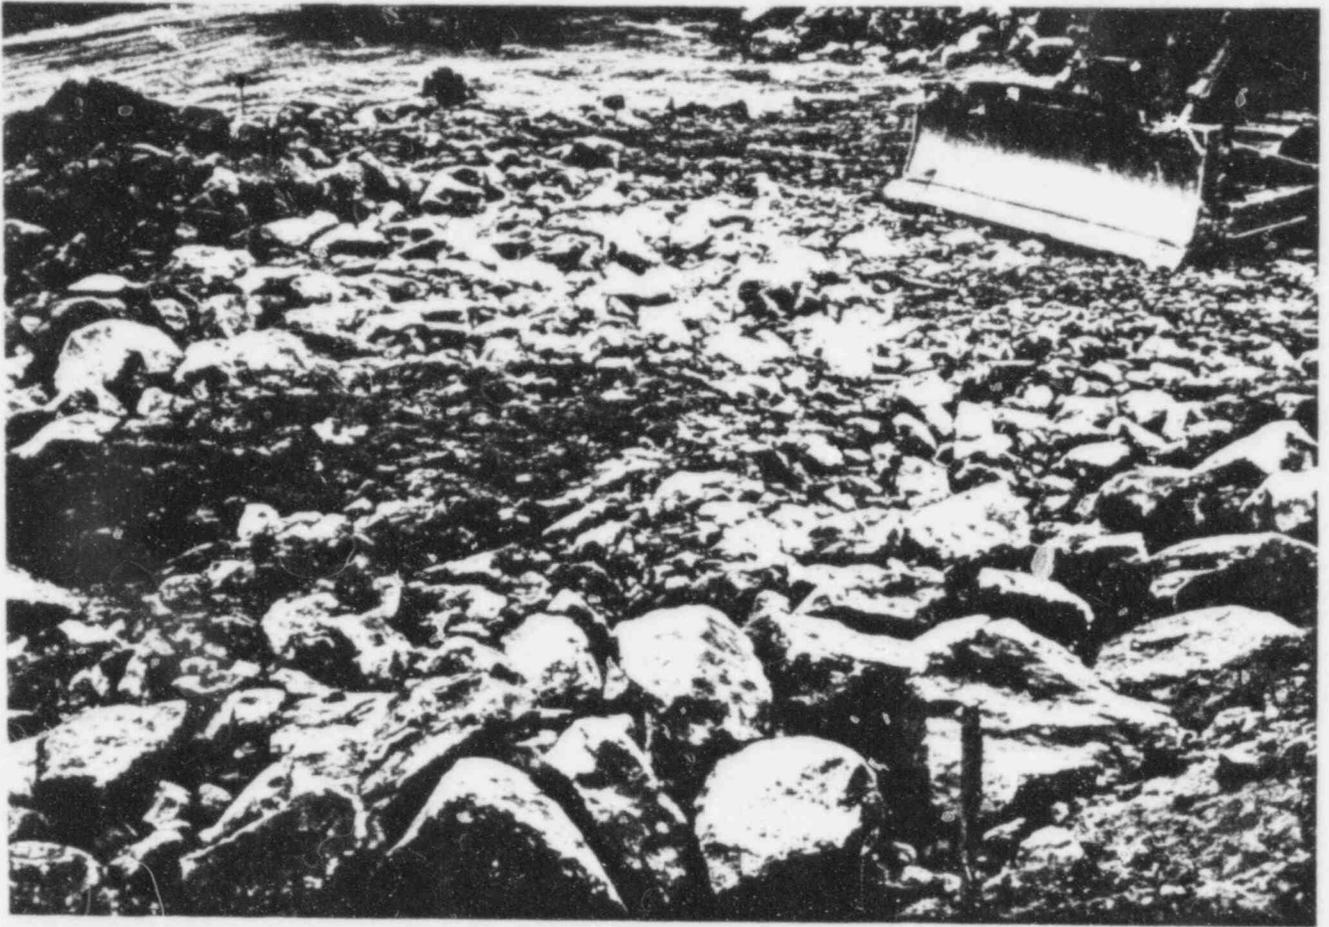
Photo 4 Test Section VRMD-24-2-4 after spreading but prior to rolling.

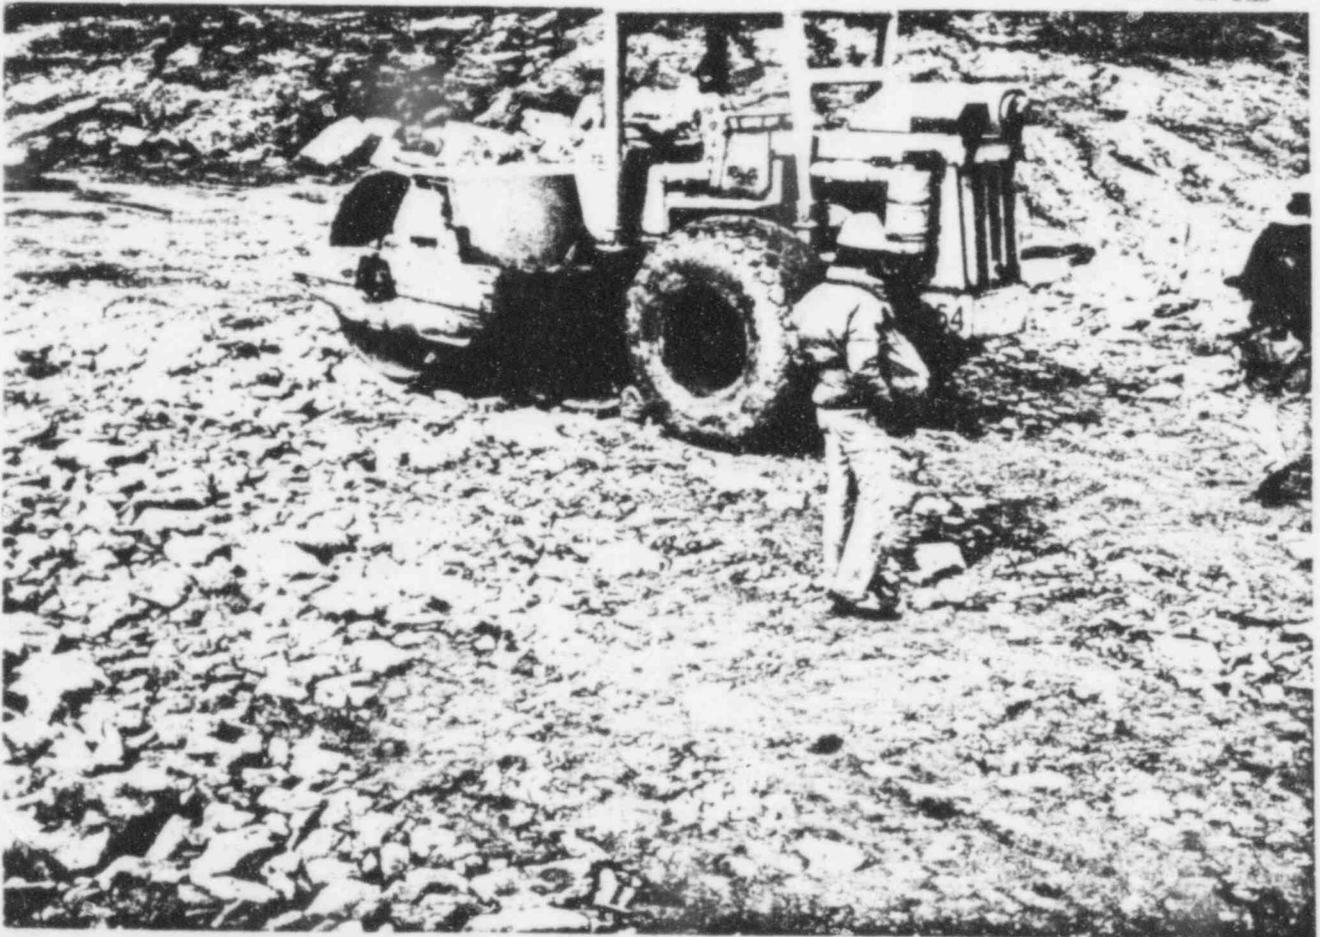
Photo 5 Test Section VRMD-24-4-3 during rolling with smooth drum vibratory roller.

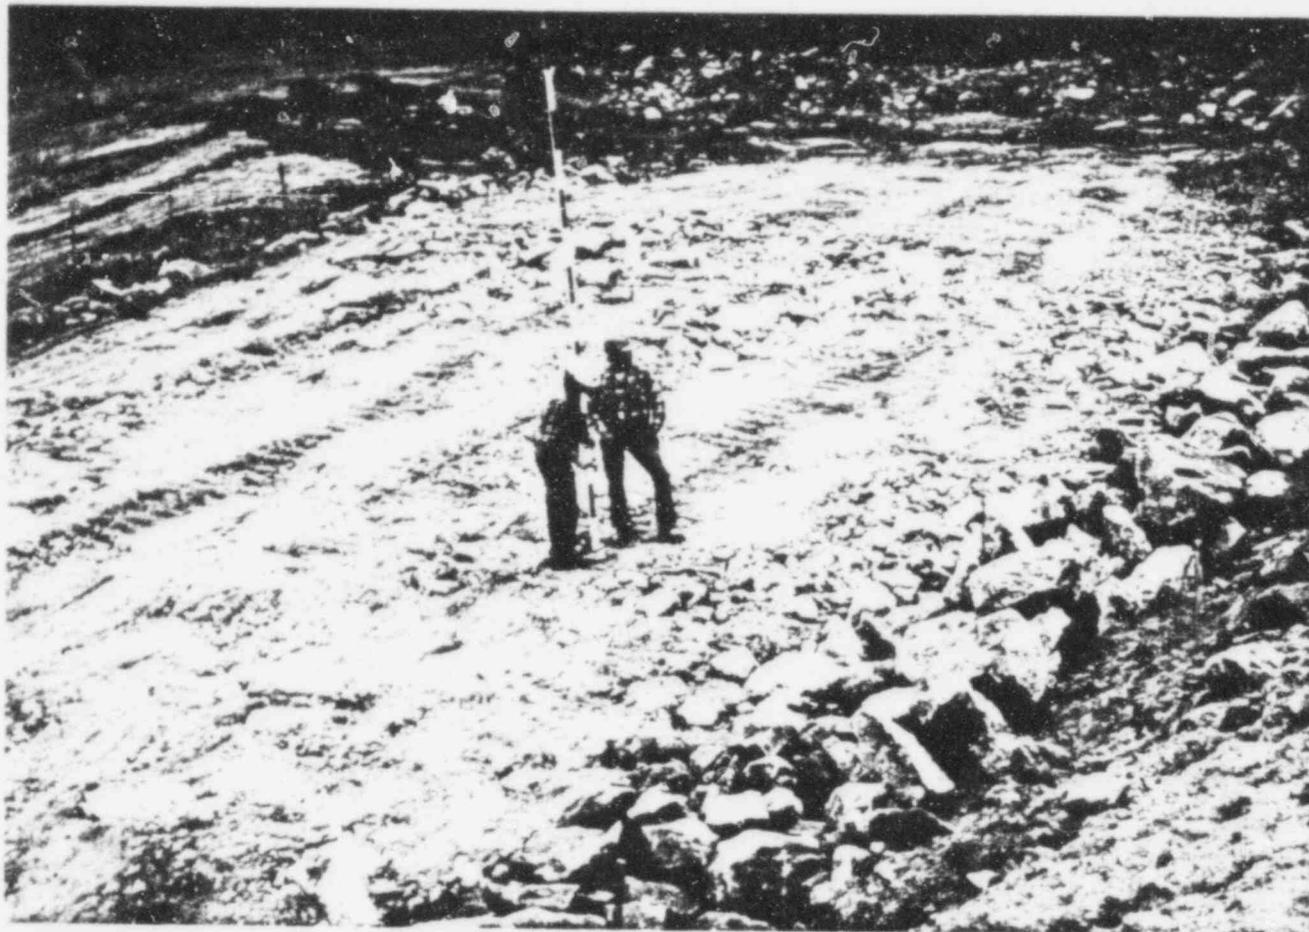
Photo 6 Test Section VRMD-24-2-4 lift surface after rolling (5 passes)

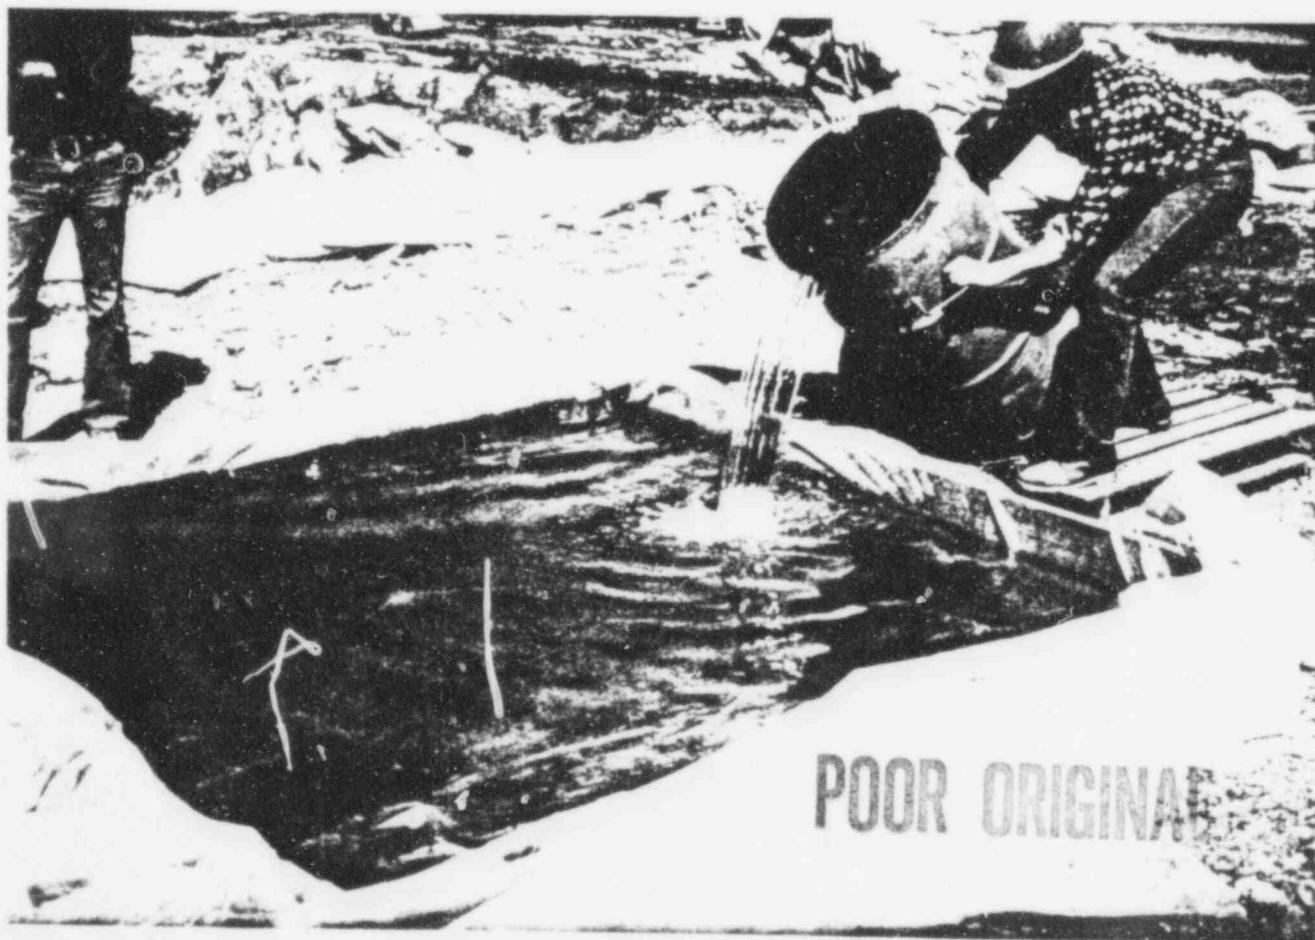
Photo 7 Volume measurement of density hole.

3. One sheet of polyethylene was laid loosely over the frame to be in as close contact as possible with the inside of the frame and the rock surface.
4. The depression in the slack membrane was filled with water via a calibrated barrel to within 3 or 4 inches of the top of the frame (Photo 7).

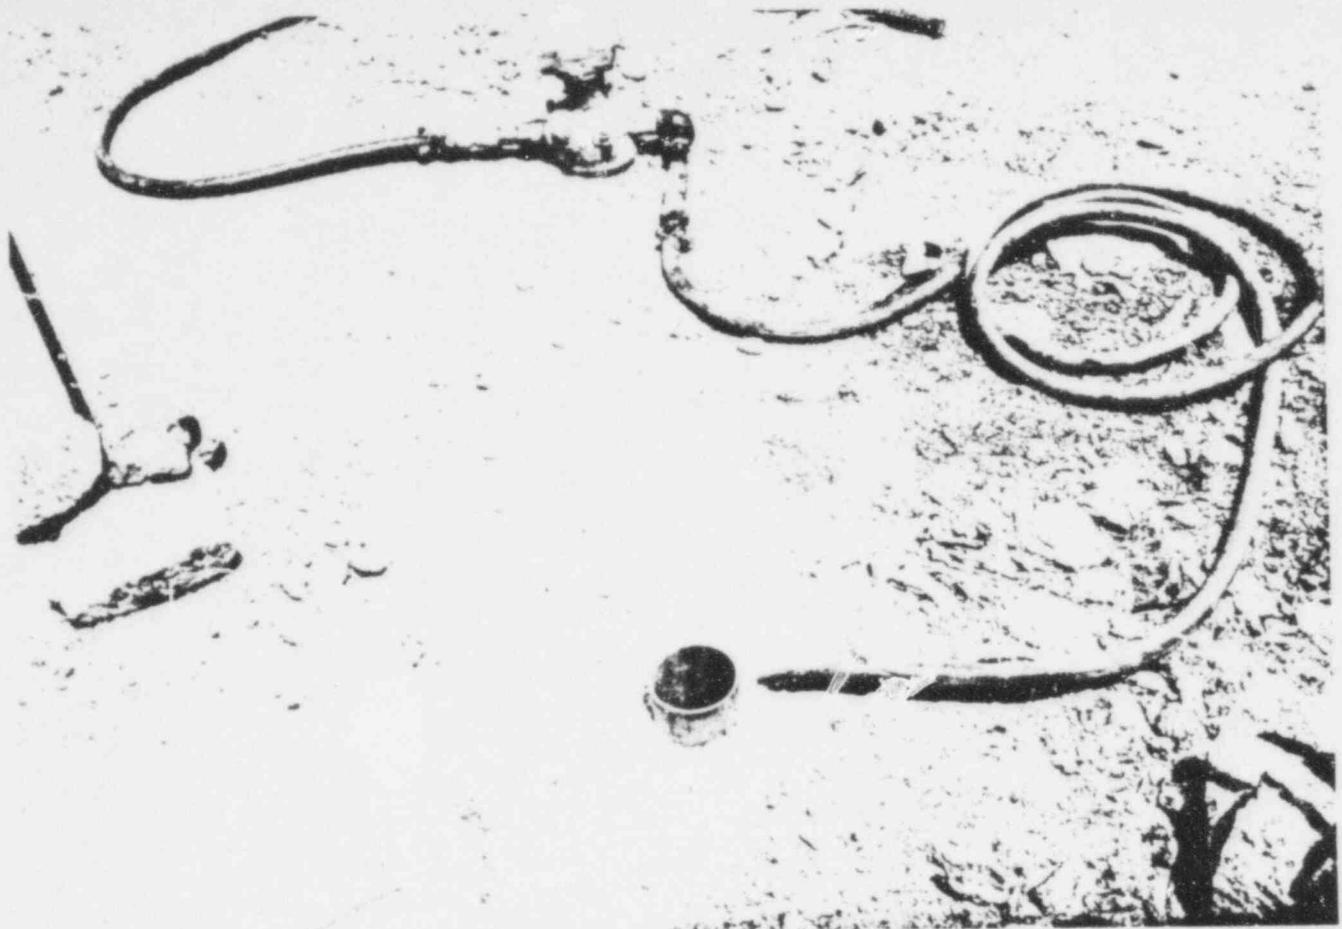
Photo 8 Test Equipment used in in-place permeability test.

3. In order to provide a large enough reservoir of water to conduct each permeability test at anticipated flows, a pump truck was used instead of the calibrated 50 gallon barrel. Flow rates were controlled by pump rate and by valve and were measured by using an in-line calibrated flow meter at the collar of the hole (Photo 8).

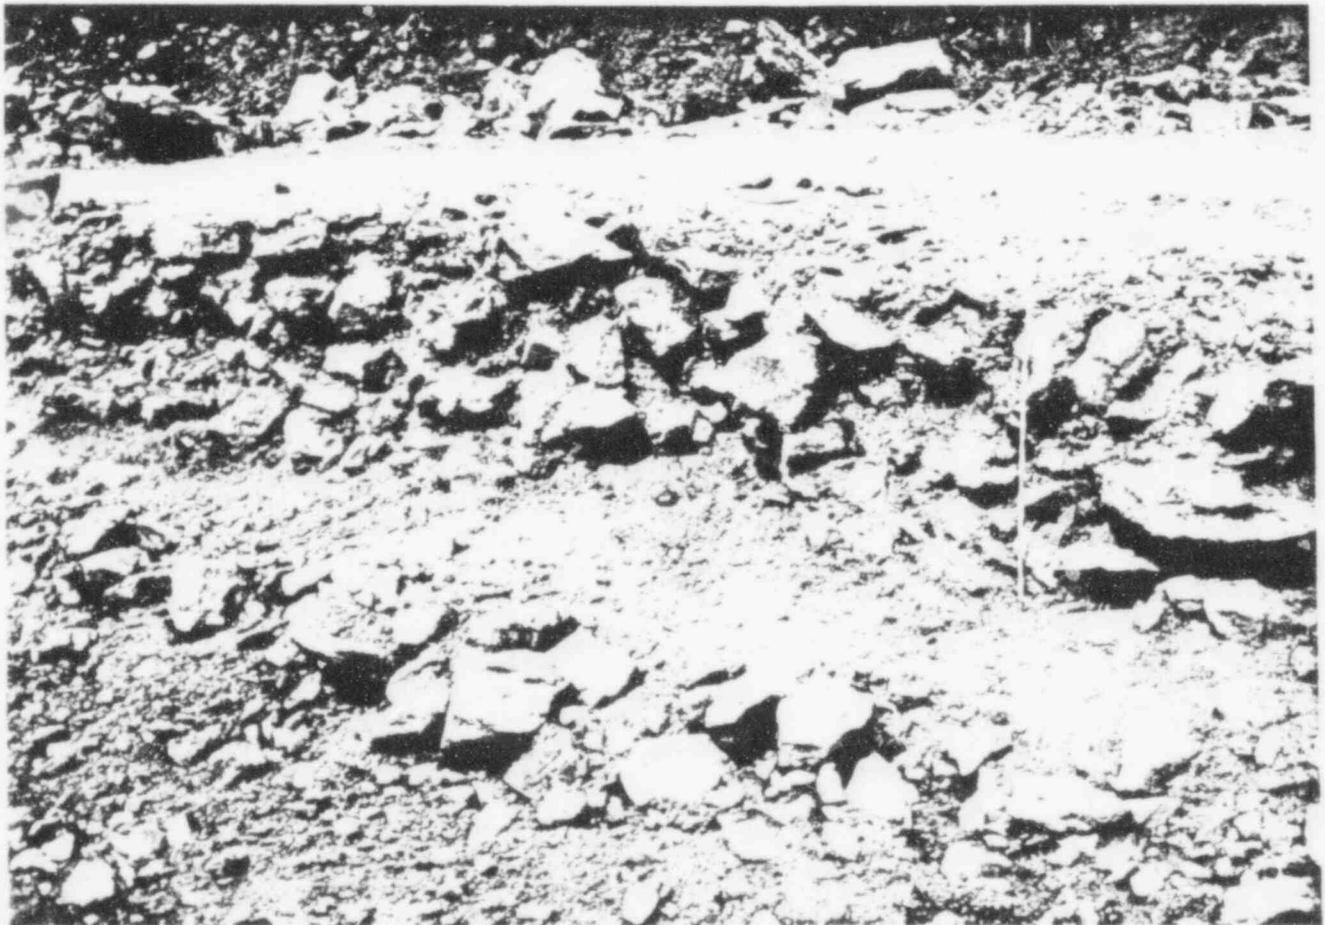
Photo 11 Overall View of Cross Section of Test Section VRMD-24-2-4. Two 24" lifts shown.

A longitudinal cut was made thru the two lifts of Test Section VRMD-24-2-4. As in Test Section VRMD-24-4-3, good bonding between each lift was observed. No layering or segregation of large particles can be seen (Photo 11). Fines are uniformly distributed and compacted. As in Test Section VRMD-24-4-3, small areas of the cross section have well compacted fines separating the larger rock particles (Photo 12).
