THE TMI-2 ACCIDENT

Herman M. Dieckamp, President
General Public Utilities Corporation

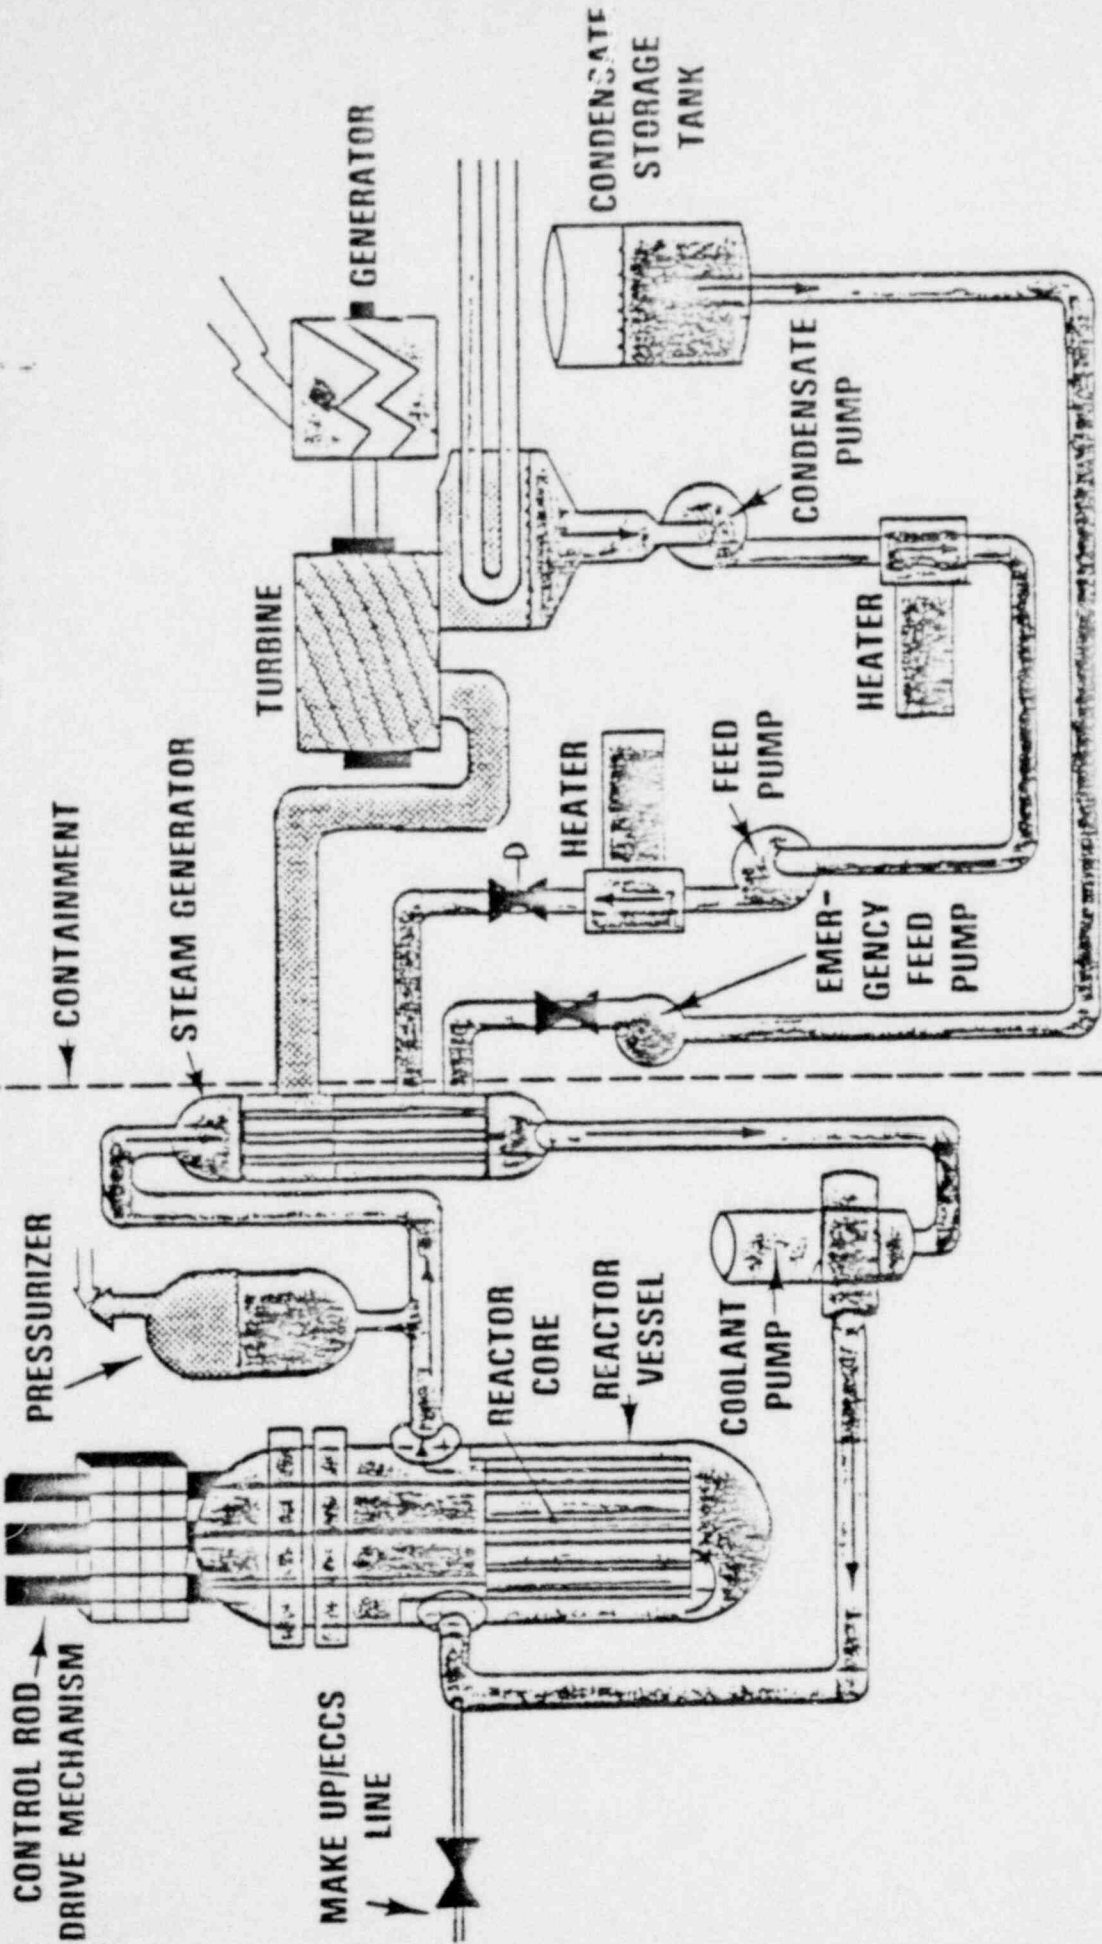
THREE MILE ISLAND UNIT TWO SCHEMATIC

If you look to the left side of the visual aid (enclosed), you will see what we refer to as the primary coolant circuit of the plant. That portion is all contained within the reactor containment building, represented by the dashed line with the label up towards the top with the caption that says, "Containment." When you look at pictures of nuclear plants you will see generally a large cylindrical concrete structure — that is the containment building of the plant.

Now let's look at some of the components within that primary cooling circuit. First let's start with the reactor core. It is there within the reactor vessel. The reactor core is a region of nuclear fuel assemblies. The core is, roughly, 10 feet in diameter and about 12-13 feet in height. The reactor itself is a heavy-walled pressure vessel that is of the order of 60 feet high and about 15 feet in diameter.

The primary system runs at about 2,000 pounds per square inch and at about 600°F. The primary coolant pump causes that water to circulate through the system. The purpose of this circulation is to transport the heat from the reactor to the steam generator.

In the steam generator, water from a separate loop (that one which starts out in the sector outside the containment building, the right hand portion of the schematic drawing) is caused to boil and absorb the heat from the reactor in the

form of high-pressure and high-temperature steam. That steam in turn then is fed through a turbine and then is discharged from the turbine to a condenser. The steam is cooled, "condensed" and changed back to water. It then is returned by means of feed water pumps to feed water heaters and then back to the steam generator. In many ways, this secondary portion outside the containment of the plant is not at all unlike a fossil-fired power plant.

One other component that I would like to point out at this time is back in the primary loop and is the one labeled "Pressurizer." Its purpose is two-fold: 1) it is the device by which we maintain the high pressure in that primary circuit and attempt to maintain that cooling water at all times in a liquid or non-boiling state; 2) that pressurizer is used to absorb changes in volume as the primary system heats up and cools down.

Again, briefly, the heat in the reactor is transported by flowing water to the steam generator. The secondary loop of water is converted to steam in the steam generator, expands through a turbine, the turbine turns a generator and makes electricity. The discharged steam from the turbine is condensed and returned to the steam generator. The heat energy which is not converted to electricity is rejected to the environment in a third loop through the massive cooling towers that you see dominating photos of the TMI station.

At this point everything was in accordance with normal design. Immediately, however, the pressure in the primary system (the nuclear portion) began to increase. In order to prevent that pressure from becoming excessive, a valve located at the top of the pressurizer opened up. That valve (you will sometimes find it referred to as an electromatic valve) should have reclosed when the pressure decreased by about 100 pounds per square inch. However, that valve failed to reclose.

As the system pressure continued to decrease due to the stuck valve, voids began to form in portions of the system other than the pressurizer. Thus the liquid in the primary system redistributed itself and the pressurizer became full of water, but there were voids in other parts of the system. The level indicator in the pressurizer suggested that the system was full of water and caused the operator to stop adding water to the system. He was unaware that, because of the stuck valve, the indicator can, under some circumstances, become ambiguous.
