Millstone Unit No. 2

Steam Generator Eddy-Current Test Results

January 10, 1982

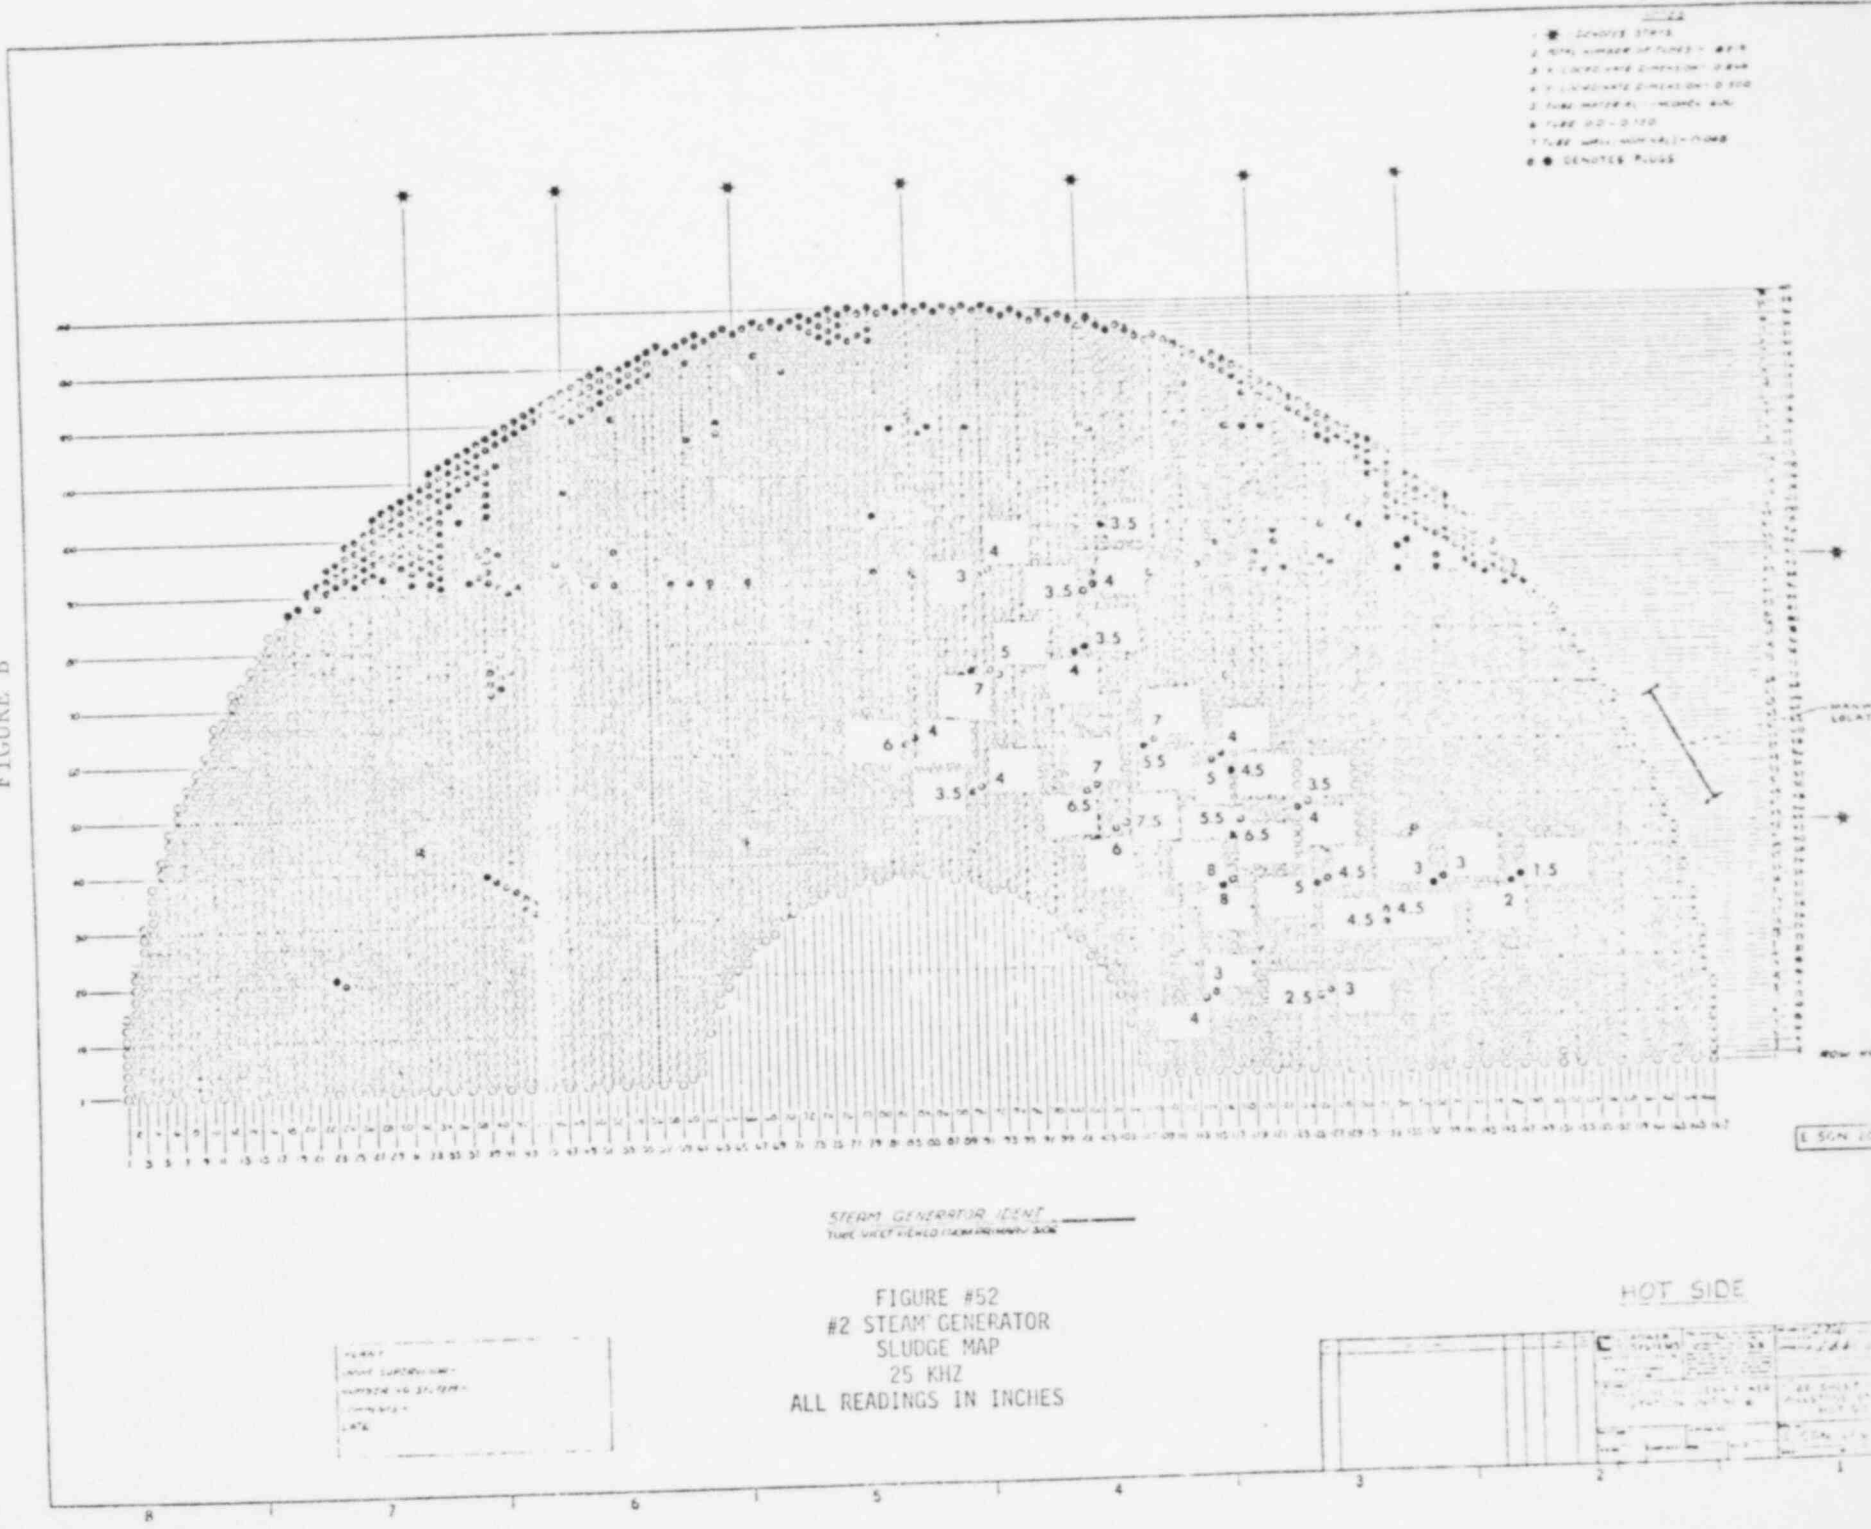
FIGURE B

- 1. □ SCHEMATIC SYMBOL
- 2. ○ SLUDGE DEPOSIT
- 3. ▲ SLUDGE DEPOSIT - 0.5 IN
- 4. ▼ SLUDGE DEPOSIT - 0.75 IN
- 5. ◆ SLUDGE DEPOSIT - 1.0 IN
- 6. ★ SLUDGE DEPOSIT - 1.5 IN
- 7. ⬡ SLUDGE DEPOSIT - 2.0 IN
- 8. ⬢ SLUDGE DEPOSIT - 2.5 IN
- 9. ● DENOTES PLUGS

STEAM GENERATOR ISSENT
TUBE SHEET VIEWED FROM PRIMARY SIDE

FIGURE #52
#2 STEAM GENERATOR
25 KHZ
ALL READINGS IN INCHES

HOT SIDE
