Department of Energy
Washington, D.C. 20545

Docket No. 50-537
HQ:S:83:193

ADDITIONAL INFORMATION - PRIMARY HEAT TRANSPORT SYSTEM (PHTS) HOT LEG PIPING
CODE EVALUATION

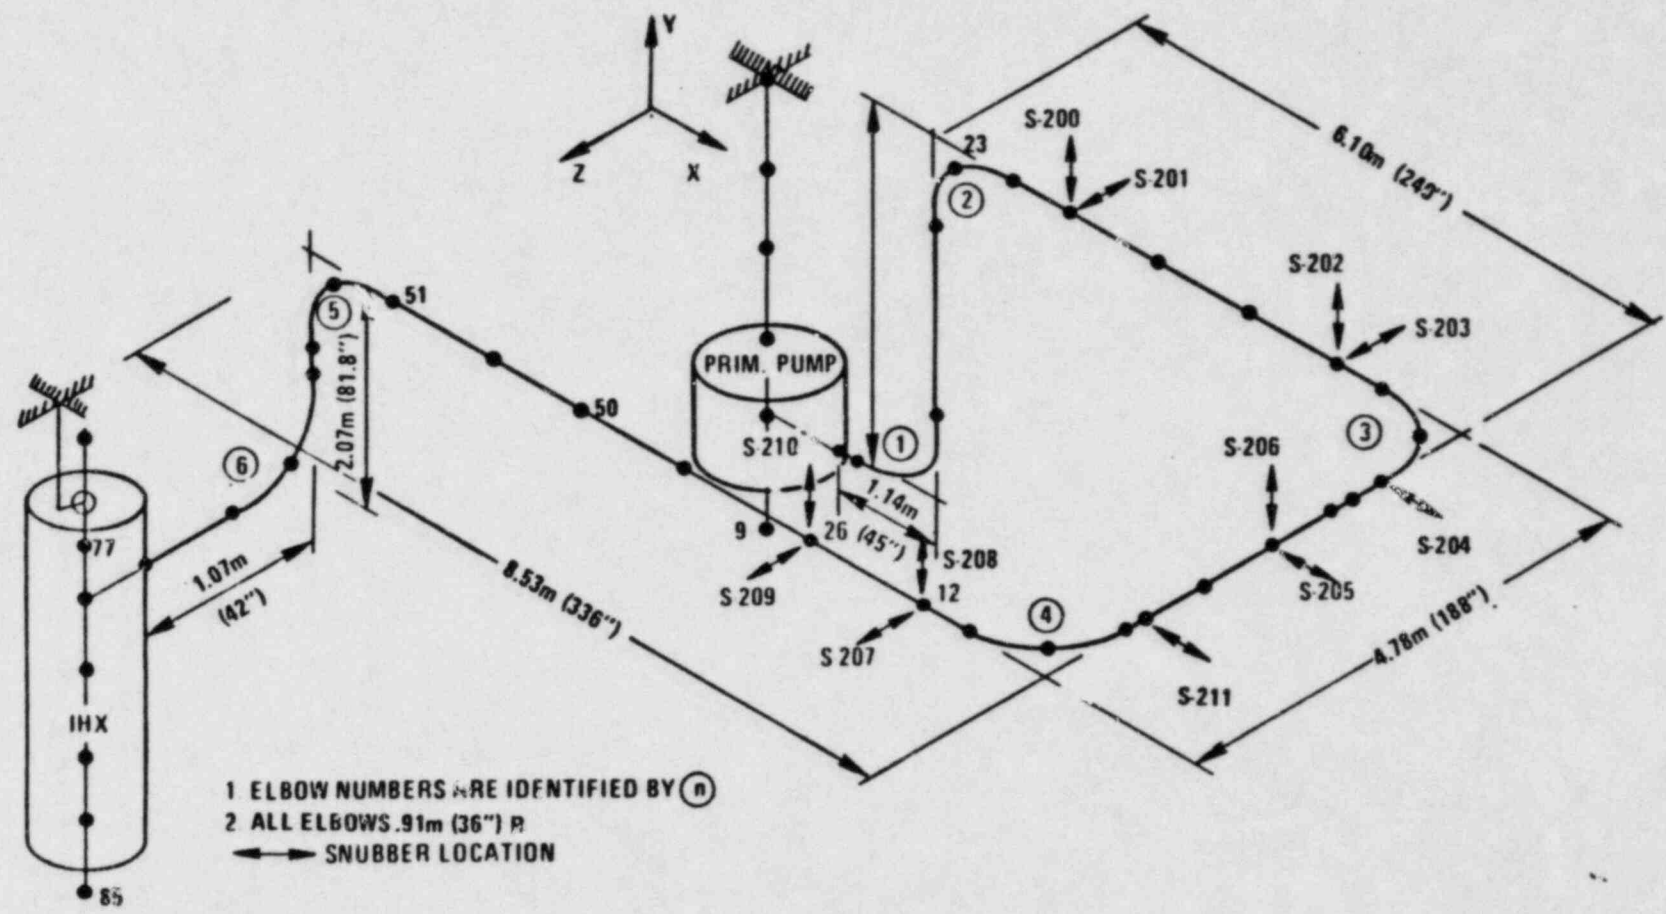
FIGURE 1
 PHTS 24-INCH HOT LEG
 PIPING LOOP ANALYSIS MODEL

The enclosed Table 1 is a summary of the inelastic ratchetting and creep-fatigue check for the PHTS 24-inch hot leg. Table 1 shows that the maximum ratchetting strain occurs at the middle of elbow 1 and the maximum creep damage occurs at the girth weld between the primary pump nozzle extension and elbow 1. The calculated strains and creep-fatigue damages are well within Code Case 1592-7 limits. Hence, the analysis results reported in the Piping Integrity Report (Reference 2), when supplemented by these inelastic analysis results, substantiate the compliance of the hot leg creep-fatigue values with the ASME code limits.

NOTES: (1) SEE ATTACHED FIGURE FOR LOCATION OF ELBOWS.
