Consumers Power Company  
Palisades Plant  
Docket 50-255

SERVICE LIFE ASSESSMENT OF PALISADES  
SPRAY AND SURGE NOZZLE SAFE ENDS  
BWNT CALC No. 51-1235130-01

April 24, 1995

Title Service Life Assessment of Pressurizer Spray and Surge Nozzle Safe Ends

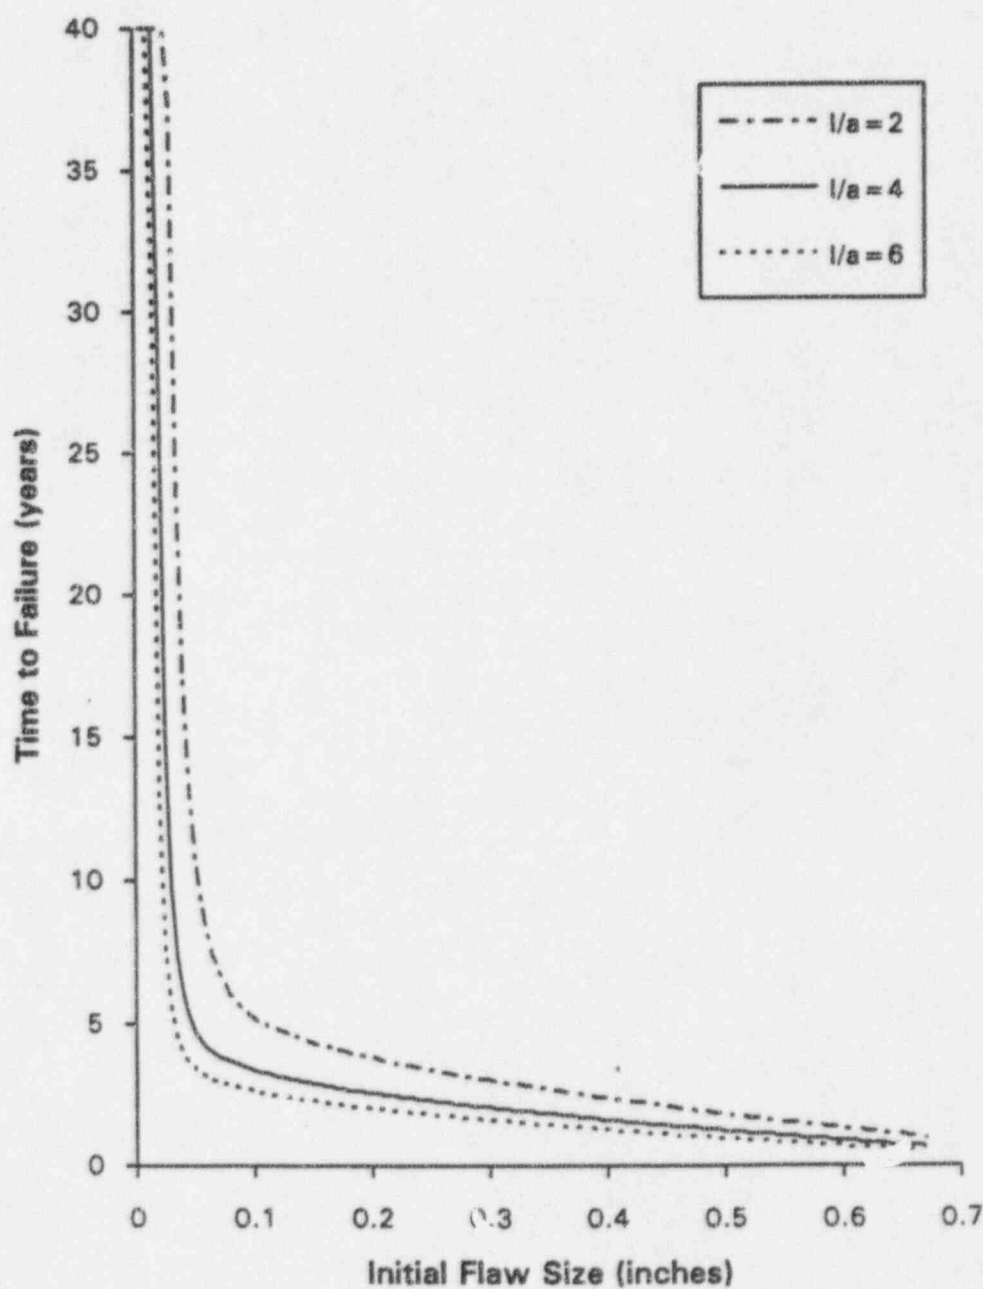
FIGURE 13

REMAINING LIFE VS. INITIAL CRACK DEPTH  
FOR THE PRESSURIZER SURGE NOZZLE SAFE END  
CIRCUMFERENTIAL FLAW  
BASED ON NUREG-0313  
(Ref. 5)

Again, flaws that exceed the maximum allowable sizes as shown above are not acceptable for one cycle of operation, based on the NUREG-0313 approach. Figures 11 through 13 illustrate remaining life vs. flaw size for the three cases tabulated above.
