BASIS FOR
CABLE SYSTEM DESIGN
POWER GENERATING STATIONS

Public Service Electric and Gas Company
Newark, New Jersey
July 16, 1971

INDEX

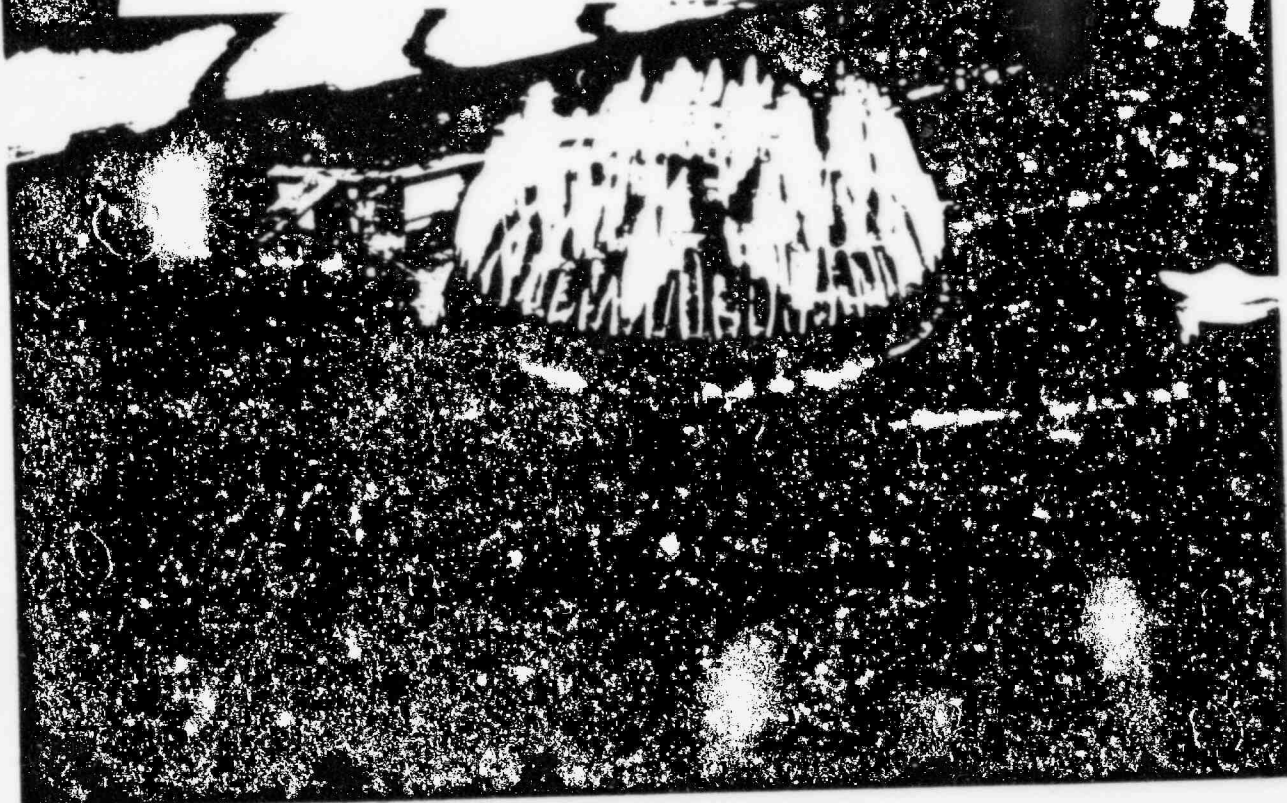
6. Burner Calibrations Prior to Flame Testing

5. An Ellipse wheel gas burner with a 14" outer diameter shall be used as the source of fire. The burner shall be located below the center point lower tray and shall be adjusted to produce a temperature of 1500°F at the point of impingement with the cables. (See Fig. 6)

The complete test data for all the tests is given in tables attached to this section. The gas burner was adjusted prior to the tests to 1500°F at the hottest part of the flame. It was noted that when the thermocouple was moved away from the hottest part of the flame, the temperature dropped off rapidly. During the tests the thermocouple directly above the burner never read above 1060°F because it was not possible to position the thermocouple in the hottest spot. During the test the temperature decreased because of movement of the cables and tray caused by the extreme heat.
